Emerging Technologies in Non-Destructive Testing VI

Editors

D.G. Aggelis & D. Van Hemelrijck

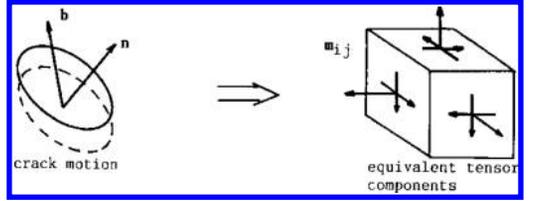
Figure 1. Crack motion and equivalent tensor components.

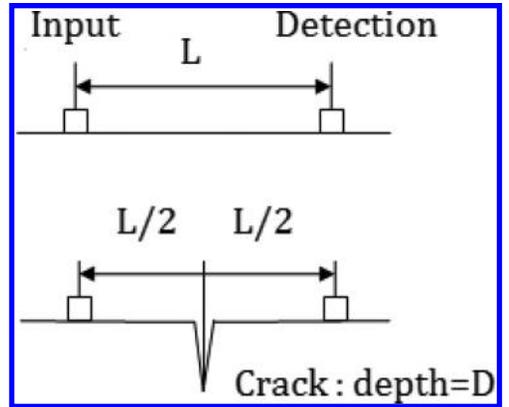
Figure 2. Crack depth estimation by UT (BS1181).

$$d = \frac{L}{2} \sqrt{\left(\frac{T_\varepsilon}{T_0}\right)^2 - 1} \quad (8)$$

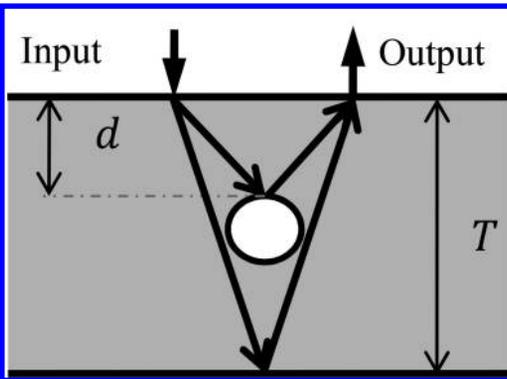
Figure 3. Configuration for impact-echo.

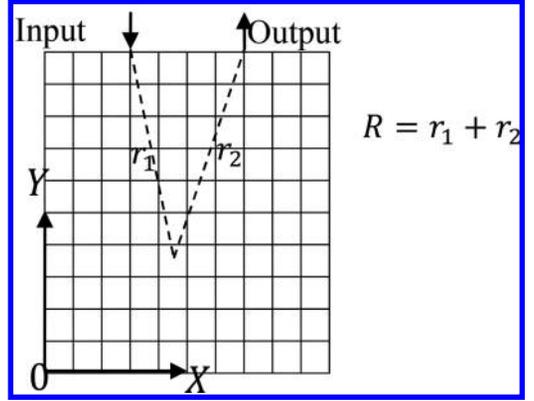
Figure 4. SIBIE imaging model (Ohtsu&Watanabe, 2002).

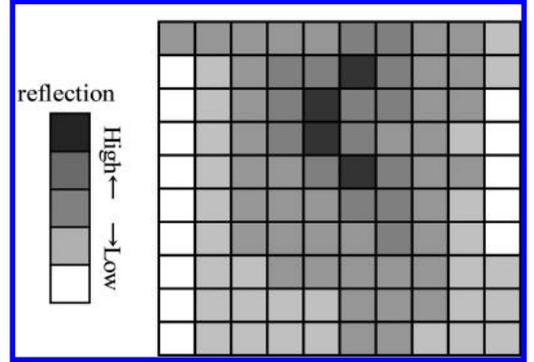
Figure 5. Example of SIBIE result.

Spectral amplitudes corresponding to these two resonance frequencies in the frequency spectrum are summed up at each element as shown in Figure 5. Thus, reflection intensity at each element is estimated as stack image.

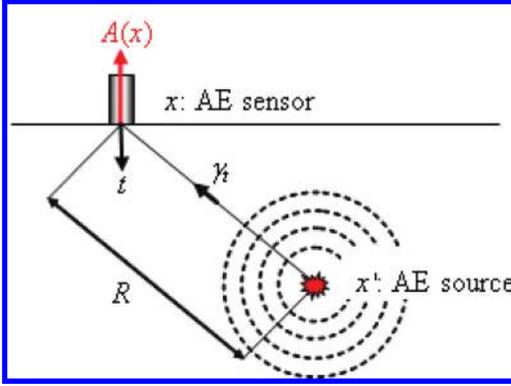
Figure 6. Crack nucleation and AE detection.

coefficient at the surface of detection. R is the distance between the source y and the detection point x , of which direction cosine is $\mathbf{r} = (r_1, r_2, r_3)$. These factors are illustrated in Figure 6.

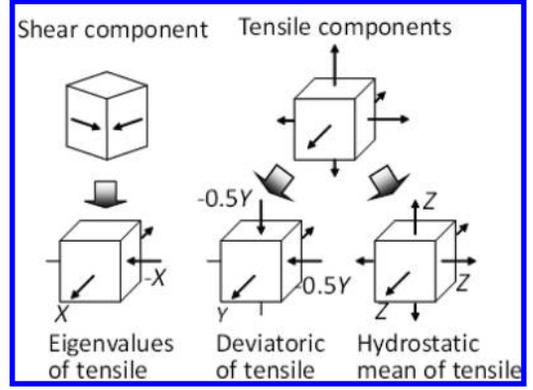
Figure 8. Unified decomposition of eigenvalues.

The eigenvalues of the moment tensor are represented by the combination of the shear crack and the tensile crack as shown in Figure 8.

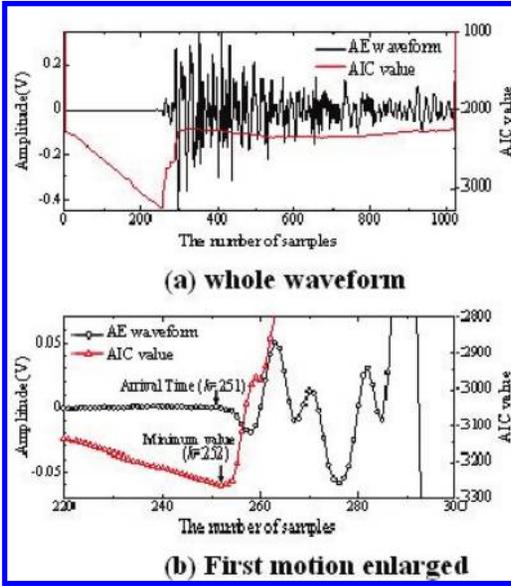
Figure 7. Recorded AE waveform (Ohno & Ohtsu, 2010).

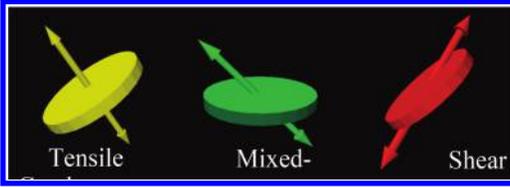
are determined. Here, vector \mathbf{l} and \mathbf{n} are interchangeable. In order to visualize kinematical information of AE sources, crack models classified as tensile, mixed-mode and shear are given in Figure 9. Here, an arrow vector indicates the crack motion vector \mathbf{l} , and the circular plate corresponds to a crack surface which is perpendicular to the crack normal vector \mathbf{n} .

Figure 9. Visualized models of tensile, mix-mode and shear cracks.

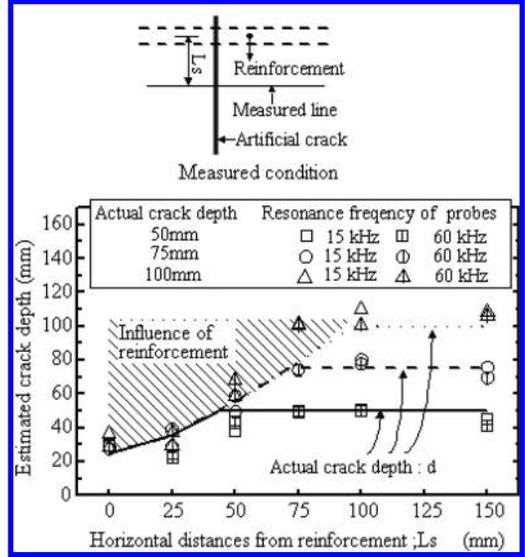
where L_c is the cover-thickness from rebar and L_s is the horizontal distance from the rebar to the crack as shown in Figure 10. If the depth d determined by Eq. 8 is shorter than d_r , the presence of rebar is negligible, without the effect of sensor selections. Otherwise, the crack depth is underestimated, as shown in the figure, due the effect of rebar. This could happen if the crack is nucleated deeper than the cover-thickness and rebar is located close to the crack (JCMS-III B5705, 2003).

Figure 10. The effect of rebar on crack-depth evaluation (JCMS-III).

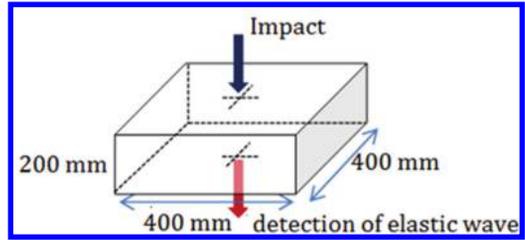
In the case where Lamb's solution is available (Ohtsu & Ono, 1984), Green's function in Eq. 3 is known. Consequently, impact $f(t)$ and frequency spectrum $F(f)$ are rationally recovered if the detecting system has a flat response. In a concrete block illustrated in Figure 11, elastic waves are detected

Figure 11. Concrete block for calibration.

due to impact, by the laser-interferometer, which is calibrated of a flat response up to 50 kHz. The configuration of the impactor and the detection presents Lamb's problem of buried pulse.

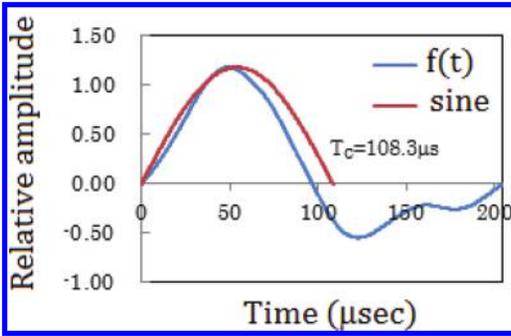
In the proposed procedure, a detected wave by the laser-interferometer is transformed by Fast Fourier Transform (FFT) and then $U(f)$ in Eq. 5 is obtained. After calculating $G(f)$, $F(f)$ is derived from $U(f)/G(f)$. In order to check an applicability of this procedure, a steel-ball of 20 mm diameter was dropped from 100 mm height. Then, $F(f)$ was calculated, and further transformed into the time domain by inverse FFT. According to the Sansalone (Sansalone & Streett, 1997), the impact due to a steel-ball drop is known to be approximated by a sine function of the contact time t_c . So, function $f(t)$ is compared with a sine function in Figure 12. A reasonable agreement is confirmed as the contact time $t_c = 108.3 \mu s$ obtained from $0.0043D$.

Figure 12. Recovered function of the impact due to steel-ball drop.

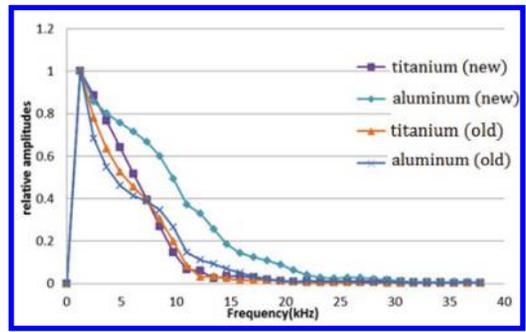
Figure 14. Frequency responses of the impactor devices.

Frequency responses $F(f)$ are estimated from Eq. 5, and normalized as shown in Figure 14. It is found that a new impactor with titanium head has the wide frequency up to 25 kHz.

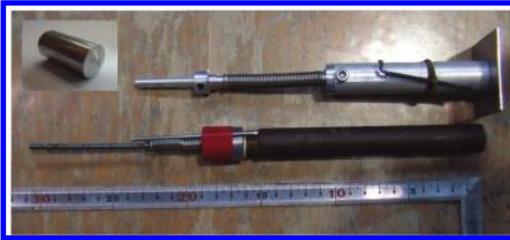
Figure 13. Impactor devices.

Although Sansalone proposed to employ the steel-ball drop as the impactor, it is not easy to apply on-site measurement. In addition, the higher frequency is in demand for shallow defects, the smaller power could be driven by the steel ball of small diameter. Therefore, a device for the impactor is under development. Previously, a bullet was shot with compressed air (Ohtsu et al. 2008). In order to make the device light-weight and easy-use for on-site measurement, an impactor driven with a spring is recently developed. So far, two types of the impactors are made as shown in Figure 13. A bullet in the figure is attached to the rod-head inside the cylinder. An old device on the bottom is made of steel cylinder, while a new device on the top is of aluminum cylinder to decrease the weight. Two bullets (heads) are prepared. One is made of titanium and the other is of aluminum.

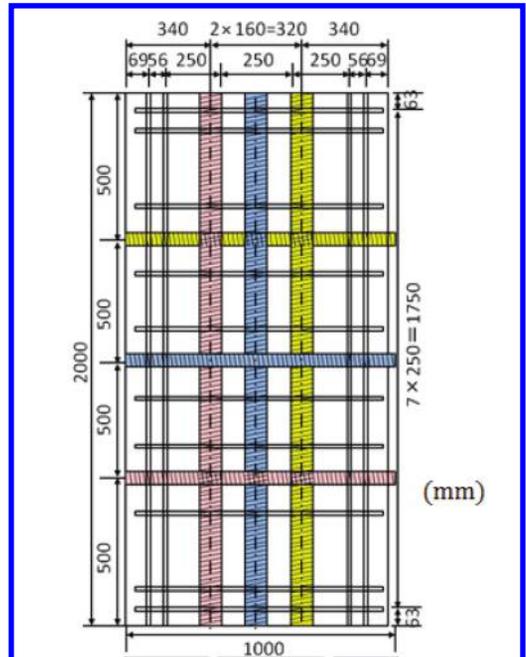
A model specimen for experiments is illustrated in Figure 15. Three ducts for post-tensioning in pre-stressed concrete are embedded. By employing the new impactor with titanium head, impact tests were conducted. As shown in Figure 15 (b), three ducts are ungrouted, partially grouted and fully grouted.

(a) plan view of model specimen.

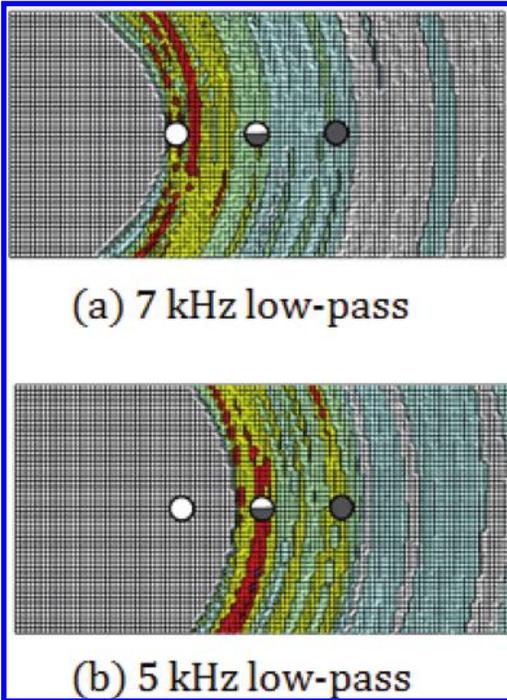
Figure 16. Results of SIBIE analysis.

Results of SIBIE analysis are shown in Figure 16. The impact was driven from the left in Figure 15 (b). In order to visualize results in the analysis, the upper-bound frequency is set to 7 kHz for a shal-

low duct and 5 kHz for a deeper duct from the left. It is clearly found that both ungrouted and partially grouted duct are visually detected.

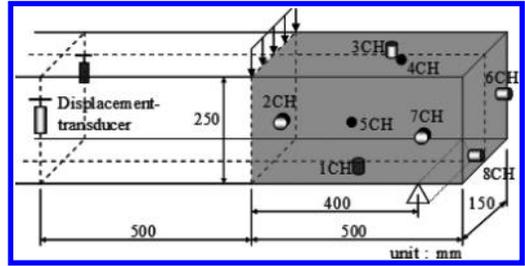
A Reinforced Concrete (RC) beam of dimensions 150 mm × 250 mm × 2000 mm was tested. The compressive strength of concrete at 28-day standard curing was 29.7 MPa. P-wave velocity was 4230 m/s. Two reinforcement bars (13 mm in diameter) were installed with cover thickness 46.5 mm from bottom. In order to focus on the diagonal-shear failure, eight AE sensors were attached using electron wax on the surface of shear span as illustrated in Figure 17.

Figure 17. AE sensor array in RC beam tested.

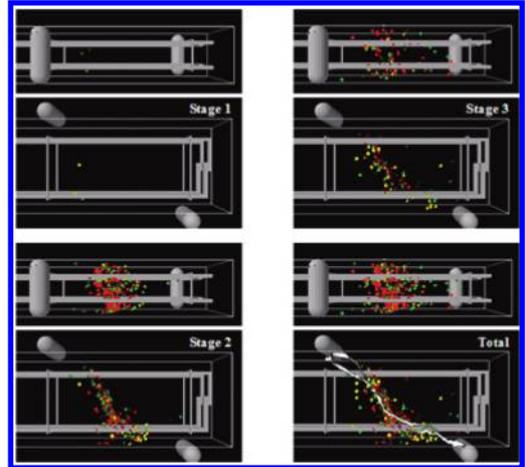
Figure 18. Results of SiGMA analysis in shear failure (Ohno & Ohtsu, 2010).

Time (EDT) of 120 μ s. Results of the SiGMA analysis are shown in Figure 18. The locations of 370 AE events are determined. It is clearly realized that most of micro-cracks are located around the cracks of the diagonal-shear failure as inserted in the graph. Thus, SiGMA analysis is applicable to visually identify internal mechanisms of concrete failure.

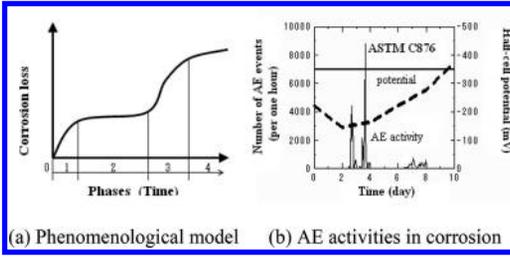
According to a phenomenological model of reinforcement corrosion in marine environments (Melchers & Li, 2006), a typical corrosion loss is illustrated as shown in Figure 19 (a). At phase 1, the corrosion is initiated. The rate of the corrosion process is controlled by the rate of transport of oxygen. As the corrosion products build up on the corroding surface of rebar, the flow of oxygen is eventually inhibited and the rate of the corrosion

Figure 19. Phenomenological mode and AE activities in corrosion process (Ohtsu & Tomoda, 2008).

loss decreases at phase 2. The corrosion process involves further corrosion loss as phases 3 and 4 due to anaerobic corrosion. Thus, at two stages of phase 1 and phase 3, the corrosion process is activated. We conducted an accelerated corrosion test of rebar corrosion, and found that two active generations of AE hits as shown in Figure 19 (b) (Ohtsu & Tomoda, 2008). Active AE generations are reasonably identified, corresponding to the two phases. It is clarified that the 1st activity corresponds to rust nucleation on rebar surface and the 2nd generation results from concrete cracking due to expansion of corrosion products.

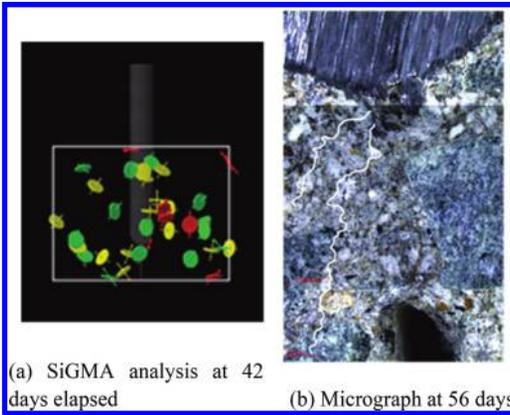
Figure 20. Results of SiGMA analysis in corrosion (Kawasaki et al., 2012).

SiGMA analysis was applied to the 2nd activities of AE in the accelerated corrosion test (Kawasaki et al., 2012). Results of SiGMA analysis at 42 days elapsed are shown in Figure 20 (a) on a cross-section. Mostly events are located surrounding rebar. The events which are located at -78.75° orientation are mostly classified into tensile (opening) cracks. Additionally, shear cracks (sliding) are observed at 78.75° orientation, after tensile cracks observed.

Results of the stereo-microscope of cross-section at 56 days are shown in Figure 20 (b). Three micro-cracks were observed at the cross section toward the bottom of RC beam. Orientation of these cracks is about -78.75° . Thus, it is confirmed that tensile cracks are observed at -78.75° orientation.

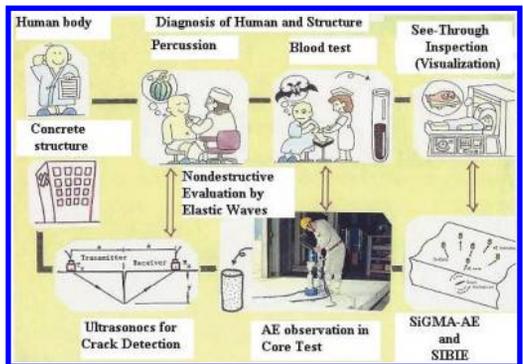
In the ningen-dock, during the course of one or two days, clients undergo such inspections as blood test, urine and fecal exams., X-ray, ultrasonography, and so forth along with a consultation with a doctor. The ningen-dock for human-body is illustrated in Figure 21, along with a conceptual illustration of the infra-dock at the bottom. Here, a percussion treatment is referred to as comparable to UT. An internal inspection by a see-through technique (X-ray CT) is compared with SIGMA and SIBIE. Thus, the elastic-wave methods could readily contribute inspection procedures in the infra-dock.

Figure 21. Concept of Infra-dock.

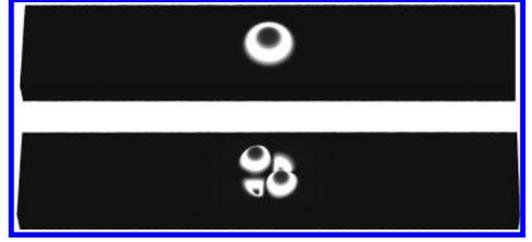
The problem in practical use of the analytical approach is concerned with the boundary conditions for the defect edges, which were assumed to be clamped in deriving (2). Instead, the finite element simulation by using the software Comsol Multiphysics (physics package “structural dynamics,” “eigenfrequency analysis”) was found to be suitable for analyzing the vibration characteristics of structures with defects and estimation of the LDR frequencies. Figure 1 (top) illustrates the vibration pattern at frequency 10.4 kHz, which is readily identified as a fundamental LDR of a circular FBH in a PMMA plate, followed by the higher-order LDR at higher driving frequency of 23.25 kHz (Fig. 1, bottom).

Figure 1. FEM simulation of vibration patterns of a PMMA plate (thickness 3 mm) with a circular FBH (radius 1 cm, depth 2 mm): fundamental LDR (10.4 kHz) (top), and higher-order LDR (23.25 kHz) (bottom).

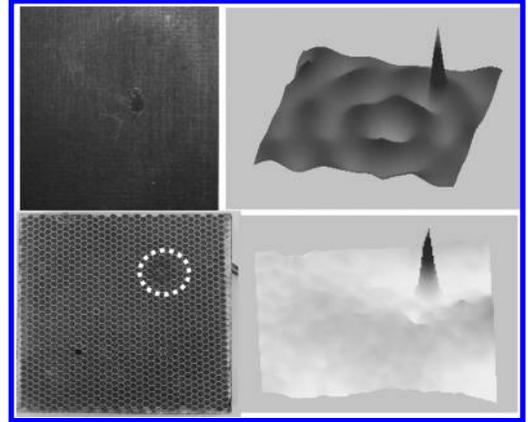
Figure 3. Fundamental LDR (48.5 kHz) in heat damaged CFRP area (top) and delamination in honeycomb glass fibre-reinforced (GFRP) structure (bottom, LDR 14.94 kHz).

scan of the vibration field inside the defect area in a wider frequency range reveals the higher-order LDR with multiple nodal lines in the vibration patterns (Fig. 2b, c). Such a methodology was successfully applied to a search of the LDR in a variety of materials. The two examples presented in Figure 3, illustrate a clear evidence of LDR in kHz-frequency range for damage in composites. Similar LDR with local resonance “amplification”

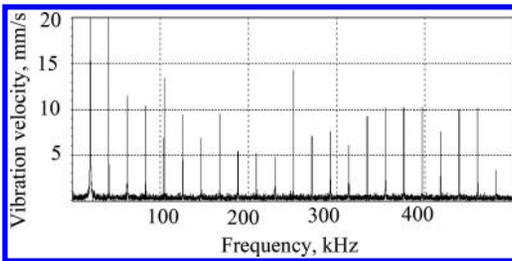
Figure 4. HH spectrum for delamination in glass fiber reinforced (GFRP) specimen driven at LDR frequency 20900 Hz. Input voltage is 7 V.

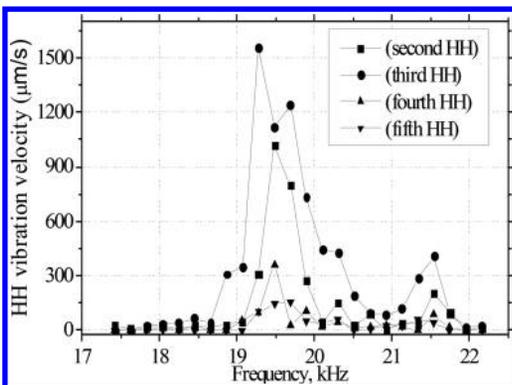
The bottleneck problem of nonlinear NDT is a low efficiency of conversion from fundamental frequency to nonlinear frequency components. Since LDR is as an efficient resonant “amplifier” of the local vibrations, one would expect it to contribute appreciably to defect nonlinearity. An extremely high resonant nonlinearity is demonstrated in Figure 4 for a delamination in GFRP plate: Multiple Higher Harmonic (HH) generation is observed in the defect area while driving the specimen at LDR frequency at LDR frequency even at moderate input voltage. A crucial role of the driving frequency match to LDR for nonlinearity increase is illustrated in Figure 5 for a crack in a UniDirectional (UD-) CFRP rod. As the driving frequency matches the

Figure 5. Higher harmonic LDR frequency responses of a crack in UD-CFRP.

LDR frequency (19.5 kHz), a strong enhancement of the HH amplitudes generated locally in the defect area is observed.

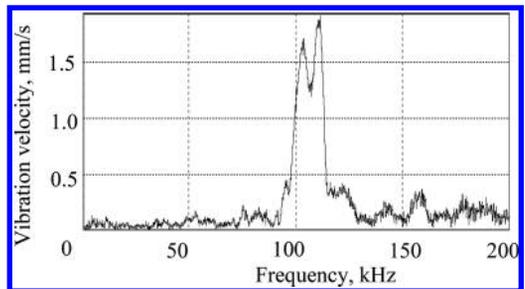
An application of LDR as the “frequency mixing amplifier” for NDE and imaging of realistic defects is illustrated then in Figures 6–7 for an impact-induced damage (area $\sim 5 \times 5 \text{ mm}^2$) in CFRP plate ($280 \times 40 \times 1 \text{ mm}^3$). A linear LDR frequency response of the impact demonstrates a well-defined double-maxima peak around 110 kHz (Fig. 6). In the experiment, the two interacting flexural waves were excited in a continuous wave mode by using the piezo-transducers attached to the opposite edges of the plate. One of the frequencies was fixed at $f_1 = 77.5 \text{ kHz}$ while the other was swept from $f_2 = 28.5$ to 37.5 kHz to provide the sum frequency variation around the LDR frequency of the defect. Figure 7 shows the velocity amplitude

Figure 6. LDR frequency response for an impact induced damage in a CFRP plate.

To illustrate the LDR benefit to enhancement of thermosonics efficiency the defect temperature response is measured as a function of driving ultrasonic frequency. The example in Figure 18 for point-like impact damage in a CFRP plate demonstrates substantial temperature increase (~ 15 times) at LDR frequency $\sim 110 \text{ kHz}$ in accord with the defect acoustic response shown in Figure 6.

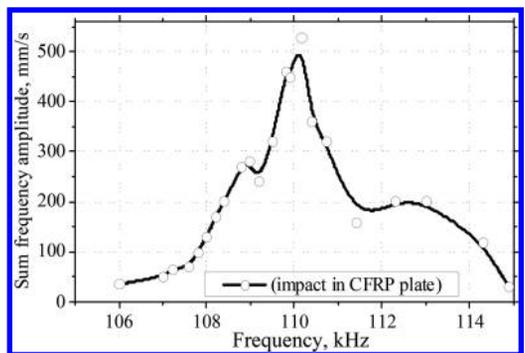
Figure 7. LDR induced amplification at the sum frequency vibration for impact damage in a CFRP plate.

at sum frequency as a function of f_1 measured by changing f_2 in the frequency range indicated above. The impact of LDR is clearly seen by comparing the data with those in Figure 6: more than 20 dB increase in the output is observed when the combination frequency matches the frequency of LDR.

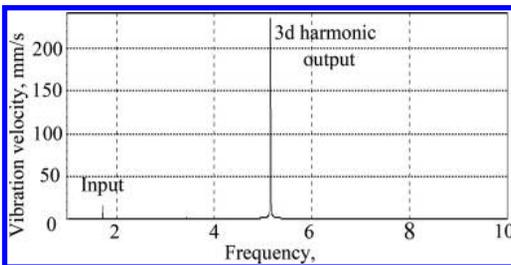
A direct proof of superharmonic resonances in defects is demonstrated for the third-order resonance in impact damaged CFRP specimen with LDR around 5140 Hz in Figure 8. One-third of the LDR frequency (1714 Hz) was therefore selected for the excitation and the input voltage was increased up to 80 V. The spectrum (Fig. 8) of the defect vibrations measured in the defect area beyond the threshold illustrates the dominance of the third harmonic: the third harmonic amplitude is ~ 25 dB higher than fundamental frequency component.

Figure 8. Spectrum of the third-order superharmonic LDR in impact damaged CFRP plate.

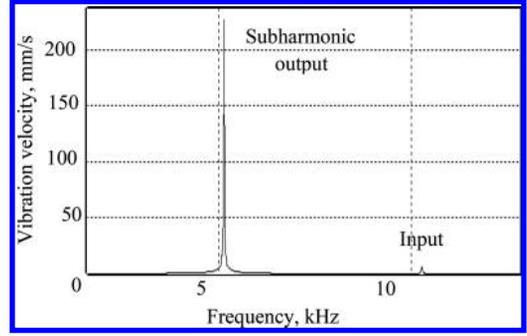
Figure 9. Subharmonic spectrum for LDR of impact damage in CFRP beyond threshold input voltage 45 V.

To observe the resonant growth of subharmonic the excitation frequency was changed to the second harmonic (10280 Hz) of the fundamental LDR for the impact damage in CFRP. The threshold for the resonance was found to be ≈ 45 V. Beyond the threshold, the subharmonic component increases dramatically and prevails in the vibration (velocity) spectrum: $V_{\omega/2} / V_{\omega} \approx 30$ dB at 10280 Hz input (Fig. 9). The input frequency range for both subharmonic and superharmonic resonances was measured to be within ~ 100 – 200 Hz that corresponds to a high Q factor of the LDR for this defect.

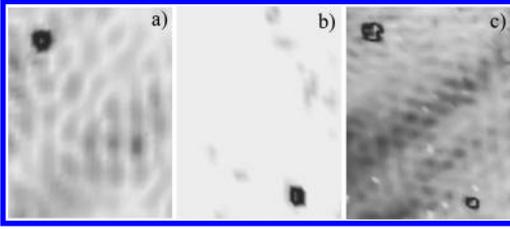
Figure 10. Frequency-selective defect imaging of delaminations in CFRP plate in a linear LDR mode: excitation frequency 71250 Hz (a); 91130 Hz (b); wideband excitation 45–100 kHz (c).

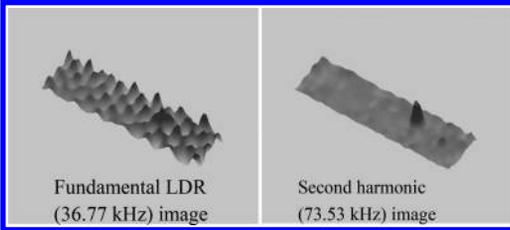
Figure 11. Linear (left) and HH (right) LDR imaging of a delamination in GFRP specimen.

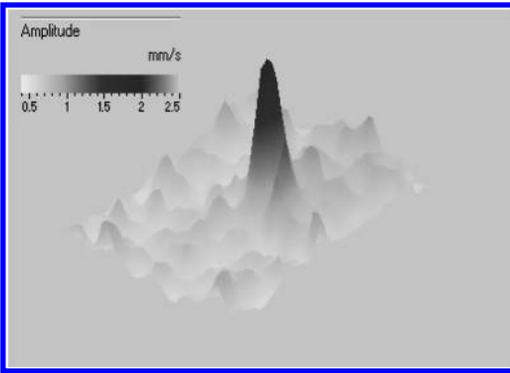
Figure 12. Sum-frequency image of the impact-induced damage ($\sim 5 \times 5 \text{ mm}^2$) in a CFRP plate.

contribution to the sum-frequency signal makes it localized in the damage area and enables to be used for mixing frequency imaging with reasonable signal-to-noise level ($\sim 15 \text{ dB}$, Fig. 12). This image of the impact in a CFRP plate was obtained by mixing two flexural waves of frequencies 77 kHz and 30 kHz via the combination frequency resonance (LDR frequency of the defect 107 kHz). The benefit of the subharmonic LDR is illustrated in Figure 13 for the impact damage in CFRP specimen.

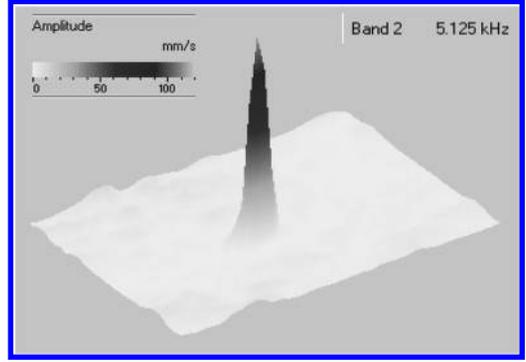
Figure 13. Subharmonic LDR imaging of impact damage in a CFRP plate: Input 10250 Hz; output 5125 Hz.

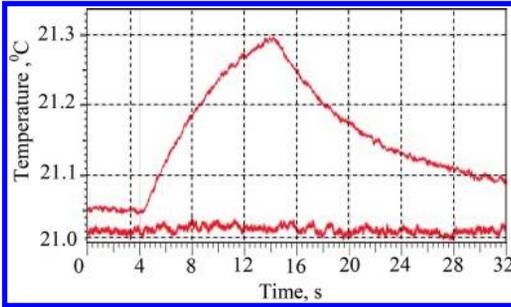
The LDR-induced amplification of local vibrations is, therefore, beneficial for enhancement of acousto-thermal conversion and would enable to reduce acoustic power required for thermosonic imaging. Figure 14 illustrates the benefit of LDR thermosonic imaging of the square insert in CFRP specimen. A crucial role of LDR is readily seen: At fundamental LDR frequency (8980 Hz) the temperature response ($\sim 0.25 \text{ K}$) is by more than an order of magnitude higher than that outside the LDR (8000 Hz).

Figure 14. Temperature response of a rectangular insert in CFRP plate at LDR frequency (8980 Hz, upper curve) and outside resonance (lower curve, 8000 Hz).

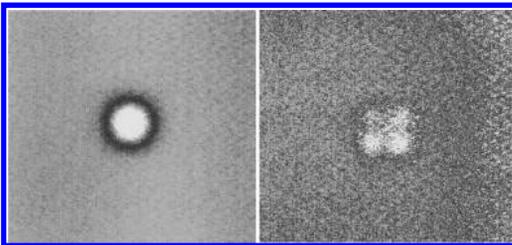
Figure 15. Thermosonic images of a rectangular insert in CFRP plate at fundamental LDR frequency (8980 Hz, left) and at higher-order LDR (15600 Hz, right).

the corresponding excitation frequencies (Fig. 15) demonstrate the importance of the higher-order resonances for visualization of the defect shape: while the fundamental LDR visualizes the center part, the higher-order LDR are responsible for imaging of the border areas of the defect.

This feature is beneficial for the quality of thermosonic imaging: the higher-order resonant thermal patterns visualize the contours of defects and thus applicable for recognizing a real defect size and shape. To image an entire defect area various order thermal images can apparently be superimposed. The impact of wideband excitation on resonant imaging of defects is illustrated in Figure 16 for both laser vibrometry and thermosonics. The excitation of the square insert with fundamental LDR of 8980 Hz by using a periodic sweep mode (1–200 kHz bandwidth) results in a superposition of various order resonant patterns (both thermal and vibration) and reproduces an entire shape of the defect.

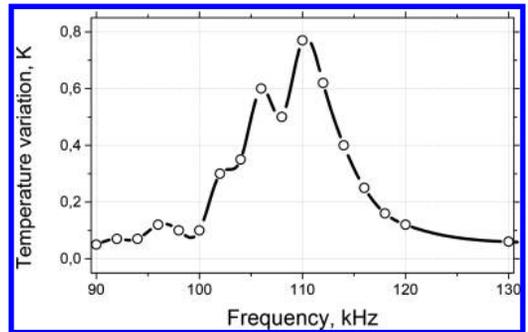
Figure 18. Thermal LDR frequency response of an impact induced damage in a CFRP plate.

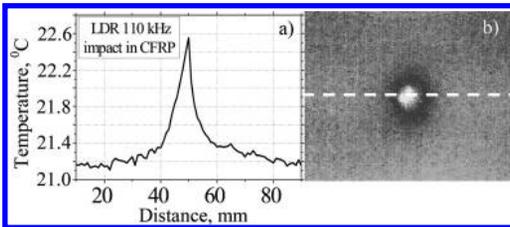
this defect is measured for calibrated ultrasonic power obtained with laser vibrometry. The data in Figure 19, a confirms highly efficient LDR thermosonics: $\Delta T = 1.4$ K for ~ 60 mW input acoustic power. Such temperature variation provides reliable imaging in mW power range with a high temperature contrast in lateral direction (Fig. 19b).

Figure 19. LDR thermosonic imaging of $\sim (5 \times 5 \text{ mm}^2)$ impact damage area in a CFRP plate (b); quantified temperature contrast of the image along the dotted line (a).

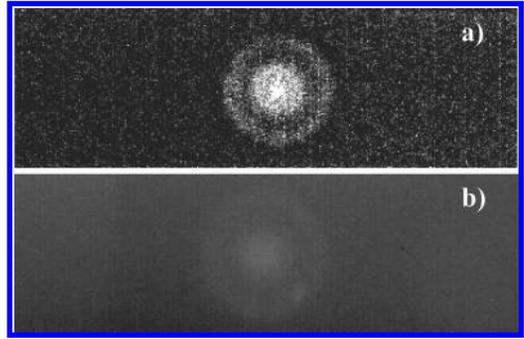
The enhancement in sensitivity and the SNR of LDR lock-in imaging are readily seen from Figure 20, where the amplitude lock-in (a) and LDR temperature (b) thermosonic images of a circular Flat-Bottomed Hole (FBH) in PMMA plate are shown. To have the $SNR > 1$ directly in the temperature image (without lock-in) (Fig. 20b), the input power had to be increased by up to ~ 2 mW (to generate $\Delta T \sim 100$ mK). On the contrary, the LDR lock-in image in Fig. 20a) was taken when the input was reduced to anomalously low power of ~ 200 μ W. The background for such an extraordinary performance is a combined action of the lock-in (reduction SNR) and the high thermosonic quality factor (efficient heat generation) in the LDR mode.

Figure 20. LDR thermosonic imaging of FBH in PMMA plate at LDR frequency 7670 Hz: (a) - amplitude lock-in (lock-in frequency 0.05 Hz) image (acoustic input ~ 200 μ W); (b) - temperature image at input power ~ 2 mW.

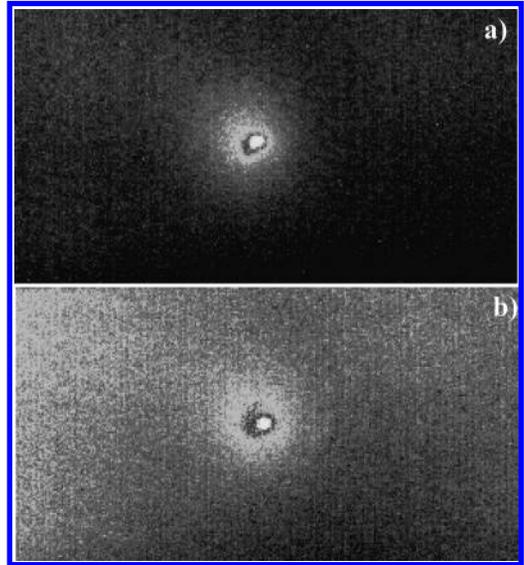
Figure 21 illustrates the enhancement in sensitivity of thermosonics by combining LDR and lock-in

Figure 21. LDR thermosonic imaging of an impact ($\sim 5 \times 5 \text{ mm}^2$) in CFRP plate: amplitude lock-in image (a) at ~ 1 mW input acoustic power; (b) - temperature image at ~ 16 mW input power.

for an impact damage in a CFRP plate: the amplitude lock-in image (a) corresponds to ~ 1 mW input power while a similar contrast of the temperature image (b) requires ~ 16 mW of acoustic power.

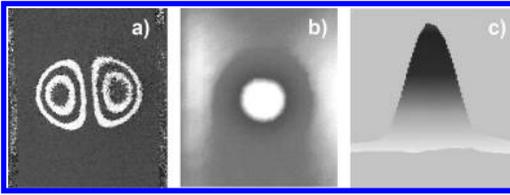
Figure 22. Sherographic (a) and laser vibrometer images (b (top view), c (side view)) of a FBH vibration in PMMA plate at fundamental LDR (7672 Hz).

In Figure 22, the laser vibrometer and shearography images of a FBH vibration in PMMA specimen obtained at the fundamental LDR (7672 Hz) are compared. The ‘butterfly’ fringe pattern (Fig. 22a) clearly demonstrates that shearography is sensitive to the gradient of out-of-plane LDR displacement (“bell-like” function in Fig. 22c) in the shearing (horizontal) direction. The increase

in out-of-plane vibration amplitude due to LDR provides a strong increase in the corresponding strain and thus enhancement of sensitivity in LDR shearography mode.

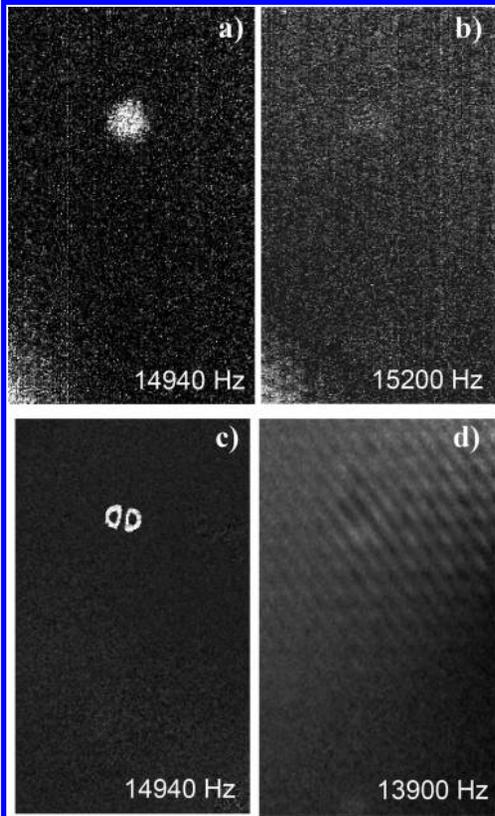
Figure 23. Impact of frequency mismatch on LDR thermosonic (a, b) and shearographic (c, d) imaging of an adhesion lack area in honeycomb structure (Fig. 3): the excitation frequencies are indicated on the images.

The effect of LDR shearography is demonstrated in Figure 23 for aluminium honeycomb structure (thickness 16 mm) with several inclusions of resin and water in GFRP liners ($0.5 \times 100 \times 100 \text{ mm}^2$). The laser vibrometry scan of the front side shown in Figure 3 indicates fundamental LDR of one of the defects at 14940 Hz. The ultrasonic excitation for LDR shearography was carried out by conventional piezo-ceramic transducers (Conrad Elektronik GmbH) attached to the rear side of the structure. The results of both shearographic and

thermosonic imaging (Fig. 23) confirm substantial enhancement of the sensitivity of detection at the LDR frequency: the images practically disappear even at a minor frequency mismatch from the LDR frequency (Fig. 23).

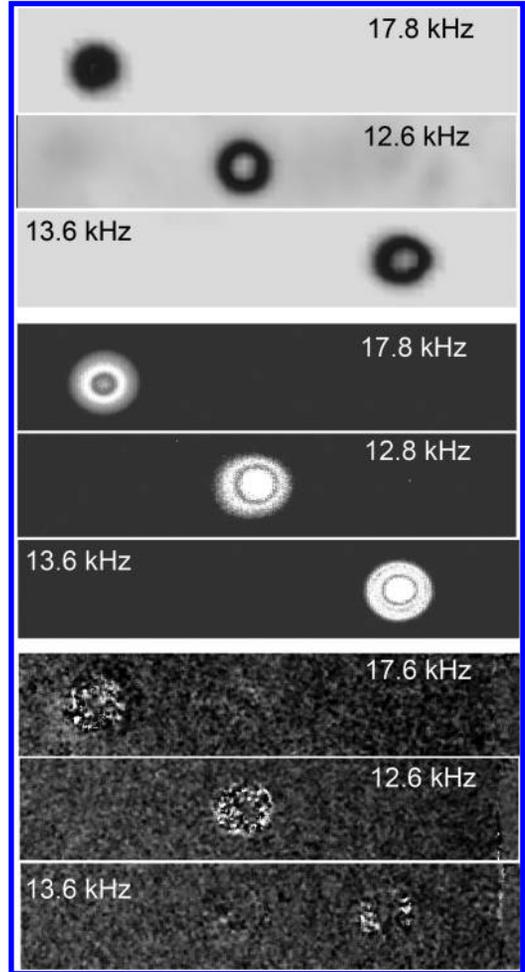
Figure 24. LDR laser vibrometer (top), thermosonic (center) and shearographic (bottom) images of three circular FBH in PMMA specimen: the frequencies of maximum output are indicated on the images.

To trace frequency selectivity of LDR shearographic imaging (discussed above for laser vibrometry) we used a set of three circular FBH in a PMMA plate. For the plate thickness of 25.5 mm, the depths of the holes changed from 22 to 24 mm thus defining different LDR frequencies and driving excitation frequencies, respectively. The images of the defects obtained by the laser vibrometry, thermosonics and shearography at corresponding LDR frequencies are compared in Figure 24. They confirm maximum sensitivity at the LDR frequencies; a minor variation of the frequencies is caused by different clamping conditions of the specimens.

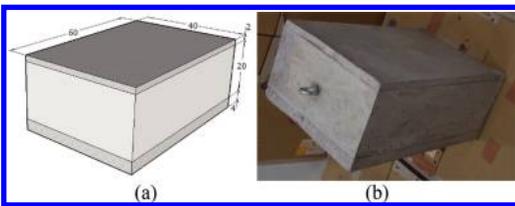
The specimen (see Fig. 1) was a cuboid of 40 cm in width, 60 cm in length and 26 cm in depth. The main body of 20 cm deep was casted with normal concrete, with a design strength $\sigma_c = 21 \sim 24 \text{ N/mm}^2$. The top and bottom surfaces was covered by mortar with a w/c ratio up to 90% and design strength $\sigma_m = 15 \text{ N/mm}^2$ to model deteriorated concrete. The depth of the surface layers is 40 and 20 mm, respectively. No rebar is embedded in the specimen for simplification and only the 40 mm side was studied in the current feasibility study.

Figure 1. Test specimen: (a) design drawing with dimensions (in cm); (b) photo.

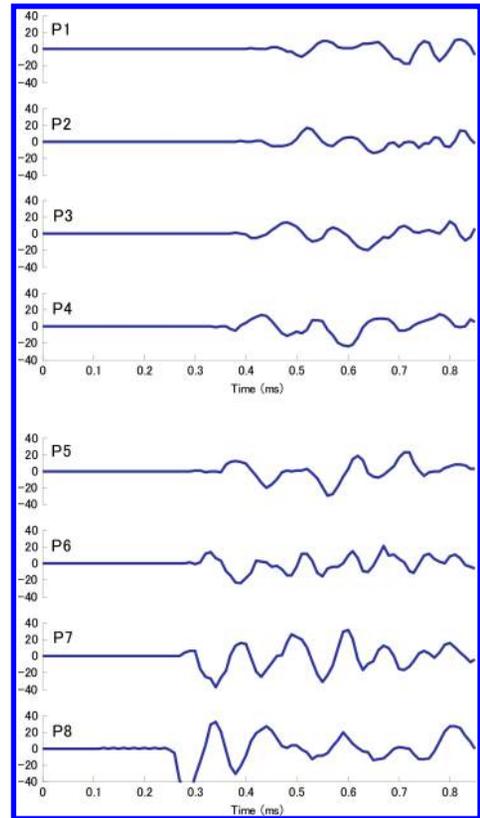
Figure 3. Waveforms recorded at all eight locations.

Firstly the waveforms of each sensor subjected to the impact were recorded, as shown in Figure 3.

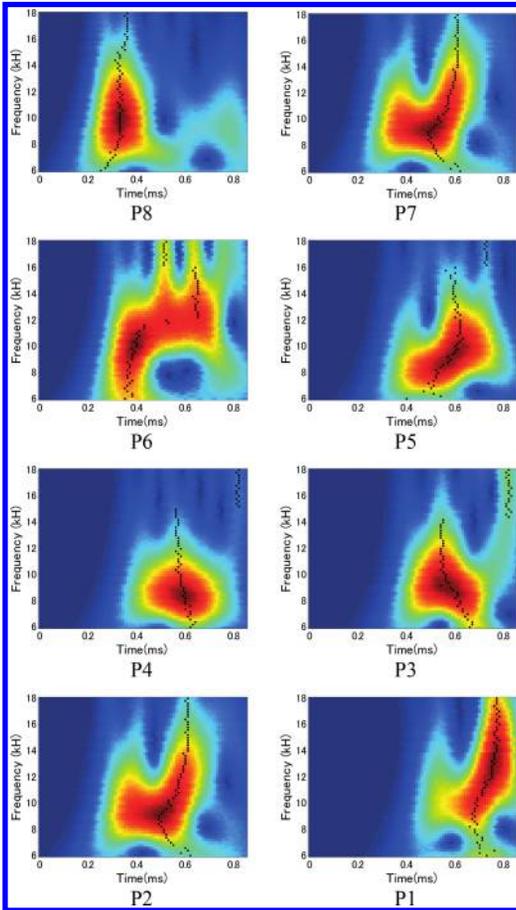
Figure 4. Wavelet spectrum of the waveforms recorded at all eight locations, impact nearby P8, $D = 5$ mm (red, yellow, green and blue counters indicate large to small amplitudes; black dots indicate the peak with respect to each frequency).

(1) P8 might serve as the reference point because it was the point closest to the impact point. From its Wavelet spectrum, it is observed that most

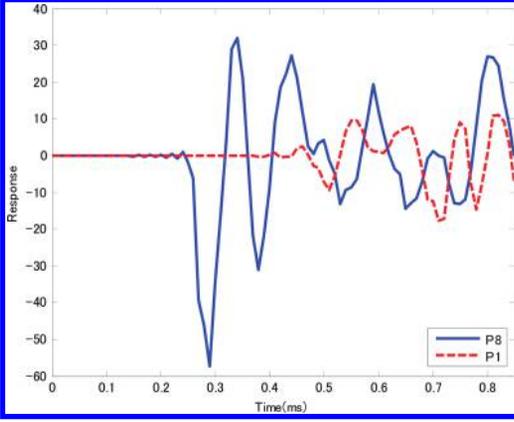
Figure 5. Waveforms recorded at P8 and P1.

Taking the vibration responses recorded by P8 and P1 sensors for example (see Fig. 5), the R-wave dispersion curve can be obtained as follows. For simplicity, this case is denoted as Case I8-D5-P8P1, where the term I8 denotes the impact point nearby P8, D5 the diameter $D = 5$ mm, and P8P1 the receivers P8 and P1. For a certain frequency, f_i , the arriving time of its largest peak to P8 and P1, say $t_{8,i}$ and $t_{1,i}$, can be read from their Wavelet spectra respectively. In knowing the distance between P8 and P1, i.e. $d = 350$ mm in this case, the propagating velocity $C_{R,i}$ of the wave of frequency f_i can be calculated as

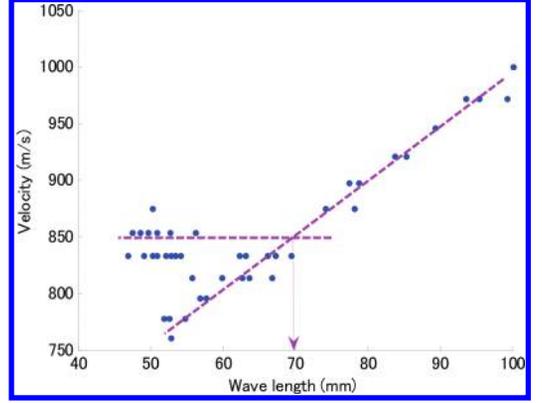
Calculating the propagating velocity and corresponding wave length with respect to a range of frequency of interest, e.g. 7 to 14 kHz in this case, and plotting their relationships in the speed-wave-length plane, a dispersion curve can be obtained, as shown in Figure 6. As expected, the wave of the largest wave length propagates the fastest (with the largest speed); the propagating speed decreases as the wave length decreases from the maximum to around 70 mm, and almost remains constant when the wave length is smaller than 70 mm. The wave-length corresponding to the turning point would be related to the depth of the surface layer. It was numerically proposed to be two times of the layer depth (Tsai et al. 2014); in other words, the layer depth could be identified as one half of the

Figure 6. Dispersion curve, Case I8-D5-P8P1.

wavelength corresponding to the turning point. By this way, the depth of the mortar layer was estimated as 35 mm, which is acceptably close to the true depth, 40 mm.

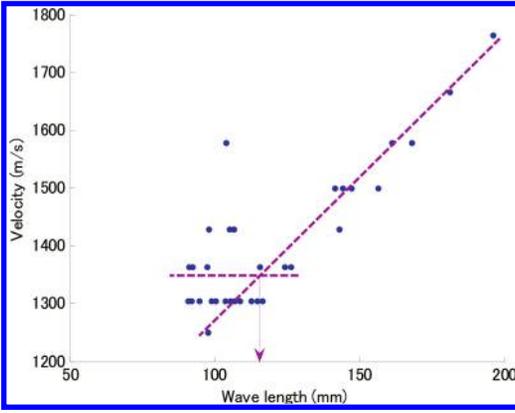
For other cases, the depth of the mortar layer could be estimated through constructing dispersion curves in the similar way. Let us consider the case with the same impact point, i.e. P8 end, and the same hammer size, i.e. $D = 5$ mm, but with different receiver spacing distances d . The propagating speed C_R vs. wave length λ_R relationships constructed with P8-P2 receivers (Case I8-D5-P8P2, $d = 300$ mm), P8-P4 receivers (Case I8-D5-P8P4, $d = 200$ mm), and P8-P5 receivers (Case I8-D5-P8P5, $d = 150$ mm) are plotted in Figures 7, 8, and 9, respectively.

The dispersion characteristics can be observed for Cases I8-D5-P8P2 and I8-D5-P8P5, but the depth of mortar layer estimated by the dispersion curves are quite deviated: $120/2 = 60$ mm for Case I8-D5-P8P2 and $54/2 = 27$ mm for Case I8-D5-P8P5, neither of which is close to the true depth. As for Case I8-D5-P8P4, no dispersion characteristics is observed in the $C_R - \lambda_R$ plot. It follows that the estimation of depth of mortar layer is failed. Moreover, the other cases with smaller receiver spacing distances are not considered herein, e.g. P8-P6 receivers with $d = 100$ mm or P8-P7 receivers with $d = 50$ mm, for the reasons that dispersion phenomenon may not be obvious within a

Figure 7. Dispersion curve, Case I8-D5-P8P2.

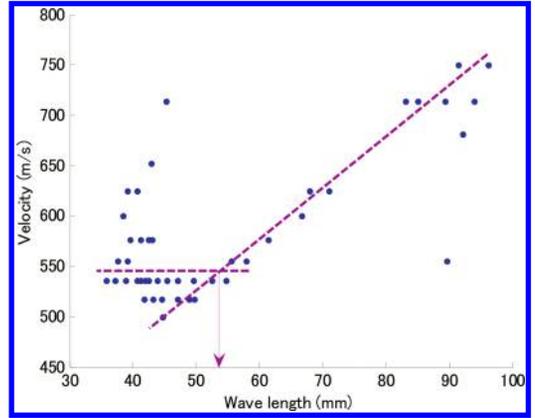
Figure 9. Dispersion curve, Case I8-D5-P8P5.

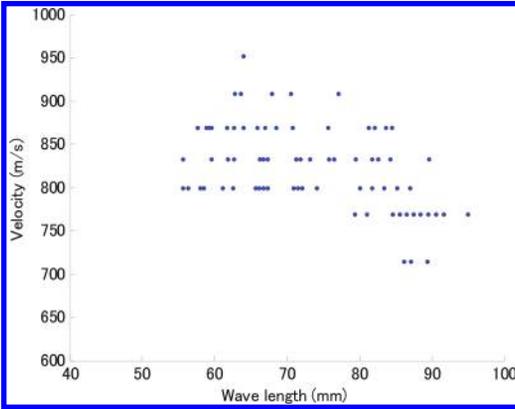
Figure 8. Dispersion curve, Case I8-D5-P8P4.

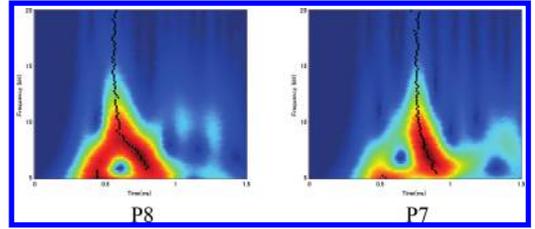
Figure 10. Wavelet spectrum of the waveforms recorded at P8 and P7, impact nearby P8, $D = 15$ mm.

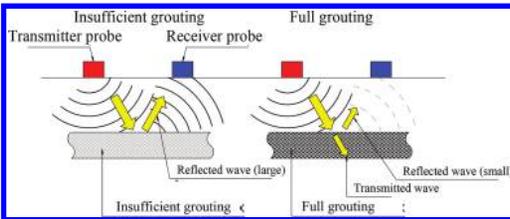
Figure 1. Illustration of ultrasound propagation.

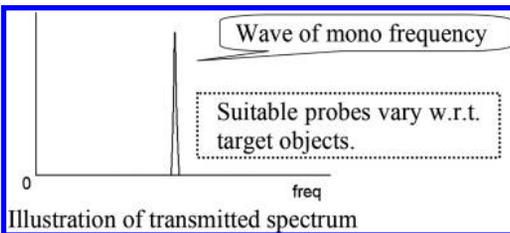
Figure 2. Frequency band employed in conventional ultrasound methods.

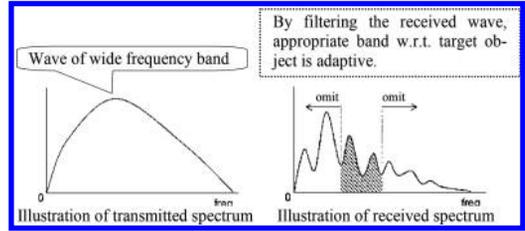
Figure 3. Frequency band employed in the wide-band ultrasonic wave method.

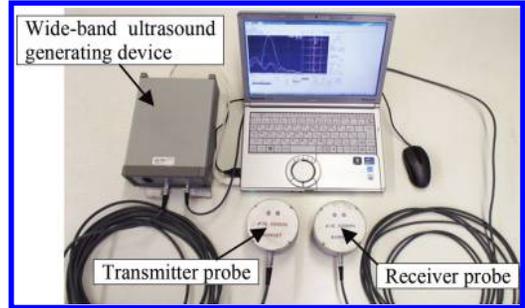
Instruments used in this study is shown in Photo 1, and their specifications are listed in Table 1. The transmitter and receiver probes are 76 mm in

Photo 1. Instruments for wide-band ultrasonic wave method.

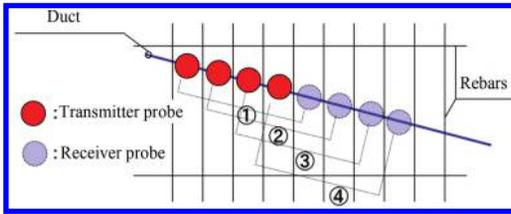
Figure 4. Multipoint measurement approach.

superposed waves are difficult and accordingly to evaluate grouting conditions is difficult. To solve this difficulty, multipoint measurements were conducted to amplify the waves reflected from ducts. This approach can be illustrated as in Figure 4 and a field measurement case is given in Photo 2.

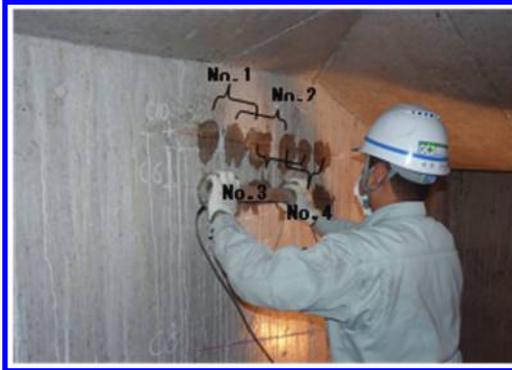
Photo 2. Multipoint measurement approach: a field measurement case.

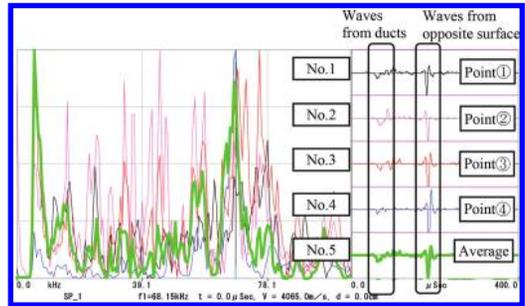
Figure 5. An example of averaging waveforms.

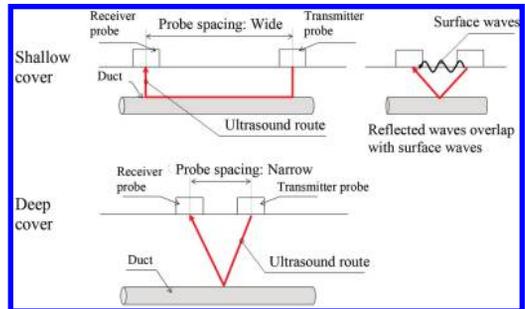
Figure 6. Probe spacing and ultrasonic wave propagation path.

face. In cases of deep concrete cover, the arriving time difference between surface waves and reflected waves is large, but in cases of shallow cover, it decreases and those waves might be confused. To address this issue, a probe-spacing strategy were employed as shown in Figure 6. In the case of shallow cover, the probe spacing was tuned wider so that the surface waves and target reflected waves could be distinguished. Generally, in the case of a cover smaller 140 mm, probe spacing was tuned to 500 mm; otherwise, it was tuned to 200 mm.

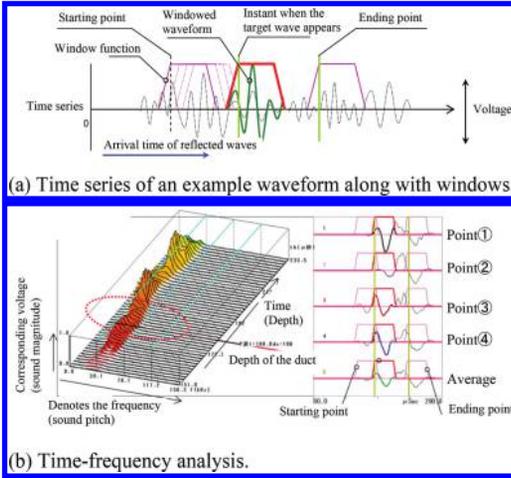
As mentioned above, the averaged waveforms obtained from multipoint measurements are taken for further analysis. An outline of the waveform analysis is shown in Figure 7. Figure 7(a) gives the time series of an example averaged waveform along with window functions. Window functions are functions used for spectral analysis, being shifted continuously along time axis to extract (or to window) waveforms of interest. In the figure, the first vertical line indicates the starting point (the instant when the target wave is received); the second vertical line indicates the ending point (the instant when the shift of window function ends). The window

Figure 7. Outline of the waveform analysis.

function in bold is located at the instant when the target wave appears; the waveform within the window is the zoom-in of the windowed waveform. The right-hand side of Figure 7(b) shows the time series of received waveforms: those labelled No. 1 to 4 were measured from different locations respectively and that labelled No. 5 is the averaged waveform. The left-hand side of Figure 7(b) shows the time-frequency spectrum of the averaged waveform, where X-axis denotes the frequency (sound pitch), Y-axis the corresponding voltage (sound magnitude), Z-axis the time (depth from concrete surface). Herein, the spectral magnitudes were normalized by the maximum, i.e. they are expressed in a ratio to the maximum.

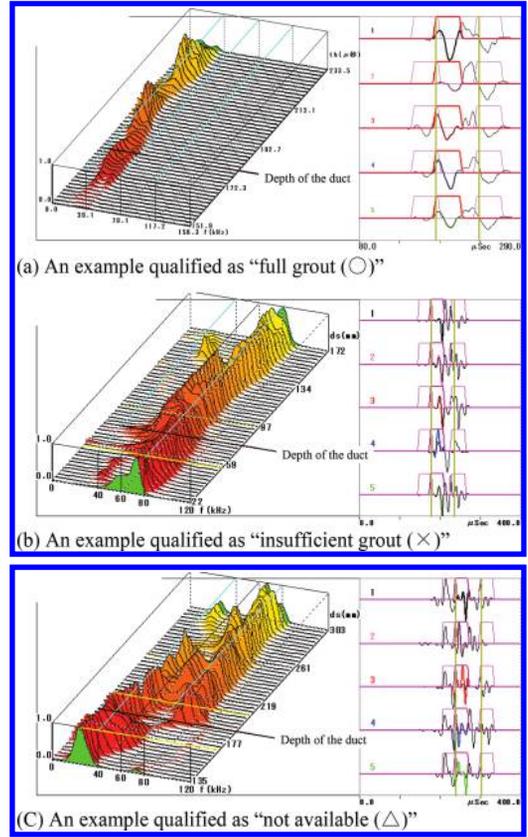
Figure 8. Example outcomes of the wide-band ultrasonic wave method.

An example of evaluating different grouting conditions is given as in Figure 8. The time-frequency spectrum in Figure 8(a) presents large peaks in a low frequency band (lower than 40 kHz) nearly at the depth of the duct, so this case was qualified as “full grouting (○)”. In comparison to Figure 8(a), the spectrum in Figure 8(b) presents large peaks in a higher frequency band (about 70 kHz), so this case was qualified as “insufficient grouting (×)”. As for the spectrum in Figure 8(c), although it presents peaks in low frequency band (lower than 40 kHz) nearly at the depth of the duct, it also presents peaks in higher frequency band (about 70 kHz) at certain locations deeper than the duct. Such a case like this was qualified as “not available (Δ)”.

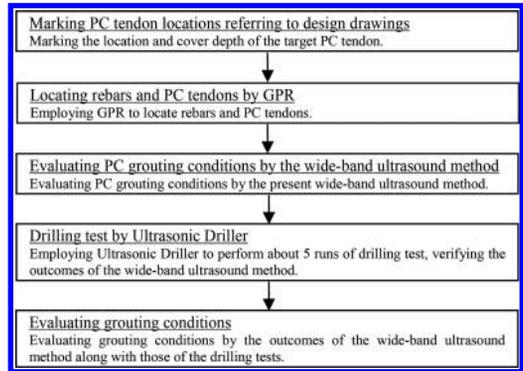
Figure 9. PC grouting condition investigating procedures.

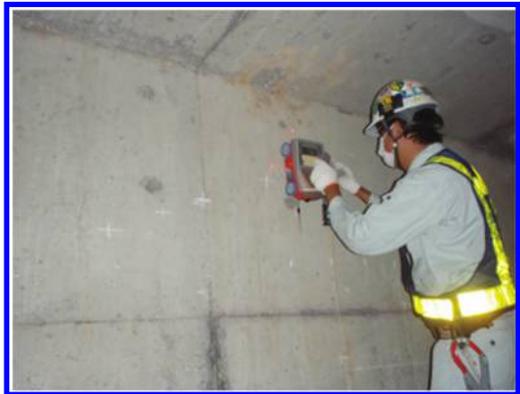
It possibly happens that the PC tendons in field are not located in the expected positions referred by the design drawings due to some construction reasons like a conflict with other members or construction errors. The precise localization of PC tendons is an important factor to the accurate evaluation of PC grouting conditions by the present method. For this reason, GPR were employed to locate rebars and PC tendons (see photo 3).

Photo 3. Locating PC cables.

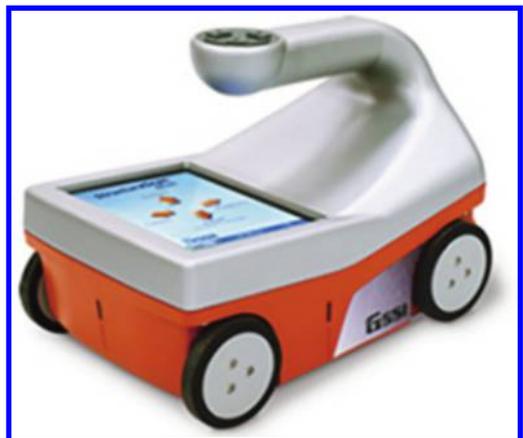
The GPR in use were StructureScan by GSSI company, as shown in Photo 4. StructureScan outperforms other conventional GPR products in little multiple reflected waves so that dense

Photo 4. StructureScan.

allocated rebars and dual allocated rebars can be quickly detected. One example outcome yielded by StructureScan is shown in Figure 10, where the solid lines locate rebars and dashed lines locate

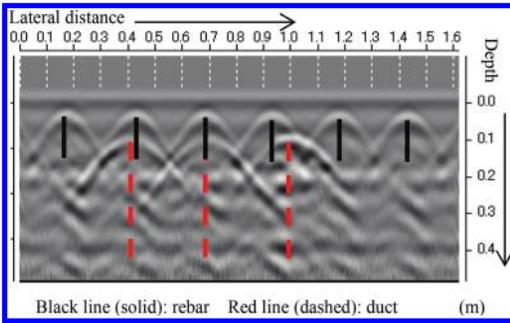
Figure 10. An example outcome.

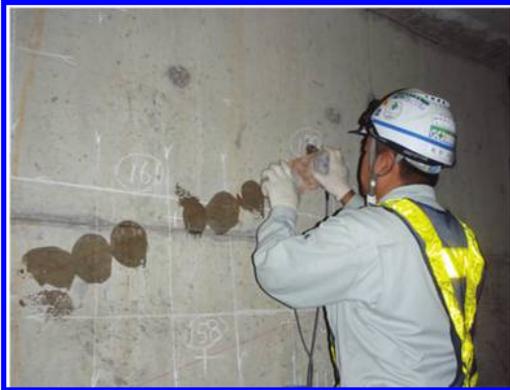
Photo 5. Evaluating PC grouting conditions.

This step is to evaluate PC grouting conditions by the present wide-band ultrasound method (see Photo 5).

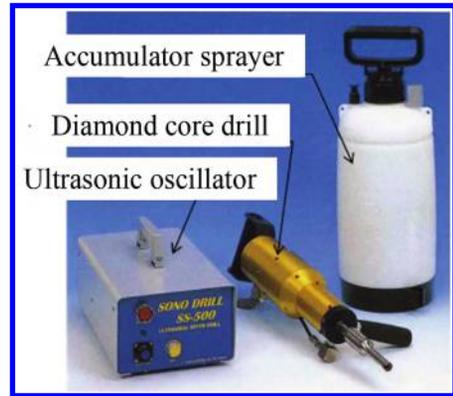
Photo 6. Ultrasonic Driller.

An Ultrasonic Driller is shown in Photo 6 and a duct surface layer after a drilling is shown in Photo 7. Ultrasonic Driller is a drilling device that applies ultrasonic vibrations of a certain frequency to drilling blades; the applied frequency is tuned suitable for cutting concrete but unsuitable for steel, so that the rebars and PC tendons could be protected from damage by the drilling device. An example of the drilling test results is shown in Photo 8.
