Emerging Technologies in Non-Destructive Testing VI

Editors

D.G. Aggelis & D. Van Hemelrijck

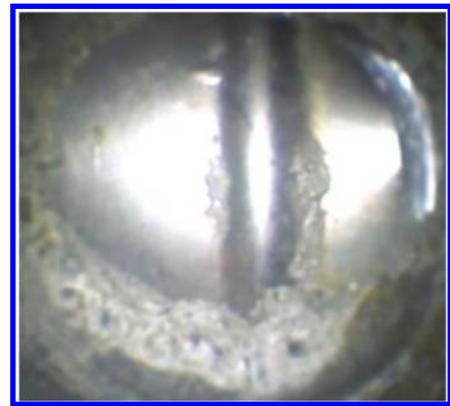
Photo 7. Duct surface.

An Ultrasonic Driller is shown in Photo 6 and a duct surface layer after a drilling is shown in Photo 7. Ultrasonic Driller is a drilling device that applies ultrasonic vibrations of a certain frequency to drilling blades; the applied frequency is tuned suitable for cutting concrete but unsuitable for steel, so that the rebars and PC tendons could be protected from damage by the drilling device. An example of the drilling test results is shown in Photo 8.

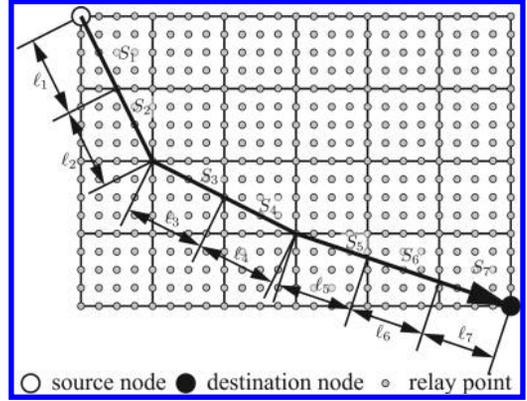
Figure 1. Representation of ray-path on two-dimensional mesh.

analysis and ray-path is approximated as polylines as illustrated in Figure 1. On the approximation, relay points are installed on the mesh to raise the accuracy of ray-path representation in the presented technique (Kobayashi 2013). If it is assumed that elastic wave velocity is constant in each cells and materials of a cross section is isotropic, a travel time between a source and a receiver is shown as follows.

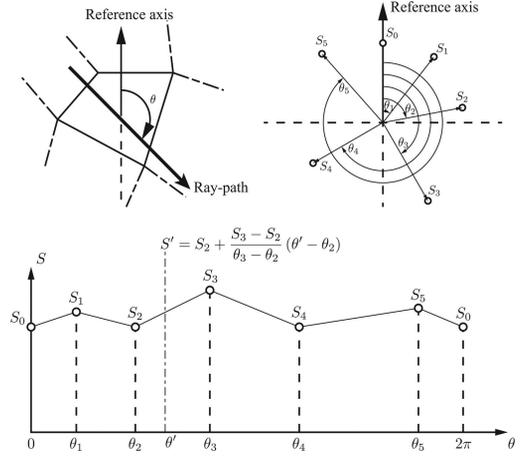
Figure 2. Slowness profile.

To apply the elastic wave velocity tomography for anisotropic bodies, the anisotropy of materials is implemented in the elastic wave velocity tomography by defining the slowness S_i as a function of an angle of a ray-path. The function $S(\theta)$ is set to the individual cells on the mesh, and each of the function is represented by a slowness profile that is shown in Figure 2. In this profile, the directivity of the slowness is set by specifying slowness at specified angles to a reference axis that is defined on each cells. It should be noted that the slowness between the specified angles are given by lineary interpolating the slownesses at the adjacent specified angles as shown in Figure 2. The function is actually described as follows in this study.

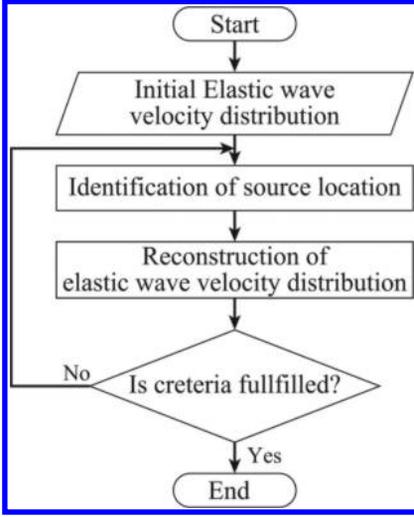
Figure 3. Conceptual flow diagram of AE-Tomography.

AE-Tomography is a technique that uses AE as signals, i.e. this technique uses only arrival time of AE at receivers, to identify elastic wave velocity distribution on the basis of the elastic velocity tomography. As introduced in the previous section, elastic wave velocity tomography reconstructs elastic wave velocity distribution from first travel times that are computed from emission times and arrival times of elastic waves and ray-paths that are determined by ray-trace technique between source locations of the elastic waves and locations of receivers. However, AE is inappropriate as the signals for the identification since it is impossible to compute the travel times and determine the ray-path because emission times and source locations of AE are generally unknown. Therefore, in AE-Tomography, the source locations and the emission times are identified prior to the reconstruction of the elastic wave velocity distribution by using the AE source location technique as shown in Figure 3. The source locations have been identified by assuming that elastic wave velocity distribution is homogeneous and ray-paths can be approximated as straight lines between the source location and receivers in the conventional AE source location techniques to simplify its computational procedure. However, the assumptions are violated if deterioration of the cross section is localized and severe since the elastic wave velocity locally decline in this case, and consequently, it leads to degrade the accuracy of the identified AE source locations. Hence, the authors proposed a source location technique based on the ray-trace technique to avoid the difficulty (Kobayashi, Shiotani, & Oda 2014b). And

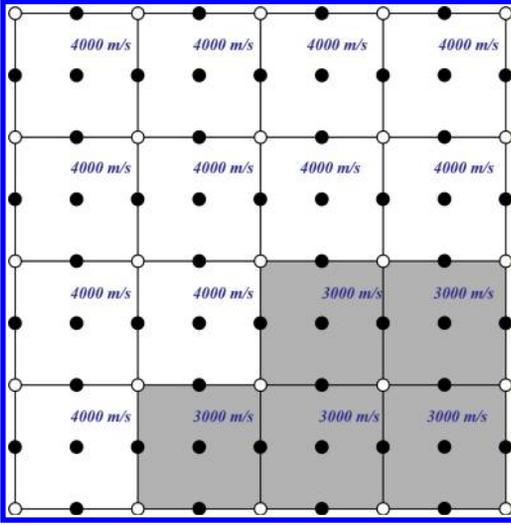
Figure 4. Mesh for verification and original elastic wave velocity distribution.

In this section, the elastic wave velocity tomography technique for anisotropic materials is verified by performing a series of numerical investigations because AE-Tomography is implemented on the basis of elastic wave velocity tomography, and its accuracy is degraded if the result of elastic wave velocity tomography is insufficiently accurate. Figure 4 shows a cross section that is used for the verification. The cross section is a square of 10 m of its edges, and it consists of two parts that are colored in white and gray in Figure 4. In this model, ratio of vertical and horizontal elastic wave velocity is 10 vs 1 on the entire cross section, and vertical elastic wave velocity of the white area is set to 4000 m/s to simulate area of integrity, and vertical elastic wave velocity of the gray area is set to 3000 m/s to simulate damaged area as well. The velocity on an angle between the vertical and horizontal axes are computed by linear interpolation as shown in Figure 2. On this cross section, 200 AE source locations are randomly generated, and travel times of the AE are computed by executing the ray-trace from the sources to the locations of receivers. It should be noted that the anisotropy is considered on the computation of the travel times. The receivers are installed at apexes of the cross section, and consequently, 4 receivers are used in this case. It should be noted that the source locations and the emission times, i.e. the emission times are actually zero in this case, of the artificial AE are known. Thus, we virtually used the travel time as the first travel time from the source to receivers, and the source locations that are used to compute the travel times are used as the real source locations. On these condition, the first travel times and the source locations are used as observation data for elastic wave velocity tomography, and the accuracy of the identified elastic wave velocity distribution by elastic wave velocity tomography is discussed. As the first case, the elastic wave velocity distribution is identified with the anisotropy. As the initial elastic wave velocity distribution for elastic wave velocity tomography, homogeneous elastic wave velocity distribution of 4000 m/s with the same anisotropy with the original model is given. Thus, the vertical elastic wave velocity is 4000 m/s, and the horizontal elastic wave velocity is 4000 m/s on the initial model. On this model, the elastic wave velocity distribution is updated

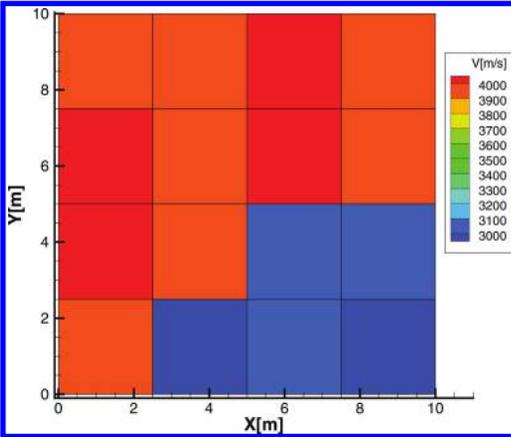
Figure 5. Identified elastic wave velocity distribution with consideration of the anisotropy.

30 times by using the first travel times as observation data on the basis of the presented algorithm of elastic wave velocity tomography. Figure 5 shows the identified elastic wave velocity distribution. It should be noted that this is a contour of the vertical elastic wave velocity distribution. Thus, horizontal velocity is 10% of the vertical velocity since the algorithm does not consider change of the anisotropy in its computational procedure. According to Figure 5, the contour shows the same tendency with the original elastic wave velocity distribution, and further, its value is also consistent with the original one. In this case, number of the ray-path is 800 due to 200 sources and 4 receivers,

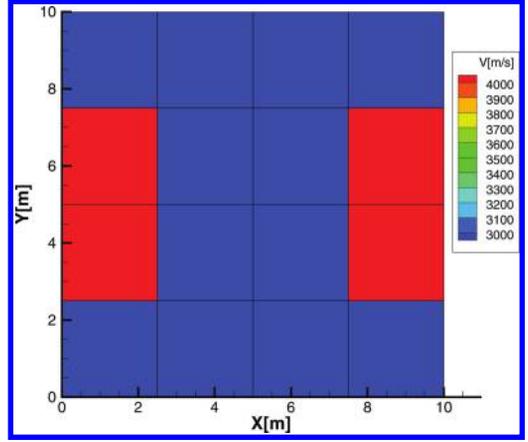
Figure 6. Identified elastic wave velocity distribution without consideration of the anisotropy.

and number of variables that are identified is 16. Thus, the number of observation equations are 50 times of the number of variables, and it implies that the observation equations sufficiently exist to identify the elastic wave velocity distribution accurately. As the second case, the elastic wave velocity distribution is identified without any consideration of the anisotropy as well as the case with consideration of the anisotropy by using a conventional algorithm of elastic wave velocity tomography. Figure 6 shows a contour of the resultant elastic wave velocity distribution. It should be noted that the elastic velocity on the contour does not have any anisotropy in this case. According to Figure 6, it is shown that the resultant elastic wave velocity distribution is not consistent with the original elastic wave velocity distribution. This reveals importance of the consideration of the anisotropy for the identification of elastic wave velocity distribution on anisotropic materials. Consequently, it is confirmed that the proposed algorithm for elastic wave velocity tomography correctly considers the anisotropy of the materials, and identifies the elastic wave velocity distribution.

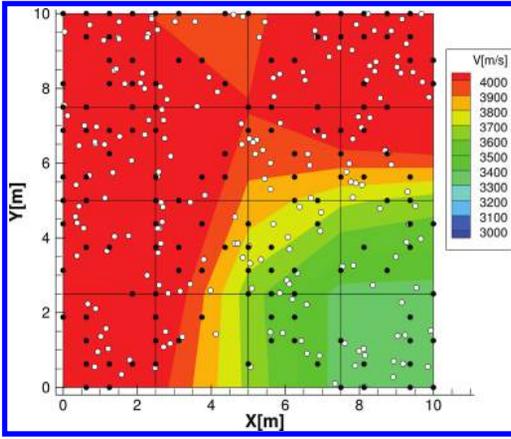
Figure 7. Identified elastic wave velocity distribution by AE-Tomography with consideration of the anisotropy (White circles: real source locations, Black circles: identified source locations).

arrival times of AE at the receivers are necessary for AE-Tomography, the travel times are used as the arrival times of AE at receivers and the source locations and emission times are not given as computational conditions in this verification. On this condition, the elastic wave velocity distribution is identified with the proposed algorithm of AE-Tomography that considers the anisotropy and the conventional algorithm of AE-Tomography that does not consider the anisotropy. Figure 7 shows the resultant elastic wave velocity distribution that is identified by considering the anisotropy. According to Figure 7, the resultant elastic wave velocity distribution is qualitatively consistent with the original elastic wave velocity distribution. The accuracy is lower than the result of elastic wave velocity tomography because AE-Tomography identifies the elastic wave velocity distribution with less number of boundary conditions, i.e. source locations and emitted times of elastic waves. As introduced in previous section, AE-Tomography estimates the source locations and the emission times of AE, and then, the observation equations are structured by using the “estimated information”. Thus, it is natural that the accuracy of the resultant elastic wave velocity distribution is lower than the ones by the elastic wave velocity tomography. However, the result qualitatively catches the tendency of the original elastic wave velocity distribution, and this fact reveals that AE-Tomography enables to identify the damaged area as a tool by considering the anisotropy in its algorithm. Figure 8 shows the resultant elastic wave velocity distribution that is identified without consideration of the anisotropy. The resultant elastic wave

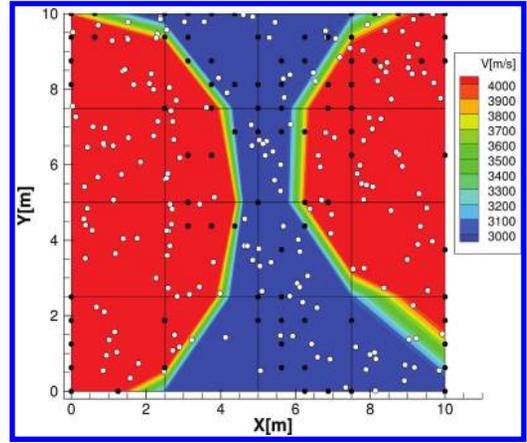
Figure 8. Identified elastic wave velocity distribution by AE-Tomography without consideration of the anisotropy (White circles: real source locations, Black circles: identified source locations).

velocity distribution in Figure 8 is significantly different from the original elastic wave velocity distribution, and this result also reveals the importance of the consideration of the anisotropy in the algorithm of AE-Tomography to evaluate integrity of anisotropic materials.

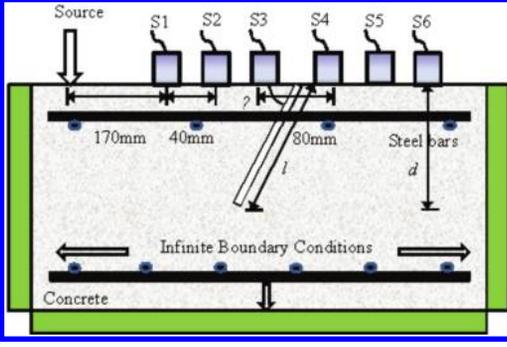
Figure 1. Wave motion simulation model.

The simulation work was conducted using commercial software [5] that solves two dimensional (2D) elastic wave propagation problems by temporal acoustic interrogations based on the finite difference method. [Figure 1](#) illustrates the model of simulation, which is essentially a steel reinforced concrete section of 500 mm (width) \times 300 mm (depth), resembling that of a bridge deck. The model was configured to have longitudinal wave velocities of approximately 4300 m/s and 6099 m/s, for concrete and steel reinforcement, respectively. The left, right and bottom sides of model were set as “infinite boundary” to avoid occurrence wave reflections. In the simulation, three sensors were placed on left and right side of the crack on top surface of concrete, respectively with spacing of 40 mm. Excitation of waves was made from a point source on the top surface of concrete.

Simultaneous recording by all the six sensors was triggered by sensor S1 located 170 mm from the excitation point. The simulations were conducted with one excitation that produced a full-cycle elastic wave. From the simulation, the influence of crack on waveform distortion, attenuation and pulse velocity was examined.

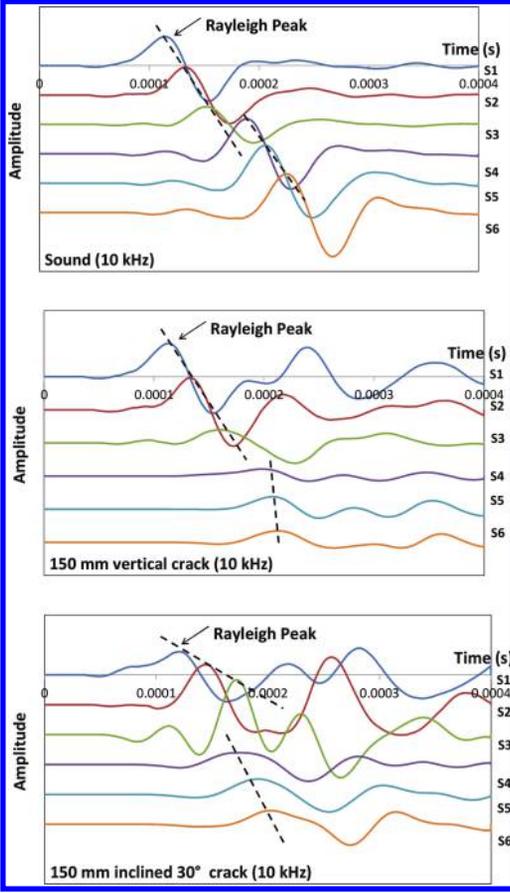
Figure 2. Simulated time domain data for sound concrete and models with 150 mm crack inclining at 30° and 90° (vertical crack).

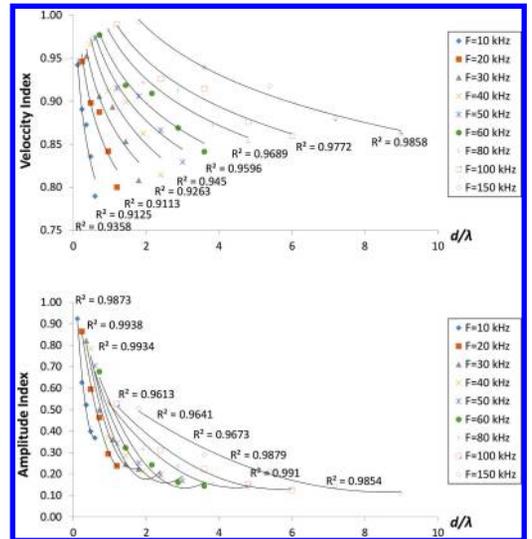
Figure 3. Velocity and amplitude indices plotted against d/λ for different R-wave excitation frequencies.

Figure 3 shows examples of velocity and amplitude indices plotted against the crack depth to R-wave wavelength ratio (d/λ), respectively for models with crack inclining at 30°. It is found that the velocity index decreases as d/λ increases, in logarithmic regressions for crack cases of 30° and in linear regressions for the vertical one, respectively. Also, a different trend was found in which the velocity index decreases in polynomial regressions for cases of crack inclining more than 90°. On the other hand, it was noted that amplitude index decreases with increase of d/λ in polynomial trend. In addition, the amplitude index becomes lower as the frequency increases due to the tendency of higher frequency components easily to lose their energy through absorption, scattering and distortion by the crack. In general, it is found that the amplitude index seemed to decrease with regards to the degree of inclination from 30° to 150°. It is suggestive of the phenomenon that more energy has been blocked from arriving at the other side of crack as the crack inclination angle increases.

The attenuation of amplitude manifested to be a more suitable parameter for crack characterization than velocity index since the discrepancy between the homogenous and cracked models was greater and more noticeable than it was for velocity.

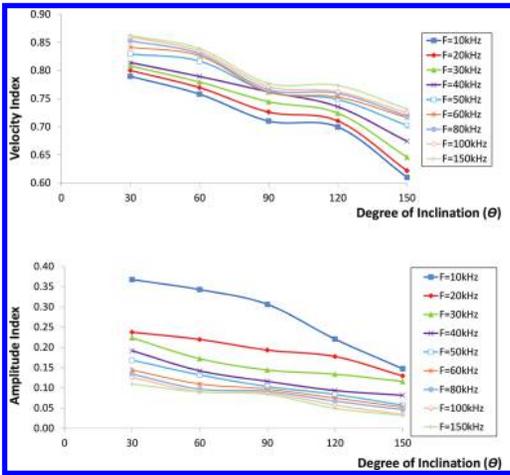
Figure 4. Velocity and amplitude indices plotted against degree of inclination for crack (constant vertical depth of 150 mm).

To further investigate the effect of crack inclination on R-wave propagation, velocity and amplitude indices are plotted against the crack inclination degree as exemplified in Figure 4. The vertical depth of crack was made constant at 150 mm regardless of degree of inclination. In general, both the velocity and amplitude indices decrease with increase of inclination angle from 30° to 150°, justifying the fact that large amount of energy has been blocked due to the increase in effective vertical depth as result of crack inclination angle increase. It could be confirmed as well that the drop of velocity with increase of crack inclination was due to the fact that R-waves, in particular those with effective penetration depth lesser than the crack vertical depth, have consumed longer time to propagate to the opposite side of crack.

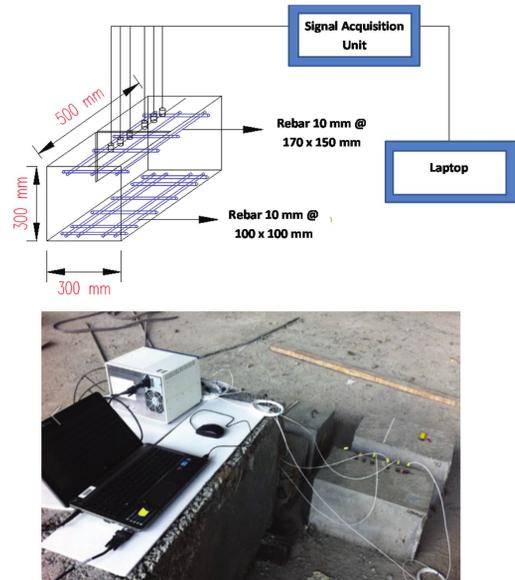
Figure 5. Experimental set-up for wave measurement.

Experimental measurements were conducted on steel reinforced concrete block specimens of 300 mm × 300 mm × 500 mm prepared. Figure 5 shows the experimental set-up. One of the specimens was the control with no defect, while the other two comprised of one artificial crack inclining at 30° and 90° (the vertical crack), respectively as measured against the horizontal plane. The crack inclining at 30° would become 150° if measured from the other side of the specimen.

The artificial crack was instigated by suspending a polystyrene foam board in the concrete mould before casting. The polystyrene foam boards were prepared in triangular shape so as to provide different “crack depths” along the transverse direction of specimen. Six accelerometers with frequency range of 0.005 kHz to 60 kHz (PCB Inc.) were placed on the top surface of specimen in an arrangement similar to that adopted for simulation work. Elastic waves were excited by dropping steel balls of different sizes to the concrete surface at location similar to that examined in the simulation work, which was 170 mm away from the trigger sensor. The impact point formed a straight line with the locations of accelerometers. The steel balls have multiple sizes to give a variety of excitation frequencies. A waveform acquisition system (NI PXIe-4492 by National Instruments Co.) was used control measurement and record waveform data.

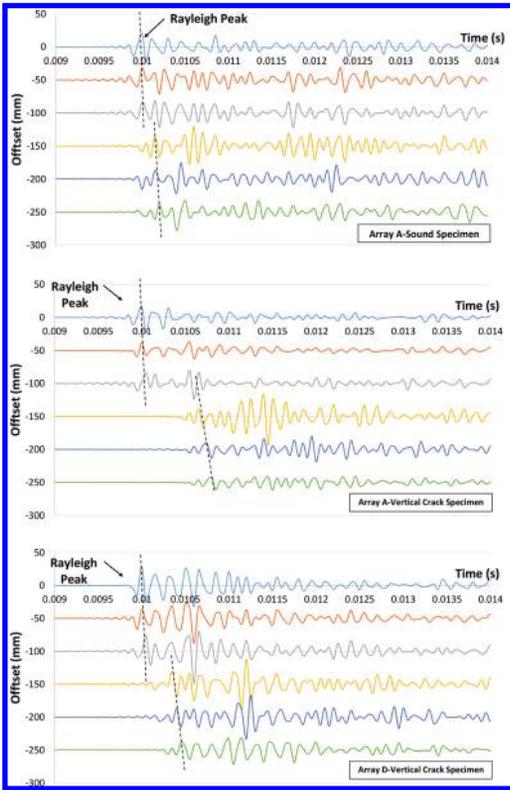
Figure 6. Time domain data measured from the sound concrete specimen and that with vertical crack depths of 125 mm and 25 mm.

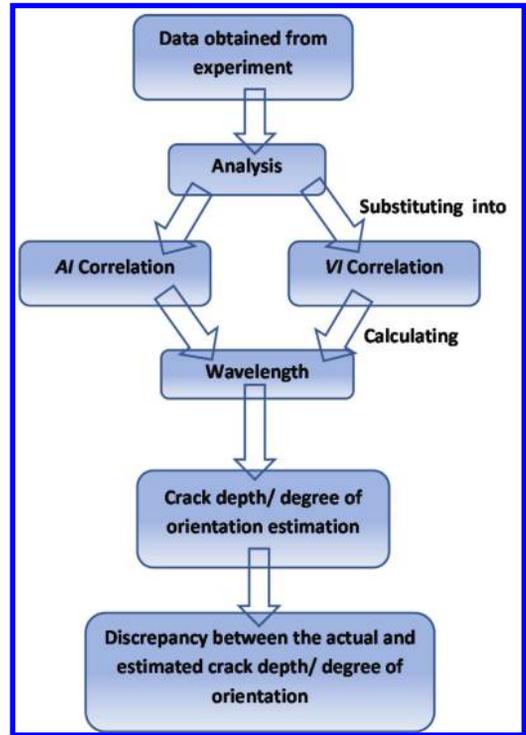
Figure 7. Proposed procedures for concrete surface crack characterization.

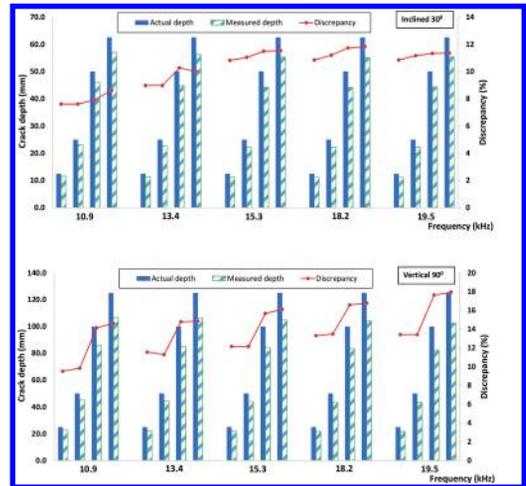
Figure 8. Comparison of actual crack depth with estimated results for 30° degree inclined and vertical cracks.

Examples of time domain data obtained from measuring the control specimen as well as specimens with vertical crack depths of 125 mm and 25 mm are given in Figure 6. Identification and extraction of R-waves were performed for computation of the velocity and amplitude index. The key procedures involved in crack characterization using the measured data are shown in Figure 7. The results of estimation are exemplified as in Figures 8 and 9, which are compared with the actual depth and crack inclination angle. Considering the experimental

findings from all cases, it shows that when crack depths are greater than the R-wave wavelength, the corresponding discrepancy values between the actual and experiment measured crack are smaller. Besides, underestimation seems to be consistent, with maximum error of approximately 18%.

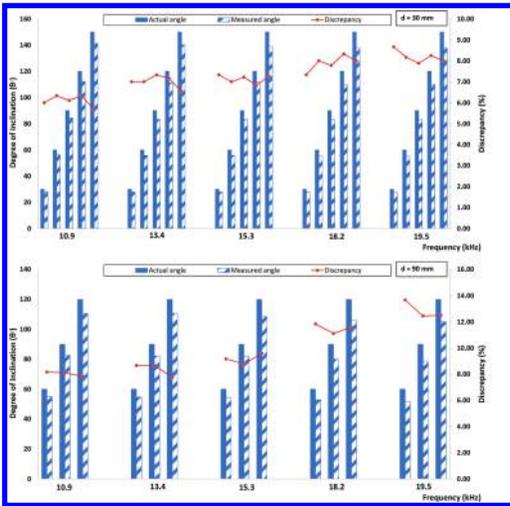
Figure 9. Comparison of actual crack inclination angle with estimated results for 30 mm and 90 mm deep cracks.

In estimating crack inclination angle by both velocity and amplitude indices, the measured data consistently underestimate. The maximum error was found to be approximately 12%. The errors as obtained from both estimating the depth and angle of inclination were considered acceptable considering the many factors that have potentially contributed to this, such as inherent porous nature and minor cracking of concrete surface layer on which accelerometers were mounted and slight unevenness of the concrete surface due to protruding aggregates. Besides, the attenuation of waves in concrete that was not actually “homogenous” should not be overlooked, even in the absence of crack as local variations in properties is common for concrete. The complex reflections

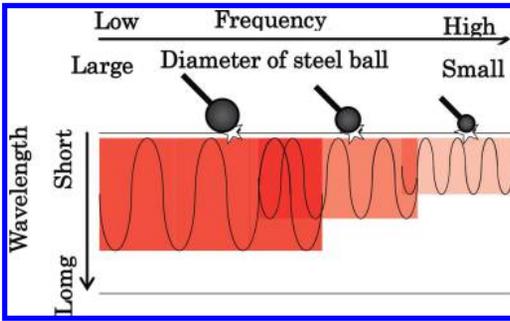
Figure 1. Directions of surface wave vibration and progress.

and Lamb wave), which propagate on the surface, among elastic waves. In this study, Rayleigh wave was mainly examined. As shown in Figure 1, a surface wave propagates near the surface while vibrating ellipsoidally. The range of the ellipsoidal vibration is identical to the length of the surface wave. Phase of the surface wave varies according to the depth, which is equivalent to the wavelength. Figure 2 shows that in the case where defects such as cracks and voids exist in the range of vibration of surface wave, which is the sum of the scanning line and depth, phase changes in the defective section of surface wave due to reflection or scattering even though there is no change in the pressure wave propagation velocity on the surface. It was believed that by properly analyzing the change in wave properties, internal health evaluation with sensors installed only on one side of the structure can be realized. As an index indicating the change of surface wave, the phase velocity of surface wave

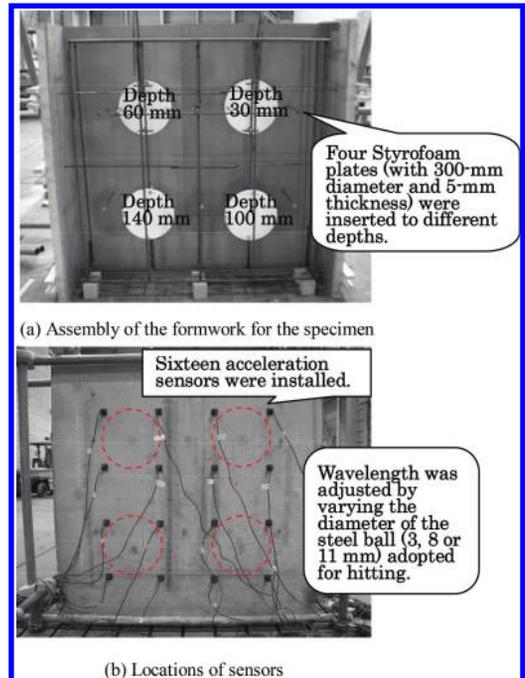
Figure 3. Outline of concrete specimen.

Distributions of phase velocities of surface wave were obtained in concrete specimens with pseudo defects (Styrofoam plates) (Figure 3) using the elastic wave tomography with sensors only one side of the structure (Figure 4). The distributions of phase velocities of surface waves were obtained using elastic wave tomography with sensors only one side of the structure (Figure 4). The data on the wave generation point (time of generation and waveform) was obtained by hitting near sixteen acceleration sensors, and the receiving point data (receiving time and waveform) was collected from the remaining fifteen sensors. Then, analysis was made based on the phase velocity obtained from the 240 scanning lines (16 wave generation points x 15 receiving points). Wavelengths were estimated from the predominant frequency of the surface

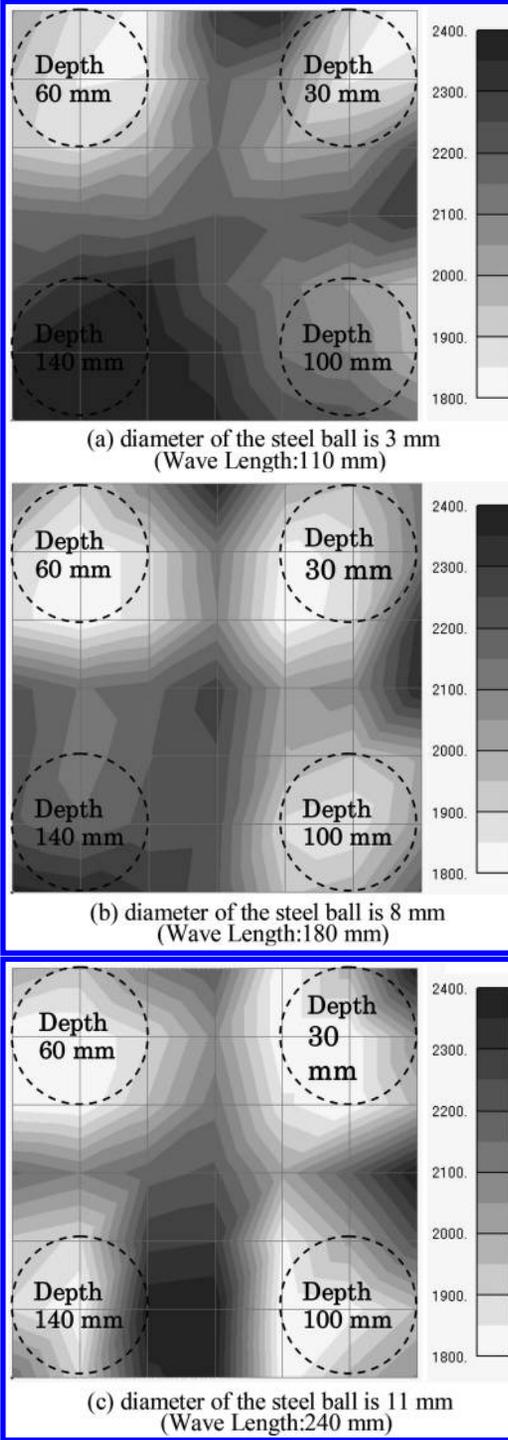
Figure 4. Distributions of phase velocities of surface wave using elastic wave tomography with sensors only one side of the structure.

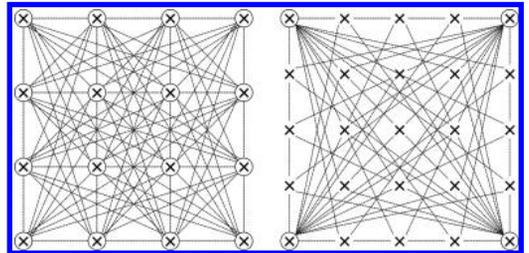
The wave generation location and time are estimated from the receiving location and the first arrival time for receiving waveform by making back analysis. This is a general practice in the Acoustic Emission (AE) method, a nondestructive evaluation technique [4]. Conventional AE methods estimate the wave generation location and time based

Figure 5. Images of conventional (left) and developed (right) techniques (x : wave generation point, o: receiving point).

on the assumption that the study area is homogeneous (propagation velocity is constant). The wave generation location and time estimated based on the assumption, therefore, are highly likely to differ from the true value in heterogeneous structures deteriorated with time.

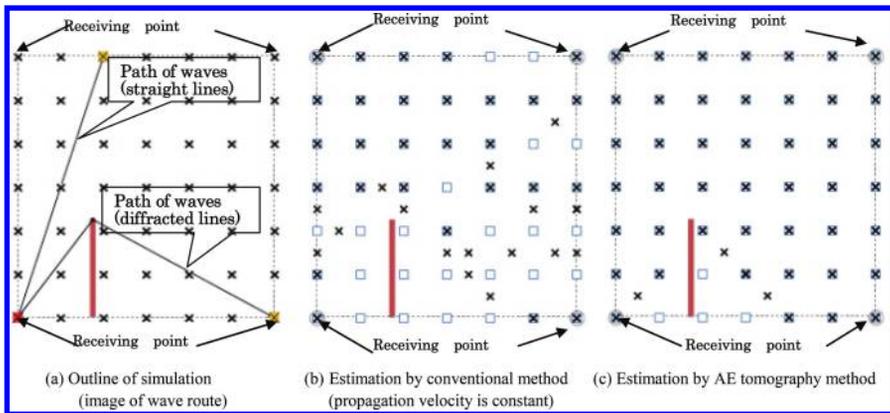
Figure 6. Wave generation locations (x) estimated by conventional method and AE tomography method (square: true wave generation location).

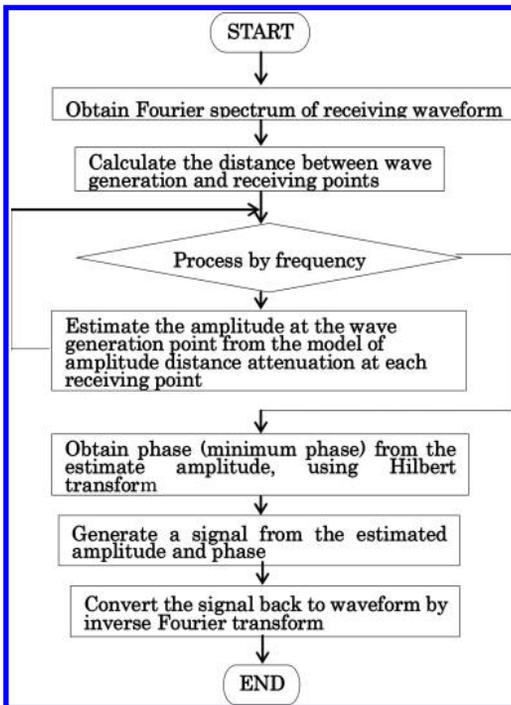
Figure 7. Flow of generated waveform estimation steps.

The waveform with zero amplitude before a certain point in time is referred to as the causal function [6]. The amplitude and phase of the Fourier spectrum of this function are correlated to each other. The phase can be uniquely determined from the amplitude using the Hilbert transform [7]. The waveform determined by the process is referred to as the minimum phase shift function [8]. If the Fourier spectrum of the generated waveform can be estimated, the generated waveform can be obtained as a minimum phase shift function. Accordingly, Figure 7 shows the flow of steps for estimating the generated waveform, using the developed technology.

First, Fourier spectrum of receiving waveform is obtained for an impact signal. Then, an amplitude distance attenuation model is developed using the distance between the wave generation location estimated by the AE tomography method and each receiving location. The amplitude is estimated at the wave generation point for each frequency by regression analysis. The phase is obtained for the amplitude at the wave generation point by the Hilbert transform. The signal generated from the amplitude and phase is subjected to inverse Fourier transform. Then, the generated waveform is estimated as a minimum phase shift function. Figure 8 shows the waveform obtained using the sensors installed near the impact point and the minimum phase shift function estimated based on the receiving waveform using the developed method. The figure shows that the generated waveform obtained was similar to the generated waveform used in conventional elastic wave tomography

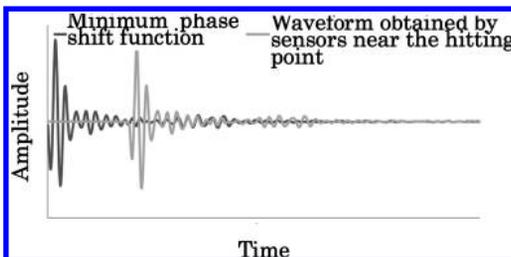
Figure 8. Minimum phase shift function and waveform obtained by sensors near the hitting point.

with sensors on one side (waveform obtained using the sensors installed near the hitting point). The minimum phase shift function exhibits a waveform starting at zero in time history. Shifting the function to the wave generation time that is estimated by the AE tomography method enables estimation as a generated waveform for an arbitrary hitting signal.

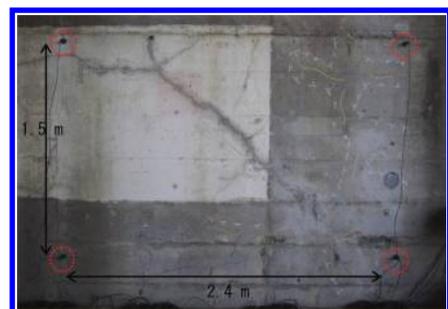
Figure 9. Locations of sensors (Wave generation by arbitrary hitting. Four sensors were installed.)

The validity of the developed technology was verified using an actual structure. Verification was made in a 1.5-by-2.4 m area of an abutment (Figure 9). A crack is found along a diagonal line in the study area. The goal of verification was to check whether the crack could be detected as a deflection or not. Accelerometers used in the developed technology were located at four edges of the study area (Figure 9). The area was hit randomly by a steel-ball hammer. For comparison, analysis was also made by the elastic wave tomography with 16 sensors attached on one side at 0.5-m vertical and 0.8-m horizontal intervals (Figure 10).

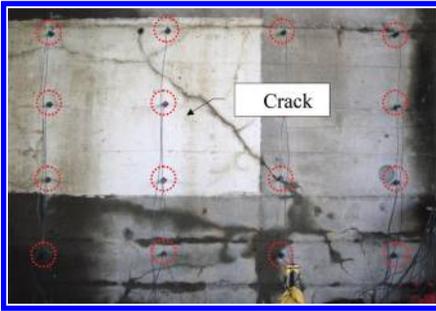
Figure 10. Locations of sensors (Conventional technology. Sixteen sensors were installed.)

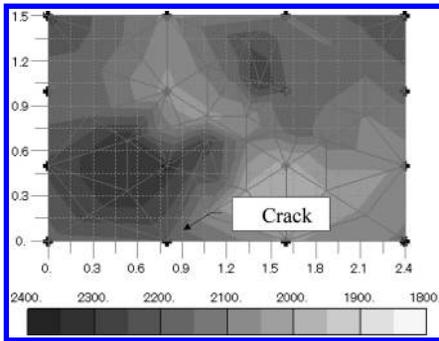
Figure 11. Distribution of phase velocities based on arbitrary hitting signals.

Figures 11 and 12 show phase velocity distributions obtained by the developed method and by conventional elastic wave tomography with sensors on one side, respectively. Preparation for verification and measurement required approximately 15 minutes with the developed method, while one hour was required for the conventional method. In verification, it was found that the AE tomography estimated 107 wave generation points. The number of scanning lines was 428 (107 x four receiving points), nearly double the data volume obtained by conventional technology (240 scanning lines). It was therefore possible to increase the number of elements according to the data volume for enhanced resolution. Both figures show a low-velocity area along the crack. The velocity distribution obtained using the developed technology providing higher resolution show the distribution of cracks more clearly. The developed method is applicable without using numerous arbitrary impact signals as in hammering tests and without requiring numerous sensors. It was shown in this study that the method

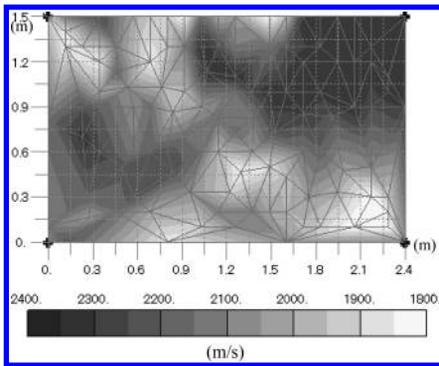
Figure 12. Distribution of phase velocities based on conventional technology.

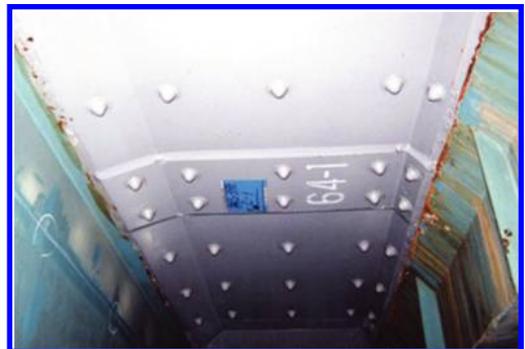
Figure 1. A site strengthened by steel plate bonding method.

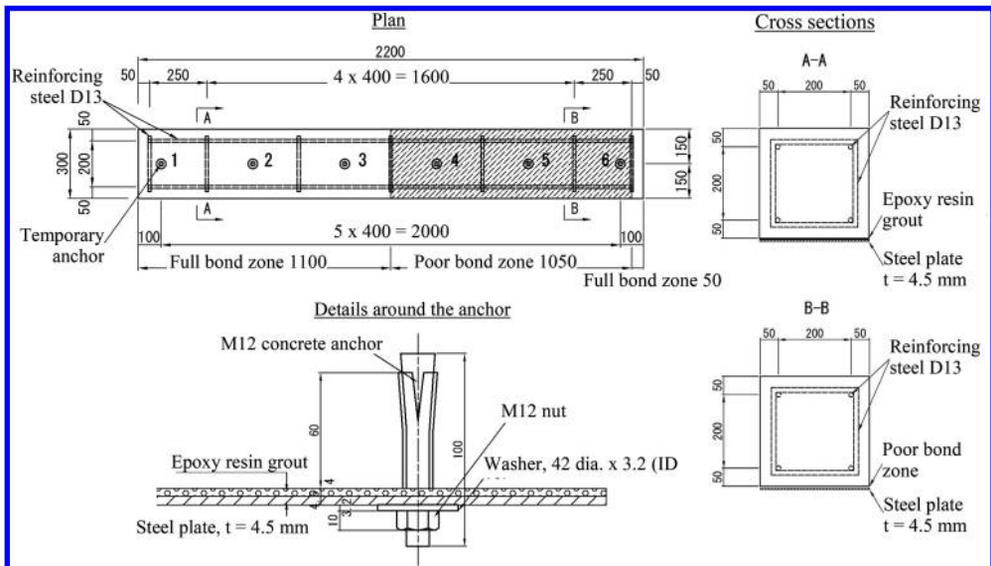
Figure 2. Schematic diagrams of the specimens.

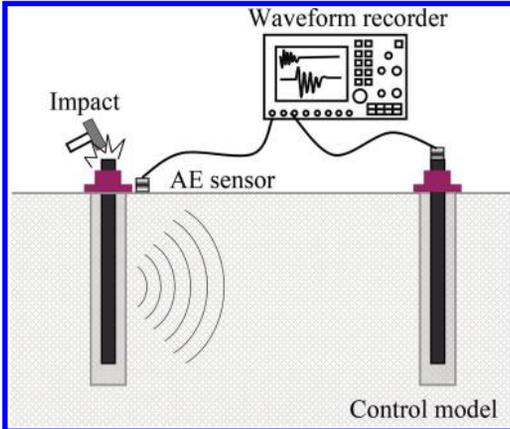
Figure 3. Schematic diagram of measurement.

Measurement by impact elastic wave method was carried out on both control and defect specimens before and after steel plate bonding, using the anchors to record waveforms at propagation distances of 400 to 1200 mm. The recorded data was sorted by distance, propagation velocity was calculated, and frequency spectrum distribution and prominent frequency were determined from the frequency analysis by fast Fourier transformation. Using some data selected from these analyses,

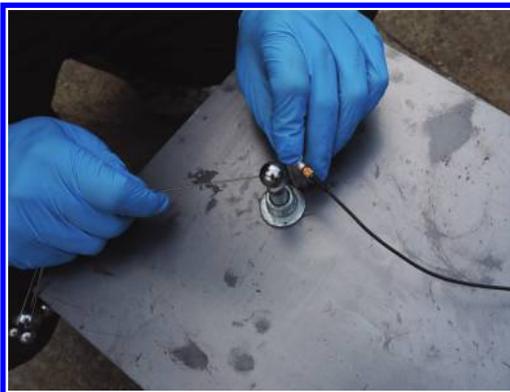
Figure 4. Impact applied after steel plate bonding.

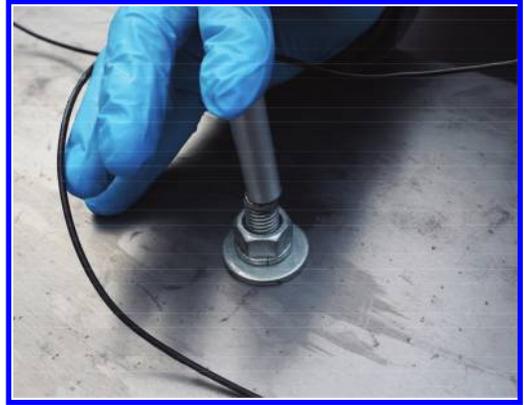
Figure 5. Receiving sensor installed.

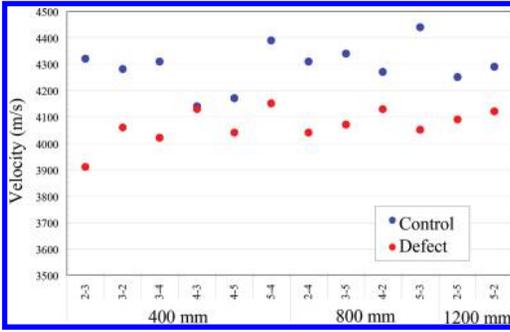
Figure 6. Propagation velocities in the control and defect specimens before steel plate bonding.

Figure 6 shows propagation velocities measured in the control and defect specimens before steel plate bonding, by distance between the sensors. Sensor-to-sensor distances were 400, 800 and 1200 mm. Propagation velocity in the control specimens was around 4300 m/s. Propagation velocity in the defect specimens was about 4000 to 4100 m/s, decreasing by about 5% as compared with the control specimens.

The difference in propagation velocity between the control and defect specimens was likely due to the defect part simulated in the concrete surface, suggesting that sensitivity was not affected by the use of temporary anchors for probes. However, variation in propagation velocity was slightly larger at a propagation distance of 400 mm which was shorter than 800 or 1200 mm in both control and defect specimens. The reason for this was likely that degree of contact or magnitude of impact of the steel ball was expressed locally due to the short propagation distance. This suggests that more accurate measurement of propagation velocity in concrete would be obtained at reasonably larger distances.

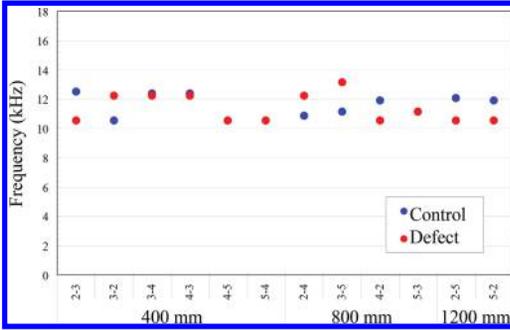
Figure 7. Prominent frequency at the receiving sensor.

Figures 7 and 8 show the analysis results for prominent frequency and spectral centroid, respectively, in frequency distribution of the received waveforms

As shown in Figure 7, prominent frequency fell in the range from 10 to 14 kHz for both control and defect specimens. Unlike in propagation velocity, no significant relationship with properties of the concrete was found.

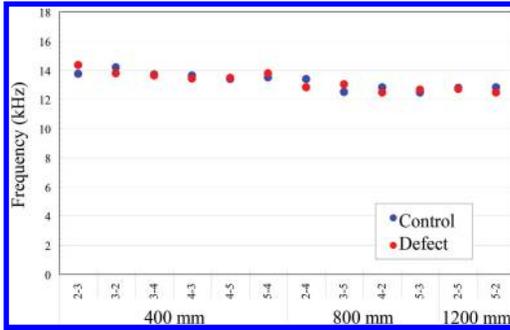
Figure 8. Spectral centroid at the receiving sensor.

Spectral centroid is an analysis technique focused on elastic wave energy as explained by Kuzume et al. (2013) which can express attenuations in the elastic wave in low and high frequency components quantitatively. The spectral centroid used here is an average weighted according to the frequency spectrum obtained by propagation waveform analysis.

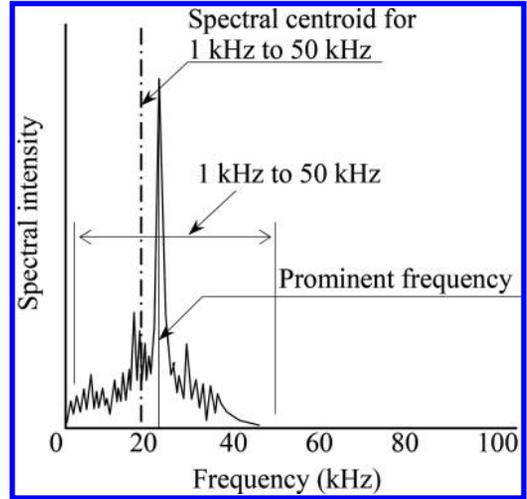
Figure 9. Schematic diagram of the spectral centroid.

The spectral centroid was obtained by weighting the average with frequency components between 1 kHz and 50 kHz (slice width: 150 Hz) so that

influence of noise or minor vibration of the specimens would be reduced (Equation 1, Fig. 9).

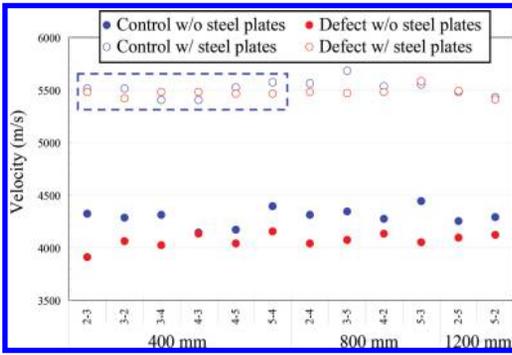
Figure 10. Propagation velocity of the control and defect specimens after steel plate bonding.

Figure 10 shows propagation velocities measured in the control and defect specimens after steel plate bonding, by distance between the sensors. Figure 11 shows the results for Measurement line 2–4 as an example of measured waveform.

The significant difference found in propagation velocity between the control and defect specimens before was not found generally after steel plate bonding, with velocity values in both types being about 5500 m/s. Although impact was applied to the end of the anchor, it was likely that the elastic wave also traveled through the steel plate and reached the receiving sensor before the arrival of the signals through the concrete.

In order to identify how the presence of epoxy resin used in steel plate bonding could influence propagation velocity and frequency distribution, a comparison was made in each of the control and defect specimens between the following three categories: Measurement lines 2-3 and 3-2 in the full bond zone; Measurement lines 4-5 and 5-4 in the poor bond zone; and Measurement lines 3-4 and 4-3 crossing the border between the full and poor bond zones. The measurement results for these are boxed with a dotted line in Figure 10.

As shown in the diagram, no significant difference was found in propagation velocity between the three categories. This suggests that influence of the propagation of elastic waves through steel plates is likely to be much larger than that of the presence of resin.

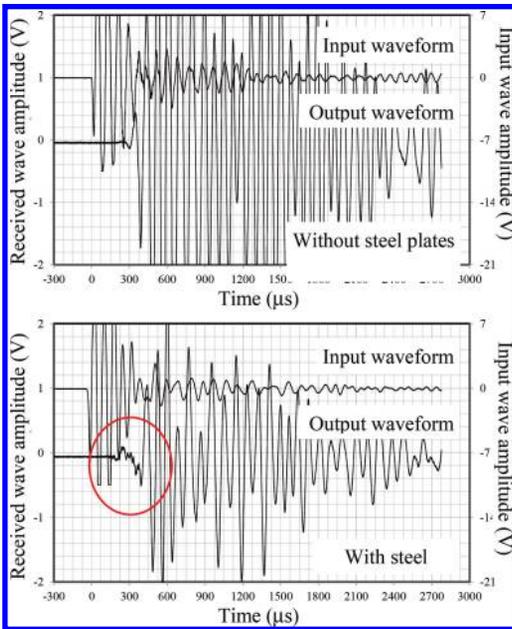
Figure 11. Initial waveforms before and after steel plate bonding.

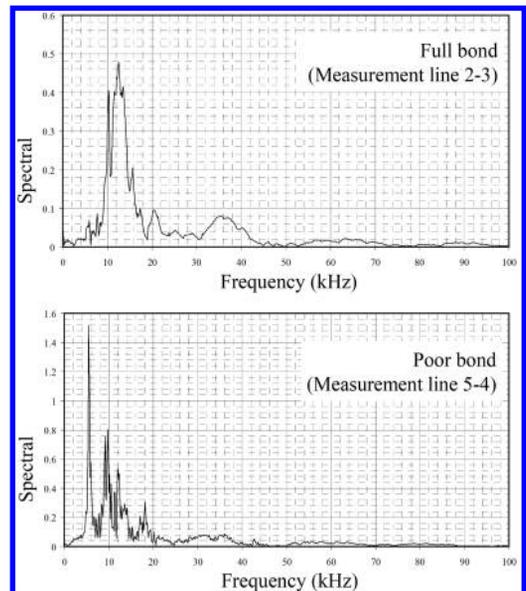
Figure 12. Frequency distributions in input waveforms after steel plate bonding.

Figure 12 shows elastic wave frequency distributions measured near the impact point of Measurement line 2-3 in the full bond zone and that of Measurement line 5-4 in the poor bond zone. When the impact point was in the poor bond zone, a significant shift appeared from the high frequency side to the low frequency side. The reason for this was likely to be a bending resonance phenomenon. When evaluated based on a parameter of spectral centroid, the frequency was almost above 15 kHz in the full bond zone and was below that in the poor bond

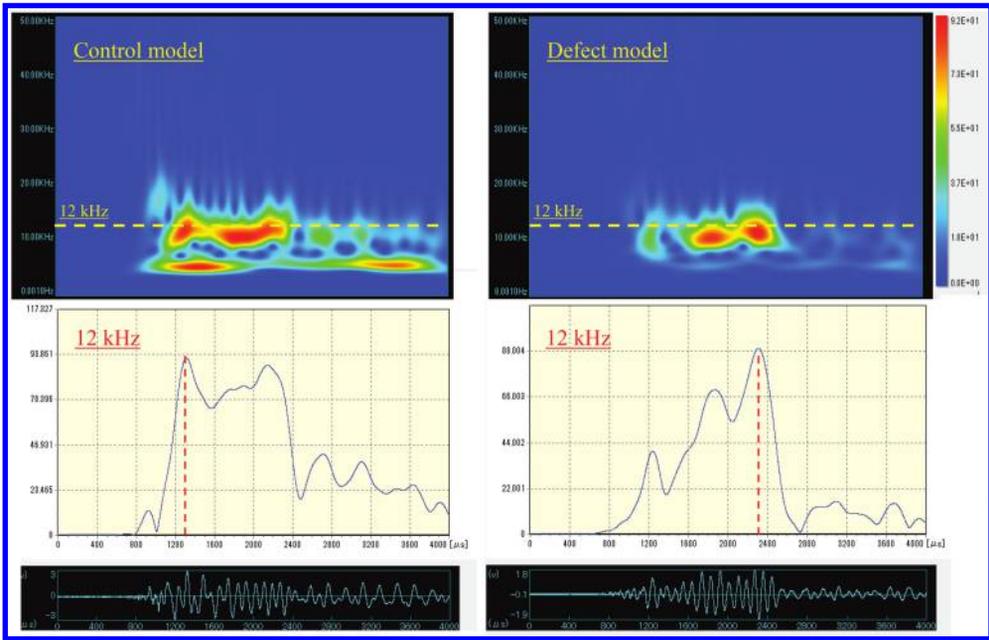
Figure 13. Wavelet analysis results for the control and defect specimens after steel plate bonding.

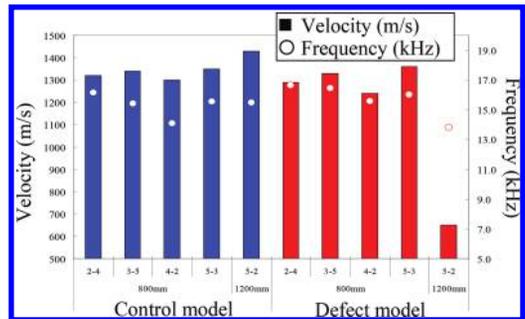
Figure 14. Relationship between spectral centroid and propagation velocity.

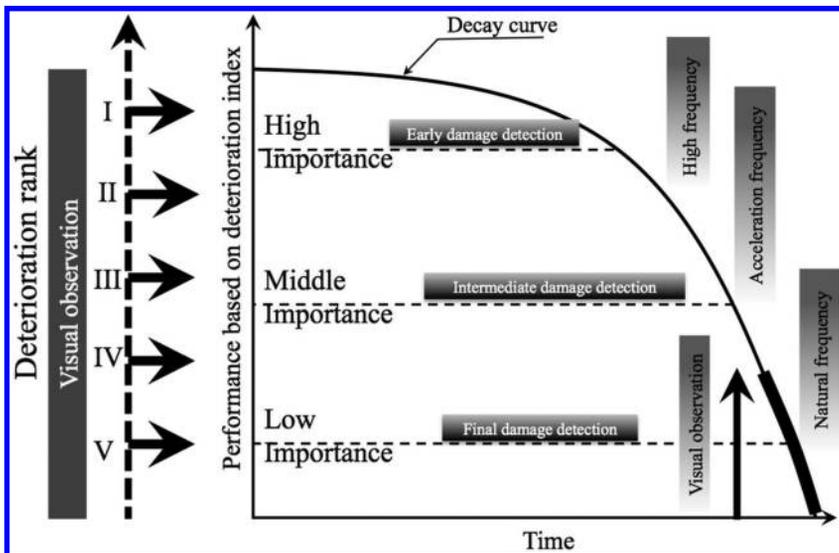
Figure 1. Current performance evaluation of infrastructures based on deterioration rank.

Let remind the current situation of infra-maintenance management. Figure 1 shows a typical performance curve of infrastructure showing the performance versus time. When implementing the management program, the minimum level of service or performance shall be set in advance. The level might be determined based on the importance of the structure in consideration both of direct and indirect impact when it has been failed. In advanced cases, external diseconomies including environmental load substances are considered. When the integrity

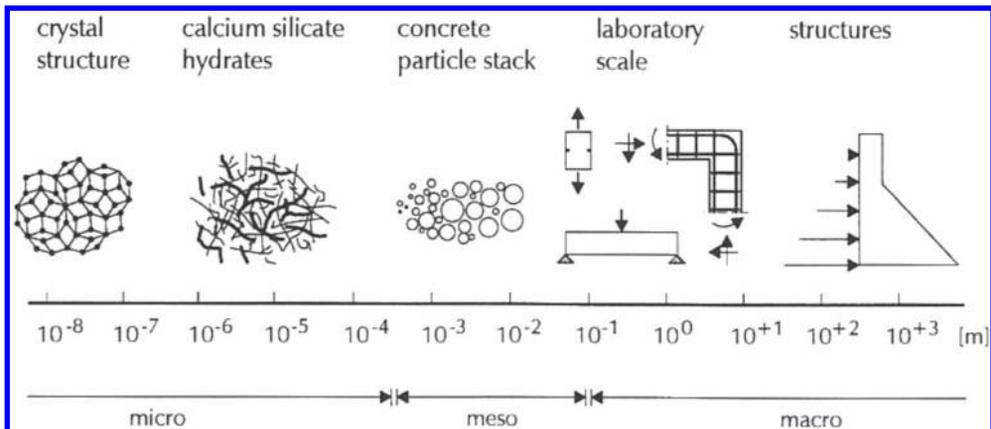
Figure 2. Various scale of observation that must be considered when studying materials and structures (Van Mier 1997).

As shown in Fig. 2, when study concrete materials objective scale shall correspond to the scale of the objectives. When evaluating the concrete particle e.g., the resolution of millimeters scale shall be necessarily measured. As the elastic wave approaches, the wavelength, being effective to the resolution, has been thought that it should be smaller than the resolution i.e., in concrete a couple mega hertz will be equivalent to this millimeters scale resolution. Notation of frequency shown in the right side of Fig. 1 exhibits such corresponding frequencies to the deterioration scales. As in the chart ultrasonic measurement with high frequency shall be conducted for the early damage detection whereas seismometer will be appropriate for the eventual failure phase. It is noted however, as found in other ultrasonic applications, the wavelength with larger than resolution is not always negligible, rather effective to estimate tiny defect (Kawai et al., 2009). Accordingly it would be important to study the substantial relation between the scale of objective and wavelength/ frequency in concrete while clarification of objective scale corresponding to the maintenance level, presumably determined by infra-owner, is other crucial issue to set the strategic maintenance.

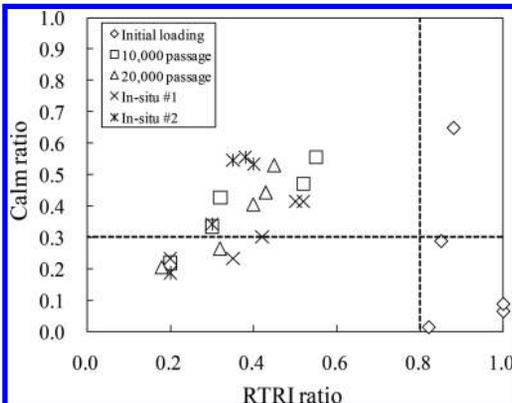
Figure 3. Calm and RTRI ratios in three incremental damage while wheel loading test of RC deck.

As for on going damage, local damage can be visualized by AE sources detected with a passive approach. The damage has also been quantified based on the AE activity obtained during loading and unloading processes. The combination of RTRI or Load and Calm ratios has been employed to quantify the damage as show in Fig. 3 (Shiotani et al., 2009). As shown in the chart, the symbol is successfully shifted to the upper left side with increase of damage, wheel-load repetitions in this case.
