Emerging Technologies in Non-Destructive Testing VI

Editors

D.G. Aggelis & D. Van Hemelrijck

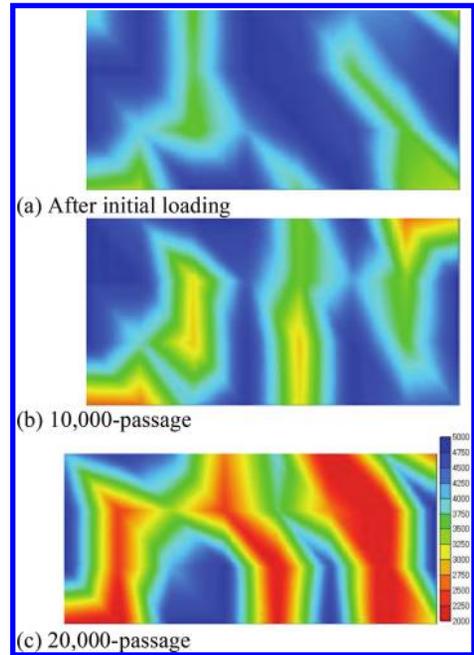
Figure 4. Tomogram in a specific section. Legend shows the velocity in m/s.

While as for existent damage, as elastic wave generation, namely AE occurrence could not be expected during no-load conditions so that active approach with elastic waves, exciting and detecting waves through the media have been crucially utilized. In this case, the damage can be visualized by the elastic wave parameters such as velocity and attenuation of amplitude as show in Fig. 4 exhibiting velocity distributions. The velocity, however, must be recognized as one of the non-sensitive damage indices among other elastic wave parameters as shown in Fig. 5 (Shiotani & Aggelis, 2009). In addition these parameters are influenced by measurement conditions i.e., these can not be an intrinsic parameter being quantitative to the damage e.g., the velocity is a parameter showing dispersion of which the values change depending on frequency (Aggelis 2008), and amplitude can be readily decayed with propagation distance. Accordingly damage indices which are not influenced by these experimental conditions shall be studied. Currently new damage index has been proposed by the author using attenuation coefficient, Q-value, in elastic waves (Shiotani et al. 2012).

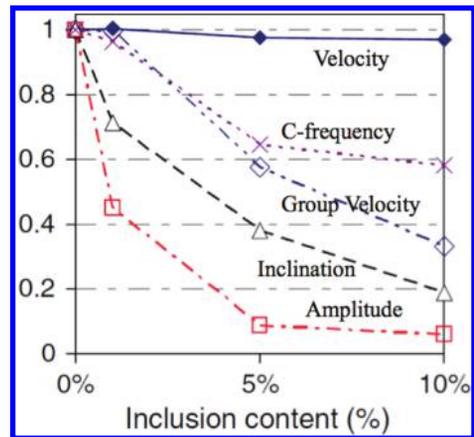
Figure 5. Normalized elastic wave parameters in terms for artificial damage contents.

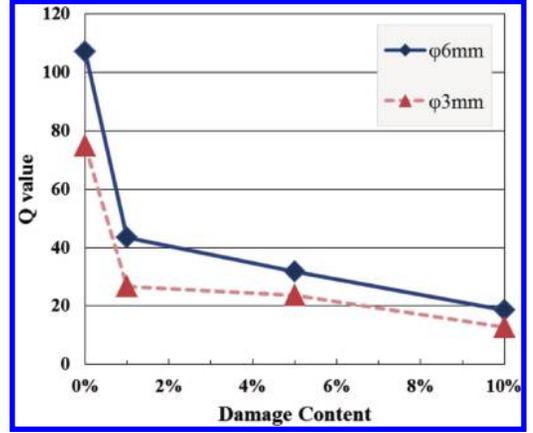
Figure 6. Q-value as a function of damage contents.

The Q-values of all cases are summarized as shown in Fig. 6. For both cases of ϕ 6 mm and ϕ 3 mm, the Q-value becomes smaller with increase

of damage content. Comparing the result of ϕ 6 mm and ϕ 3 mm, the Q-values of ϕ 3 mm show slightly smaller values than those of ϕ 6 mm. In the fact that smaller scale inclusions influences more on attenuation characteristics than that of larger in the same volume of inclusions accords quite well with the past study (Aggelis & Shiotani, 2008). However, it is noted that two results of 0%, exhibiting no artificial inclusions, namely no damage, show different Q-values. This might be attributed to the heterogeneity of the specimen. These might be attributed to existent initial air volume different when casting, a slight difference of sensors' setup condition or propagation paths. However, it can be resulted that the Q-value uniquely represents the degree of damage as a normalized parameter, and this is the very concept to quantify the damage of the materials with the frequency response ratio using AE waveforms.

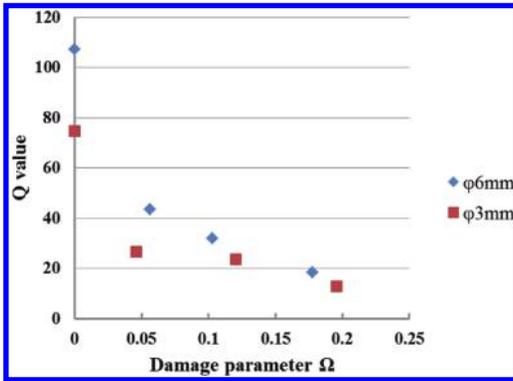
Figure 7. Q -value as a function of damage parameter Ω .

Subjected to uniaxial compression, both for reference and simulated damage specimens, Young's moduli were obtained, and Ω is calculated accordingly based on Eq. 5. The resultant relation of Q -values and Ω is shown as in Fig. 7. The Q -values decrease remarkably when the Ω value increases from 0 to 0.05 corresponding to the initial damage/deterioration, implying that Q -value has a potential to provide useful information to the early damage stage. Also as the good correlation of Q -value and Ω is obtained, the damage or the deterioration of the materials can be quantified with Q -values, which can be then converted to the damage parameter Ω .

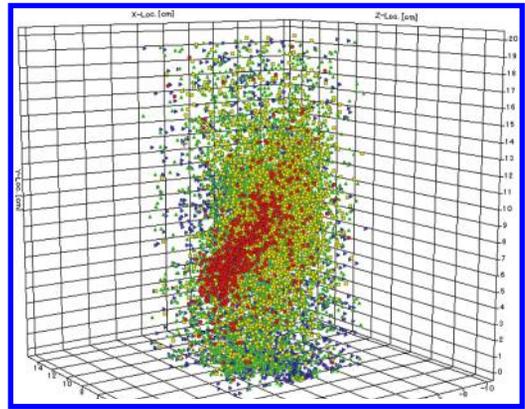
Figure 8. Cumulative AE sources derived through triaxial compression test of tuff sample.

As shown in Fig. 8, damage evolution can be visualized when plotting accumulated AE sources through the whole failure process. In in-situ structures, however, as there is few cases installing AE sensors from default condition, cumulative damage interpretation with AE activity cannot be performed, and therefore tomographic approaches using through the thickness or reflected elastic waves have been employed. In conventional elastic wave tomography, the excitations shall be made at designated locations with accurate time record of excitation, leading to time-consuming measurement and requiring a large numbers of sensors. For the bulky 3D structures of which no access allowed to the real area, 3D visualization of damage cannot be implemented. As a solution for this difficult configuration, the authors' research group has proposed new approach namely 'acoustic emission tomography' (hereafter referred to as AET). In AET, source locations and evaluation of velocity distributions are simultaneously implemented with the following procedure. Hereafter, the source

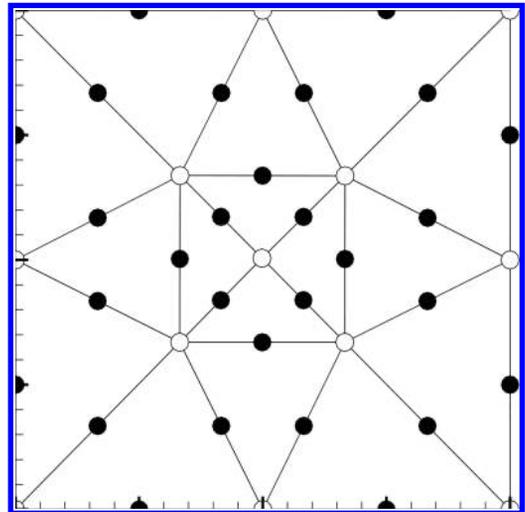
Figure 9. Conventional set of relay points.

The source location technique is based on ray-trace algorithm (Schubert, 2004). This algorithm is characterized by installation of relay points in each cell as illustrated in Fig. 9. As the ray-paths are formed by segments among nodal points in conventional ray-trace algorithm, its resolution depends on the mesh characteristics, implying that high accuracy source location requires fine mesh. This leads to increment of the number of degrees of freedom since slowness, which is a reciprocal of velocity, shall be defined in each cell, and consequently makes the identification procedure more complicated. In this ray-trace algorithm, the relay points between nodes are proposed and a ray-path

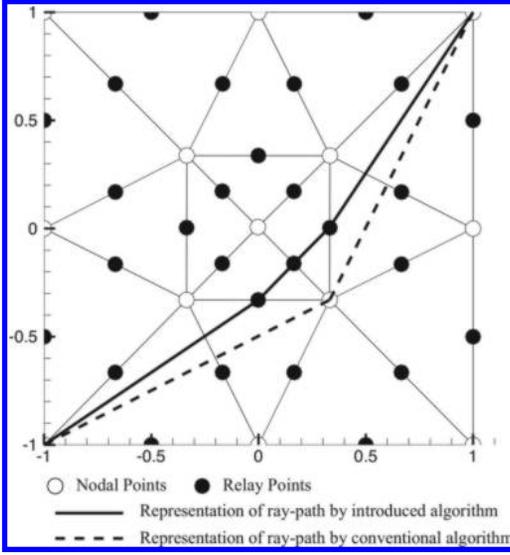
Figure 10. Revised ray path in consideration of proposed relay points.

is formed by segments among nodal and relay points as shown in Fig. 10.

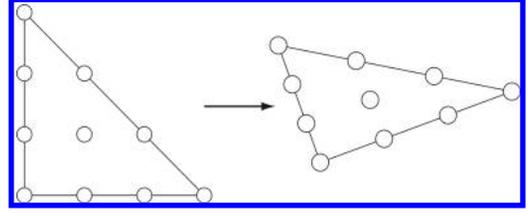
Figure 11. Mapping to the global coordinate of set relay points.

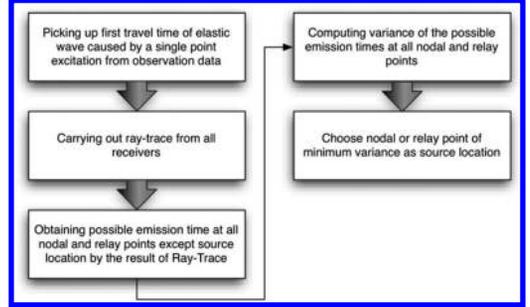
Figure 12. Procedure to estimate the source locations.

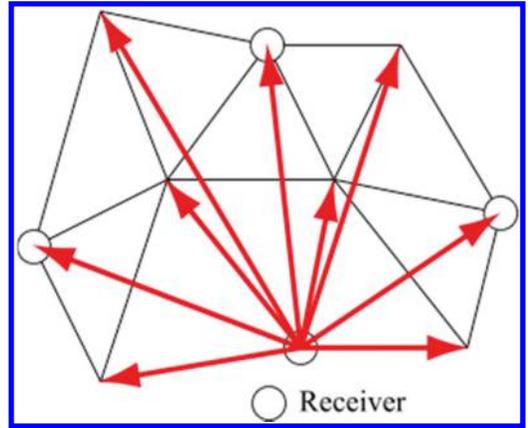
Figure 13. Radiation of waveform form a receiver.

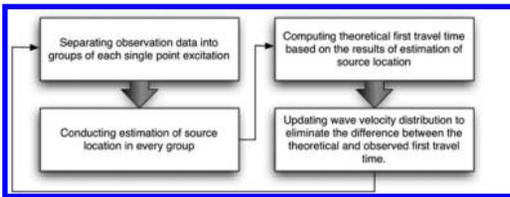
Figure 14. Procedure of seismic tomography with estimation of source location.

Seismic tomography requires source location, emission time and travel time to the receiver. However, the signals having neither emission time nor source location can be used for seismic tomography. It is noteworthy that the source location and emission time can be estimated from travel times to the receivers under the wave velocity distribution determined by the method introduced in previous section. Based on these facts, a procedure of seismic tomography with estimation of source location is introduced. Figure 14 illustrates the procedure of seismic tomography with estimation of source location. In the seismic tomography with estimation of source location, the first step is to estimate the source location and emission time. If the observed travel times can be separated into groups that are respectively associated with individual excitation points, the estimation of source location and emission time are carried out for each observed travel time group. The second step is applying the ray-trace to all estimated source locations. In this step, the ray-trace is carried out for the all of estimated source locations, and the travel time among the estimated source locations to the other nodal or relay points are figured out. Finally by adding the computed travel time to the

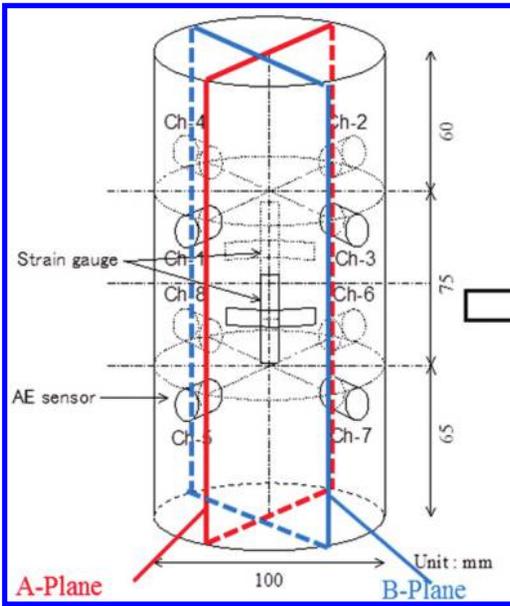
Figure 15. Revised ray path in consideration of proposed relay points.

Cylindrical tuff specimens were sampled at the site of rock slope failure monitoring in Hokkaido, Japan. The specimen has 100 mm in diameter and 200 mm in height. The array of eight AE sensors (60 kHz resonance, R6, PAC) for the AE tomography is shown as in Fig. 15. Four strain gauges were installed onto the central surface of the specimen. Figure 16a shows the photos with regards to the triaxial compression test and b. the rock material. The triaxial compression tests were conducted under consolidated drained condition for generating AE activity in the specimen. The confining pressure was set at 294 kPa and the loading rate was kept constant by 1 kN/min. Finally, shear fracture was observed in the specimen as shown in Fig. 16d causing 907 AE events.

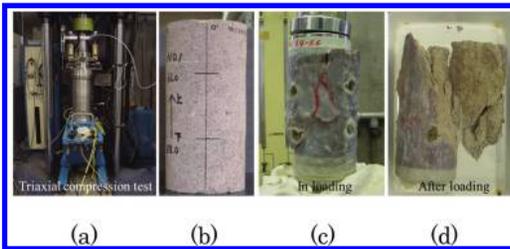
Figure 16. Photos of a. testing apparatus, b. tuff specimen, c. specimen under loading, and d. one after the test from left.

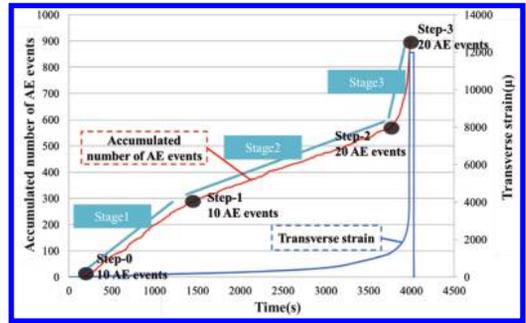
Figure 17. Cumulative numbers of AE events and transversal strain over the experimental time.

Figure 17 shows the accumulated numbers of AE events and the transverse strain with elapsing time. As shown, the accumulated number of AE events is increasing along with increase of transverse strain. Focusing on the relation between time and accumulated number of AE events, the state of fracture progress is divided into three stages. The stage from step-0 to step-1 is regarded as the progress stage of the microscopic failure. Then the stage from step-1 to step-2 is considered as of a steady stage of mesoscopic failure and the

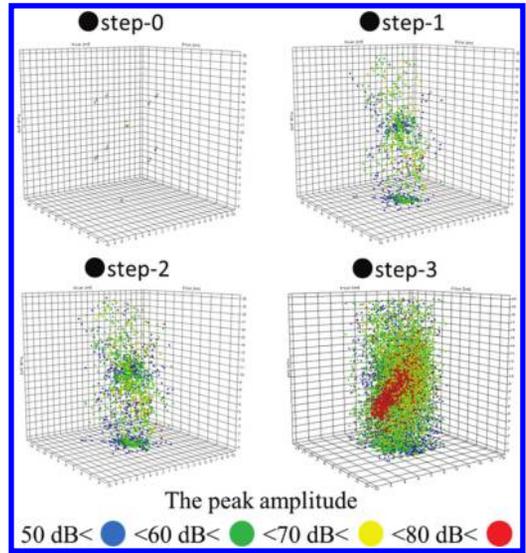
Figure 18. Evolution of 3D AE sources.

stage from step-2 to step-3 is one to be the final macroscopic failure. Then in order to verify the change of velocity structure in each stage, 3D AE tomography analysis was conducted for four steps. The AE tomography can reflect the whole of the past-fracture/ damage phenomenon only with the most latest AE data, so that AE tomography analysis was conducted with 10 or 20 AE events data obtained around the end of the specific stage. Figure 18 shows the AE source locations in the specimen in each step, where the sources are divided with their peak amplitude as exhibited in the legend. It is obvious that the number of AE sources is increasing in accordance with the load application. Although the precise comparison shall be further examined, the plane comprised of red points in step-3 might be identical to the

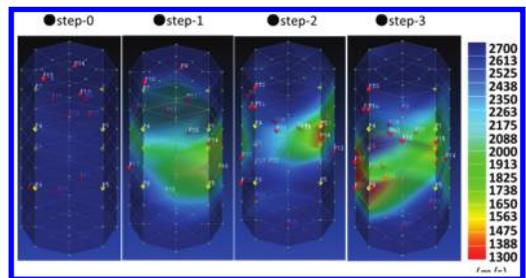
Figure 19. Velocity distributions by 3D AET.

shear failure plane observed visually after the test. The results of 3D AE tomography are shown in Fig. 19. The decrease areas of elastic wave velocity couldn't be confirmed in step-0, implying no remarkable damage progress in this step. In the following step-1 and step-2, the low elastic wave velocity was confirmed to develop in the central

area of the specimen. In the step-3, the large scale of damage evolution was apparent as the low elastic wave velocity was confirmed from the upper right area to the lower left area in the specimen, which is regarded as the final step of the failure. It is noted that this final damage evolution was in good accordance with the shear plane confirmed by both of visual observation and the result of AE source location in 3 dimensions.

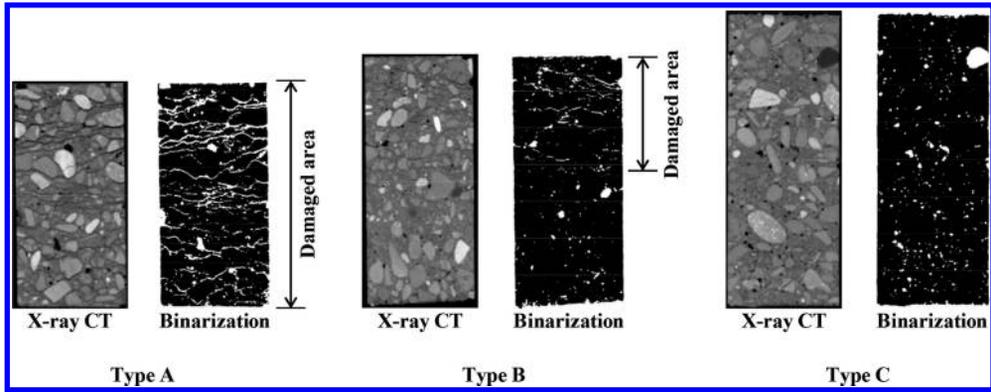
Figure 1. Characteristics of concrete damage in testing samples.

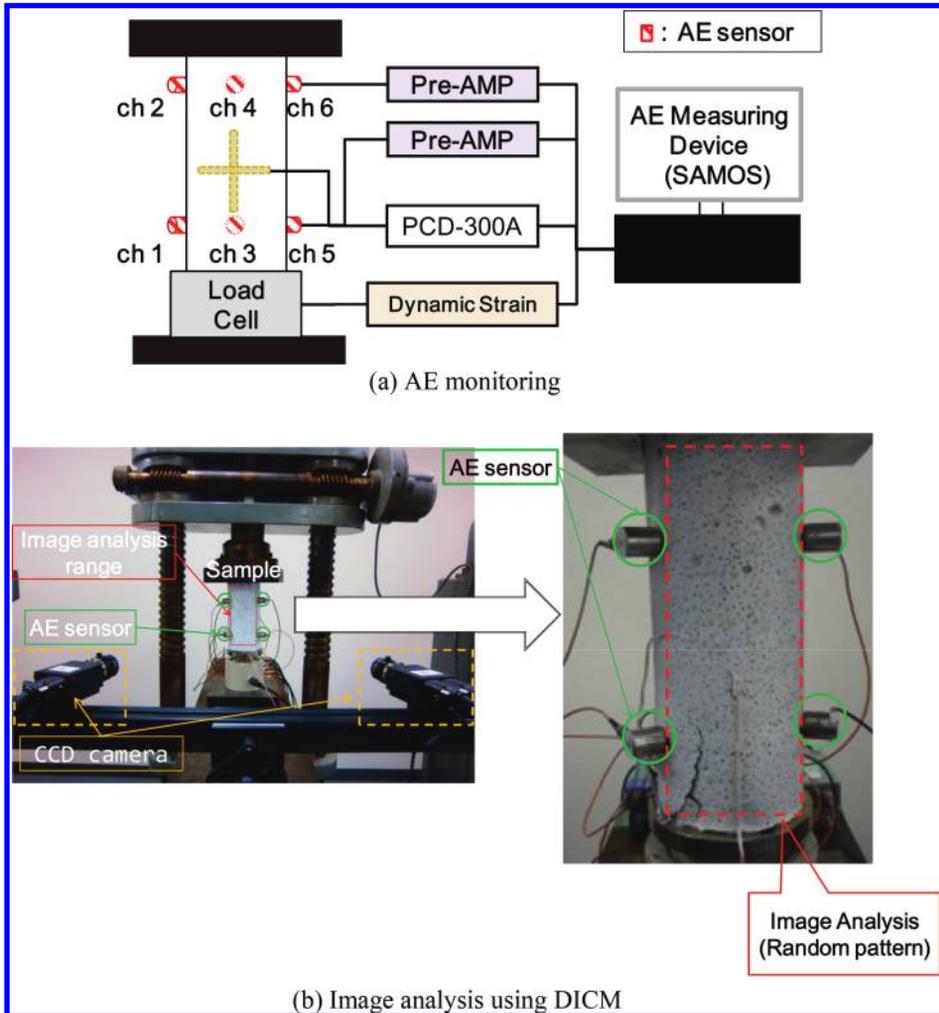
Figure 2. Test setup for AE and DICM monitoring in compression test.

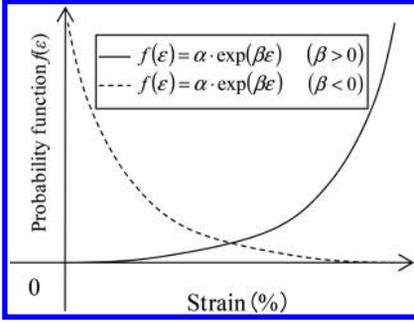
Figure 3. Two possible relations of probability function $f(\epsilon)$.

where α and β are empirical constants. Here, the value ' β ' is named the rate (Fig. 3). The probability varies in particular at low strain level, depending on whether rate ' β ' is positive or negative. If rate ' β ' is negative, the probability of AE events is high at low strain level. This indicates that the testing concrete may be damaged. If the rate is positive, probability is low at low strain level and the concrete is in stable condition. Therefore, it is

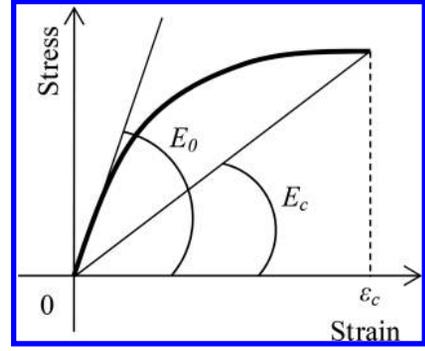
Figure 4. Stress-Strain relation and determination of Young's modulus.

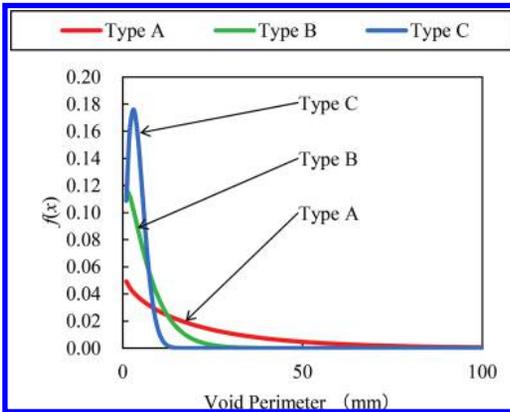
Figure 5. Characteristics of crack and void in testing concrete using the probability function $f(x)$ of X-ray CT data.

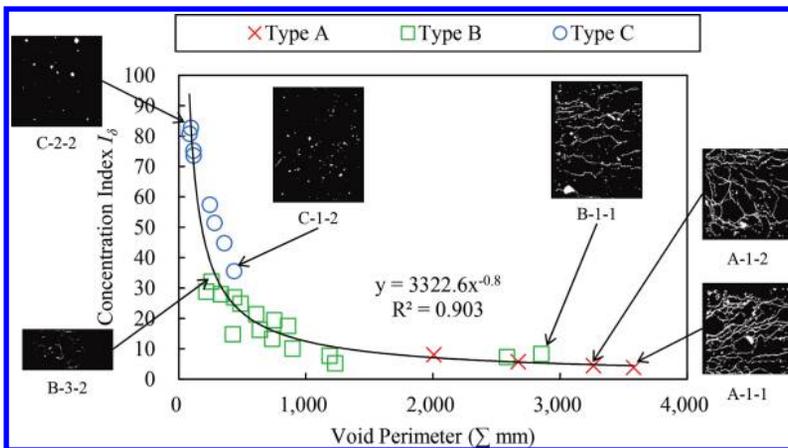
Figure 6. Comparison of void perimeter and the concentration index I_δ .

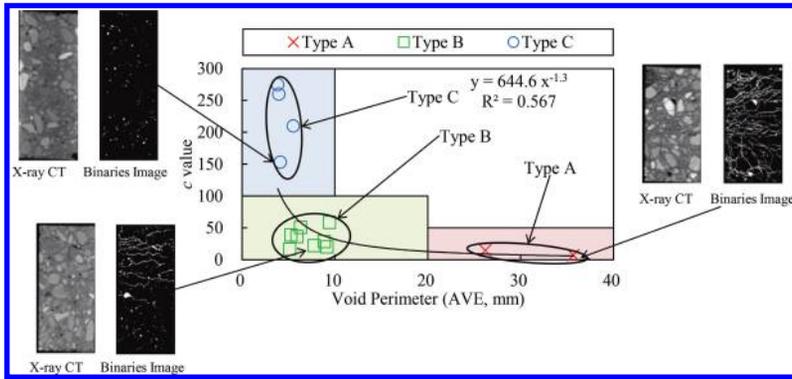
Figure 7. Comparison of void perimeter and c value from the concentration index I_s .

The c values are compared with average void perimeter in Fig. 7. Thus, it can be clearly separated in each sample type by using relation between c value and the void perimeter. Our recent studies, the concentration of crack damage in concrete was positively correlated with decrease trend of CT value (Suzuki et al., 2010). Thus, the results of Type A and Type B are plotted in low c value part ($c < 100$), it is considered that these samples have been fairly damaged. In Type A sample, AE gener-

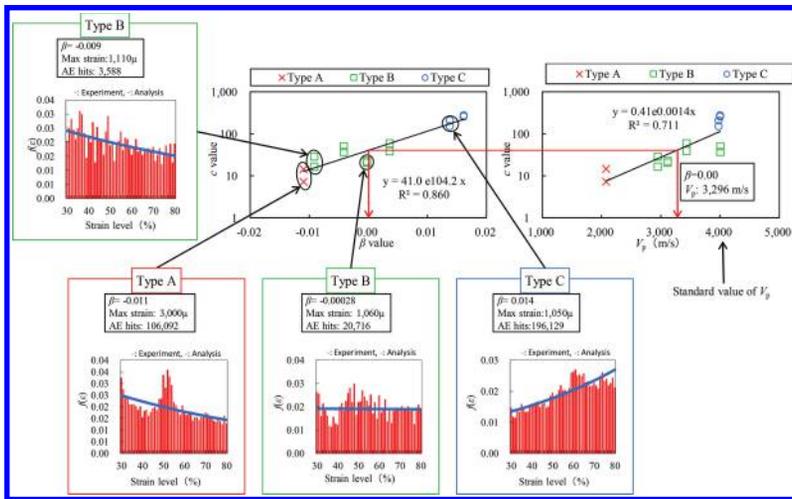
Figure 8. Comparison of X-ray CT parameter ' c ' and damage parameter (' β ', ' V_p ').

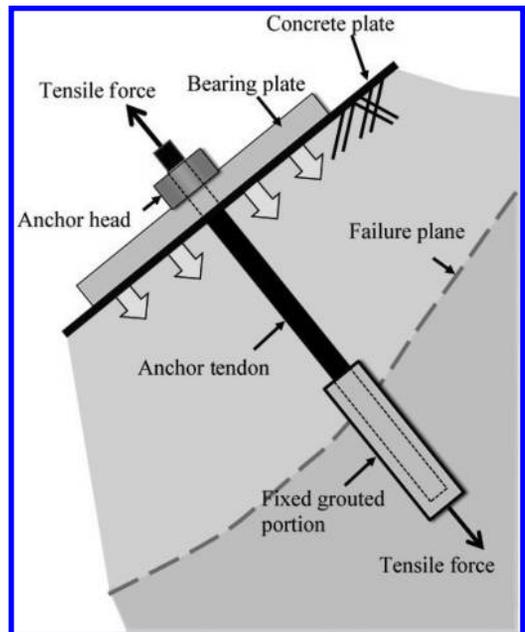
Figure 1. Outline of ground anchor.

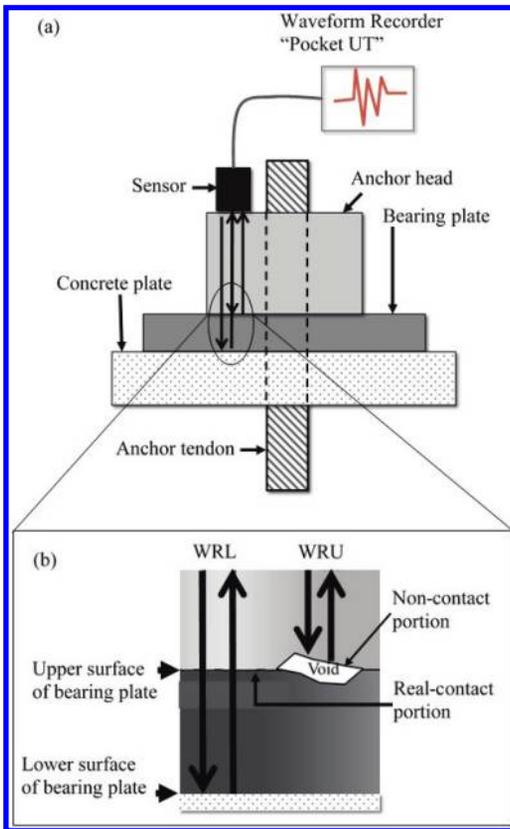
Figure 2. (a) Outline external portion of anchor and (b) Close up view of contact boundary surfaces.

Real-contact portion increases with the increase in axial tension and vice versa. Schematic diagram of contact portions for the boundary contact surfaces between the lower surface of anchor head and the upper surface of the bearing plate is shown in Figure 2b. In real-contact portion, two contacting surfaces have similar acoustic impedances and they are under higher tension. Here, all the incident waves are transmitted downward. In contrary, in non-contact portion as there exist empty or void portion between two contacting surfaces, all the incident waves are reflected back because the acoustic impedance of air (void) is very small. In general, both real-contact and non-contact portions exist between two contacting surfaces. But their ratio depends on the axial tension of the anchor.

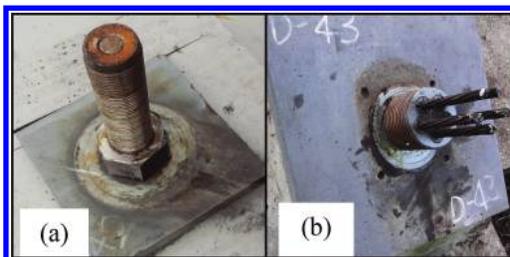
Figure 3. (a) Nut-fix type and (b) Wedge-fix type anchor.

For a steel rod tendon, hexagonal shaped anchor head is used (see Fig. 3a). This type of anchor is known as nut-fix type anchor. Most of the anchors installed in the past are of this type and they were installed without proper remediation against water permeation. So, they undergo corrosion-induced deterioration.

Another type of anchor is known as wedge-fix type anchor (see Fig. 3b). It consists of number of steel stranded wires which are fixed to the round shaped anchor head by wedges. Most of the recent anchors are of this type and they are strong against corrosion. Depending upon the size and number of stranded steel wires present, this type of anchor is marked as E5-3, E5-4, E5-12, etc. Here, in this research, wedge-fix type anchors are only considered.

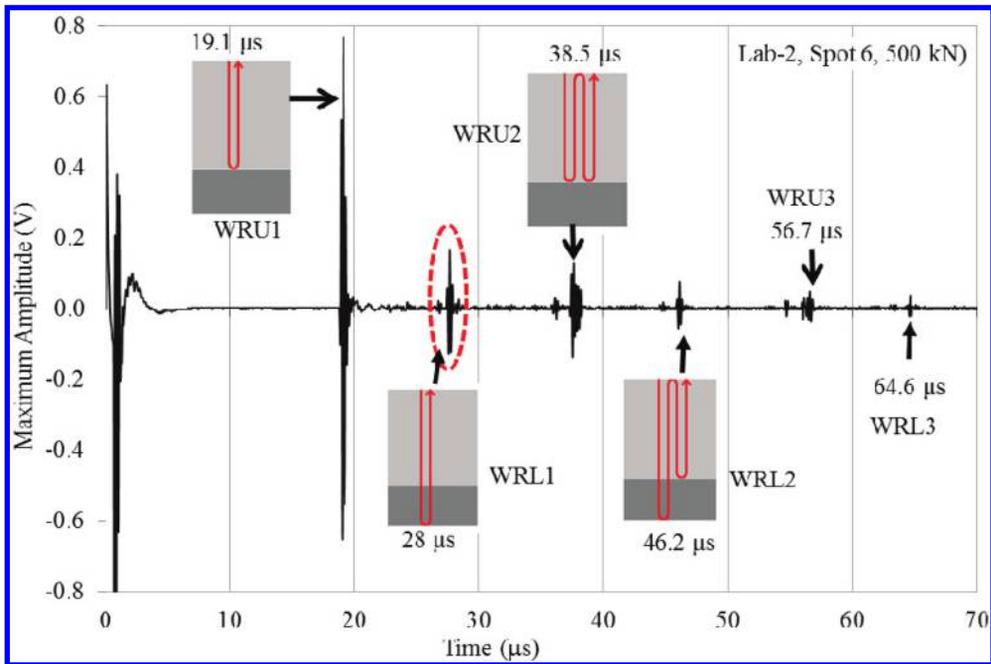
Figure 4. Waveform showing different reflected waves (Lab-3, 500 kN).

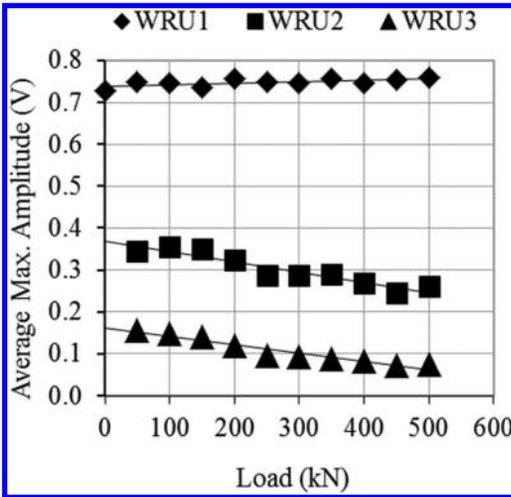
Figure 5. Comparison of WRU1, WRU2 and WRU3.

[Figure 5](#) represents the reflected waves from the upper surface of the bearing plate. Here, with the increase in applied tensile loads, there is decreasing trend in average maximum amplitude. WRU1 shows almost same value in all the loads.

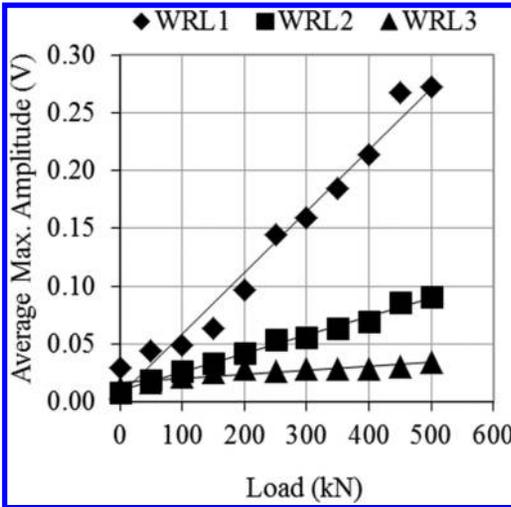
Figure 6. Comparison of WRL1, WRL2 and WRL3.

At higher loads, WRU2 and WRU3 show very less difference in their average maximum amplitudes. Figure 6 represents the reflected waves from the lower surface of the bearing plate. It shows increasing trend in average maximum amplitudes with increasing tensile loads. Comparing the average maximum amplitude values of all the reflected waves with corresponding tensile loads, it can be observed that the 1st reflected wave from the lower surface of the bearing plate (WRL1) shows the best linear relationship showing wider range in amplitude values and tensile loads. Hence, in all the experiments, the average maximum amplitude

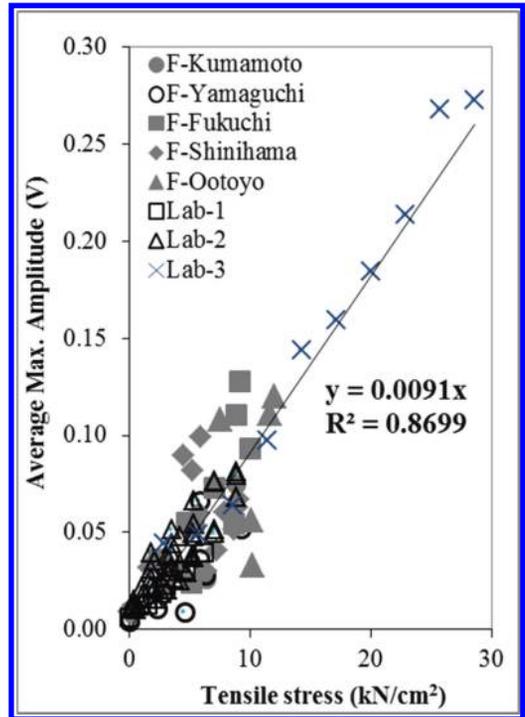
Figure 7. Comparison of average maximum amplitude and tensile stress.

Comparison between this axial tensile stress and average maximum amplitude of WRL1 for all the laboratory and field experiments performed is shown in Figure 7. As shown in Figure 7, a generalized relationship between the average maximum amplitude and the axial stress can be obtained.

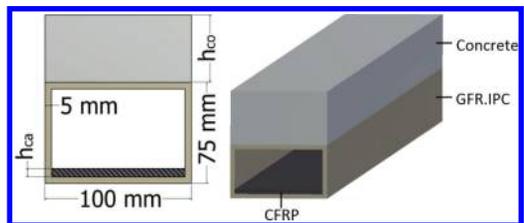
Figure 1. Geometry and dimensions of the proposed hybrid beam design. Two parameters are varied in the experiments: the concrete height and the thickness of the CFRP reinforcement.

The authors propose a composite-concrete design composed of a hollow GFR.IPC box with a Carbon FRP (CFRP) strip (TRADECC 2007) inside and concrete on top (Figure 1). The experimentally determined material properties are given in Table 1. Two dimensional parameters (h_{co} : height of concrete; h_{ca} : thickness of CFRP) are varied within the proposed concept to test the feasibility of the hybrid beams (Table 2). Of every type two beams are tested

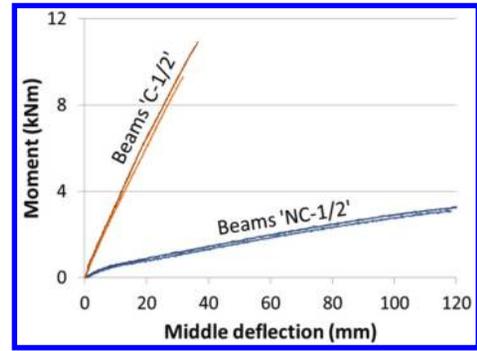
Figure 2. The non-carbon reinforced beams 'NC' clearly exhibit a less stiff behaviour.

Moment-deflection curves (Figure 2) are plotted based on load measurements from a load cell and displacement measurements by a LVDT placed in the middle of the beam's span. These curves indicate the significant difference in stiffness between beams 'NC-1/2' and 'C-1/2'.

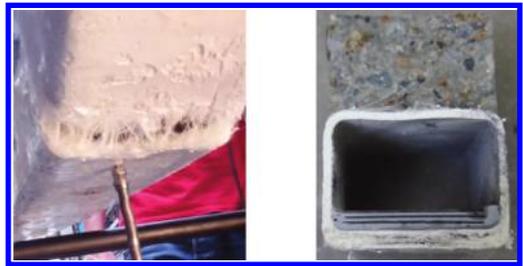
Figure 3. Tensile failure of beam 'NC-1' (left) and the ILS-failure of beam 'C-1' (right).

The absence of carbon reinforcement for beams 'NC-1/2' leads to too high stresses at the bottom of the GFR.IPC box, causing failure in tension due to fibre pull-out for both beams (Figure 3 left). The presence of sufficient CFRP reinforcement, which is the case for beams 'C-1/2', results in a theoretical concrete crushing failure. Experimentally, both carbon reinforced beams exhibit Interlaminar Shear Failure (ILS) at the bottom of the box. This may have limited a further monolithic action between the CFRP strip on the one hand and the concrete-box on the other hand, resulting in a limited further load increase (Figure 3 right).

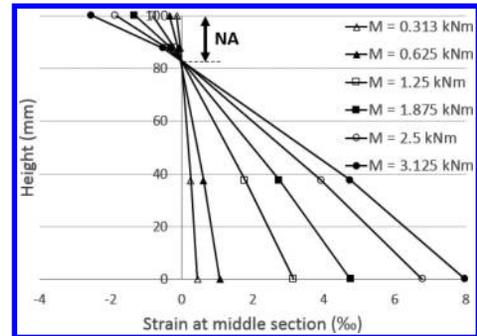
Figure 4. The strain profile of beam 'NC-1' at the mid-span for increasing load steps.

Four strain gauges, located at mid-span and along the height of the cross-section (top, middle concrete, middle GFR.IPC box, bottom) allow us to draw the strain profile at different load steps. All strain profiles exhibit a linear variation. Despite the tensile failure of beams the non-carbon reinforced beams, the tensile strain only reaches 8.0 ‰ for NC-1 (Figure 4), which is lower than the failure strain obtained with material tests (11 ‰). The ultimate concrete strain in the reinforced beam types also does not approach the theoretical failure

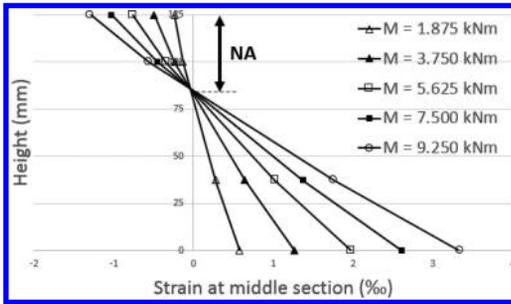
Figure 5. The strain profile of beam ‘C-1’ at the mid-span for increasing load steps.

strain of 3.5 ‰ for beam C-1 (Figure 5) due to the premature ILS failure.

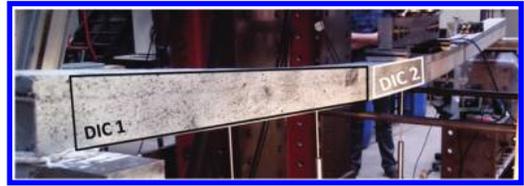
Figure 6. Two 3D DIC systems are used to monitor the behaviour of one half of the beam’s span.

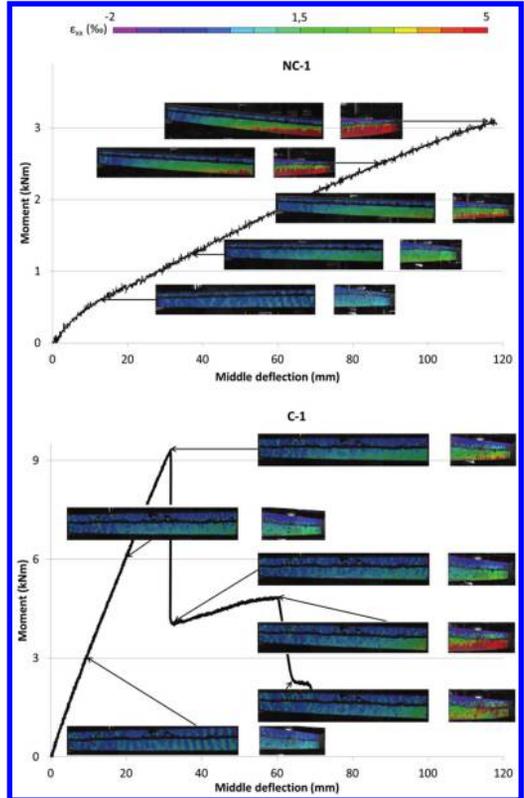
Figure 7. The longitudinal strains gradually increase up to the maximum load. During consecutive load drops, a varying amount of strain is released.

for beams ‘NC-1’ and ‘C-1’ (Figure 7), indicates a gradual increase in tensile strain in the GFR.IPC box and compressive strain in the concrete. This smooth and gradual increase corresponds to the continuous evolution of the experimental moment-deflection curves up to their maximum load.

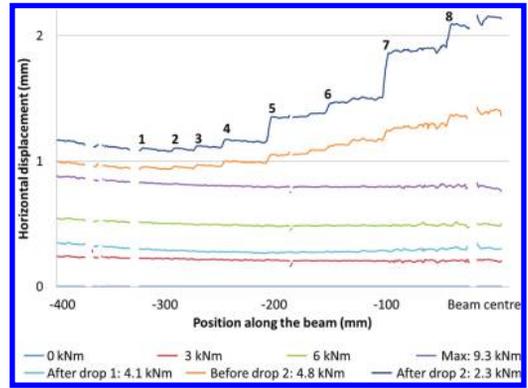
Figure 8. No concrete cracks are present up to the maximum load. However, 8 cracks develop between the first and second load drop.

A visualisation of the crack development in the concrete compression layer of beam C-1 can be obtained by plotting the horizontal displacement (at a height of 15 mm above the GFR.IPC—concrete interface) versus the longitudinal location in the beam for different load steps (Figure 8). Considering the higher bending moment in the central beam area, only the results of DIC2 are represented in Figure 8. The vertical jumps, indicated by numbers 1 to 8, correspond to a sudden increase in displacement and thus a crack in the concrete. In this paper a crack is defined as a difference in horizontal displacement larger than 0.02 mm over a horizontal interval of 5 mm, which is not adjacent to another crack interval.

The horizontal displacement curves clearly indicate a continuous evolution until the second load drop. This indicates the absence of concrete cracks up to beam failure, which is a direct consequence of the position of the neutral axis around the GFR.

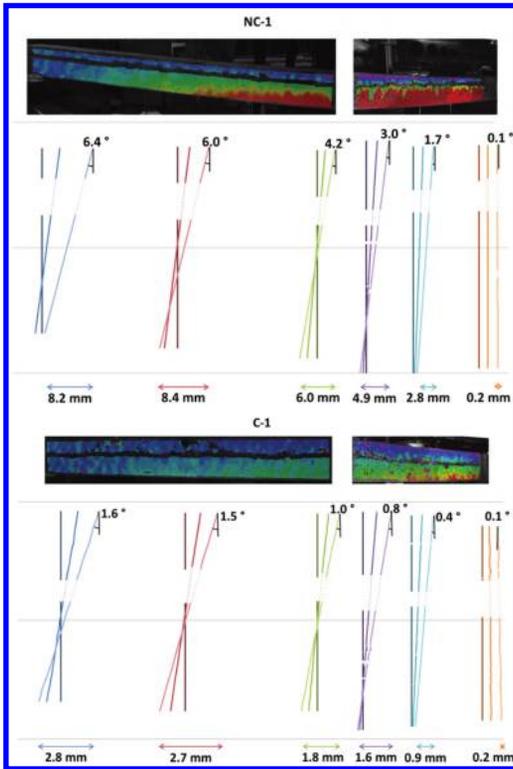
Figure 9. The continuous evolution of the horizontal displacement over the beam's height proves the assumption of a perfect bond between the concrete and the GFR-IPC box and the Bernoulli criterion.

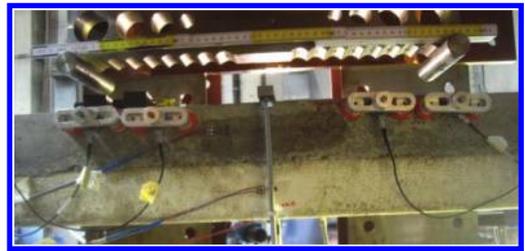
Figure 10. Four AE sensors mounted on the concrete layer of the composite beams by means of magnetic clamps.

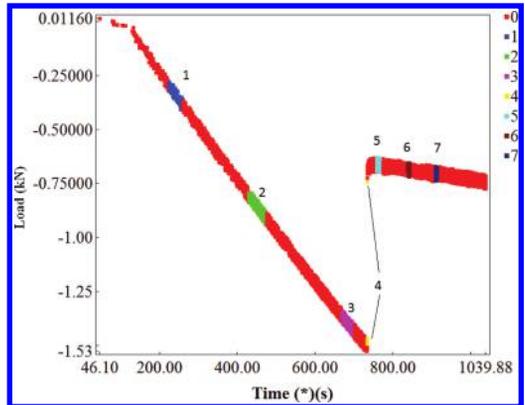
Figure 11. Indicative selection of AE classes during loading of a CFRP reinforced beam. Class 4 is exactly at the load drop.

The total AE activity accumulated to the order of more than 50000 hits for each beam. In this case the trends of AE parameters are of particular interest. As already mentioned above the reinforcement by CFRP played an important role in the fracture behavior; the two reference beams fractured by tensile cracks at the bottom of the IPC box while the CFRP reinforced beams induced additional delaminations in between the layers of the IPC apart from the tensile stress cracking. In order to check the transition of AE indices, the total population of each experiment was preliminary divided in 7 classes. Class #1 corresponded to the AE recorded during low load at the start of the experiment, while #7 was at the end, after the major damage has occurred. An indicative separation of classes for one beam is shown in Fig. 11.

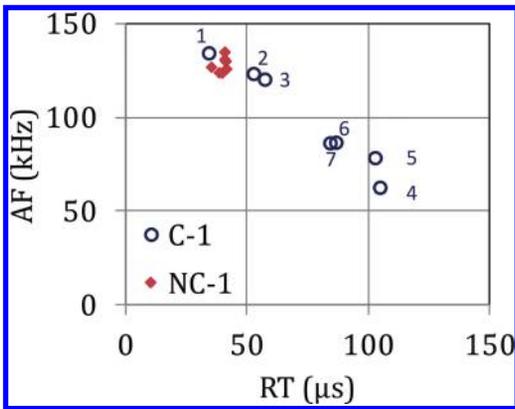
Figure 12. Average values of AF vs. RT for CFRP reinforced (C-1) and reference (NC-1) composite beams, for different loading stages (numbers 1–7).

The AE activity recorded at the different windows is plotted in terms of AF vs. RT axes and shown in Fig. 12.

It is obvious that the activity of the reference beam (NC-1) does not exhibit strong shifts throughout the experiment. The average frequency of the emissions stays approximately constant at 130 kHz

and the rise time of the signals at 40 μs from the initial stages of loading until the end, denoting a similar way of fracturing, or else that the dominant fracture mechanism (in this case cracking at the bottom of the IPC box) does not seriously change. On the other hand it is interesting to note the transition of the CFRP reinforced beam (C-1). While at the initial stages the activity starts at similar values with the reference beam (see point 1 in Fig. 12), there is a gradual shift to higher RT and lower AF resulting in a large leap for stage 4, when the average RT is more than 100 μs and the AF drops to 62 kHz. This shift denotes the debonding shear action that has its peak during the macroscopic load drop moments (Aggelis 2011) and has been reported in other cases of debonding of IPC layers (Blom et al. 2014). For the subsequent stages the values remain much higher than those of the initial stage. The above results indicate that in controlled laboratory conditions it is possible to realize the fracturing trends by AE monitoring. However, in any case, care should be taken to the geometry of the specimens and the location of sensors relatively to the zone sustaining most of the damage. In case the experimental layout changes, although the trends may still exist, the values will not be directly comparable. In this case in all four beams, geometry and test setup was identical enabling the comparison between the different types of beams. It is mentioned that the other beams of the same types exhibited exactly the same trend, but are not presented or discussed due to size limitations.

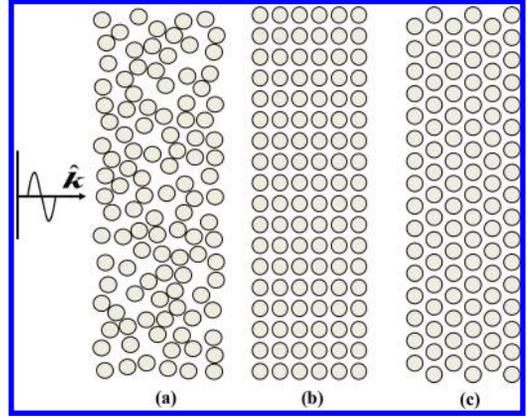
Figure 1. A longitudinal plane wave propagating in $\hat{\mathbf{k}}$ direction impinges upon the q (a) randomly, (b) square and (c) hexagonal distributed elastic fibers.

In Fig. 2 the magnitude of radial scattering amplitudes in the forward direction, for three different fiber arrangements (Fig. 1) are presented for a propagating longitudinal wave, with respect to the range of non-dimensional frequencies $ka = 0.1 - 2$. The size of the virtual control volume containing the fibers for all three cases is $180 \times 540 \mu\text{m}$. The volume fraction is 35% for the square and random fiber arrangement and 32% for the hexagonal arrangement. The total number of the considered identical fibers is 108 for the square and random arrangements and 99 for the hexagonal, while their radius is $a = 10 \mu\text{m}$. The material properties used are presented in Table 1.

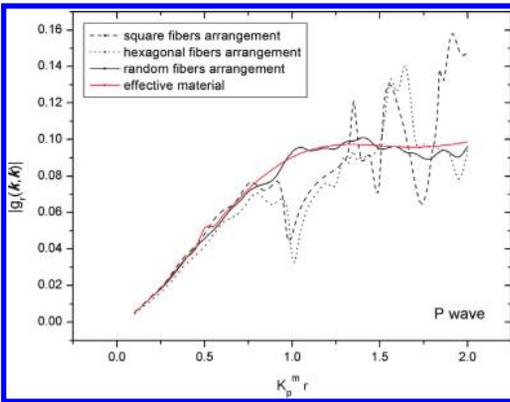
Figure 2. Radial scattering amplitude in the forward direction for a propagating longitudinal wave, calculated for the square, random and hexagonal fiber arrangements, as well as the effective material provided by IEMA.

Observing Figs 2 and 3 one can say that the results obtained for the effective material provided by IEMA are in very good agreement with the corresponding ones taken by the random arrangement of fibers at all the considered frequencies. For low frequencies ($ka < 1$) the same conclusion is valid for the periodic arrangements of fibers. For dimensionless frequencies $ka > 1$ there are significant differences between the periodic and the random arrangement of fibers. In the case of periodic arrangement of fibers there are certain frequencies where a sudden decrease of the value of the scattering amplitude is observed. For those frequencies part of the scattered energy is either diverted in different directions than the forward one or it is trapped between the scatterers as standing waves. Moreover there are also frequencies where the scattered energy in the forward direction is amplified due to the multiple scattering effect.

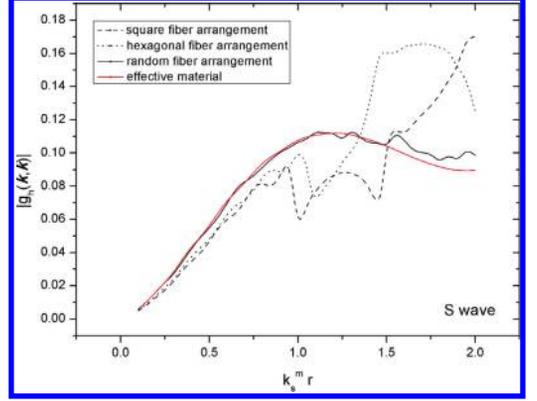
Figure 3. Horizontal scattering amplitude in the forward direction for a propagating longitudinal wave, calculated for the square, random and hexagonal fiber arrangements, as well as the effective material provided by IEMA.

Similarly, in Fig. 3 the magnitude of the vertical scattering amplitudes in the forward direction, for a propagating shear wave, are presented for the three different arrangements and the same non-dimensional frequency range.

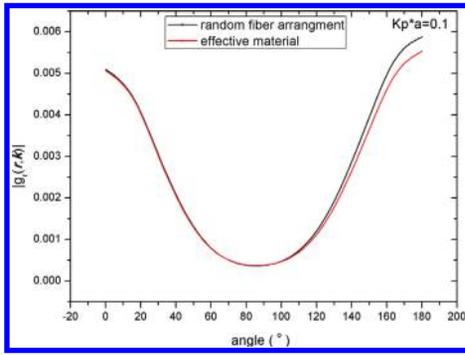
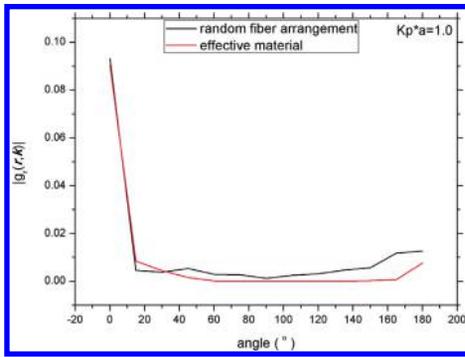
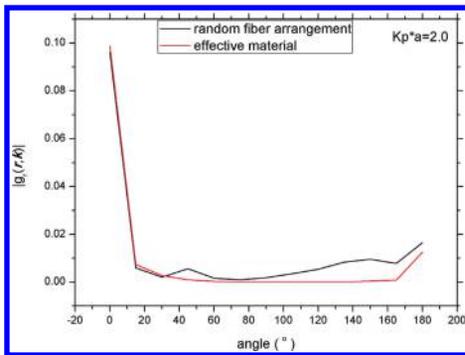
Figure 4. Magnitude of the radial scattering amplitude for different angles and frequency $k^*a = 0.1$.

Figure 5. Magnitude of the radial scattering amplitude for different angles and frequency $k^*a = 1.0$.

Figure 6. Magnitude of the radial scattering amplitude for different angles and frequency $k^*a = 2.0$.

one, the magnitude of the radial scattering amplitude is calculated for a longitudinal incidence in randomly distributed fibers and for three different frequencies $k^*a = 0.1, 1, 2$ at the angle range $0^\circ - 180^\circ$, with the angles 0° and 180° representing the forward and backward direction, respectively. The obtained results are depicted in Figs. 4, 5 and 6 and as it is

observed IEMA predicts pretty well the scattered energy by the composite with the random arrangement of fibers at all directions, while provides almost identical results for the angle range $0^\circ - 20^\circ$.

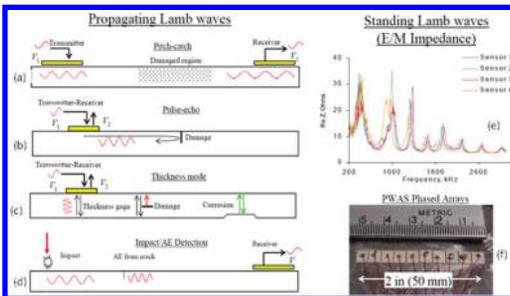
Figure 1. Use of Piezoelectric Wafer Active Sensors (PWAS) for damage detection with propagating and standing guided waves in thin-wall structures (Giurgiutiu, 2008).

As shown in Figure 1, PWAS transducers can serve several purposes (Giurgiutiu, 2008): (a) high-bandwidth strain sensors; (b) high-bandwidth wave exciters and receivers; (c) resonators; (d) embedded modal sensors with the electromechanical (E/M) impedance method. By application types, PWAS transducers can be used for (i) **active sensing of far-field damage** using pulse-echo, pitch-catch, and phased-array methods, (ii) **active sensing of near-field damage** using high-frequency E/M impedance method and thickness mode, and (iii) **passive sensing of damage-generating events** through detection of low-velocity impacts and acoustic emission at the tip of advancing cracks. By using Lamb waves in a thin-wall structure, one can detect structural anomaly, i.e., cracks, corrosions, delaminations,

and other damage. Because of the physical, mechanical, and piezoelectric properties of PWAS transducers, they act as both transmitters and receivers of Lamb waves travelling through the structure. Figure 1a illustrates the **pitch-catch method**. An electric signal applied at the transmitter PWAS generates, through piezoelectric transduction, elastic waves that travel into the structure and are captured at the receiver PWAS. Figure 1b illustrates the **pulse-echo** method. In this case, the same PWAS transducer acts as both transmitter and receiver. Figure 1c illustrates the use of PWAS transducers in **thickness mode**. The thickness mode is usually excited at much higher frequencies than the guided wave modes discussed in the previous two paragraphs. For example, the thickness mode for a 0.2-mm PWAS is excited at around 11 MHz, whereas the guided wave modes are excited at tens and hundreds of kHz. When operating in thickness mode, the PWAS transducer can act as a thickness gage. Figure 1d illustrates the detection of **impacts and acoustic emission (AE) events**. In this case, the PWAS transducer is operating as a passive receiver of the elastic waves generated by drop weight impacts or by AE events. Figure 1e illustrates the electromechanical impedance spectrum measured in the k-MHz range. When a structure is excited with sustained harmonic excitation of a given frequency, the waves travelling in the structure undergo multiple boundary reflections and settle down in a standing wave pattern known as vibration. Structural vibration is characterised by resonance frequencies at which the structural response goes through peak values. A natural extension of the PWAS pulse-echo method is the development of a PWAS phased array (Figure 1f), which is able to scan a large area from a single location. The PWAS phased arrays utilise the phase array principles to create an interrogating beam of guided waves that travel in a thin-wall structure and can sweep a large area from a single location.

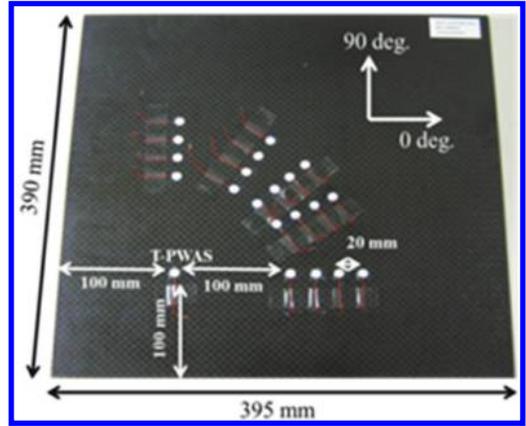
Figure 2. Picture of the network of piezoelectric wafer active sensor bonded on the CFRP.

The structure under investigation is a CFRP plate consisting of carbon fibre fabric reinforcement in an epoxy resin (Figure 2). The plate dimensions are

$390 \times 395 \times 2 \text{ mm}^3$. The CFRP material is HexPly® M18/1/939; this is a woven carbon prepreg manufactured by Hexcel. This material is commonly used in aircraft industry. The plate plies have the orientation $[0, 45, 45, 0]_s$. Twenty one PWAS transducers (Steminc SM412, 8.7 mm-diameter disks and 0.5 mm-thick) were used for Lamb wave propagation experiments. The PWAS network bonded on the CFRP plate is shown on Figure 2. The instrumentation consisted of an HP33120 A arbitrary signal generator, and a Tektronix TDS210 digital oscilloscope. A LabView™ computer program was developed to record the data from the digital oscilloscope, and to generate the raw data files.

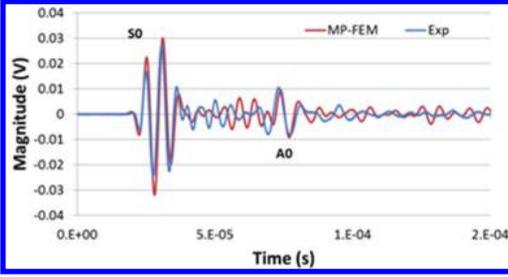
Figure 3. Comparison between the experimental and the MP-FEM received signal at 100 mm from the T-PWAS at 150 kHz with $\alpha = 0$ and $\beta = 2.10^{-8}$ (Gresil & Giurgiutiu 2014).

The multi-physics finite element (MP-FEM) simulation was carried out to determine the attenuation coefficient. A 150 kHz three-tone burst modulated by a Hanning window with a 20 Volts maximum amplitude peak to peak was applied to the top surface of the T-PWAS transducer, and the other PWAS transducers as receivers. Due to the dispersion curves presented and the tuning effect described on reference (Gresil & Giurgiutiu, 2013a; Gresil & Giurgiutiu, 2014), both S0 and A0 modes are present at this frequency. Figure 3 shows the comparison between the MP-FEM simulation and experimental electric signal measured at R-PWAS placed at 100 mm from the T-PWAS with the stiffness proportional coefficient $\beta = 2.10^{-8}$ which corresponds to the A0 mode attenuation as calculated in the reference (Gresil & Giurgiutiu, 2013c; Gresil & Giurgiutiu, 2014). With this stiffness proportional coefficient $\beta = 2.10^{-8}$, the MP-FEM signal for the S0 and the A0 modes are in very good agreement with the experimental signal.

However, the MP-FEM signal between the S0 mode packet and the A0 mode packet is different from the experimental signal. This different

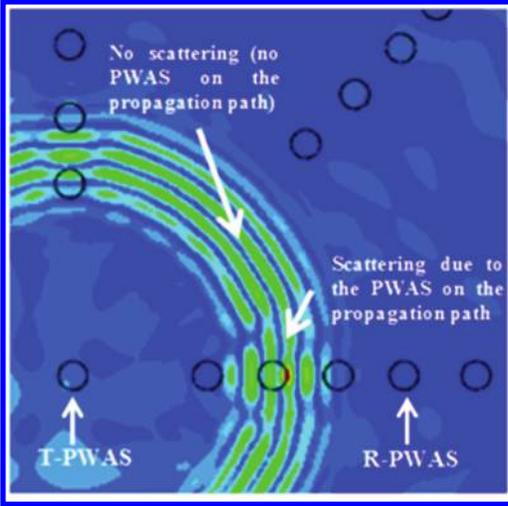
Figure 4. Snapshot of the guided waves propagation showing the scattering due to the bonded PWAS on the guided wave propagation path between the T-PWAS and the R-PWAS (Gresil & Giurgiutiu 2014).

signal may be due to the scattering effect by the other bonded PWAS on the guided wave propagation path between the T-PWAS and the R-PWAS as described on the MP-FEM snapshot on Figure 4 (Gresil & Giurgiutiu, 2014).

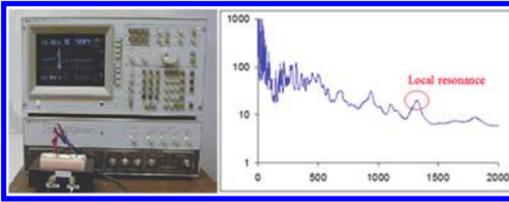
Figure 6. (left) Impedance analyser; (right) example of measured impedance spectrum (Gresil et al. 2012).

During a frequency sweep, the real part of the E/M impedance, $\text{Re}[Z(\omega)]$, follows the up and down variation as the structural impedance goes through the peaks and valleys of the structural resonances and anti-resonances (Figure 6b). By comparing the real part of the impedance spectra taken at various times during the service life of a structure, meaningful information can be extracted pertinent to structural degradation and ongoing damage development. On the other hand, analysis of the impedance spectrum supplies important information about the PWAS integrity. The frequency range used in the E/M impedance method must be high enough for the signal wavelength to be significantly smaller than the defect size. From this point of view, the high frequency EMIS method differs from the low-frequency modal analysis approaches.
