Emerging Technologies in Non-Destructive Testing VI

Editors

D.G. Aggelis & D. Van Hemelrijck

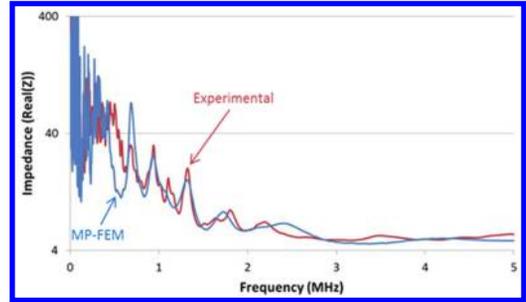
Figure 7. Comparison of experimental and 3D MP-FEM model impedance spectra of laminate GFRP for a frequency range 10 kHz to 5 MHz (Gresil et al. 2012).

The comparison between the simulated and the experimental impedance spectra results are presented in Figure 7. In Figure 7, the results are in the range up to 5 MHz. It is apparent that a relatively good agreement between the experiments and 3D MP-FEM simulation has been achieved. The good matching is achieved by adjusting the damping coefficients used in the structural model. The correlation of the modal frequencies between the experimental and the numerical results is quite good, especially at higher frequencies. However, some discrepancies in the magnitudes of some resonances are observed, especially in the range of 450 to 650 kHz. It is interesting to see that the best match is obtained in the 700 kHz to 2 MHz frequency range. This is very beneficial, because this frequency range has shown the best detection of delamination damage (Gresil et al., 2012).

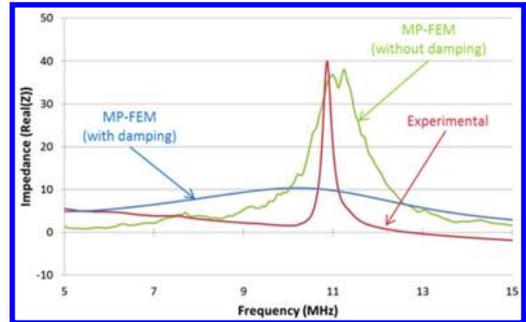
Figure 8. Comparison of experimental and 3D MP-FEM model impedance spectra of laminate GFRP for a frequency range 5 MHz to 15 MHz (Gresil et al. 2012).

Figure 8 shows a comparison of the impedance spectra in a very high frequency range (of 5 to 15 MHz).

Only one peak is observed at ~11 MHz; this peak corresponds to the thickness mode resonance of the PWAS transducer. It seems that at high

frequency (5 to 15 MHz), the vibration is localized near the PWAS so the bonding condition and the PWAS geometry is very important. In the case of the simulation the bonding layer is perfect and also the PWAS geometry. In reality, this is not true so we can explain more difference between the experimental and the simulation results for high frequency. Moreover the magnitude of the vibration pick is very small due to the damping effect, and this effect is very hard to simulate because of the non-linearity of this effect.

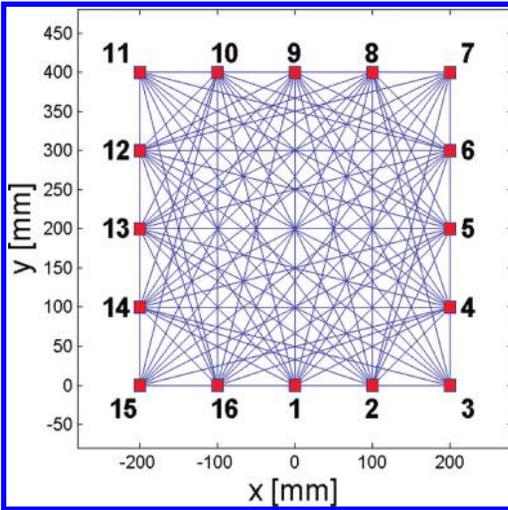
Figure 1. Rectangular array configuration with 16 active transducers. The lines connect different TR pairs and mark the region of interest.

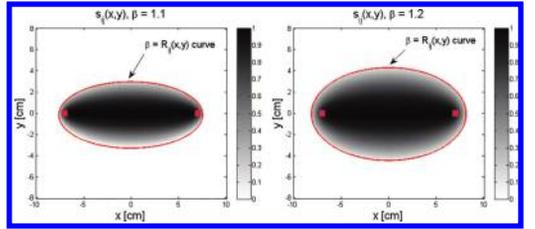
Figure 2. Values of the $s_{ij}(x, y)$ function calculated for a rectangular mesh. Transducers are indicated by the small squares.

where β stands for an free threshold parameter that defines the area influenced by one TR pair (see [Figure 2](#)). $R_{ij}(x, y)$ is the geometrical function defined as

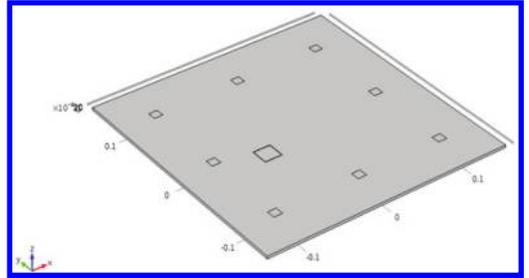
Figure 3. Model of the orthotropic CFRP plate with a linear delamination centered at 1/4 of the plate thickness. 8 elements form the array.

Numerical simulations were carried out using COMSOL® finite element software. The sample was simulated as an orthotropic plate with dimensions of $288 \times 296 \times 2.7$ mm (see [Figure 3](#)). The modelled material was a T300/924C CFRP polymer with density $\rho = 1548$ /³. The elastic properties of the simulated plate are noted in [table 1](#). Rayleigh damping model was used with the mass damping parameter $\alpha_{dK} = 0$ and stiffness damping parameter

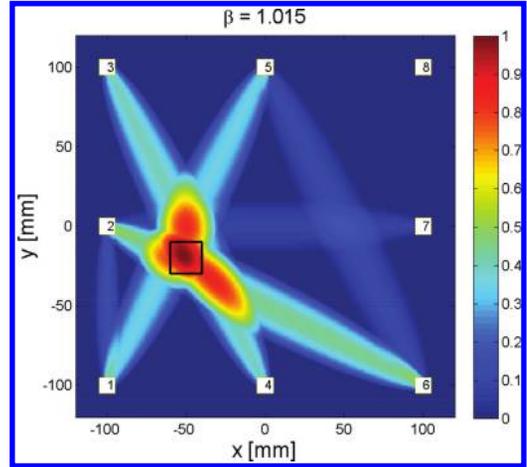
Figure 4. Conventional RAPID with single linear delamination. Excitation parameters: 20 cycles, Hanning window, $f = 50$ kHz, $B_{ex} = 1 \mu\text{m}$, $\beta = 1.015$. Black box indicates the damaged area. The defect is centered at $[-50, -20]$.

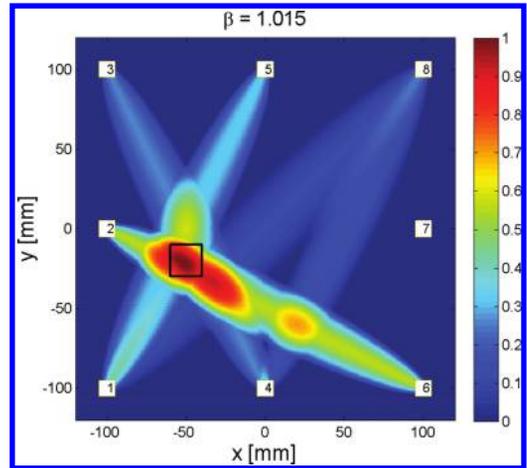
Figure 5. Conventional RAPID with single nonlinear delamination. Excitation parameters: 20 cycles, Hanning window, $f = 50$ kHz, $B_{ex} = 1 \mu\text{m}$, $\beta = 1.015$. Black box indicates the damaged area. The defect is centered at $[-50, -20]$.

The second simulation result shows the detection of a nonlinear delamination by the conventional RAPID. If the excitation amplitude $D_{ex} = B_{ex} \Rightarrow a = 100$ then there is an indication of the defect in the resulting image (see Figure 5). The nonlinearity (“clapping”) was triggered and the delamination can be detected using the conventional RAPID due to the added nonlinearity in the signal. This effect illustrates that a is a critical parameter

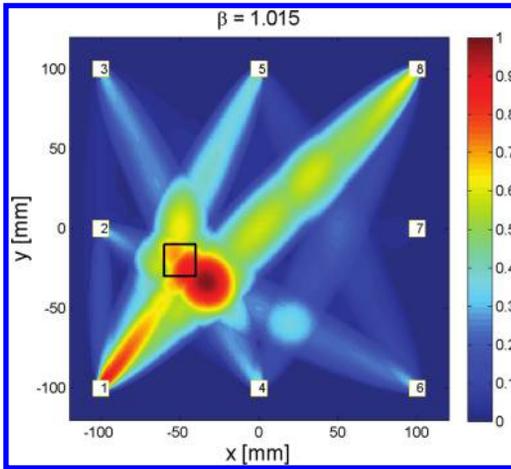
Figure 6. Baseline-free RAPID with single nonlinear delamination. Excitation parameters: 20 cycles, Hanning window, $f = 50$ kHz, scaling factor $a = 100$, $B_{ex} = 10$ nm, $D_{ex} = 1$ μ m. Black box indicates the damaged area. The defect is centered at $[-50, -20]$.

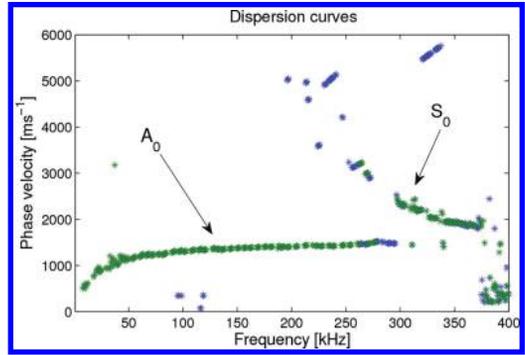
Figure 7. Dispersion curves for the tested sample as measured by laser Doppler vibrometer and processed using the 2D FFT algorithm.

The tested sample was a large CFRP plate with dimensions of $500 \times 500 \times 5$ mm with a low velocity barely visible impact (BVID) in the upper right hand corner (see Figure 8). 16 elements were arranged in a rectangular array around as depicted in figure 8. The sample was quasi-isotropic. The low frequency A_0 mode was selected for the inspection, because A_0 is rather nondispersive in the selected region with the phase velocity reaching a constant level (see Figure 7).

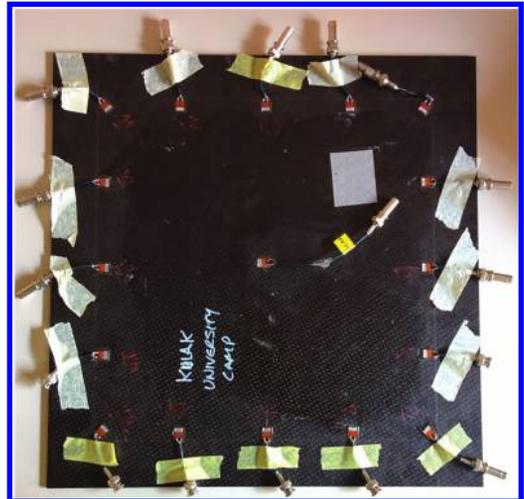
Figure 8. The large CFRP test sample with 16 array elements organized into rectangular array.

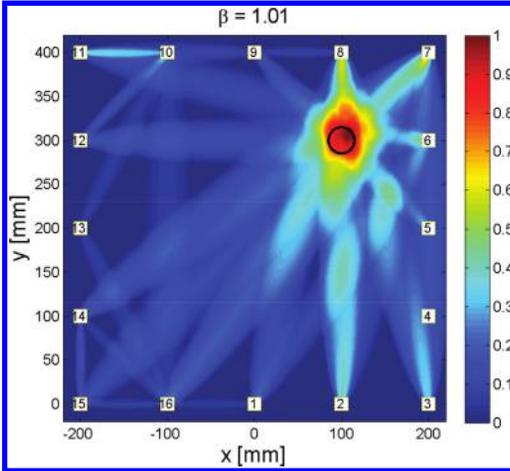
Figure 9. Conventional RAPID image of the large CFRP plate. Excitation parameters: 3 cycles, Hanning window, $f = 50$ kHz, $\beta = 1.01$. The original defect zone is marked with a black circle.

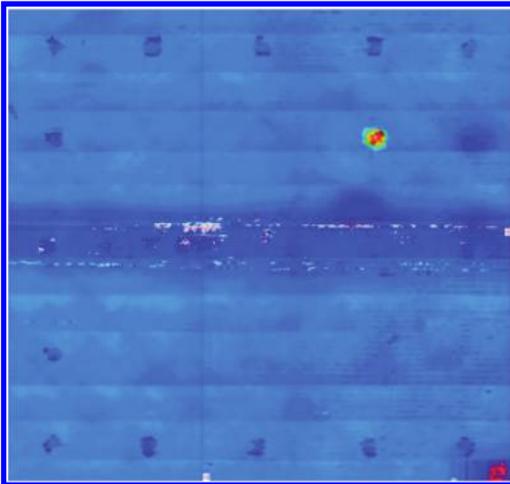
Figure 10. Ultrasonic C-scan of the large CFRP sample. Damage is located in the upper right hand corner. Dark blue strip in the middle of the plate is an embedded thin copper foil in the bottom surface layer.

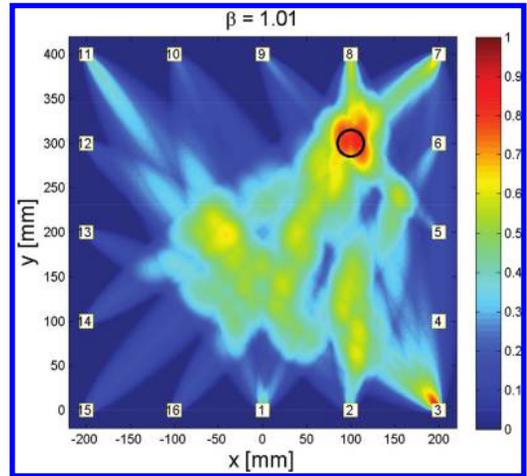
Figure 11. Baseline-free RAPID localization. Excitation parameters: 3 cycles, Hanning window, $f = 50$ kHz, $\beta = 1.01$, $a = 10$. The original defect zone is marked with a black circle.

10. The resulting image is shown in figure 11. The lower excitation voltage was $B_{ex} = 8$ V. The correct defect position was roughly localized. However, the location accuracy is lower than with the conventional RAPID, but still sufficient to reliably discern it from intact areas, without having to rely on the “intact state” reference signals.

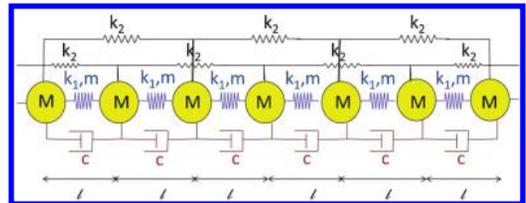
Figure 1. Non local lattice model with two-neighbor interactions.

Assuming for the sake of simplicity the lattice model of Figure 1 without considering the dashpots concludes to the following one dimensional wave equation, classical and non-classical boundary conditions:

As it is clearly shown the aforementioned lattice model fully reproduces the Mindlin's differential equation, as well as the classical and non-classical boundary conditions and it additionally provides a physical link between the microstructural coefficients and the geometrical and mechanical properties of the considered medium.

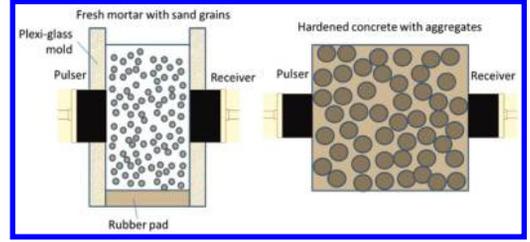
Figure 2. Experimental setup for fresh mortar and hardened concrete velocity measurements in a schematic representation.

in a typical through transmission arrangement. In the first case, a special plexi-glass mold was used where holes of the shape and size of the sensors had been drilled to provide direct contact with the cementitious material (Fig. 2). The propagating distance (thickness of the specimen) was defined by a U-shaped rubber between the two external plates. Concerning the hardened material, the sensors were also directly attached on the tested concrete elements (Fig. 2).

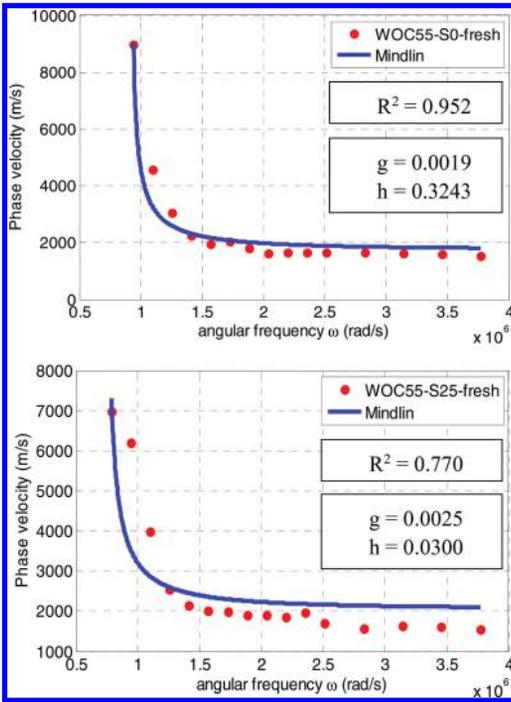
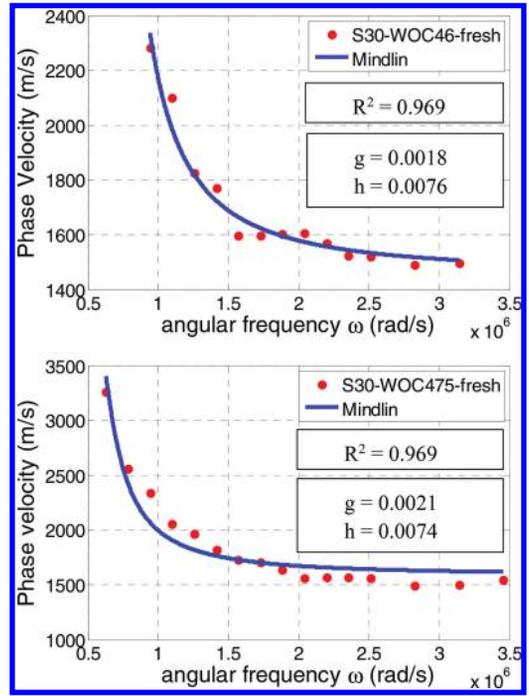
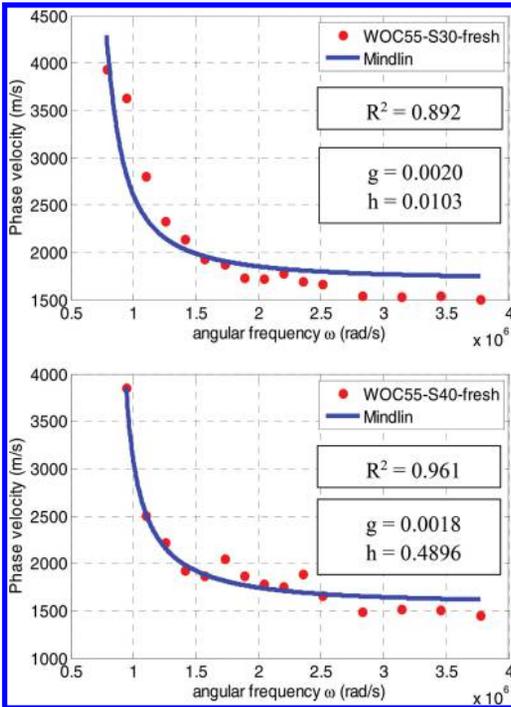
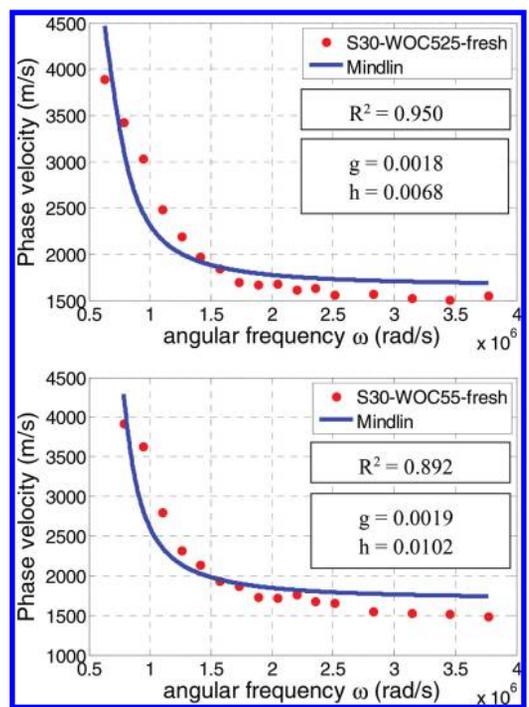
Figure 3. Experimentally observed velocity dispersion of fresh concrete with various sand contents and theoretical predictions using the Mindlin's wave dispersion equation [g and h in m].

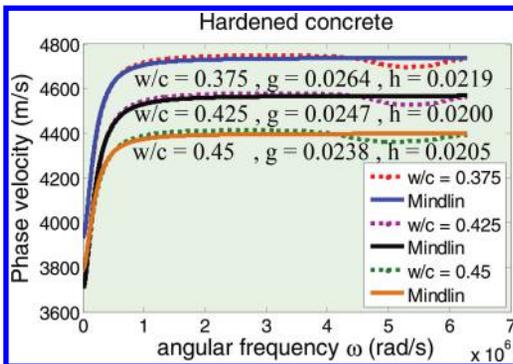
Figure 5. Experimentally observed velocity dispersion of hardened concrete with various w/c ratios (dashed lines) and theoretical predictions (continuous lines) using the Mindlin’s wave dispersion equation [g and h in m].

On the contrary, as shown in Figure 5 the dispersion in hardened concrete is the opposite, characterized by a continuous increase of the phase velocity up to 150–200 kHz (angular frequencies around 10^6 rad/s) beyond which it remains constant (up to the maximum frequency tested—1 MHz). It is therefore made clear that the microstructural effects responsible for the dispersion turn around as the material is transformed from the initial liquid phase to a hardened solid medium.

In order to identify the two “unknown” microstructural coefficients (g and h) of the Mindlin’s wave dispersion equation 11 the experimental data of fresh and hardened concrete are separately used. Through a least square minimization procedure between the experimental and theoretical data the values of the micro-stiffness g , the micro-inertia h and the coefficient R^2 which shows how good the theoretical curves (continuous lines) fit to the experimental data are found and displayed in Figures 3–5.

Unlike the fresh material, when concrete is hardened (Fig. 5), the inverse relation between the microstructural coefficients is observed; the micro-stiffness parameter g is greater than the micro-inertia parameter h in all w/c cases, suggesting that monitoring of the relative difference of the microstructural coefficients could effectively provide information on the setting process of the above mentioned material in a nondestructive way.

It is equally interesting to notice that an increase of the w/c ratio causes a monotonic decrease of the micro-stiffness g and that the latter is of the order of a few cm, which is in agreement with the aggregate sizes used for the experiments on hardened concrete (maximum size 37.5 mm). Comparing g values of fresh concrete, which vary between 1.8 mm and 2.5 mm, with g values of hardened concrete which vary between 23.8 mm to 26.4 mm it is evident that the first case exhibits an order of magnitude lower values than the second case, similarly to the particle size used in these cases.

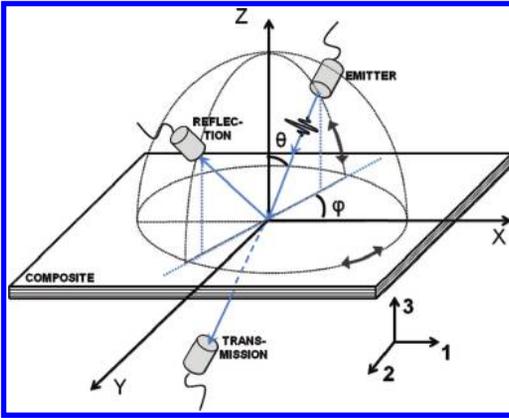
Figure 1. Schematic of UPS method.

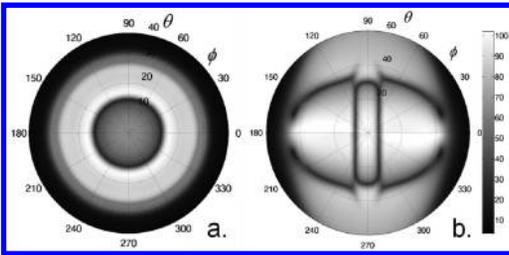
Figure 2. Pulsed UPS experiment for (a) aluminum and (b) $[0]_8$ C/E laminate.

The experimental barrier has been tackled by the development of a 5-axis scanner which performs UPS experiments in a fully automated way. The scannerinsonifies more than 1,000,000 incidence angles $\psi(\varphi, \theta)$ in less than 15 minutes. In this way, we identified several pitfalls in the experimental procedure which prevented the correct recording of a UPS [11]. The exceptional quality of the obtained UPS experiments can be seen in Figure 2a-b for aluminum and $[0]_8$ C/E laminate.

are identical to those of the experimental recordings. Hence, the simulations (Figure 3) may be straightforwardly compared with the experiments (Figure 2).

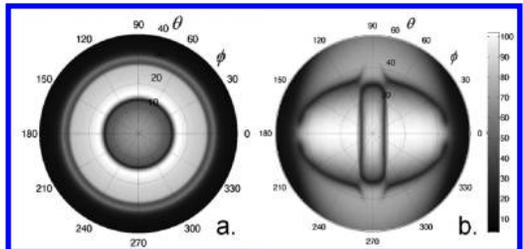
Figure 3. Pulsed UPS simulation for (a) aluminum and (b) $[0]_8$ C/E laminate.

Secondly, a simulation technique has been implemented to support experimental observations [12]. The simulation model is founded on a cascade matrix technique [13], and allows the simulation of UPS for layered viscoelastic anisotropic media. Compared to previous simulation models [7–8], we were able to significantly reduce the computational time. Figure 3a-b shows the simulated UPS of aluminum and $[0]_8$ C/E laminate. The used parameters

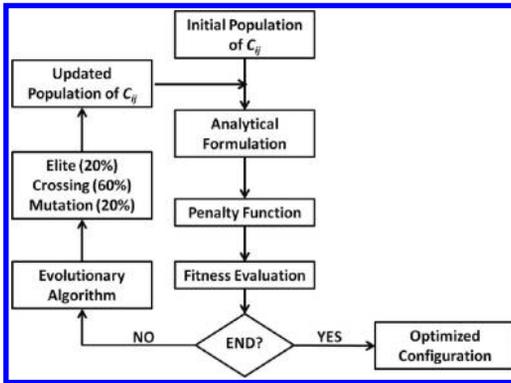
Figure 4. Schematic of inversion procedure to identify composite properties [14].

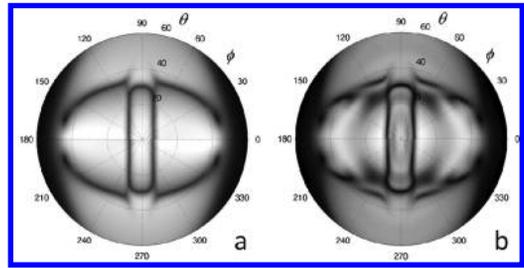
Figure 5. Experimental recordings of a $[0]_8$ C/E laminate: (a) pulsed UPS and (b) harmonic UPS.

Contrary to the pulsed UPS image, the patterns in the harmonic UPS image depend on the employed ultrasonic frequency. This is easily understood considering that the harmonic UPS image puts on view the stimulation condition of dispersive Lamb waves, while the pulsed UPS image is mainly governed by bulk wave characteristics [16].

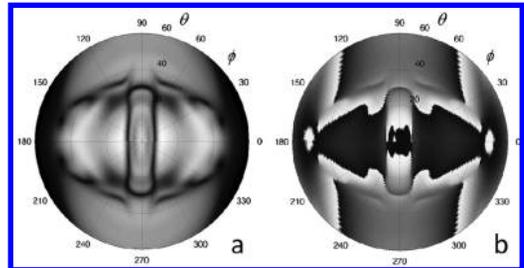
Figure 6. Harmonic UPS recordings for $[0]_8$ carbon/epoxy laminate: (a) amplitude and (b) phase analysis.

amplitude and the phase of the transmitted wave. Figure 6 shows the harmonic UPS images for a $[0]_8$ C/E laminate, considering the analysis of both the amplitude and the phase of the transmission signal.

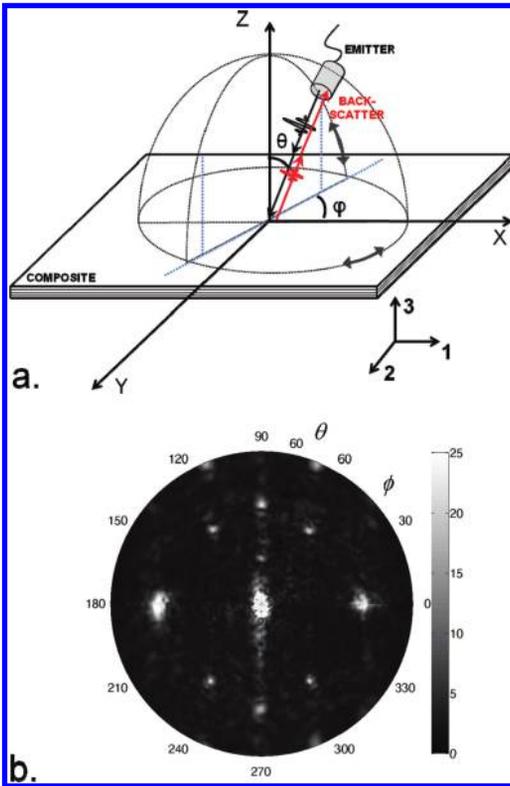
Figure 7. (a) Schematic of UBPS and (b) harmonic UPS experiment for a $[0]_s$ C/E laminate.

During our UPS investigations, we persistently observed a small amount of energy being backscattered to the emitter, even for large incidence angles. Recording of the backscattered signal according to the UPS principle then results in an Ultrasonic Backscatter Polar Scan (UBPS). Depending on the employed wave, we speak of a pulsed UBPS [17] or a harmonic UBPS [18]. A schematic of the UBPS method, together with a harmonic UBPS recording for a $[0]_8$ C/E laminate, is presented in Figure 7.

Typically, such a harmonic UBPS image is characterized by high amplitude spikes, and we found that these spikes expose geometrical characteristics of (sub)surface structures. For the $[0]_8$ C/E laminate, the backscatter spikes originate at the imprint left by the peel-ply cloth during manufacturing of the laminate.

As the characteristics of a periodic (sub)surface structure determine the position of the observed backscatter spikes in a harmonic UBPS experiment (see Figure 7b), we may also reverse this: start from a UBPS experiment and reconstruct the periodic (sub)surface structure. We have demonstrated this for a 2D subsurface corrugation (see Figure 11),

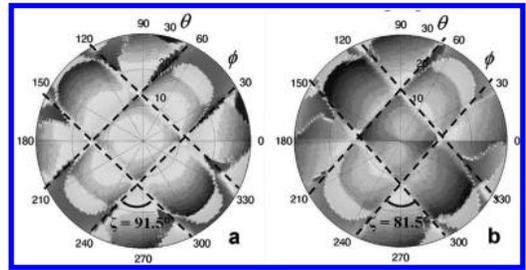
Figure 8. UPS image of $[-45,+45]_s$ UD C/E laminate: (a) virgin state and (b) after applying shear load.

Various fiber reinforced plastics have been statically loaded to induce material degradation. In **Figure 8**, UPS image are shown of $[-45,+45]_s$ C/E laminate before as well as after (quasi-)static shear loading. The indicated overlap angle ζ provides a measure for the actual fiber orientation. Initially $\zeta = 91.5^\circ$ indicating that the stacking of the laminate was not done correctly (see **Figure 8a**). After loading in shear, the overlap angle reduced to $\zeta = 81.5^\circ$ (see **Figure 8b**), which thus reveals a fiber distortion of 10° . The evolution of the overlap angle ζ has been monitored for a range of shear load levels, and we found a clear relation between the applied shear load level and the observed fiber distortion [19].

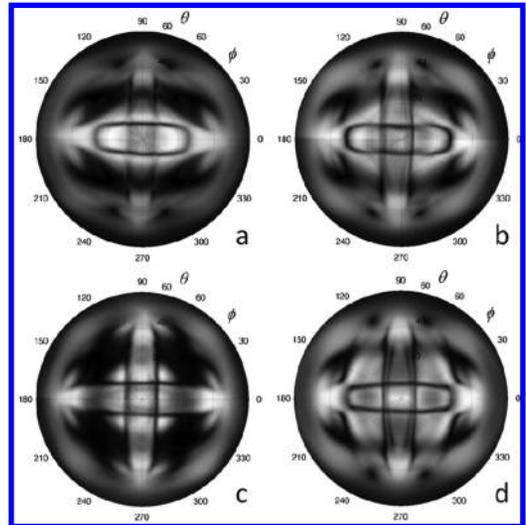
Figure 9. Harmonic UPS recordings of a cross-ply C/E laminate: (a) $[0,90,90,0]$, (b) $[0,D,90,90,0]$, (c) $[0,90,D,90,0]$ and (d) $[0,D,90,90,D,0]$. ‘D’ stands for the depth position of the water-filled delamination.

a delamination divides the original laminate in two sub-laminates having different boundary conditions. This change in boundary conditions invokes different Lamb wave stimulation conditions, and as such yields a different harmonic UPS image [20]. This is demonstrated in **Figure 9** for a cross-ply C/E laminate (thickness of 1.1 mm) provided with a water-filled delamination (thickness of $50 \mu\text{m}$) at different depth positions. Note that such types of delaminations are in general difficult to assess in thin composites using conventional normal incidence techniques. **Figure 9** clearly shows that the depth position of the delamination is well represented in the harmonic UPS images. **Figure 9d** further indicates that also a multi-delamination is easily detected.

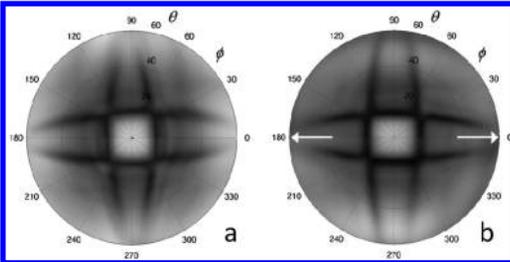
Figure 10. Pulsed UPS: (a) before and (b) after applying tension fatigue.

The UPS method was also applied to fatigued composites. Fatigue loading typically leads to the initiation, progression and accumulation of micro defects. At the macroscopic level, these defects manifest themselves in a directional reduction of the stiffness properties. Such a directional stiffness reduction should be visible as a stretching (along the direction of loading) of the UPS contours. This is explicitly demonstrated in Figure 10 for a woven C/E laminate which was fatigued along $\varphi = 0^\circ$. The UPS experiment yields a stiffness reduction of 12.8% along the loading direction, which is in good agreement with extensometer data yielding a stiffness reduction of 11% [21].

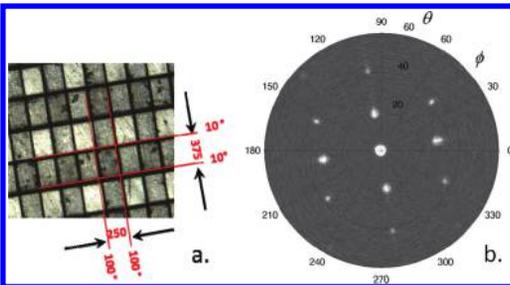
Figure 11. (a) 2D subsurface corrugation and (b) corresponding harmonic UBPS recording.

and obtained excellent agreement with both the design parameters and optical measurements (see Table 1).

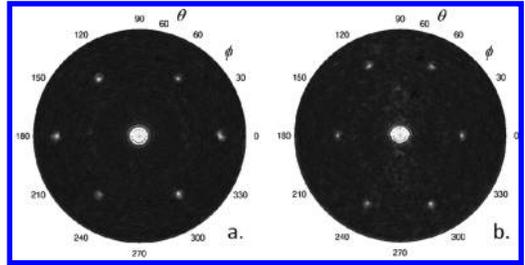
Figure 12. Harmonic UBPS for (a) unstrained and (b) strained DC06 steel coupon.

As the UBPS method is capable to reconstruct a (sub)surface structure with excellent accuracy, it should also be capable to detect any change in surface parameters due to strain. Analysis of the transformed surface structure then yields a representation of the applied in-plane strain [22]. Instead of machining a periodic surface structure, which would mechanically weaken the sample, we simply exploit residual surface roughness features. The ultrasonic strain measurement technique has been demonstrated on cold-rolled DC06 steel coupons which were strained at different levels (see Figure 12). One can clearly observe the shifting of the backscatter spikes when strained. This shifting is then used to reconstruct the applied in-plane strain field.

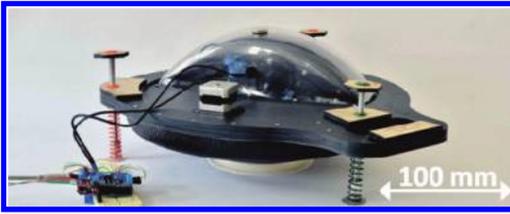
Figure 13. Current design of portable UPS scanner.

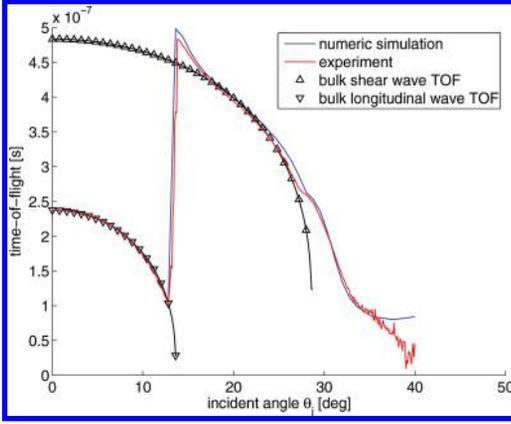
Figure 1. Comparison of the experimentally obtained TOF with the numerically simulated TOF as function of the incidence angle for an aluminum plate of 1.5 mm examined at a frequency of 5 MHz. The bulk wave solutions are represented by the dashed lines.

As an alternative, the Time-Of-Flight (TOF) of the P-UPS can be considered for elastic material characterization. The use of TOF measurements has been successfully applied for the determination of elastic properties assuming rather thick samples (ranging from 3 to 6 mm at frequencies of 2–5 MHz) in combination with a bulk wave approximation [3][4]. In many cases, however, the actual thickness of plates is smaller and, as such, deviations from the bulk wave approximation are to be expected, as shown in [figure 1](#) where a clear deviation from the bulk wave TOF solution is seen around the longitudinal and shear critical angles for an aluminum plate of 1.5 mm, examined at a frequency of 5 MHz.

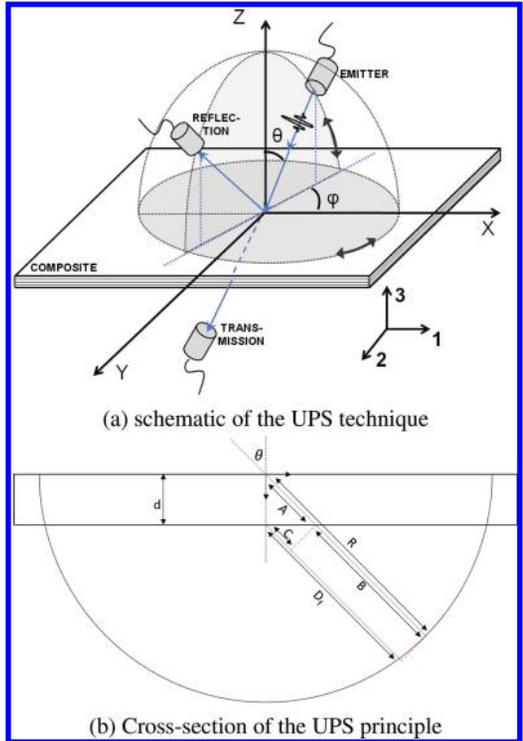
Figure 2. Top: General scheme of the UPS technique with source and receivers moving on a sphere with radius R ; Bottom: Cross-section of the UPS principle in transmission.

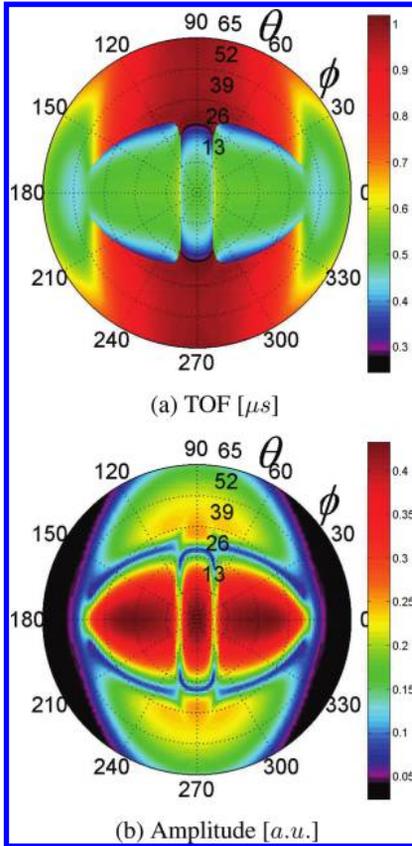
Figure 3. Numeric P-UPS simulation TOF (a) and amplitude (b) of an orthotropic plate ($d = 1.5$ mm) at a center frequency of 5 MHz.

As an example, a numerically simulated TOF-UPS experiment is illustrated in Fig. 3a for an

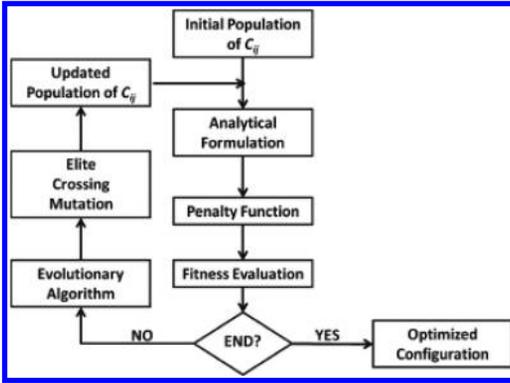
Figure 4. Schematic of the presented inversion technique.

principles of evolution to create a parameter set that best minimizes the cost function. This optimization is performed over several generations. Each generation consists of a specific amount of members, and each of the members gets a fitness value based on the cost function (7). Only the members with the best fitness value are chosen to create the members of the next generation. Some pass directly to the new generations (elite) whilst others undergo mutation and crossover. This results in a new generation with most parameter sets iteratively converging to values in the neighbourhood of the best set. However, the presence of mutation can lead to the discovery of an area of better sets which are not in the vicinity of the current best parameter set. The algorithm stops when a pre-set convergence criterium is fulfilled. A schematic summary of the inversion technique is presented in Fig. 4.

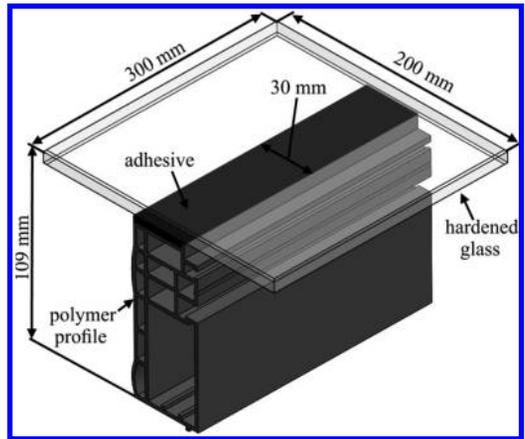
Figure 1. Glass panel specimen.

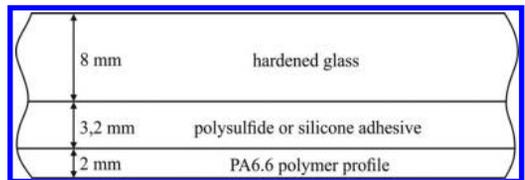
Figure 2. Adhesively bonded joint.

various thicknesses: hardened glass with a thickness of 8 mm, polysulfide or silicone adhesive with a thickness of 3.2 mm and a PA6.6 polymer profile with a thickness of 2 mm.

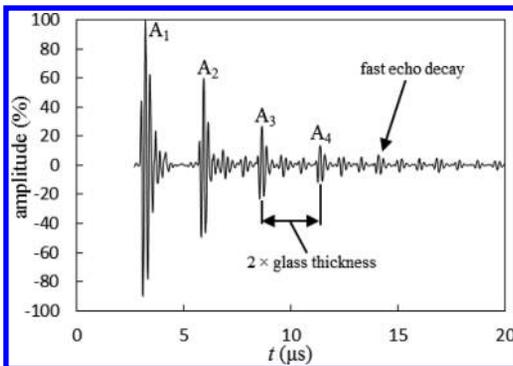
Figure 3. Reflected signal amplitude in glass-adhesive interface.

Polysulfide adhesive was used in testing the glass-adhesive interface. The ultrasonic transducer was positioned on the top side of the glass. Measurements were taken in separate areas with good adhesive presence and with lack of adhesive. The course of the reflected signal in a good glass-adhesive interface is presented in figure 3. The course of the reflected signal in a glass-adhesive interface with an air void is presented in figure 4. Reflected signal amplitude decays faster in case of a good bond, because a larger part of the sound pressure passes through the adhesive than through air, as the acoustic impedance of air is lower than that of adhesive. That also indicates a lower coefficient of

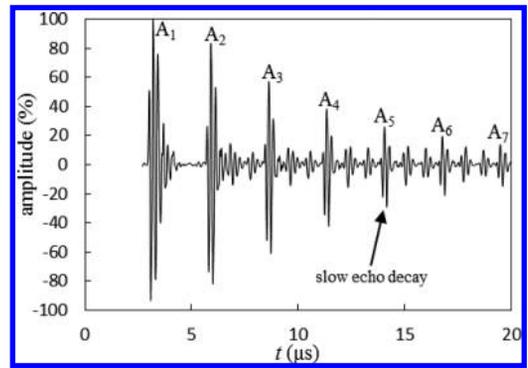
Figure 4. Reflected signal amplitude in glass-adhesive interface, with an air void present.

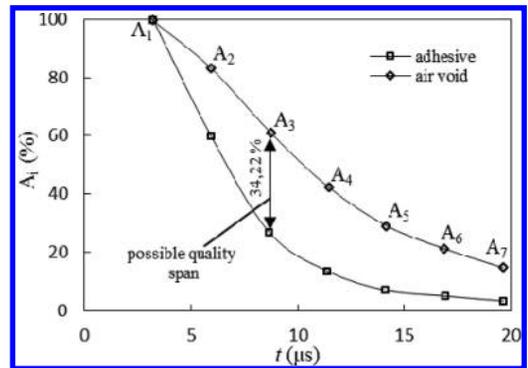
Figure 5. Comparison of echo amplitude decay in glass-adhesive interface.

reflection in case of a good bond. A comparison of the reflected signal decay for both cases is presented in figure 5. Points of decay were determined using the absolute value of the main ultrasonic echoes, marked as 'A_i', the index 'i' indicating the number of the main echo.

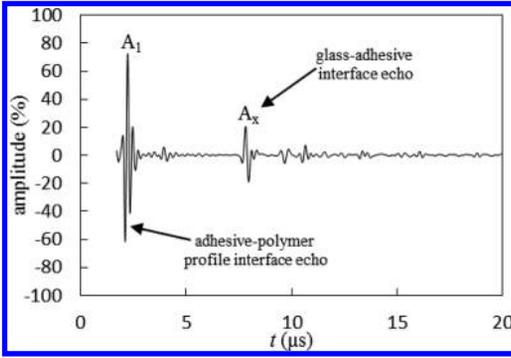
Figure 6. Reflected signal amplitude in adhesive-polymer profile interface.

therefore the amplitudes of the reflected signals are smaller and only one main echo 'A₁' can be clearly seen in case of a good bond. The other echo 'A_x' is reflected from the glass-adhesive interface. This echo is not visible in case of a bad joint with an air void, as the ultrasonic waves reflect at the interface adhesive-polymer profile and do not reach the glass-adhesive interface.

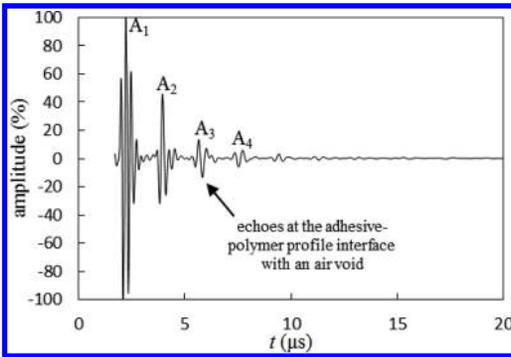
Figure 7. Reflected signal amplitude in adhesive-polymer profile interface, with an air void present.

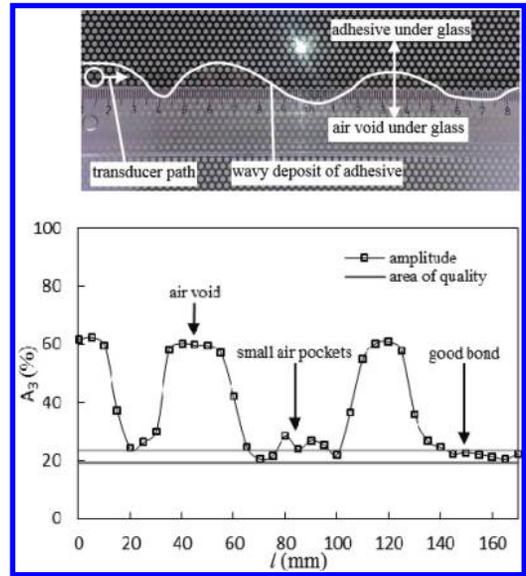
In order to test the validity of the chosen quality evaluation parameters, several adhesively bonded joints were tested along their length. The first specimen had a purposely wavy deposit of polysulphide adhesive in order to clearly record the difference of a good adhesive bond and an adhesive bond with an air void at the glass-adhesive interface. The tested area of the specimen is presented in figure 8 together with the test results. Measurements were taken every 5 mm in a straight line. The third echo amplitude 'A₃' was recorded and plotted against joint length. The adhesively bonded joint was unacceptable if the third echo amplitude left the predetermined area of quality. Air voids were easily detected, as they fell out of the area of quality. The difference in amplitude between a good adhesively bonded joint and a joint with an air void was as big as 35%. Small air pockets were also detected and confirmed with visual inspection. Keeping in mind, the transducer diameter was 6 mm, so only a part of the joint width was tested. A matrix array ultrasonic transducer would be recommended to evaluate the quality of the entire joint.

Figure 8. Third echo amplitude along the joint length in glass-adhesive interface.

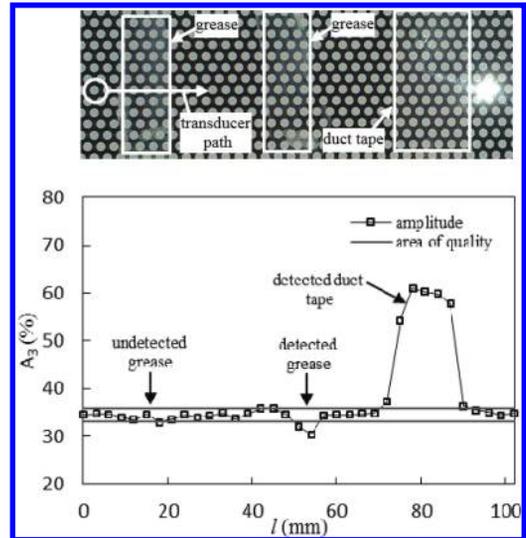
Figure 9. Third echo amplitude along the joint length in glass-adhesive interface for a joint with contaminants.

The tested area of the specimen is presented in figure 9 together with the contaminants and the test results. Measurements were taken every 3 mm in a straight line. As seen by the results, the contaminant detection at the glass-adhesive interface was limited. The second area of grease was detected, while the first area of grease remained undetected. The duct tape area was successfully detected, as witnessed by more than a 27% increase in the third echo amplitude. Flaw detection in the

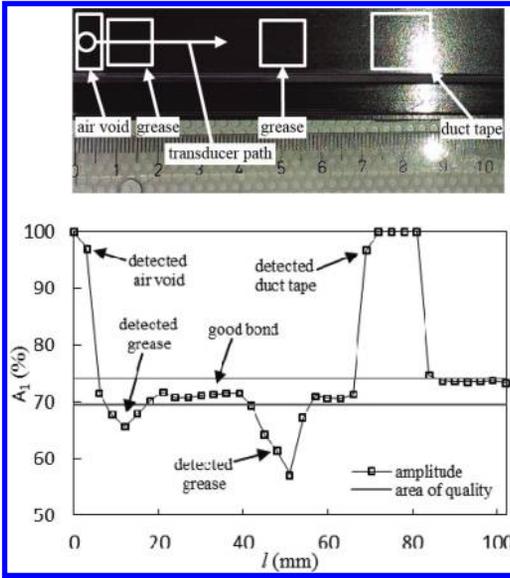
Figure 10. First echo amplitude along the joint length in adhesive-polymer profile interface for a joint with contaminants.

glass-adhesive interface was therefore dependent on contaminant type and its arrangement. Very thin areas of grease were hard to detect.

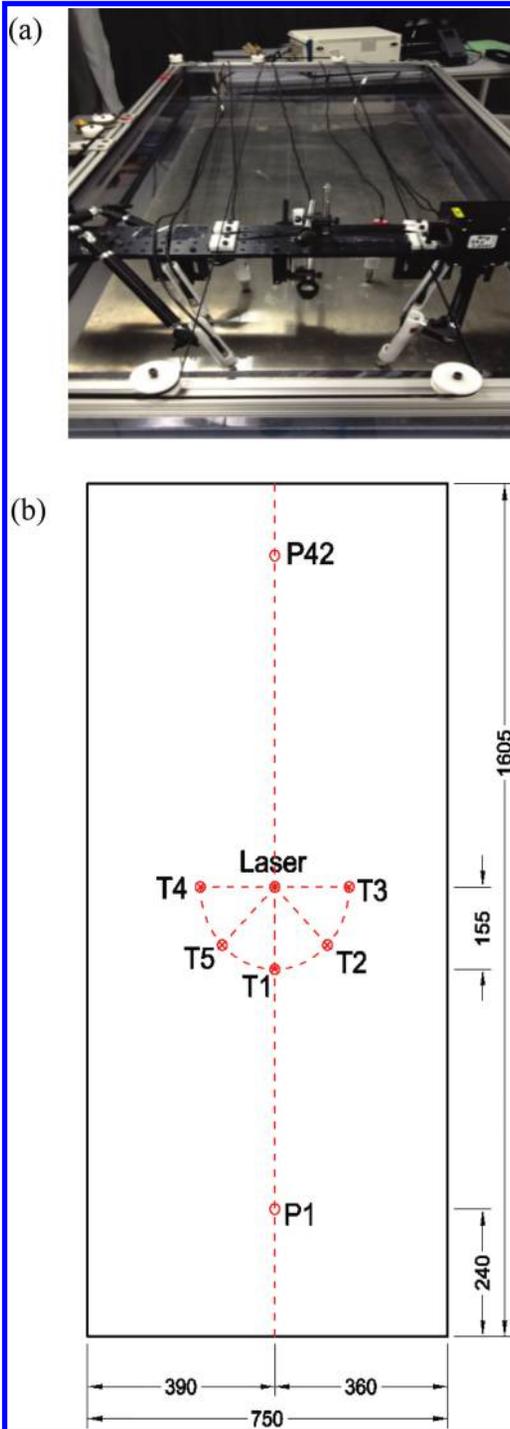
Figure 1. (a) Photographs of the experimental setup. (b) Plan view illustrating the position of the transducers (T1–T5). The drawing is on scale and the quotes are in mm.

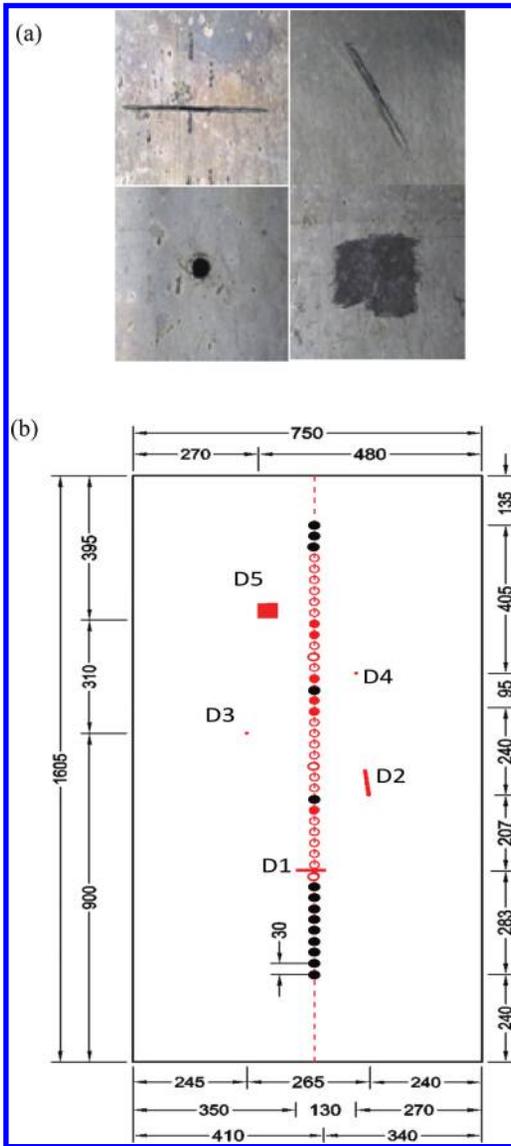
Figure 2. (a) Photographs of four of the artificial defects devised on the plate. (b) Position of the defects with respect to the scanning points. The name of the defect is with respect to the scan direction. For example defect D1 is encountered first.

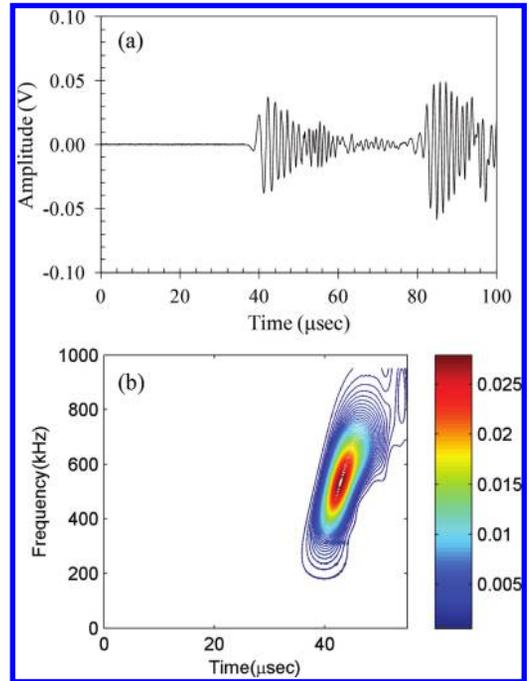
Figure 3. (a) Time waveforms generated at the scanning point 27 and sensed by the immersion transducer T1, and (b) its Gabor wavelet transform (GWT) scalogram.

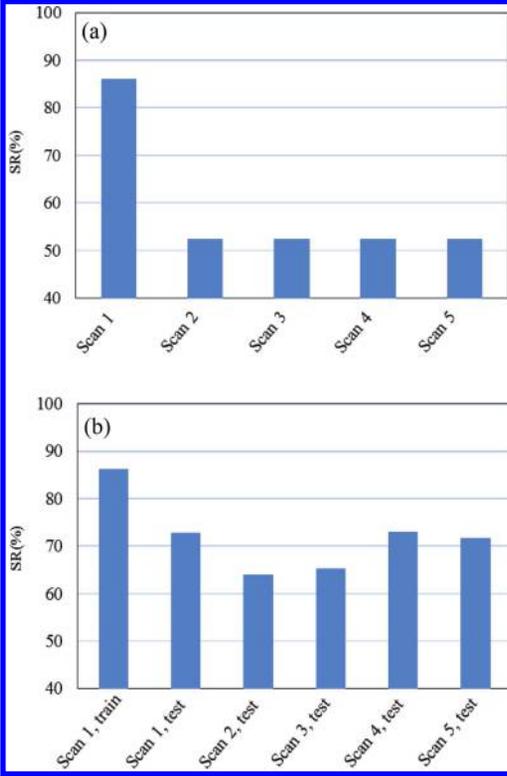
Figure 4. Success rate when eight features were used: (a) OA and (b) ANN.

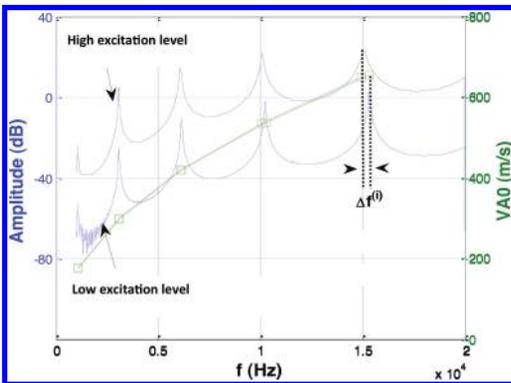
where, E is the young modulus and ρ is the density. Here one should keep in mind that Equation (1), when only the first flexural resonances are considered, gives the same results as the ones developed by Timoshenko and Rayleigh (Graff 1991). At these frequencies, the obtained velocities are the same as the ones corresponding to the fundamental antisymmetric guided mode A0. The frequency below which flexural modes velocities are the same as A0 mode velocity depend on the material properties and dimensions. In the case of the abovementioned metal based composite it has been found to be around ~ 18 kHz. Therefore, the velocity dispersion can be determined at resonance frequencies f_i as shown in Figure 1.

Figure 1. Influence of frequency on amplitude and velocity of A0 mode.

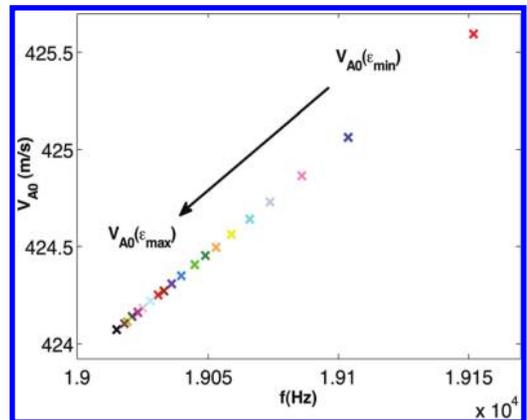
As a function of an increasing strain (or excitation amplitude) the velocity will decrease with the amplitude as shown in Figure (2).

Figure 2. Influence of the excitation on the velocity V_{A0} .

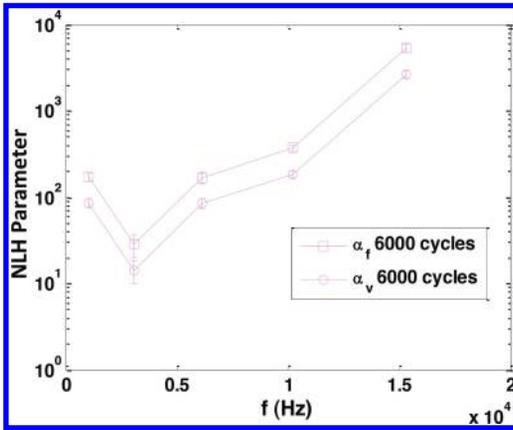
Figure 3. Evolution of the nonlinear hysteretic parameters α_f and α_v (related to the decrease of resonance frequency) as a function of frequency in the case of a fatigued metal composite with 6000 cycles.

In the case of a Steel-TiC composite plate, one should keep in mind that α_f was very dispersive as shown in Figure 3. Its value changes from approximately between ~28 and more than ~5270 at the fundamental resonances (the five first flexural resonances). When the nonlinear convolution is applied on this sample, results show that the appearance of harmonics is not straightforward. Indeed, for the resonance modes 1 and 2, we haven't detected any harmonics. At the same time, we noticed the appearance of the 2nd and 3rd harmonics corresponding to the resonance mode 3. This allowed us to evaluate the parameters

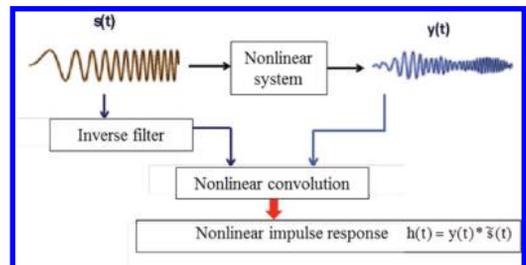
Figure 4. Block diagram of the nonlinear convolution method (Novak et al. 2012).

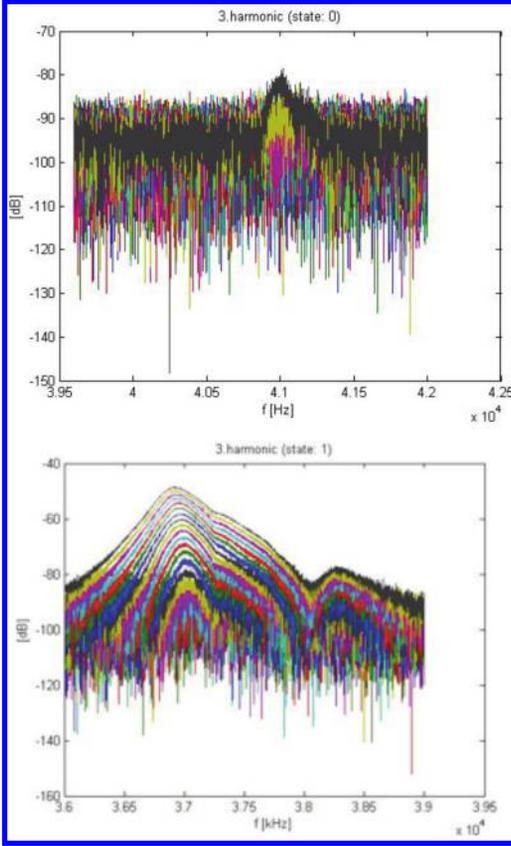
Figure 5. Appearance of a peak corresponding to the 3rd harmonic of the fundamental resonance of a glass bar when thermally damaged.

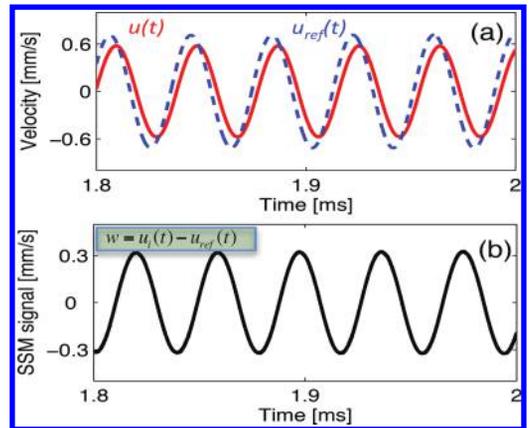
Figure 6. (a) Reference and large amplitude signals, (b) SSM signal.

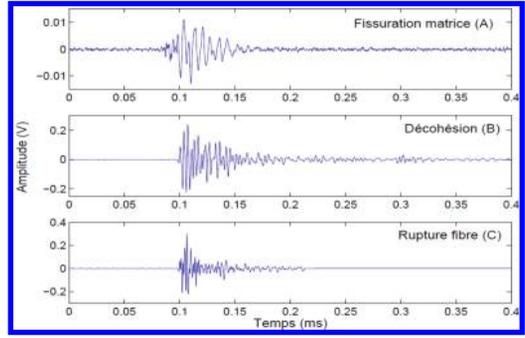
Nonlinear acoustic parameters revealed to be very sensitive to the evolution of the microstructure of materials. As abovementioned, the consideration of higher order frequency variations allows to increase this sensitivity by several orders of magnitude, which is valuable information for NDT applications. However, the sensitivity of the different parameters is unable to give systematically information about the degree of damage created within the material. This quantification of damage could be made through acoustic emission by linking a given acoustic nonlinear parameter to the elastic energy released by the material during the damage process. Furthermore, the same acoustic emission data can be analyzed in order to link them to the created damage mechanisms. In the case of a polymer-based composite, an appropriate multivariable data analysis based on the time domain characteristics of the AE signals, namely (amplitude, duration, energy, etc.) will allow the monitoring of the different damage mechanisms during a mechanical test for instance (Marec et al. 2008). By doing so, one can calculate the energy related to every damage mechanism at every damage step. Figure 7 shows the main damage mechanisms created in a sheet molding compound SMC composite sample.

Figure 7. Typical acoustic emission signal created in a glass fiber composite sample (SMC).

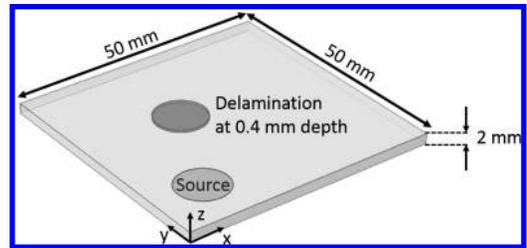
$\rho = 1800 \text{ kg/m}^3$ containing a circular delamination, parallel to the surface. The composite plate has a length and width of 50 mm, and a thickness of 2 mm, as illustrated in Figure 1. The delamination has a diameter of 10 mm and is centered at $x = 20 \text{ mm}$ and $y = 30 \text{ mm}$, at a depth of 0.4 mm, with respect to the top surface of the plate. An external acoustic/ultrasonic circular source with a diameter of 10 mm and located at $x = 10 \text{ mm}$ and $y = 10 \text{ mm}$ is introduced in the model by applying an out-of-plane (normal) displacement boundary condition at the top surface of the sample. The 3D numerical model for wave propagation in the considered composite plate uses the commercially available finite element based software package COMSOL Multiphysics, in combination with our own custom-developed clapping model in order to simulate the macroscopic nonlinear clapping behavior of kissing bond flaws (Delrue and Van Den Abeele 2012b, Delrue and Van Den Abeele 2012a). The so-called clapping model considers the introduction of a non-perfect bond between surfaces. This can be described by a set of virtual spring and damper forces at both sides of the defect surface. Above a pre-set separation threshold, the two sides are completely separated (stress-free surfaces). Below the threshold, particular formulations of the Vanderwaals forces are implemented. When the surfaces are close to each other, they will be attracted to each other. However, when they tend to be too close, the force will turn into a repulsive force, trying to separate the surfaces again. Apart from the elastic contact force, damping forces were also implemented as forces that are acting against the velocity of the separation. These forces make sure that the surfaces are not separating too abruptly, avoiding a destruction of the material. At the same time the damping forces assume that the two surfaces are not closing too fast either, so that they cannot overlap. The nonlinear viscoelastic behavior at the defect level, as described above,

Figure 1. Illustration of the composite plate used in the simulation. The plate has dimensions 50 mm \times 50 mm \times 2 mm and contains a circular delamination with a diameter of 10 mm, centered at $x = 20 \text{ mm}$ and $y = 30 \text{ mm}$, at a depth of 0.4 mm, with respect to the top surface of the plate. An ultrasonic circular source with a diameter of 10 mm is located at $x = 10 \text{ mm}$ and $y = 10 \text{ mm}$.
