Emerging Technologies in Non-Destructive Testing VI

Editors

D.G. Aggelis & D. Van Hemelrijck

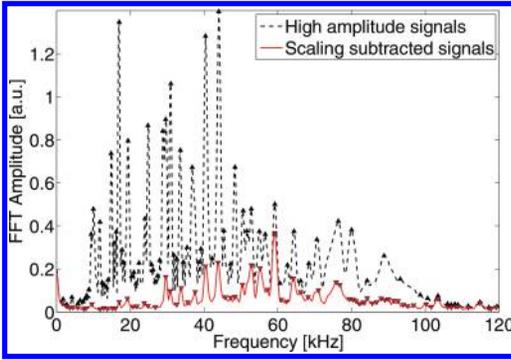
In order to determine the local defect resonance frequencies, only the peaks in the scaling subtracted response signals should be studied. Indeed, the scaling subtraction method allows to isolate the nonlinear contributions in the time signals calculated at the top surface of the sample and therefore, the peaks observed in the amplitude response of the scaling subtracted signals only occur at frequencies at which the layer above the nonlinear defect is strongly vibrating. Two possibilities still remain:(1) the layer is vibrating at a resonance frequency of the sample because the defect is positioned in or close to an anti-node of the created standing wave pattern (Delrue and Van Den Abeele 2011, Delrue

Figure 2. Mean amplitude response at the top surface of the studied composite plate with delamination. The responses are obtained by Fourier transforming both the temporal evolution of the normal surface displacements in case of a high amplitude excitation (dashed line) and the scaling subtracted normal surface displacements (solid line) in each point at the top surface of the sample and calculating the mean amplitude over the entire top surface of the sample at each frequency f . High amplitude signal peaks and scaling subtracted signal peaks, corresponding to either resonance frequencies of the sample or local defect resonances, are respectively marked with upward-pointing and downward-pointing triangles.

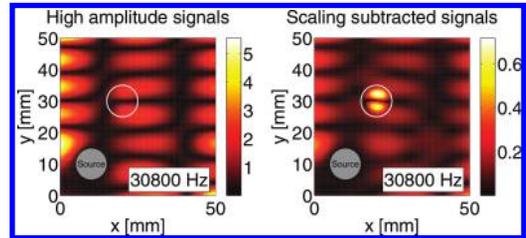
and Van Den Abeele 2012a), or (2) the layer above the delamination is vibrating at one of its own resonance frequencies. An example of the first possibility is illustrated in Figure 3, where the simulated mode shapes filtered at 30.8 kHz are plotted for both the high amplitude signals (left figure) and the scaling subtracted signals (right figure). The outer edges of the delamination are each time indicated on the figures to compare them with the displacement amplitude distributions. The maximum values in the scaling subtracted signals occur at positions above the delamination, indicating that the delamination is indeed excited. Even though the observed pattern above the defect resembles that of a higher order LDR mode, the frequency of 30.8 kHz is not a LDR frequency, but a resonance frequency of the sample. The created standing wave pattern in the sample is clearly visible in the vibration pattern of the high amplitude signals. The observed defect vibration pattern is now easily explained by noticing that the parts of the delamination positioned in a nodal area of the standing wave pattern are not vibrating, because the displacements in the vicinity of a node line are very small or even equal to zero. Taking this into account, LDR frequencies are distinguished from sample resonance frequencies by comparing the defect vibration patterns with the sample vibration patterns. If the nodes and anti-nodes of both patterns do not match, a local defect resonance is found. This is illustrated in Figure 4

Figure 3. Simulated vibration patterns at 30.8 kHz for the high amplitude signals (left) and the scaling subtracted signals (right). The white circle indicates the position of the delamination.

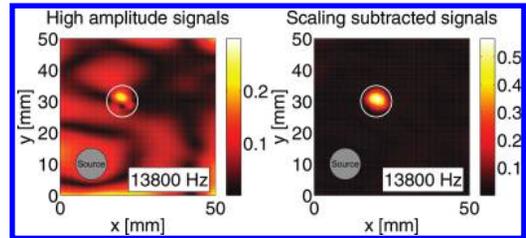
for the fundamental LDR mode. Figure 4 shows the simulated vibration patterns filtered at 13.8 kHz for the high amplitude signals (left figure) and the scaling subtracted signals (right figure). From the ‘chaotic’ vibration pattern observed for the high amplitude signals, it is obvious that the selected frequency is not corresponding to a plate resonance frequency. Moreover, the defect vibration pattern is not linked to possible nodes and anti-nodes found in the sample vibration pattern. Therefore, we conclude that the defect is excited at a LDR frequency, in particular the fundamental LDR frequency as the observed vibration pattern matches the fundamental LDR mode pattern. Figures 5–7 show similar results for some higher

Figure 4. Simulated vibration patterns at 13.8 kHz for the high amplitude signals (left) and the scaling subtracted signals (right). The white circle indicates the position of the delamination.

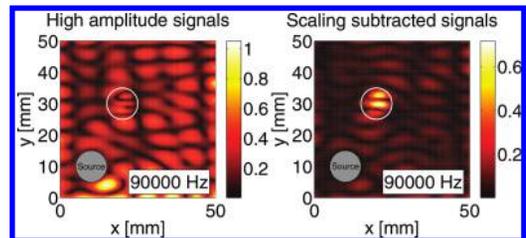
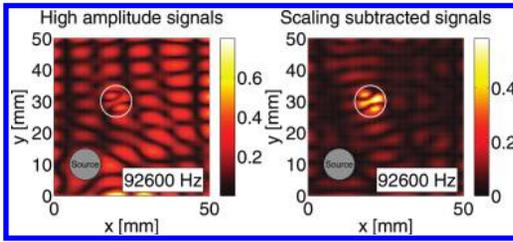
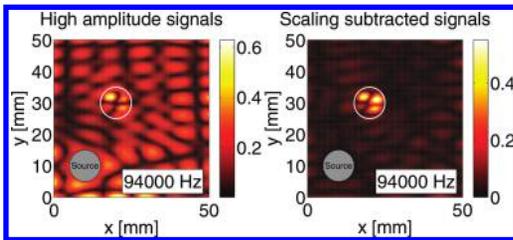
Figure 5. Simulated vibration patterns at 90.0 kHz for the high amplitude signals (left) and the scaling subtracted signals (right). The white circle indicates the position of the delamination.

Figure 6. Simulated vibration patterns at 92.6 kHz for the high amplitude signals (left) and the scaling subtracted signals (right). The white circle indicates the position of the delamination.

Figure 7. Simulated vibration patterns at 94.0 kHz for the high amplitude signals (left) and the scaling subtracted signals (right). The white circle indicates the position of the delamination.

order LDR modes at respectively 90.0 kHz, 92.6 kHz and 94 kHz. Again simulated vibration patterns at the selected frequencies are plotted for the high amplitude signals (left figure) and the scaling subtracted signals (right figure). In all three cases, the nodal and anti-nodal areas of the defect vibration patterns observed in the scaling subtracted signals cannot be linked to the plate vibrations observed in the high amplitude signals.

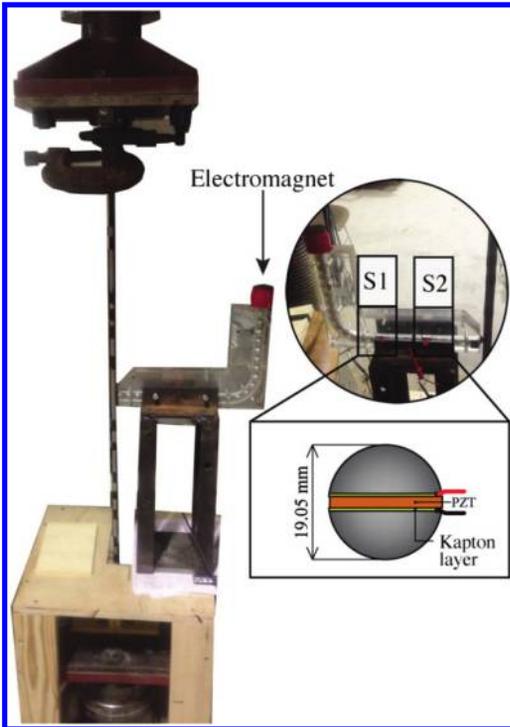
Figure 1. Photo of the experimental setup. Two sensor particles S1 and S2 were used to measure the waves. Each sensor bead contained a piezoelectric ceramic disc.

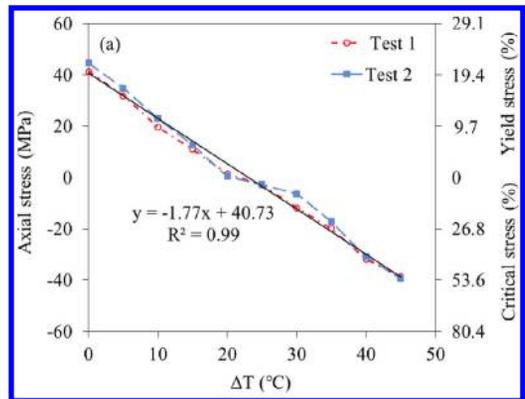
Figure 2 shows the axial stress as a function of the temperature raise ΔT for both heating ramps. We observe that at zero stress there is a slight change of the slopes. This may be attributed to some settling of the machine's grips. By interpolating the experimental data, a linear relationship between the stress and the temperature is found, in agreement with Eq. (1). By solving the linear fit for the

Figure 2. Axial stress as a function of the beam's temperature measured with a thermocouple. The continuous line is the linear interpolation of both heating loads.

zero stress we find that the neutral temperature occurred at $\Delta T = 23.01$ °C.

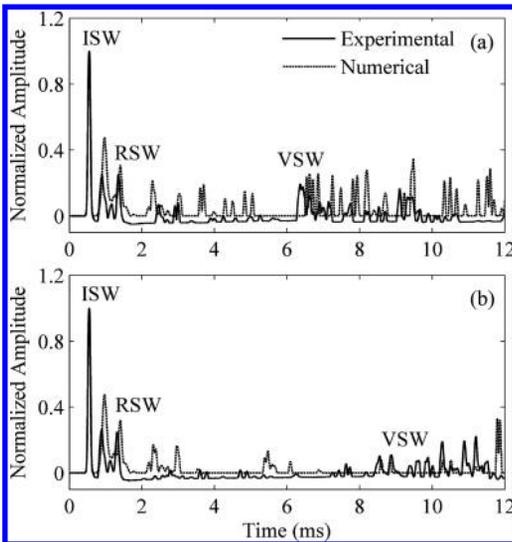
Figure 3(a) shows the experimental and the numerical solitary waves measured during test 1 in presence of the maximum value of the tensile stress equal to 41.4 MPa by sensor S1. Similarly, Figure 3(b) shows the results relative to the maximum compression stress of -38.7 MPa. The numerical results are overlapped to the first of the corresponding 15 measurements. To ease the comparison between numerical and experimental data, the abscissas were shifted horizontally in order to overlap the arrival of the first pulse. This was necessary since the numerical $t = 0$ corresponded to the motion onset of the first particle, whereas the experimental trigger was set to the arrival of the first pulse at S1. Moreover, the amplitudes were normalized with respect to the amplitude of the corresponding first peak. This was necessary as the model predicts force whereas the experiments measure voltage.

In Figure 3(a), the first pulse is the Incident Solitary Wave (ISW) generated by the striker. This pulse is tailed by another pulse that is generated at the elbow. We will detail about this second pulse later. The wave visible at about 1.5 ms is the Reflected Solitary Wave (RSW) which is the wave backscattered from the beam-chain interface, hereafter referred simply as the interface. These three waves occur also under large compression as shown in Figure 3(b). Overall, the numerical and the experimental waveforms agree fairly well.

Figure 3. Test 1. Experimental and numerical normalized amplitudes. (a) Time waveform measured by S1 at the largest tensile stress of 41.39 MPa. (b) Time waveform measured by S1 at the largest compressive stress of -38.7 MPa.

The discrepancy may be related to one or more of the following factors: absence of static pre-compression and dissipation in the numerical model; difference between the real and the selected mechanical properties of the materials. Dissipation occurs at the contact point between the granules and the guides and occurs also due to friction at those contact points. In our study these effects were ignored to simplify the formulation. The agreement between the numerical and the experimental profiles demonstrates that the simplification does not compromise the accuracy of the results.

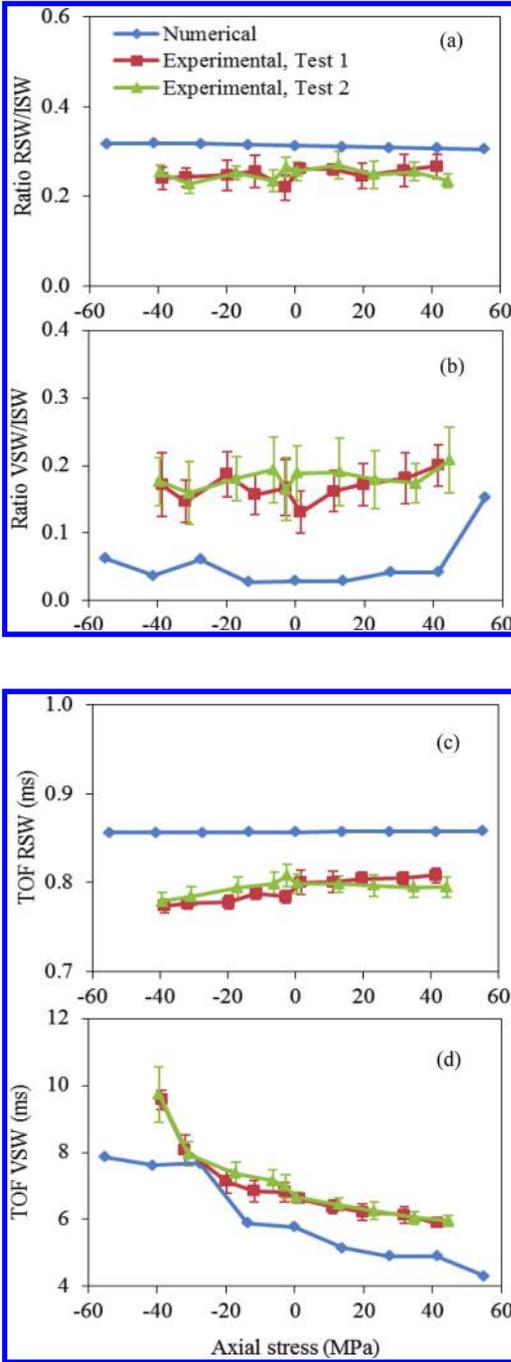
Figure 4. Features extracted from the time waveforms measured at S1 as a function of the axial stress. (a) Ratio of the amplitude of the reflected wave to the amplitude of the incident wave. (b) Ratio of the amplitude of the vibration-induced waves to the amplitude of the incident wave. (c) Time of flight of the reflected wave. (d) Time of flight of the vibration-induced wave.

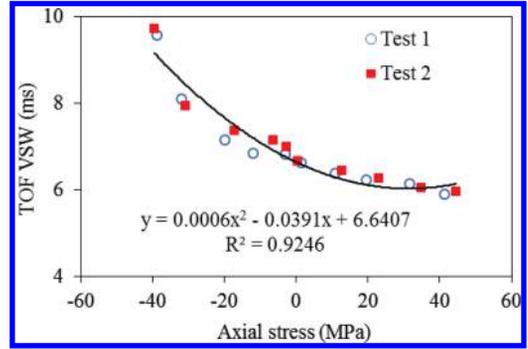
Figure 5. Polynomial interpolation of the experimental data from both Test 1 and test 2. Time of flight of the vibration-induced wave measured at sensor S1.

to determine the neutral temperature T_N . For illustrative purpose, let us use the polynomial displayed in Figure 5. The average value of the fifteen measurements obtained at $\Delta T = 35^\circ\text{C}$ during Test 2 is replaced in the polynomial shown in the figure. The stress of -15.05 MPa is retrieved from the polynomial and used in Eq. 1. Using $E = 200$ GPa, $\alpha = 9 \times 10^{-6}$ $1/^\circ\text{C}$, and the room temperature of 21°C , we determine that the beam's neutral temperature is $T_N = 47.64^\circ\text{C}$, which agrees with the experimental value of $T_N = 44.01^\circ\text{C}$ ($= 23.01^\circ\text{C} + 21.0^\circ\text{C}$, the latter being the ambient temperature) found in Figure 2.

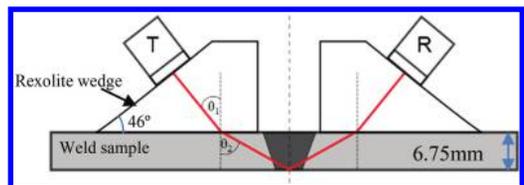
Figure 1. Schematic representation of the contact pitch-catch method for the inspection of friction stir welded butt configuration, T and R stand for Transmitter and Receiver respectively.

A contact pitch-catch experiment, as shown in Figure 1, was conducted in order to validate the concept of the pulse-inversion technique for the inspection of kissing bond defects in a friction stir welded butt-joint. Two transducers mounted on the rexolite wedges with angle of 46° degrees, one for

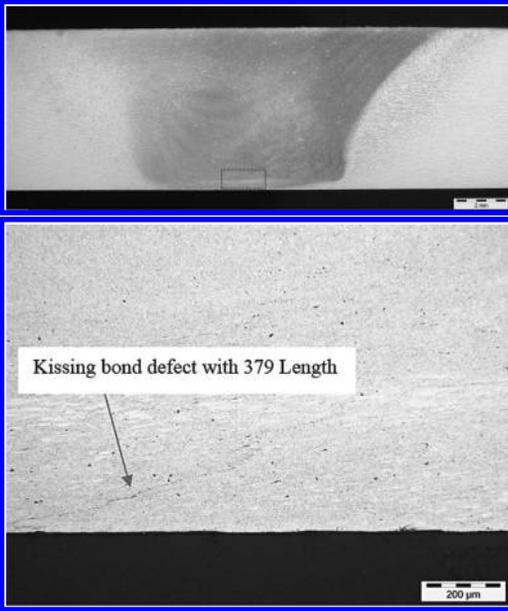
Figure 2. FSW cross-section micrograph (Sample1) showing a kissing bond defect at the weld root, with zoomed-in image (bottom).

the transmitter and the other one for the receiver, were employed in pitch-catch mode, aligned and separated to maximize the reflection from the bottom of the sample. The weld samples in this study are made of aluminum alloy, 7XXX series, with 6.75 mm thickness. Figure 2 illustrates the presence of a kissing bond defect with 379 μm length at the root of a friction stir welded butt-joint.

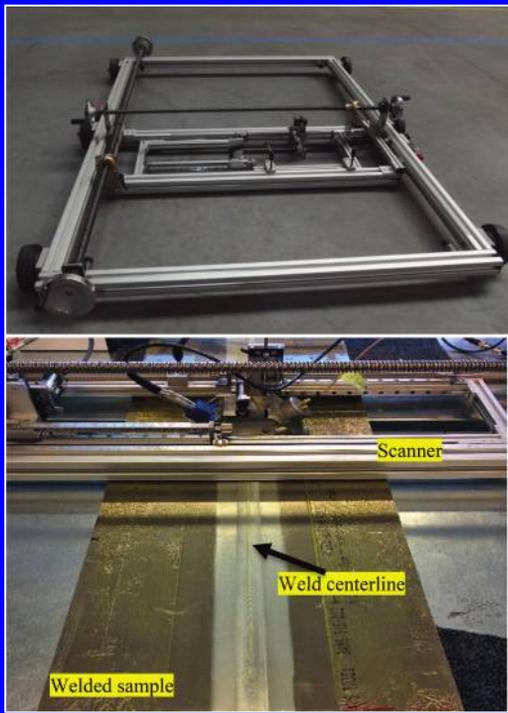
Figure 3. Manual X-Y Flat scanner (top), Measurement with the scanner along the weld centerline (bottom).

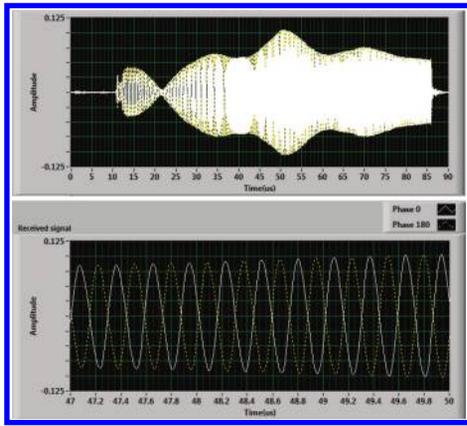
Figure 4. Typical responses of the two out of phase received signals (top); Zoomed-in representation (bottom).

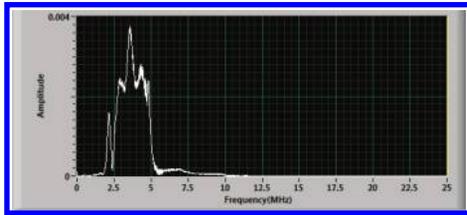
Figure 5. Frequency spectrum of the positive polarity response.

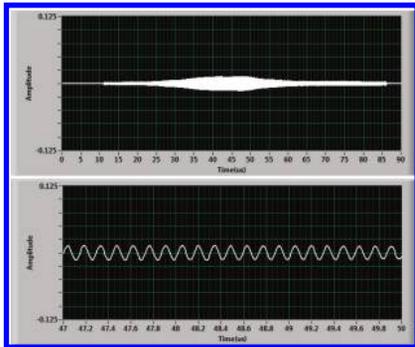
Figure 6. Typical pulse-inversion signal (top); Zoomed-in representation (bottom).

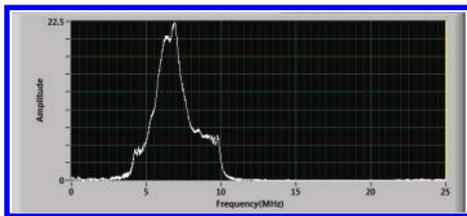
Figure 7. Normalized frequency spectrum of the pulse-inversion signal.

As can be observed in Figure 7, the fundamental frequency has been completely canceled out by the pulse-inversion technique. The main frequency components in the pulse-inversion signal span the region between 4 to 10 MHz.

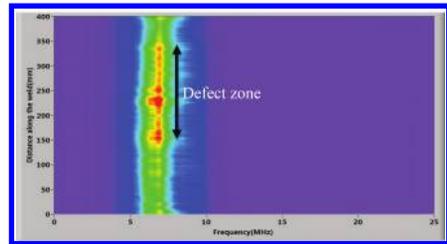
Figure 8. 2D heat map of defect sites in FSW: Pulse-inversion spectral image obtained by stacking up the normalized frequency spectra for each position along the weld centerline, Sample1.

It is important to note that the colour scale of 2D heat maps should be adjusted to an acceptable quality level of defect. For instance, flaws below 300 μm may be considered as an acceptable quality level of a FSW defect. Therefore, the colour scale should be set to a value representing defect zones greater than 300 μm .

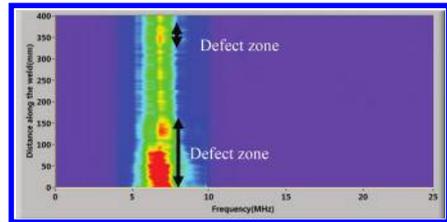
Figure 9. Pulse-inversion spectral 2D heat map of defect sites in FSW, Sample2.

As a second illustration, Figure 9 shows the pulse-inversion spectral image for a similar 7XXX aluminum alloy sample, Sample2. Here, two zones can be easily discerned as defect zones, 0–150 mm and around 350 mm, which correspond to severe and mild damage zones.

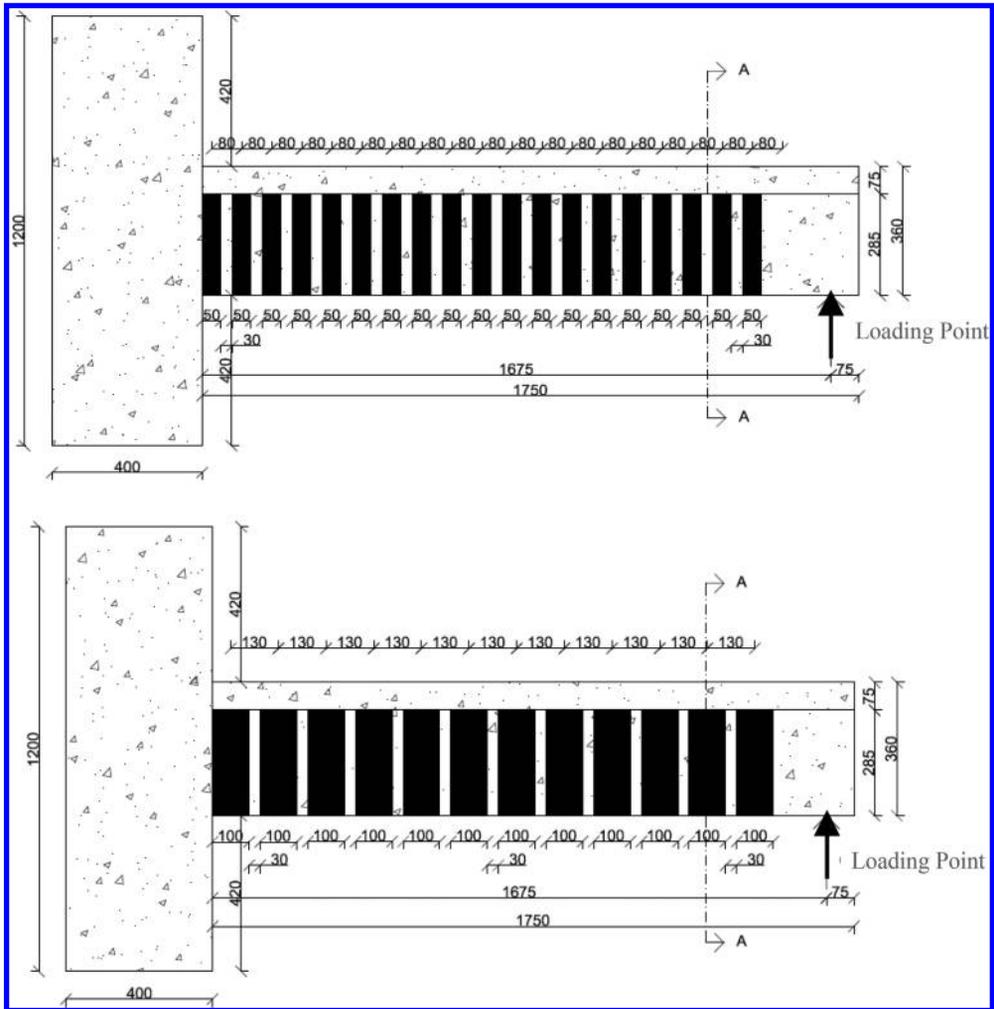
Figure 1. Strengthening schemes for BEAM-1 and BEAM-2.

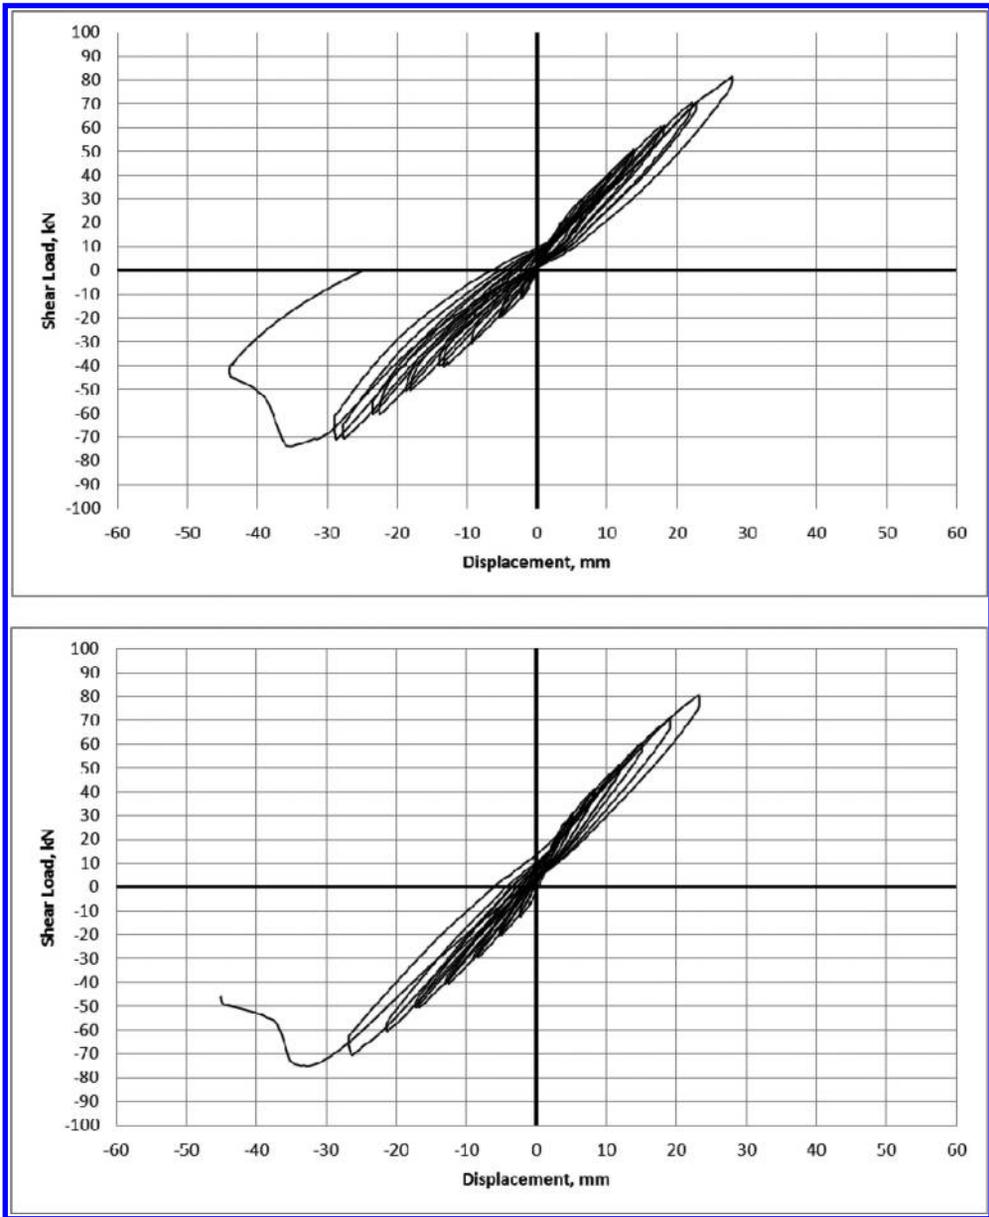
Figure 2. Shear force-displacement hysteretic curves of the test specimens (BEAM-1 and BEAM-2).

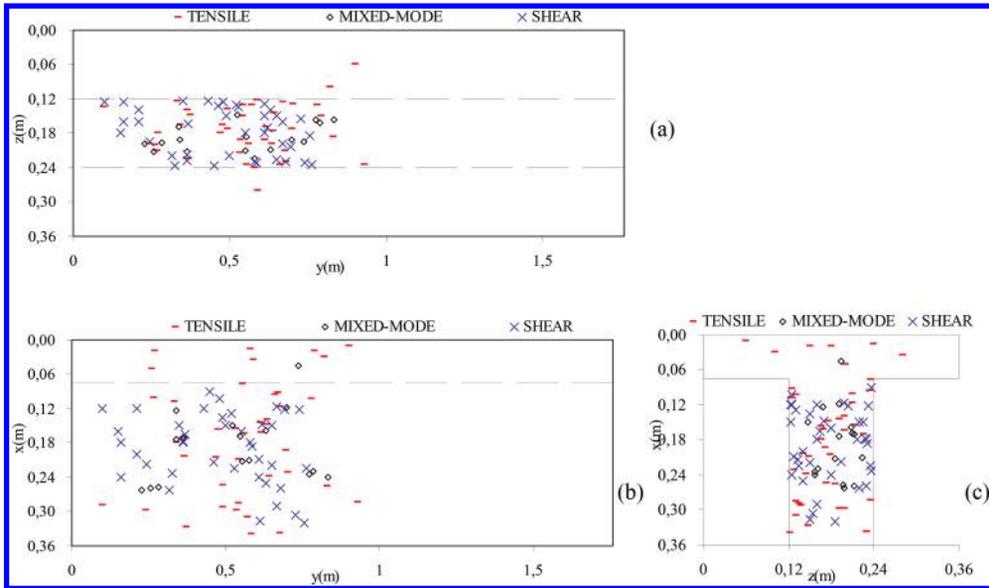
Figure 3. AE-SiGMA results for BEAM-1 after failure ((a) Top view, (b) Side view, (c) Cross-sectional view).

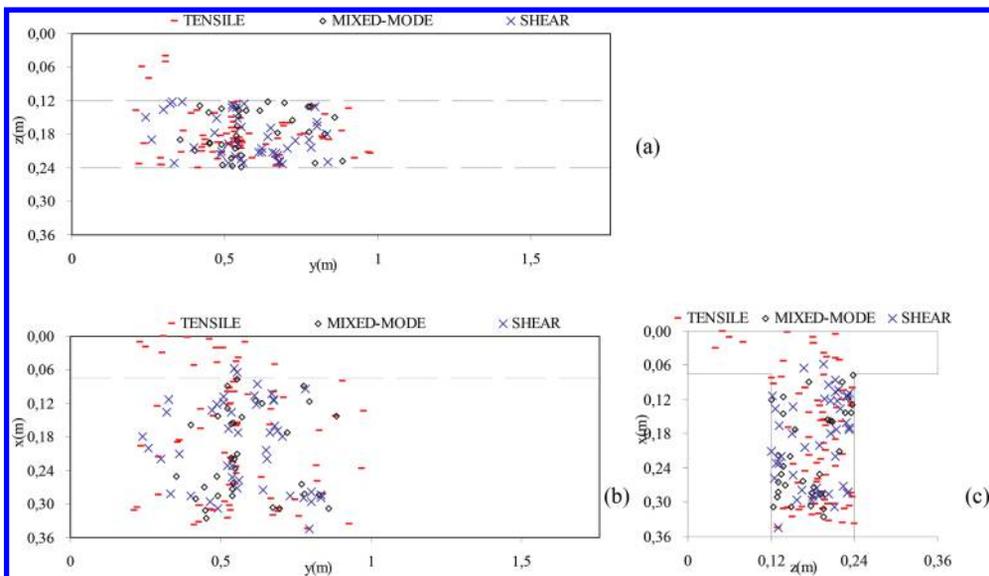
Figure 4. AE-SiGMA results for BEAM-2 after failure ((a) Top view, (b) Side view, (c) Cross-sectional view).

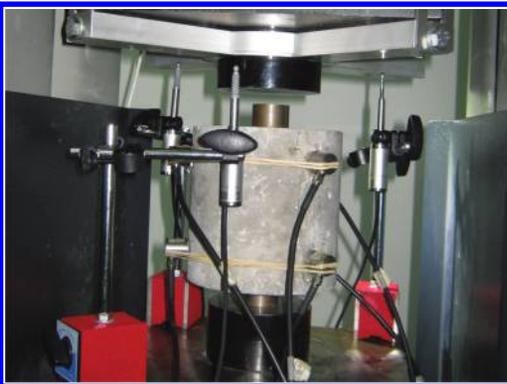
Figure 1. Set-up of Barcelona test.

The Barcelona test is a double Punch Test (DPT) performed on a cylindrical FRC specimen with height equal to diameter equal to 150 mm (AENOR UNE 83515 2010). The specimen is subjected to compression loading along its axis, by inserting two cylindrical steel punches with a height of 24 mm and a diameter of 37.5 mm between the loading machine platen and the center of the upper and lower face of the specimen (Fig. 1). An extensometer chain is placed at half-height of the specimen to measure the Total Circumferential Opening Displacement (TCOD). A constant relative displacement rate of 0.5 ± 0.05 mm/min is applied by the press piston. The force and the TCOD are also measured. Studies have shown that it is possible to estimate the TCOD without the need of using the extensometer chain (Carmona et al. 2011) using an experimental correlation between the axial displacement and the TCOD. In addition, Pujadas et al. (2014) presented that Barcelona test may be conducted with cubic specimens with 150 mm of side without the use of an extensometer chain. In this work, the set-up of the generalized double punch test was used, without using an extensometer chain.

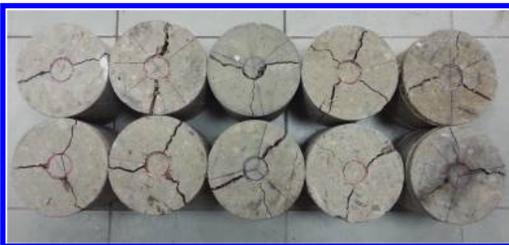
Figure 2. Fractures of all specimens.

The failures of the specimens are presented in Figure 2, from left to right: plain concrete, PPF 0.5%, PPFX 0.5%, PPF 1.0%, PPFX 1.0%. The plotted diagrams are separated to three loading stages, the first one until reaching the peak load, the second one after peak load till approaching the residual load and the third one from the end of stage two until the end of testing (Fig. 3), in order to explain more adequately the behavior of each specimen. Some typical results of AF vs. RA for the loading stage until fracture load for a) plain concrete, b) PPF 0.5% and c) PPF 1.0% fibers by volume of concrete are demonstrated in Figures 4a, b and c, respectively. Typical results at the second and third loading stages are demonstrated in Figures 5a and b respectively.

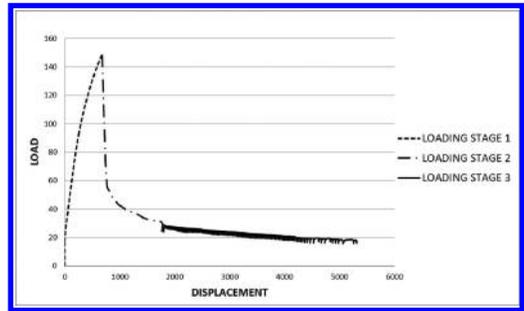
Figure 3. Typical load-displacement curve.

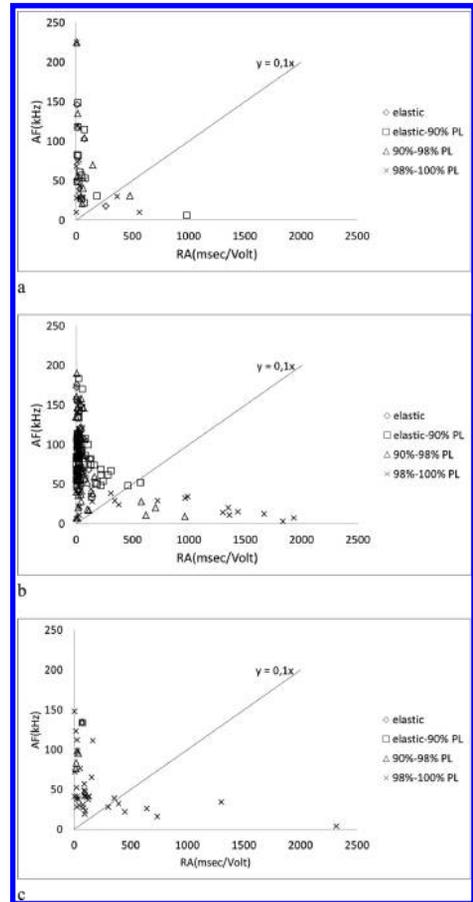
Figure 4. AF vs RA of first loading stage: a) plain concrete, b) fibers 0.5% by volume, c) fibers 1.0% by volume.

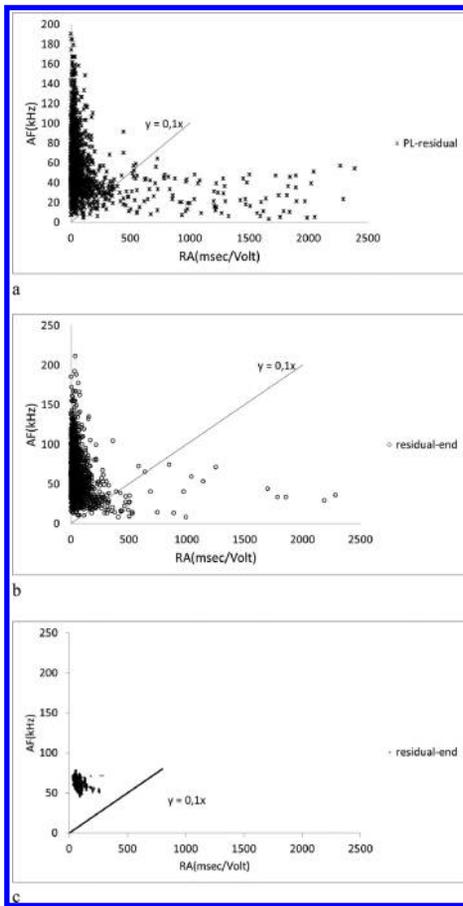
Figure 5. AF vs RA for PPF 0.5%: a) second loading stage, b) third loading stage, c) third loading stage—values calculated from the moving average of 50 hits

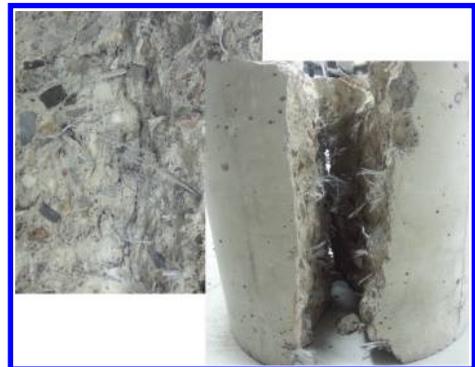
Figure 6. Fiber ruptures and extrusions.

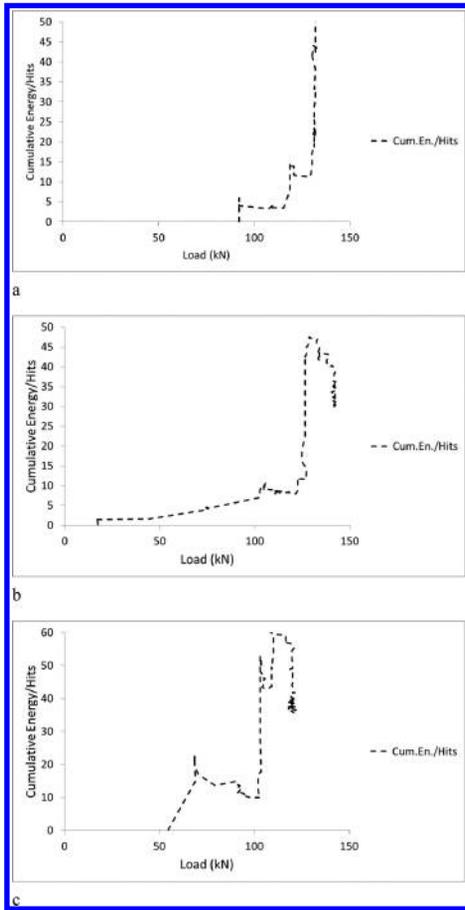
Figure 7. Cumulative energy/hits vs load: a) Plain concrete, b) PPF 0.5%, c) PPFX 1%.

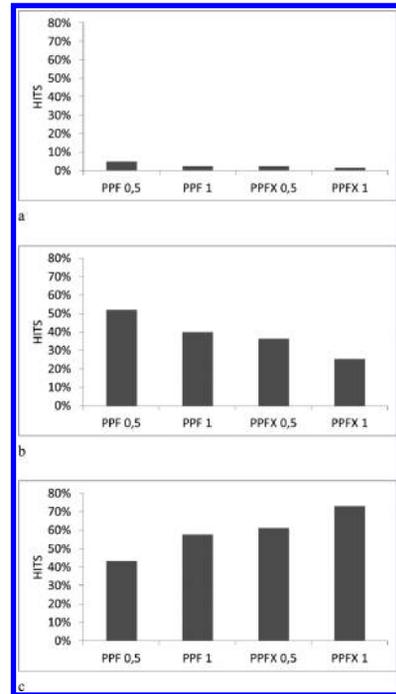
Figure 8. Hits during loading stages: a) Start-peak load, b) Peak load-residual, c) Residual-end.

fibers. During the second loading stage (Fig. 8b) the amount of hits decreases, as the percentage of fibers by volume increases, for both types of fibers. At the same loading stage, the cumulative energy that is released is independent of the percentage and the type of fibers (Fig. 9b). The third loading stage (Fig. 8c) shows the reversed trend of the behavior of the amount of hits, compared to the second loading stage (Fig. 8b) and the same behavior with respect to the cumulative energy. In summary, for all specimens, the first loading stage, with a range of the ratio of axial displacement over the whole cumulative axial displacement of the test 0.13 to 0.15 produce only a range of 0.1% to 10% of the whole cumulative energy of AE, while the second and the third loading stage, within ranges of same ratios of axial displacement from 0.08 to 0.21 and from 0.64 to 0.78 respectively, produce energy that ranges from 55% to 66% and from 33% to 37% respectively.

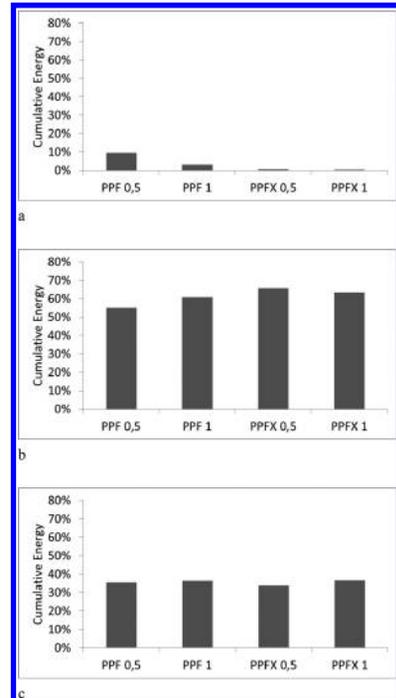
Figure 9. Cumulative energy during loading stages: a) Start-peak load, b) Peak load-residual, c) Residual-end.

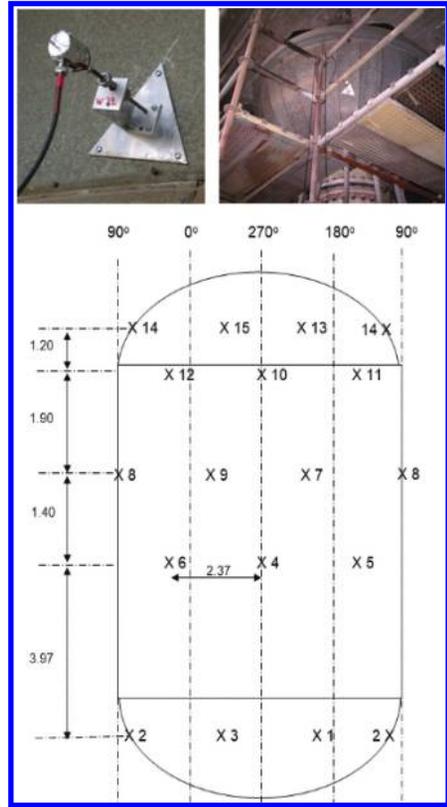
Figure 1. Mounted Sensors with with waveguide on the insulated shell.

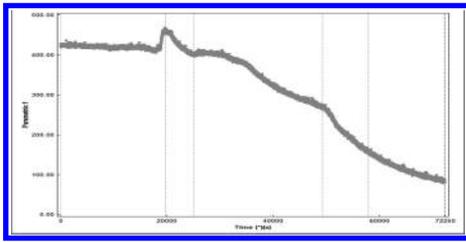
Figure 2. Reactor Temperature Vs. Time.

7 Kg/cm². The cool-down test lasted 20 hours and 4 minutes until the temperature of about 80°C. Cool down rate was not constant (Figure 2). Various external noise sources were identified during the test, in the general area of the reactor due to nearby working crews. In addition to that, due to different thermal expansion between the vessel and the insulation, sliding of waveguides relatively to the vessels was detected, by having very distinct signal features, which differentiated from the “real” AE sources due to thermal stressing.

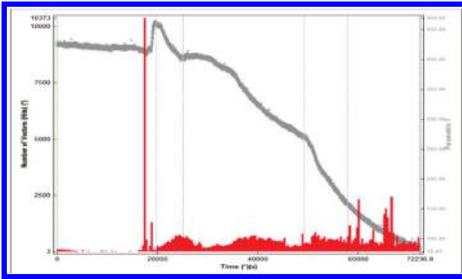
Figure 3. Reactor AE Activity & Temperature Vs. Time (NOESIS software).

The above mentioned test sequence (Temperature vs. Time) and the corresponding filtered global AE activity during acquisition is presented in Figure 3. Identification and removal of surrounding noise (nearby working crews, waveguide sliding relatively to the vessel due to contraction etc.) was removed prior to the evaluation. The results from standard analysis with zonal grading typically done in this type of testing, were further investigated using

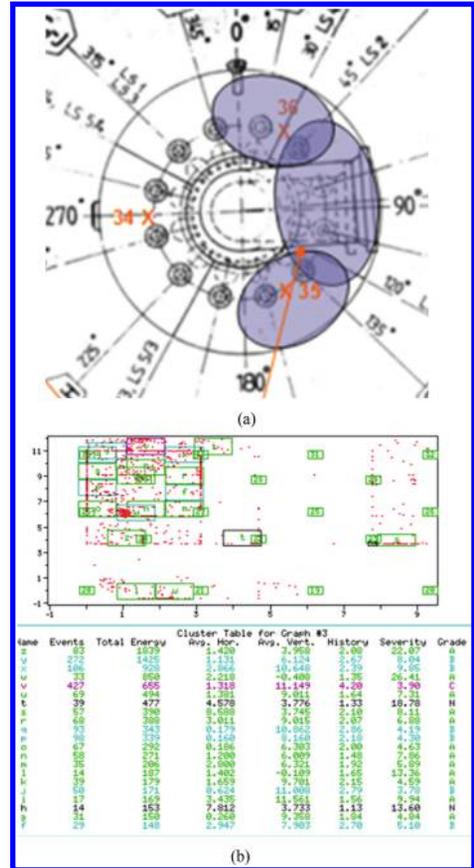
Figure 5. (a) Vessel with source areas of the first testing, (b) Clustering and grading using unfolded sensor positions.

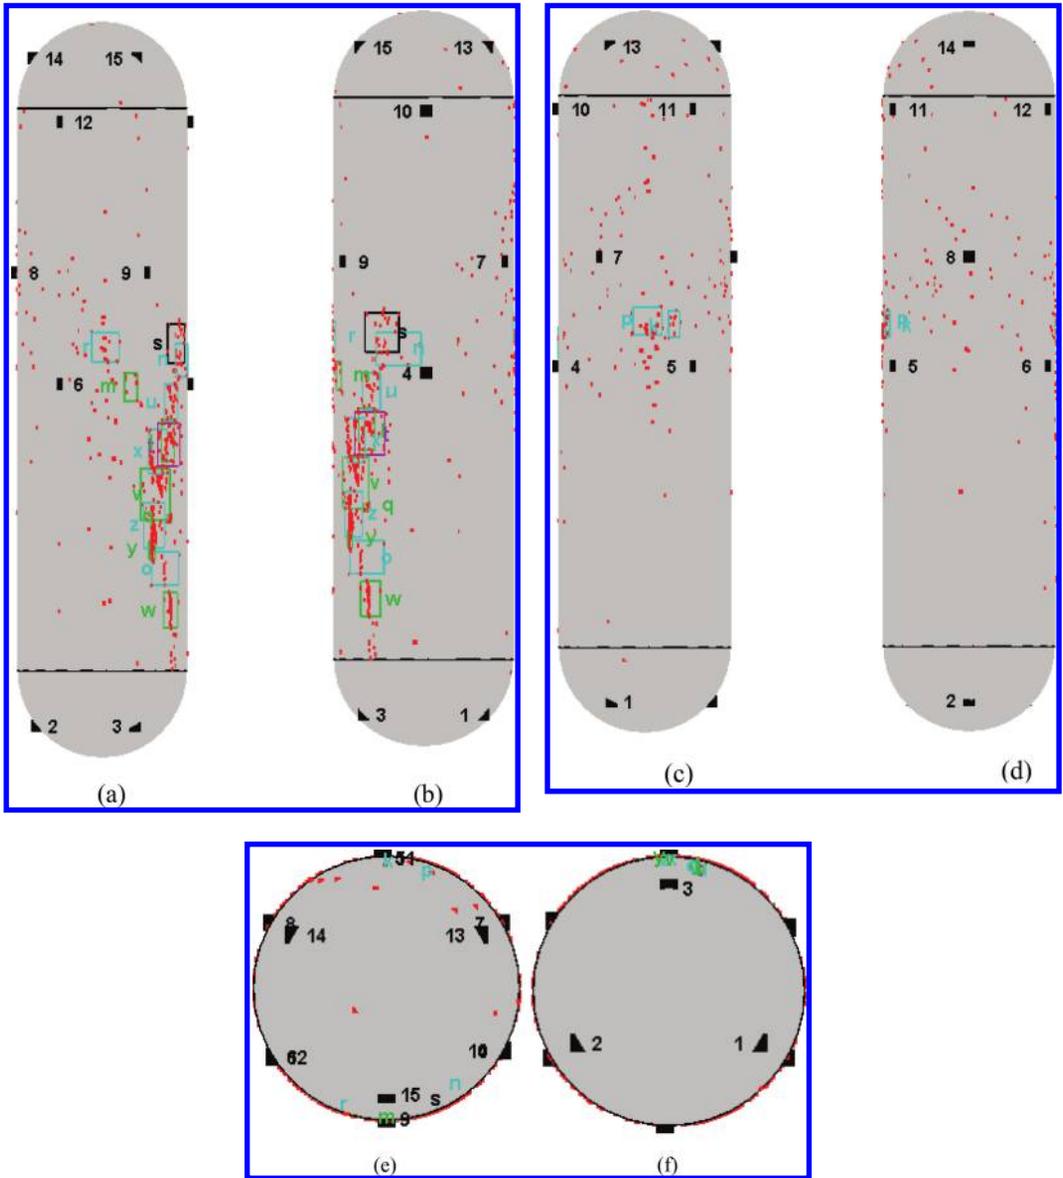
Figure 7. (a to d) West, North, East, South views, (e) Top view, (f) Bottom view of the vessel with overlapped graded sources.

GRADE	COLOUR	INTERPRETATION
A	Green	Very minor zone
B	Cyan	Minor zone
C	Magenta	Active zone
D	Yellow	Intensive zone
E	Red	Critical zone

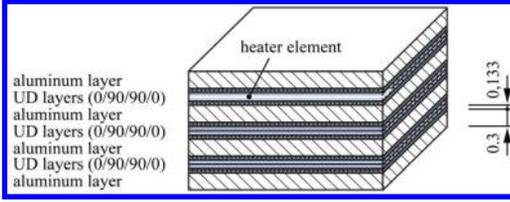
Figure 1. GLARE 5-4/3-0.3 layup with a heater element.

Two specimens of GLARE 5-4/3-0.3 with embedded heater elements were manufactured (cf. Figure 1) and cured by means of the standard autoclave procedure at 120°C and 6 bar (Hagenbeek 2005). Figure 2 depicts the ultrasonic C-scan results of one specimen including its dimensions. The C-scan results show, apart from the artificial delaminations, no delaminations in the vicinity of the heater elements.

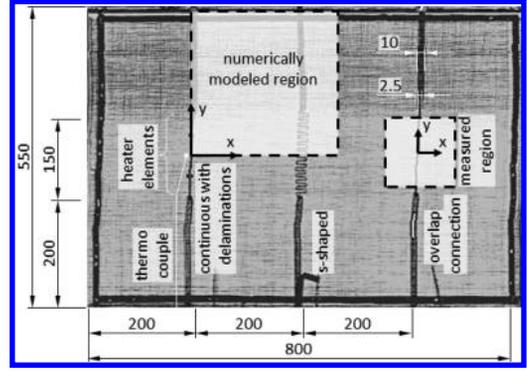
Figure 2. C-scan of specimen with three heater element types: continuous, s-shaped and overlapped connection (units in mm).

Three heater elements were embedded in each specimen (cf. Figure 2). These are the reference heater element without artificial delaminations or imperfections due to connections techniques, heater elements with different connecting techniques (overlap, soldered, spot welded), one heater element with artificial delaminations and one s-shaped heater element. Further details about the heater elements and the experimental setup are provided in Anisimov et al. (2015).

the test setup described in section 2. One quarter of the vicinity of the (reference) heater element was modeled due to the expected symmetry of the (thermal) loading conditions and geometry along and perpendicular to the heater element(s). Hence, the numerical model does not account for possible pre-deformations of the specimen (cf. Figure 7). A reduction of the modeled area was executed in order to reduce the number of elements and thus to reduce the calculation time. The area of 300×300 mm with symmetric boundary conditions along the x- and y-axis was modeled. This area is indicated by dashed lines in Figure 2.

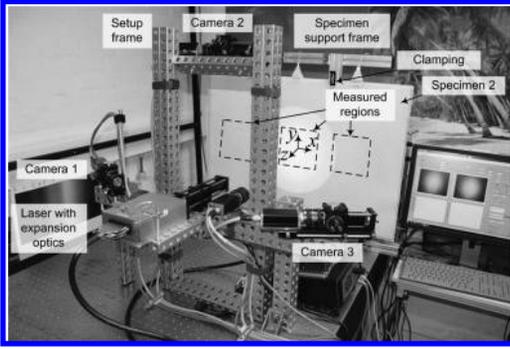
Figure 3. Experimental setup.

During measurements the speckle pattern is generated by illuminating the object with an expanded laser beam. The object is imaged by multiple cameras each with shearing devices to obtain interferograms at the initial state and after each thermal load step. Each interferogram is a superposition of two divided fields of view which are separated by the shear distance.

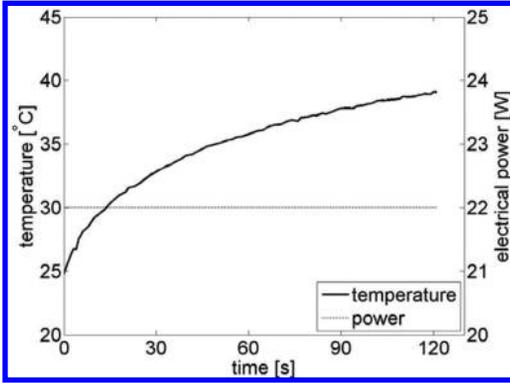
Figure 4. Thermal loading conditions.

heater element temperature (cf. Figures 2 and 4). The temperature gradients above the heater element are largest and constantly decrease with increasing distance from the heater element.

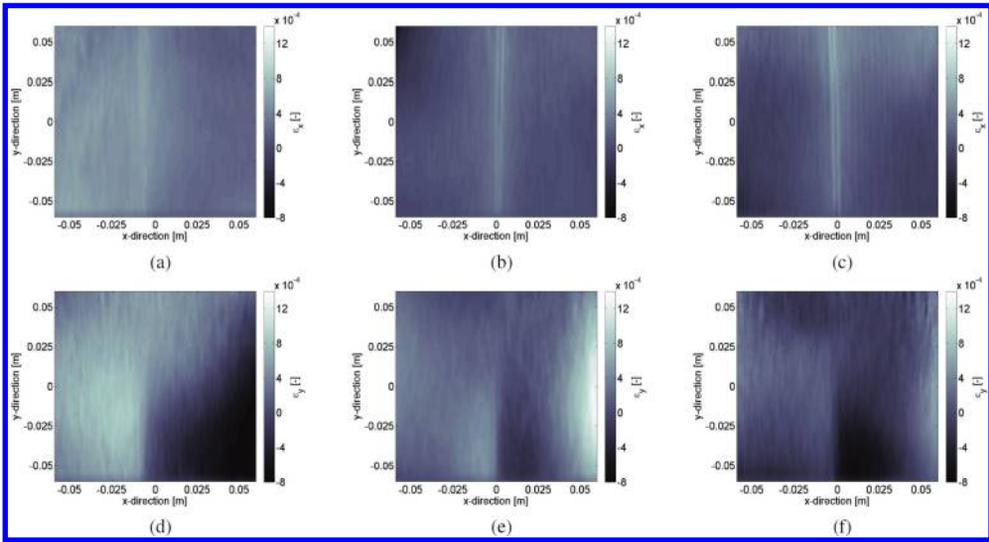
Figure 5. Shearography results: Strain distributions ϵ_x , ϵ_y of the (a,b) reference, (d,e) soldered and (c,f) spot welded heater element.

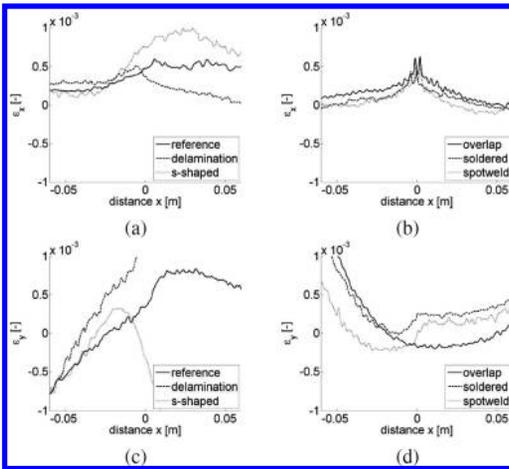
Figure 6. Shearography results: Strain components (a,b) ϵ_x and (c,d) ϵ_y along the x-axis (perpendicular to the heater element).

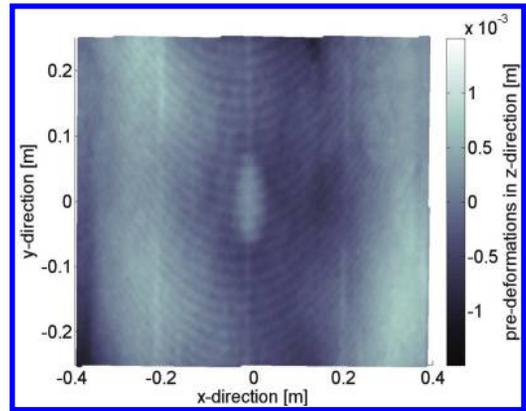
Figure 7. DIC measurements of the specimen, cf. Figure 2.

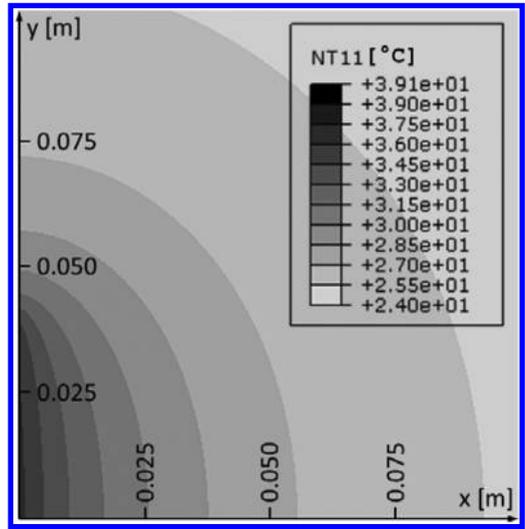
Figure 8. Temperature distribution predicted by the numerical analyses for $0 \leq x \leq 0.1$ m and $0 \leq y \leq 0.1$ m.

Figure 8 shows the temperature distribution in the field of $0 \leq x \leq 0.1$ m and $0 \leq y \leq 0.1$ m. The surface temperature varies between the ambient temperature and temperatures similar to the maximum

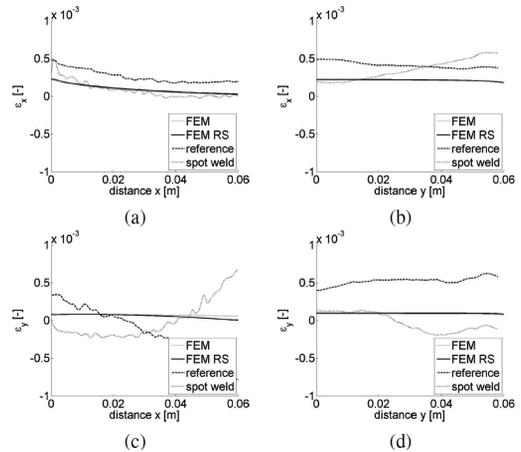
Figure 9. Comparison of the numerical and shearography results. Strain components (a,c) ϵ_x and (b,d) ϵ_y along the x -axis.

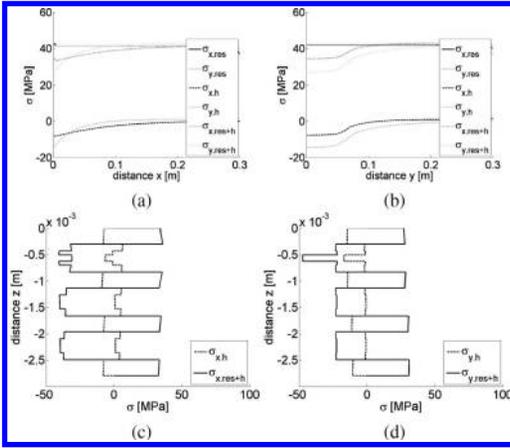
Figure 10. Stress components along (a) x -, (b) y -, (c, d) z -axis.

Figure 10 shows the residual stress components $\sigma_{x, res}$ and $\sigma_{y, res}$ caused by the temperature increase of the heater element $\sigma_{x, h}$ and $\sigma_{y, h}$ and their superposition $\sigma_{x, res+h}$ and $\sigma_{y, res+h}$ along the x -, y - and z -axes. The stress distributions along the z -axis emphasize the tensile stresses in the aluminum layers, the compression stresses in the UD layers and the effect of the heater element on the stress distribution. In Figure 10 (c,d) the position of the heater element lies between $-0.506 \geq z \geq -0.626$ mm.

Furthermore, Figure 9 shows that the numerically predicted strains due to thermal loading when taking the residual stress-strain state into account (FEM RS) are up to $\Delta\epsilon = 1.4 \cdot 10^{-5}$ larger than in case of neglecting it (FEM). The effect of the residual stresses shows more clearly in Figure 10.

The embedded heater elements cause (residual) stress peaks at the x - y -surface and in thickness (z -) direction (cf. Figure 10 (a,c,d)).

The stresses caused by the temperature increase of the heater cause a stress relief (cf. Figure 10). As the temperature increases towards the curing temperature, the (thermal) residual stresses reduce to zero. However, the residual stress magnitudes are more than twice as big as the stress magnitudes caused by a temperature difference of $\approx 15^\circ\text{C}$. Hence, accounting for the residual stress-strain state when simulating thermal loading of GLARE is recommended.

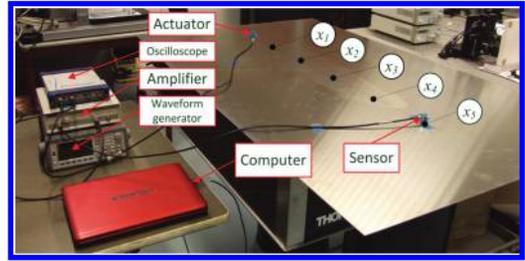
Figure 1. Experimental set-up: equipment and sensor positions.

away from the edge of the panel at the middle of the width. The Lamb wave response was sensed also by a Physical Acoustics WS α Series piezoelectric transducer (sensor 1) whose position was varied from 200 to 1000 mm away from the actuation point, with increments of 200 mm (positions x_1 to x_5) always measured collinearly with the actuator and parallel to the length of the panel. The coupling of both transducers to the plate was ensured by Sonotech shear gel and adhesive tape. The sensed signals were conditioned in a Thurlby Thandar Instruments WA301 wideband amplifier with a gain of ten times, and acquired via a PicoScope 6402 A digital oscilloscope, as depicted in Figure 1.

A five-cycle ultrasonic Hanning windowed toneburst was produced by an Agilent 33500B Series waveform generator, and transmitted to the plate through a Physical Acoustics WS α Series piezoelectric transducer (actuator) placed 200 mm

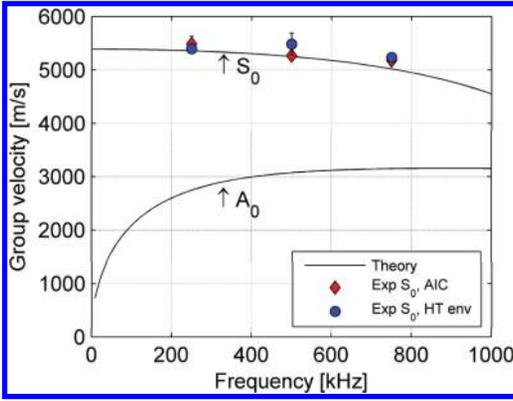
Figure 2. Group velocity dispersion curves for the aluminum panel (computed with DISPERSE™ software).

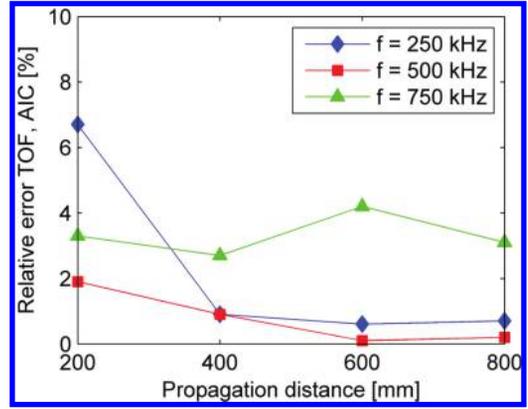
Figure 4. Variation of the relative error of the AIC results with distance, for each excitation frequency.

In both graphs the relative error falls within the same range of values for 250 and 750 kHz at all distances except at 200 mm (see discussion about relative error in the AIC algorithm results on the next page), corroborating the proximity of the Δv_g curves for these two frequencies. However, in Figure 4 the relative error for 500 kHz is always below 2%, while in Figure 5 it starts at 10% and only goes below 2% at 800 mm. Thus, the discrepancy of Δv_g for this particular frequency is in fact due to poorer TOF results from the HT envelope method at that frequency.

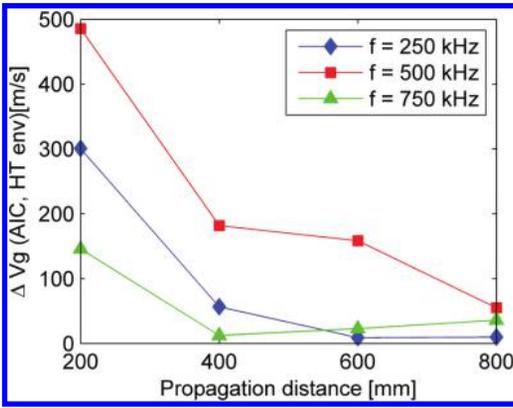
Figure 3. Variation of the S_0 group velocity difference between methods with distance, for each excitation frequency.

of the performance of the two algorithms. Hence it was decided to plot the difference of group velocity (Δv_g) obtained with each algorithm as a function of propagation distance, for each excitation frequency (Figure 3). Two main observations can be made from the chart. Firstly, there is a clear steady decrease in Δv_g with increasing distance for all frequencies, indicating consistency of both methods when applied to S_0 mode analysis. This was expected, since at larger distances the two zero-order modes are more clearly separated and the peak of the (not so dispersive) S_0 mode can be more unambiguously detected. Secondly, while the curves for 250 and 750 kHz are relatively close to each other (especially after 200 mm), almost all the points for 500 kHz are at least 150 m/s above the others.
