Emerging Technologies in Non-Destructive Testing VI

Editors

D.G. Aggelis & D. Van Hemelrijck

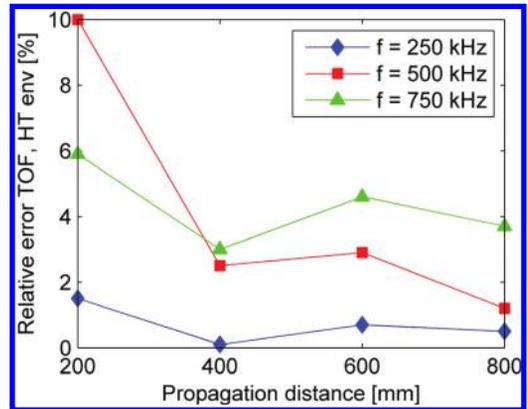
Figure 5. Variation of the relative error of the HT envelope results with distance, for each excitation frequency.

In both graphs the relative error falls within the same range of values for 250 and 750 kHz at all distances except at 200 mm (see discussion about relative error in the AIC algorithm results on the next page), corroborating the proximity of the Δv_g curves for these two frequencies. However, in Figure 4 the relative error for 500 kHz is always below 2%, while in Figure 5 it starts at 10% and only goes below 2% at 800 mm. Thus, the discrepancy of Δv_g for this particular frequency is in fact due to poorer TOF results from the HT envelope method at that frequency.

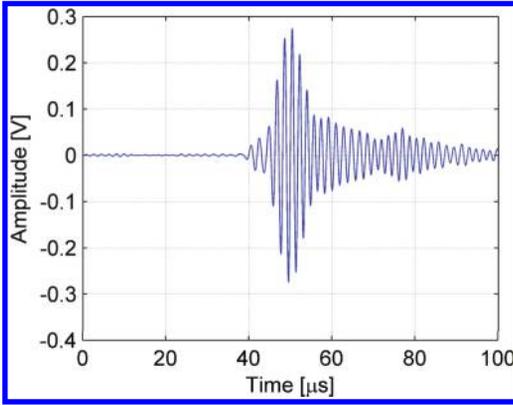
This occurrence can be explained by analyzing the first (or first two) wave-packet(s) from the signals which were captured at x_1 and x_2 for 500 kHz and used to compute the TOF for 200 mm (Figures 6 and 7). At x_1 (200 mm away from the actuator), the S_0 and A_0 are superimposed as it is

Figure 6. Part of the signal acquired at x_1 , for 500 kHz.

not possible to distinguish their groups separately. As a result, their amplitude is summed, masking the position of the peaks of each mode. Therefore, the observed first wave-packet peak is not actually the S_0 peak. At x_2 (400 mm away from the actuator), it is already possible to distinguish two groups, although they are still not completely separate. There is still mode overlapping with part of the S_0 mode (algebraically) summed to part of the A_0 mode. Therefore, at this position the first wave-packet peak approximately corresponds to the desired mode peak. Nevertheless, the subtraction of the peak times results in TOF_2 being considerably different from the theoretical value.

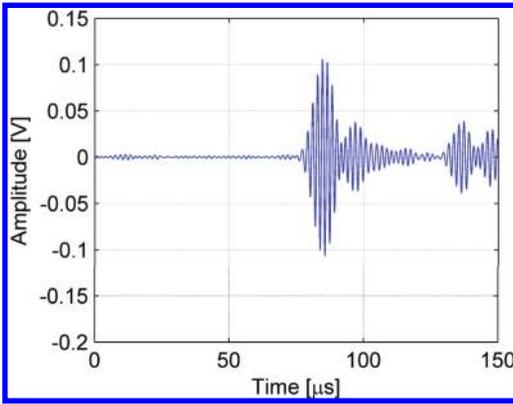
Figure 7. Part of the signal acquired at x_2 , for 500 kHz.

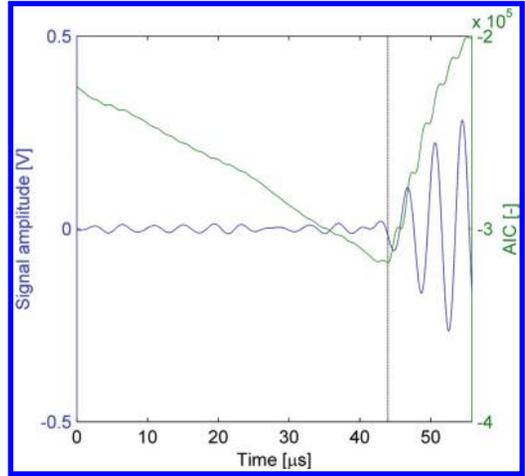
Figure 8. Determination of the signal onset with the AIC function at x_1 with a 250 kHz excitation frequency.

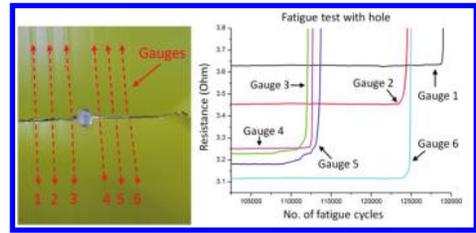
A prominent example of fracture-based systems are small-sized crack propagation gauges made from tiny metal stripes embedded in polymers to be glued on the material under investigation. Those systems are already commercially available (Pfeiffer et al., 2008), however, they are not appropriate for SHM because of their limited size and adaptability to complex surfaces. Furthermore, at some occasions, closed cracks cannot be detected reliably because the electrical contact remains intact, and partially after rupture, the reversibility of those systems is not granted. A solution to this problem is partially offered by crack gauges that are directly painted or cold-sprayed on the respective part using specific, conductive ink, adaptable to different complex surfaces and shapes. This principle has already been proposed in the past for building structures and can be combined with Radio-Frequency Identification (RFID) technology (Morita and Noguchi, 2008). The feasibility of this concept to aircraft structures was also proven by appropriate lab tests performed on Al-2024 fuselage material and A320 slat tracks (Pitropakis et al., 2012). The typical fuse-like response is clearly visible (Fig. 1).

Figure 1. Painted crack gauges under standard coating (left) and resulting electrical resistance obtained indicating progressing crack growth (right).

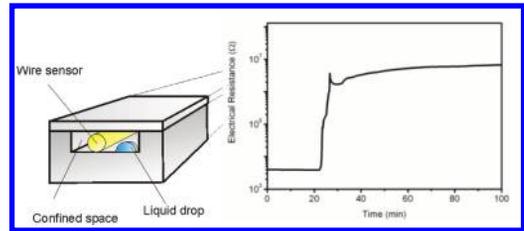
Figure 2. Detection of water leakage by a fuse-type sensing material using a lyotropic phase transition.

A solvent-dependent, thus lyotropic glass transition in polyvinyl-alcohol serves as the tool to detect the presence of water in engineering structures (Pfeiffer et al., 2012). Here, the electrical conductivity is strongly reduced after the uptake of water (Fig. 2).

A general problem to tackle are the long intervals between scheduled inspections, i.e. it is possible that corrosive liquids in those structures remain undetected for several years. The result is that heavy corrosion can occur that leads not only to partial safety issues but especially to very expensive repair costs. The sensor is thus situated in a confined space within the aircraft (Fig. 6) and a very important feature of this device is that it also detects the presence of liquid that is not touching the device but if it is only present in its neighborhood (Fig. 2, left). This is possible because evaporated liquid is

able to enter the sensing material by absorption. The obtained curves look essential like the response function given by (Fig. 2, right).

Similar to the presence of liquids in floor structures of aircraft, water-like compounds in pipelines in chemical installations can lead to heavy corrosion causing leakage of harmful compounds and expensive repair costs. Also here, the sensing material, performed as a sensing wire, was able to reliably detect the presence of corrosive liquids. In detail, the sensing wire is situated within the mineral wool that is used to thermally isolate the pipeline (Fig. 7). Comparable to the floor structures, also here, liquid in the neighborhood of the sensing material is detected because water vapor is diffusing through the whole isolation. A certain attention need to be given to the temperature ranges, i.e. the sensitivity is a function of the temperature because absorption and diffusion processes are depending on thermal boundary conditions. However, this is not a principal problem because a responding sensor always indicated a defect isolation, and it is always a question of time when those liquids will cause heavy corrosion. Also here, the response curves are similar to the examples given by Figure 2, right.

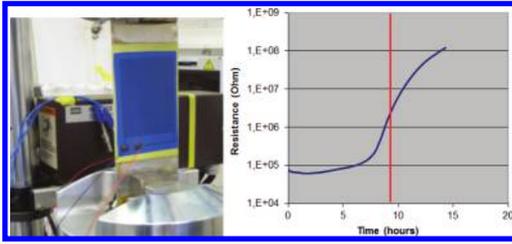
Figure 3. Printed “fuse” for detecting hydraulic liquids (left) in aircraft and response curve for engine oil or kerosene (right).

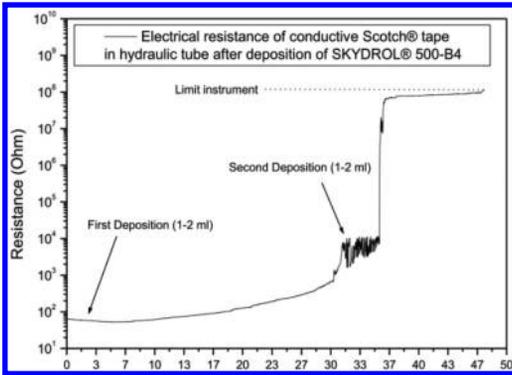
Figure 4. Deposition of aircraft-type hydraulic liquids on conductive acrylic material.

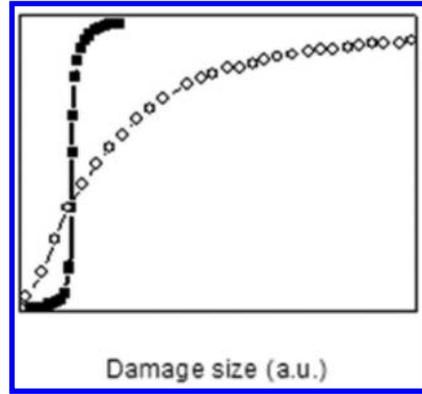
The general idea can also be explained by the Probability of Detection (POD). The POD concept gives an estimate of the performance of a detection technology in terms of a probability (Fig. 5). Basically, the POD is defined by the ratio of detected damage divided by the number of all tests performed. It is expected that the shape of the resulting POD curve

Figure 5. Highly simplified POD (a.u.) for linear sensor (circles) and fuse-like sensors (squares).

for the proposed structural fuses will be a convolution of the POD curve of the linear reference case combined with the response curve of a highly non-linear sensor, i.e. at low damage sizes, POD will be approximately zero, and at the “working point (vertical line)” it will approach $POD = 1$ within a very narrow range. Finally, very small defects will be missed (always acceptable in the case of the usual “damage tolerance” approach) but relevant damage will always be detected in a very reliable way. Last but not least, the possible loss of wide-range sensing will be highly compensated by the gain of simplicity and robustness when using this concept (see also Fig. 5).

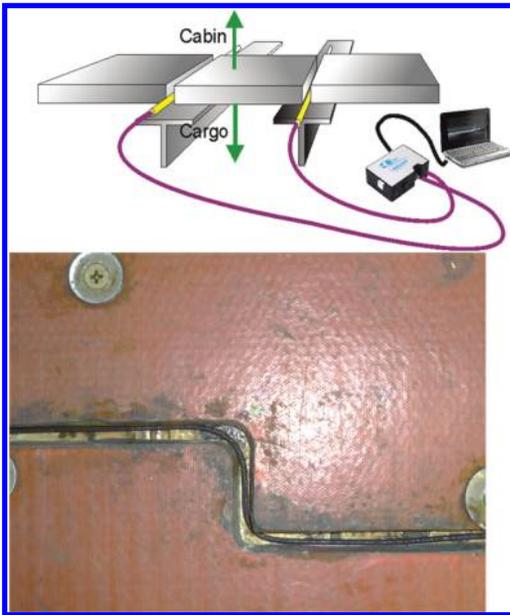
Figure 6. Position of fuse-type sensing device in the floor structures of an aircraft and real implementation in a Boeing 737-530.

The possibility to detect the presence of wetness in floor structures was practically tested in a couple of aircraft. Until today, three operational airliners are equipped with percolation sensors networks (Boeing 737–530, Boeing 747–430) protecting the floor structure below galley and service doors areas (Pfeiffer, 2012).

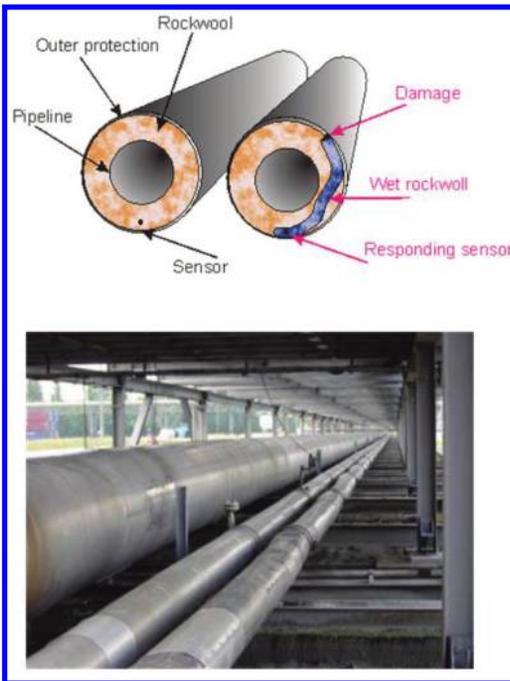
Figure 7. Positioning of the wired sensor in pipelines in chemical installations (top) and real implementation area.

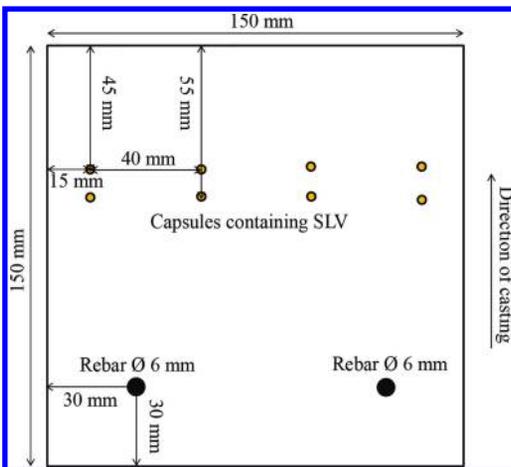
Reference concrete beams (containing no healing agent), control concrete beams (containing empty glass capsules) and self-healing concrete beams (containing SLV encapsulated in glass capsules) with dimensions of 150 mm × 150 mm × 550 mm were cast (Figure 1). The capsules in the self-healing concrete beams were fixed to nylon strings which were connected with the mould. Two reinforcement bars (Ø 6 mm) were positioned in the compressive zone in order to prevent brittle failure of the specimen during the three-point bending test.

Figure 1. Cross section at the middle of a self-healing concrete beam.

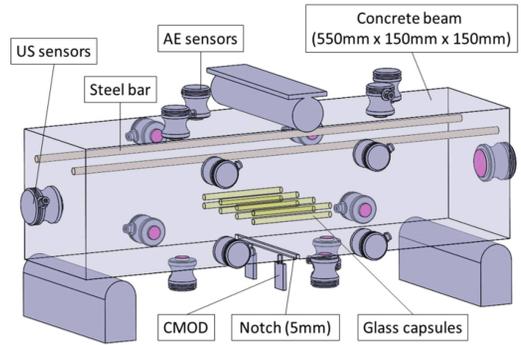
Figure 2. Set-up for the three-point bending test – positioning of the acoustic emission sensors and US transmitter and receiver.

After a storage period of 28 days under water, the specimens were moved to a climate room at 20°C and 60% RH and prepared for the first loading test. A notch with a depth of 5 mm was sawn in the middle of the specimens, Vibration Analysis (VA) measurements were performed and the Acoustic Emission (AE) sensors (15 in total) and Ultrasonic (US) transducers were fixed with hot glue to the concrete surface (Figure 2). After the crack width controlled three-point bending test (speed of 0.6 mm/min and crack width of ~ 350 µm after unloading), vibration analysis tests were performed and the polymer was allowed to cure for 3 days. During that time, the evolution of the S-waves was continuously monitored. Before reloading, vibration analysis tests were performed and acoustic emission sensors were glued to the concrete surface intentionally at the same position as during the first loading test. During reloading, acoustic emission and ultrasonic measuring techniques were applied. The settings for the acoustic emission and ultrasound transmission measurements and analysis are given in Table 2 and Table 3 respectively.

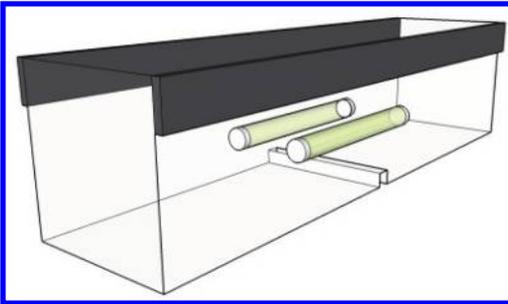
Figure 3. Cracked mortar beam reinforced with a FRP strip.

and 2 wt% of accelerator. The capsules were positioned with nylon strings crossing the mould at the mid section of the specimen, where a crack is expected during 3-point bending. The specimens were also reinforced with a 10 mm wide FRP strip along its length. The FRP was not used in a typical reinforcement configuration but as a way to stop the crack from developing across the whole height of the specimen, and thus was positioned in the compressive zone during bending. Figure 3 shows the final specimen configuration.

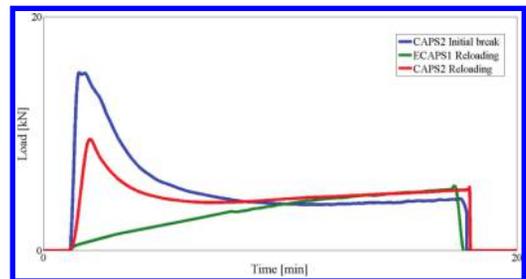
Figure 4. Loading and reloading curves of a self-healing specimen (CAPS2) and reloading curve of a control specimen (ECAPS1).

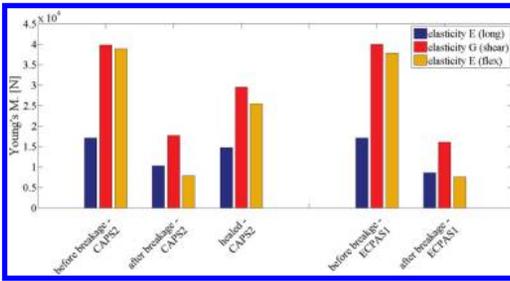
Figure 5 shows the moduli of elasticity in the shear, longitudinal and flexural mode before crack formation, after cracking and after healing (= before reloading).

Figure 5. Moduli of elasticity in longitudinal, shear and flexural mode. Control specimen (ECAPS1) - self-healing specimen (CAPS2).

As can be seen, the moduli of elasticity drastically decrease after cracking and the values obtained for the control (ECAPS1) and self-healing concrete (CAPS2) specimens are similar. A considerable increase is noticed for the self-healed specimens after curing of the SLV. Relative to the initial value, the modulus of elasticity in the flexural mode increases during the healing process from ~ 20% to ~ 65%, in the shear mode from ~ 45% to ~ 75%, and in the longitudinal mode from ~ 60% to 80%. Compared to the control specimen (ECAPS1), the self-healing specimen (CAPS2) reveals a partial regain in mechanical properties.

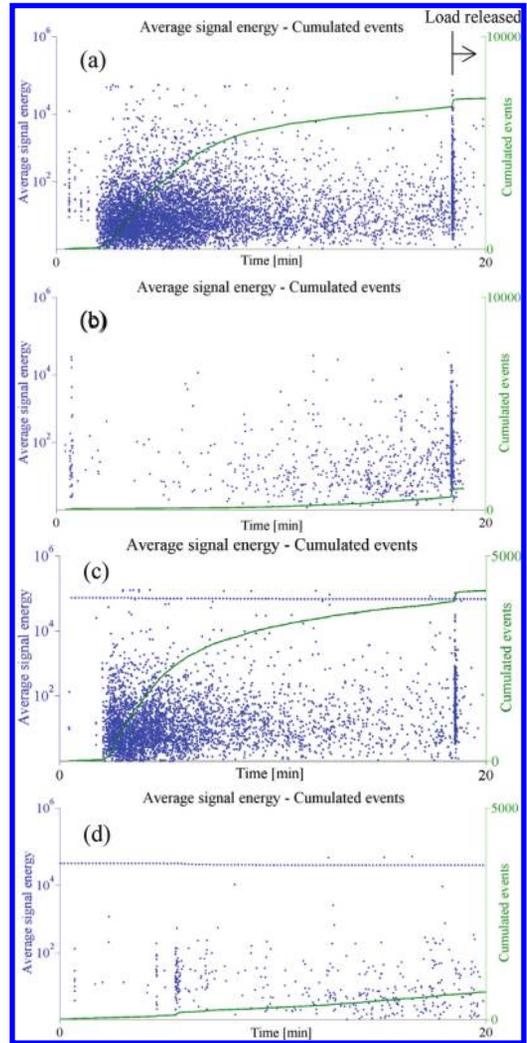
Figure 6. Average signal energy of the events during three-point bending: (a) loading – b: reloading) reference specimens, (c) loading—d: reloading) self-healing specimen.

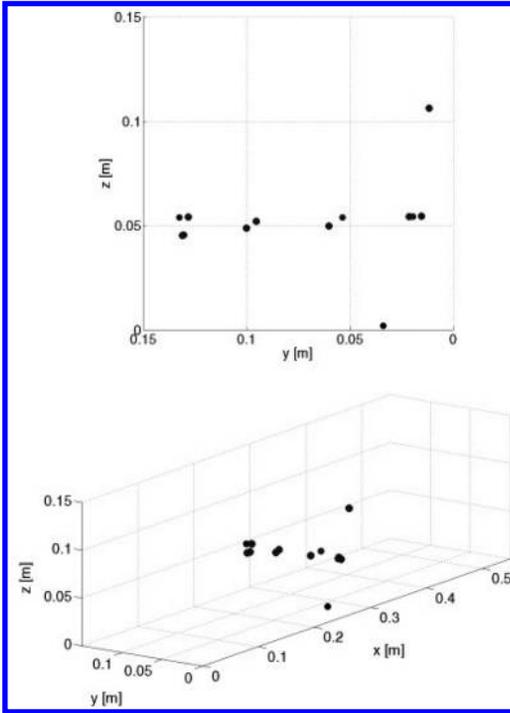
Figure 7. Localized events with an average signal energy higher than 1.6×10^5 . The position of these events corresponds with the position of the capsules.

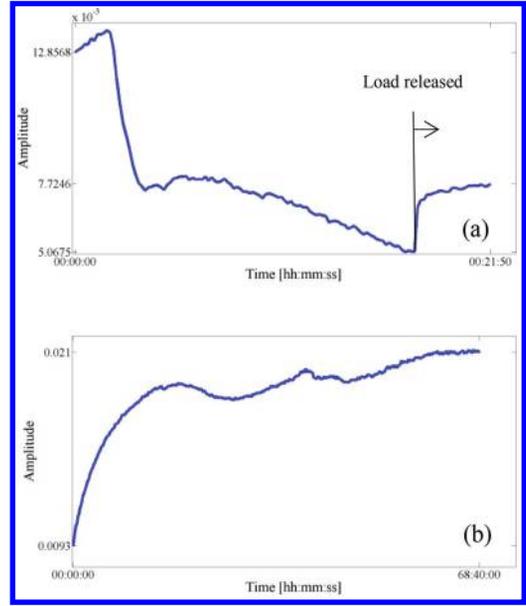
In Figure 8, the S-wave amplitude is shown in function of time. The amplitude is much more sensitive than the velocity that is usually measured. The S-wave amplitude clearly decreased with increasing crack depth and width. When the load

Figure 8. Evolution of the S-wave amplitude during loading (a) and healing (b).

was released, there was a small increase in amplitude. The reaction of the PU over the first 18 h after cracking was also clearly seen in the increasing S-wave amplitudes.

Real-time monitoring of the ultrasonic pulses by the FreshCon system allows to extract information about cracking of the concrete and healing of the crack. For the transmission measurement, shear wave sensors (Olympus Panametrics V150-RB) were used. With these sensors, the shear wave is dominant in comparison to the longitudinal wave. Moreover, it could be confirmed, based on a theoretical calculation of the shear wave velocity through a concrete sample and the predicted arrival time, that the amplitude of the selected, significant wave peak, as presented below, corresponds with the shear wave.

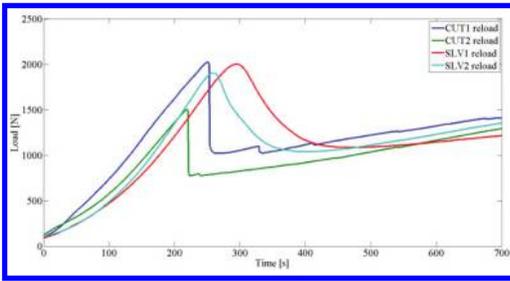
Figure 9. Load drop differences between cracked specimens healed with rigid (CUT) and flexible (SLV) polymers.

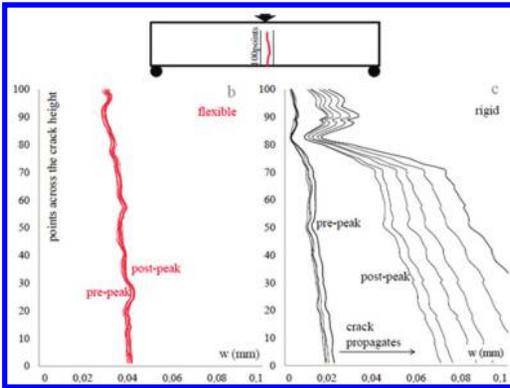
Figure 10. The brittle failure results from rupture of the rigid polymer, as shown by the sudden opening of the crack immediately after the post-peak of loading.

With DIC measurements, it was possible to accurately monitor the crack opening during testing. Figure 10 shows the crack opening across the full

height of the specimen, based on the displacement of 100 points on both sides of the crack, positioned as close to it as possible. It can be seen that during failure, i.e. after peak load, the original crack reopens instantly in the case of the specimen healed with the CUT agent. During the same time span, the crack in the specimen healed with the SLV agent opened just slightly and progressively due to its flexibility.

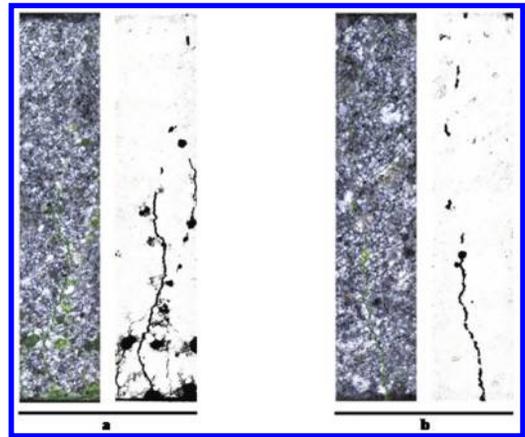
Figure 11. Crack mouth profiles of specimens CUT1 (a) and SLV2 (b).

It was also noticed after testing that the specimens healed with the brittle polymer showed new crack branches beside the original, reopened crack. The specimens were impregnated with epoxy containing fluorescent dye and a thin layer of mortar was removed from the bottom part, revealing any voids and cracks filled with epoxy. The dye in the epoxy then allowed easy highlighting of voids, new crack branches and sections of the original crack that were not healed. It can be seen in Figure 11 that at the crack mouth there were sections not healed, but also the clear opening of new crack branches in the case of the specimens healed with the CUT precursor, which were absent from the specimens healed with the flexible SLV precursor.

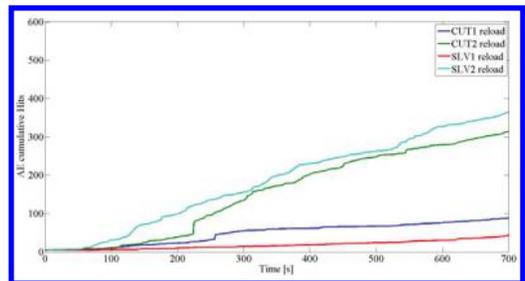
Figure 12. The brittle fracture generates a high number of hits at the same time (vertical discontinuity in the cumulative hits curve).

The data acquired by AE during loading of healed specimens also allowed identifying features that distinguish the acoustic events occurring during failure of both polymers. As shown in Figure 12, there was no correlation between the total number of acoustic events reaching the acoustic sensors and the type of precursor or failure. There are however vertical discontinuities in the cumulative hits curves of the specimens healed with the CUT precursor occurring during brittle failure (Figures 9 and 12 are time-aligned). These discontinuities represent a large number of events happening in a very short time and are an unambiguous feature of the catastrophic failure occurring when the brittle polymer was used to heal a crack. Additional features of this type of failure, which are absent when the flexible polymer was used, are a much higher number of acoustic events with energy above 100 (Figure 13) and, more clearly, the occurrence of hits with a Rise Angle (RA) above 3 (Figure 14).

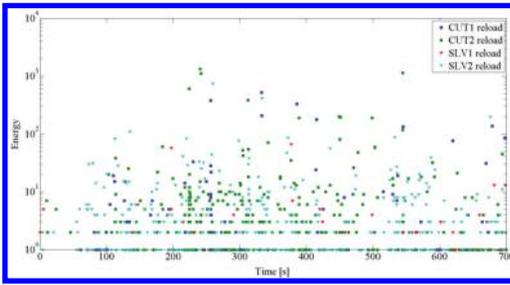
Figure 13. The specimens healed with the rigid polymer generate considerably more high energy hits (100–1000), associated with large crack propagation.

From this data, it was not clear whether the high RA and energy hits result from failure of the brittle polymer or the additional crack branches occurring during catastrophic failure, as hits with similar characteristics were also registered during cracking of sound specimens (where only cracking of the mortar matrix occurs).

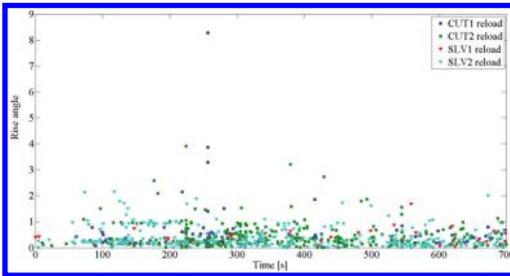
Figure 14. Only the specimens healed with the rigid polymer generate hits with high rise angle (ratio between rise time and amplitude of the first part of the waveform).

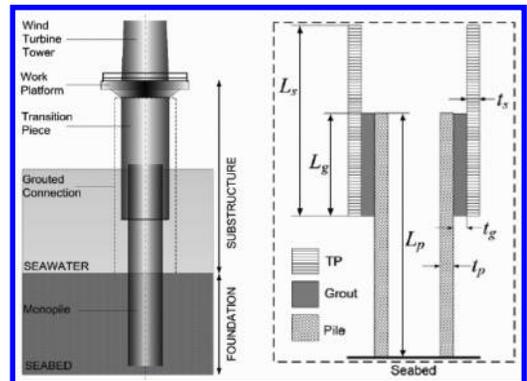
Figure 1. Lower part of the tower-foundation system of a wind turbine on a monopile foundation (left) and detailed view of the MP/TP interface.

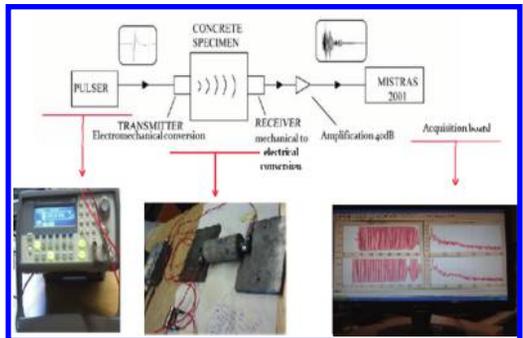
Figure 2. UPV working principle and realistic representation of the experimental setup.

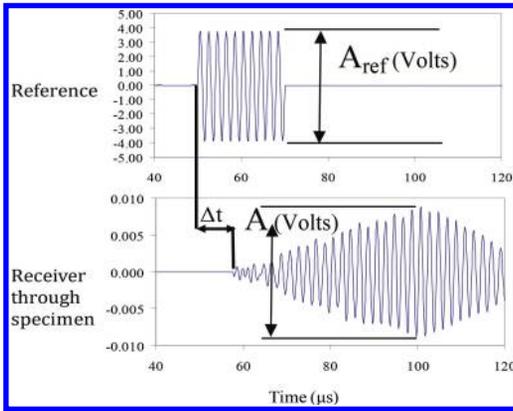
Figure 3a. Time delay between reference and received signals.

The onset of the signals is typically considered as the first visible disturbance and is measured by a “threshold” crossing, where the threshold is equal to the noise level of the system. Due to the sampling rate of 10 MHz (0.1 μs) and the propagation time of approximately 17 μs, the typical error is approximately 0.6%.

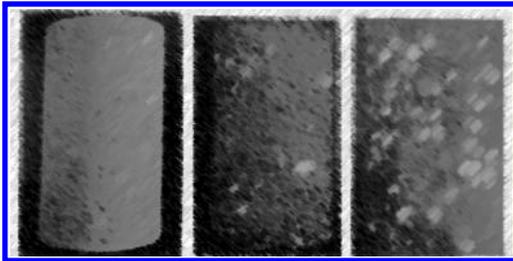
Figure 3b. X-ray analysis of a sample. From left to right: the sample; only the largest cavities; all cavities color codes with respect to the size.

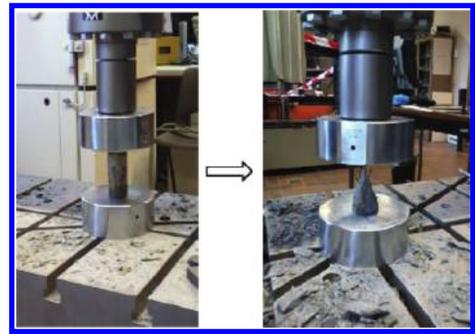
Figure 4. Process of compression until fracture of a grouted cylinder.

The most common performance measure of concrete is its compressive strength. The compressive strength is measured by breaking cylindrical concrete specimens in a compression-testing machine. The compressive strength is calculated from the failure load divided by the cross sectional area resisting the load and is reported in MPa. It is used to check if the concrete mixture as delivered meets the requirements of the specified strength in the job specification. The crushing strength of the concrete is strongly dependent on the size, shape and method of fabrication. The samples examined within the scope of this paper had a diameter of approximately 40 mm and a length of 80 mm. Figure 4 shows the two snapshots of the process of compression until fracture of the grouted cylinders.

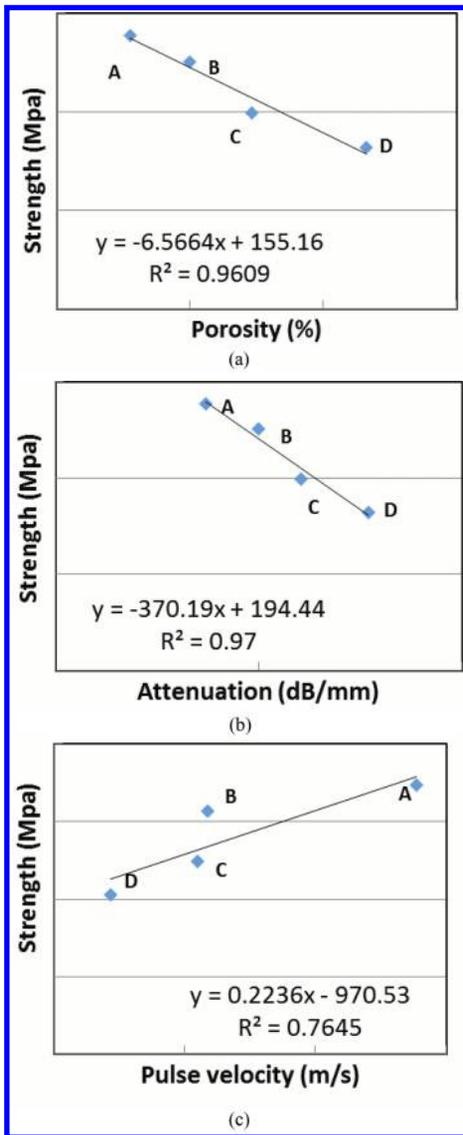
Figure 5. (a) Correlation of the compressive strength with the void content identified from X-rays, (b) correlation of the compressive strength with the attenuation calculated from the UPV technique and (c) correlation of the compressive strength with the pulse velocity calculated from UPV technique.

In Figure 5 the absolute values of all measured parameters cannot be disclosed due to industrial requirements, so the discussion focuses on the trends and correlations. Fig. 5a shows the correlation between the compressive strength and the porosity as calculated by the X-ray method. Each dot is the average of all specimens from the same wind turbine. According to Figure 5, porosity as

calculated by X-rays is very well correlated to the strength. The lowest porosity is accompanied by the highest strength (A specimens) and the highest porosity (D specimens) is observed for the less strong specimens. Furthermore, the attenuation of ultrasound matches very well the strength. Specimens with the highest strength (A specimens) exhibit the lowest attenuation whereas specimens with the lowest strength (D specimens) exhibit the highest attenuation. Finally, the pulse velocity is also in good correlation with the strength in the sense that an increase in strength between the successive groups, is escorted by an increase of UPV as well. The observed correlations between the different NDT measurements and the strength are based on the fact that voids decrease the effective load bearing cross-section resulting in lower strength; however, at the same time they increase the scattering attenuation, indirectly allowing an estimation of strength based on ultrasonic parameters. This remark opens the path for indirect strength measurements of grouted connections of offshore wind turbines from external in-situ measurements of the pulse velocity and attenuation via non-destructive UPV testing.

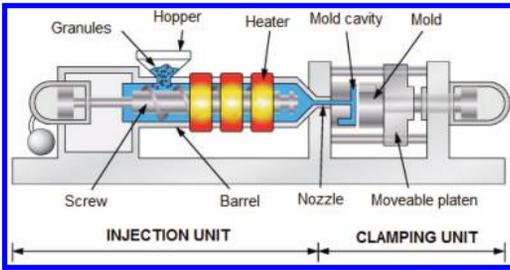
Figure 1. Example of a typical injection molding machine.

injection molding machine is shown in [Figure 1](#). Like in all today's industrial manufacturing processes, injection molding process can produce plastic parts which have poor quality and therefore are characterized as bad ones. In the field of injection molding during long term production first signs of micro-cracks can occur on the mold that usually causes production of bad parts. In such cases if a proper inspection inside the company is not provided then a whole series of freshly produced parts can be rejected. For a production company this can lead to a heavy economical loss. Location and advancement of a possible crack on the tool steel insert can be detected by the use of acoustic emission technique as already reported by many researchers (Cao et al. 2012, Biancolini et al. 2006; Mukhopadhyay et al. 2012, Berkovits & Fang 1995). The major AE signal sources detected by NDT are crack growth and plastic deformation of the steel

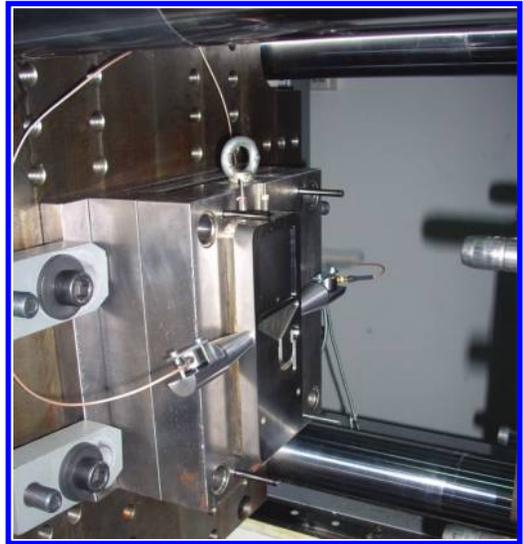
Figure 2. Tool steel insert with AE sensors.

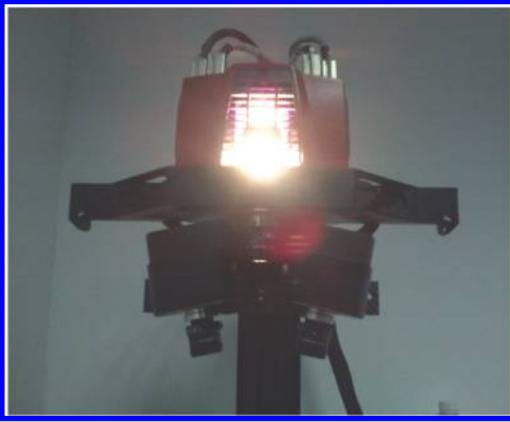
Figure 3. Optical 3D digitizer ATOS II SO with two high-resolution CCD cameras.

In the first part, we carried out the first experiments on a brand new tool steel insert. Later in the second part of experiments a tool steel insert with visible sign of macro-crack was used. In both cases to provide similar processing conditions, we used the same polypropylene material from Sirmax manufacturer (H40 C2 FNAT), which is mainly used in the automotive industry. After the test specimens were produced, they were scanned with an optical 3D digitizer ATOS II SO after 24 hours. This industrial 3D optical digitizer has two high-resolution CCD cameras (1280 × 1024 pixels) as shown on Figure 3.

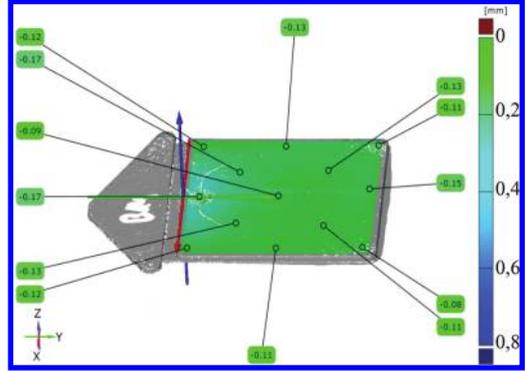
Figure 5. Measuring surface deviations on a test specimen produced on tool steel insert with visible sign of macro-crack.

A good advantage of scanning the test specimens is the fact that quality of surface and its deviation can be compared to the flat (ideal) surface as shown on Figure 5. We can notice significant surface deviations with regard to the ideal surface, which are within the range of 0.17 mm exactly on the place of macro-cracks.

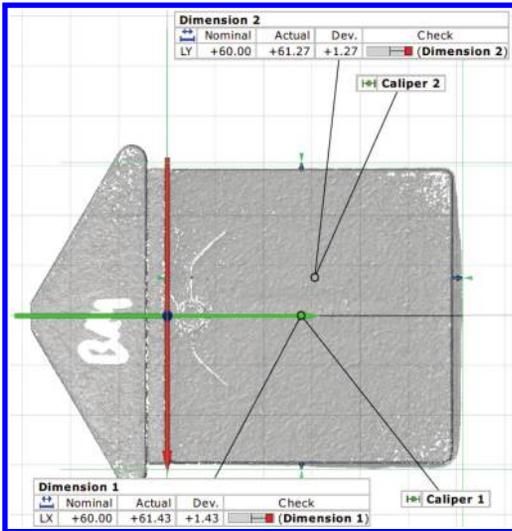
Figure 4. Scanned test specimen produced on a tool steel insert with visible sign of macro-crack.

images through the camera, which then through an appropriate program prepares a computer model. The accuracy that can be achieved with these digitizers depends largely on the quality of the camera, which records the desired object. Of course, in a very small precision scale the accuracy itself also depends on the wavelength of the light. The biggest advantage of 3D digitizer from Figure 3 lies in extremely rapid procedure of digitizing and excellent precision (precision declared for very small objects are up to 2 microns). Example of produced and later scanned test specimens with insert with a visible macro-crack is shown in Figure 4.

As can be seen from Figure 4 the test specimen has a clearly visible macro-crack. Also both dimensions are outside of the nominal 60 mm in the longitudinal (1.27 mm) and transverse (1.43 mm) direction. Test specimens produced with an undamaged tool are within the prescribed tolerances.

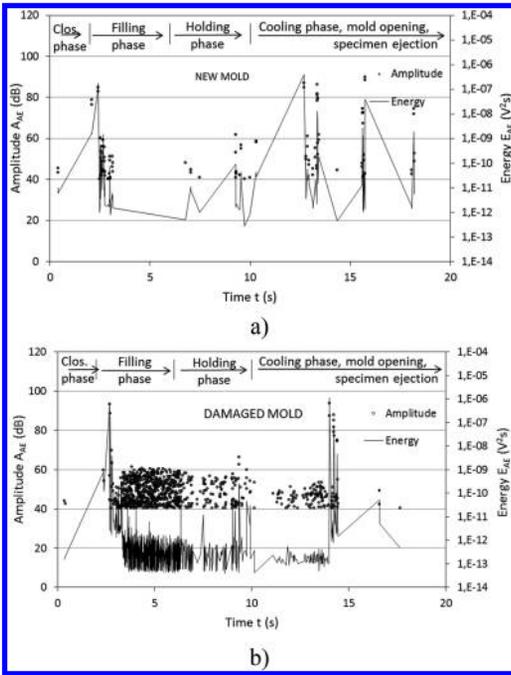
Figure 6. AE signals during production of (a) test specimen 8 (new insert), (b) test specimen 14 (insert with macro-crack).

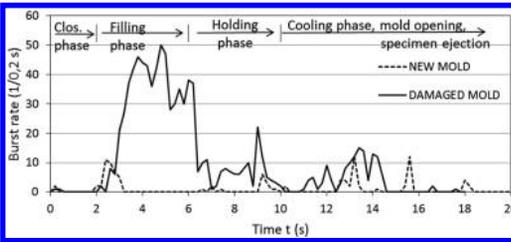
Figure 7. Burst rate during production of a test specimen with a new mold and a test specimen with a damaged mold.

Figure 6 shows the amplitudes and AE signal energy during the production of test specimens with an intact tool and damaged tool for injection molding. Presence of cracks in the insert can be detected by increase of amplitudes and energies of measured AE signals. On the tool steel insert with macro-crack a significant increase in the number of detected AE signals at the end of filling phase and beginning of holding phase can also be seen. Increase of AE burst rate is caused by increase of mechanical stresses in the injection molding machine. Figure 7 shows a distinctive increase of AE burst rate during filling phase with a use of damaged mold.

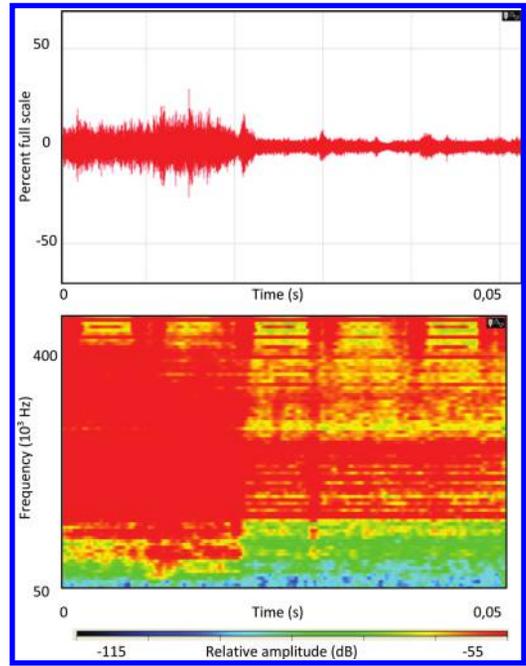
Figure 8. Time frequency diagram (spectrogram) of AE signal during filling phase with a new mold.

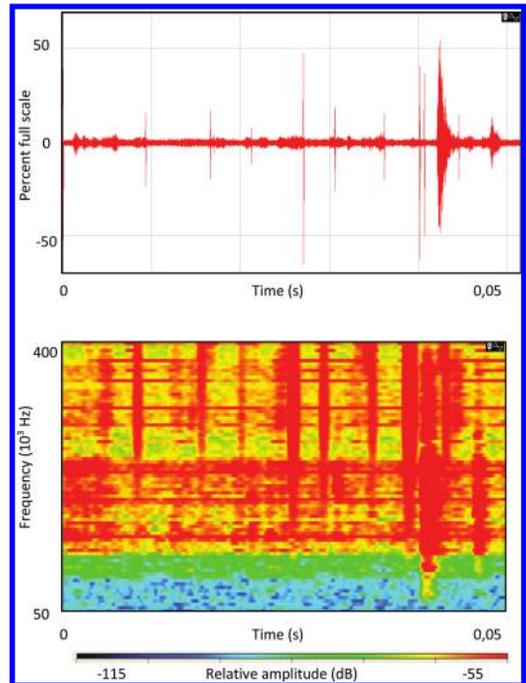
Figure 9. Time frequency diagram (spectrogram) of AE signal during filling phase with a damaged mold.

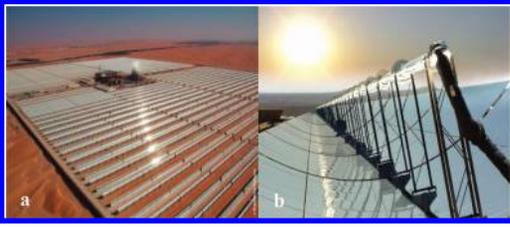
Figure 1. (a) Parabolic Trough Concentrated Plants (Staff, 2013) (b) Absorber Tube (Stewart Taggart, 2008).

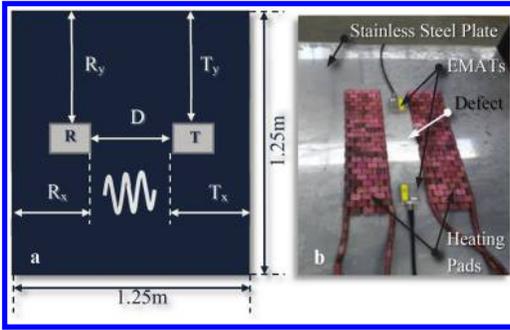
Figure 2. (a) Schematic of the experimental setup in a free of defects area (b) Experimental setup—EMATs—Heating pads-Defect.

The experimental setup used is shown in Figure 2. The specimen used is a 316Ti stainless steel square plate of 1,25 m and 3 mm thickness. The EMATs tested use a PPM configuration and a racetrack coil, made of lacquered copper wires of 0.315 mm diameter and with maximum operating temperature of 250°C. Ritec RAM 5000 SNAP pulser/receiver was used for driving the EMATs with a 6 cycle, Hanning windowed pulse of 256 kHz frequency. Ritec was also used for amplifying the signal received with a gain of 80dB and filtering it within the bandwidth of 10 kHz and 20 MHz.

distance between the transmitter and the receiver was equal to 30 cm. Five defects were created with different length and mass loss each and located 10 cm away one from the other. The defect tested was 20 mm long and with 66.6% mass loss; the transmitter was 15 cm away from one edge of the defect and the receiver were 15 cm away from the other edge of the defect. The second defect was 10 cm away from the bottom edge of first defect. The effect of extra shielding on the quality of the signal received has been also investigated; in fact, an additional thin, carbon steel cover was also placed all around the transducers for providing extra shielding. The influence of lift-off on EMAT response was investigated from zero to 1 mm lift-off with a step of 0.1 mm. A study regarding the power supply requirements of these EMATs was also accomplished by gradually decreasing the power output of Ritec with a step of 5% starting from its maximum power level (5000 Watts) and stopping at 20% of its maximum power where no useful information could be retrieved anymore from the signal received. For the high temperature experiments the distance between the transmitter and the receiver was equal to 30 cm with the first defect located 15 cm away from the transmitter and 15 cm away from the receiver as well; similarly with the room temperature setup. The temperature was increased from ambient to 180°C with a step of 10°C. During the high temperature experiments the EMATs were continuously in contact with the specimen.

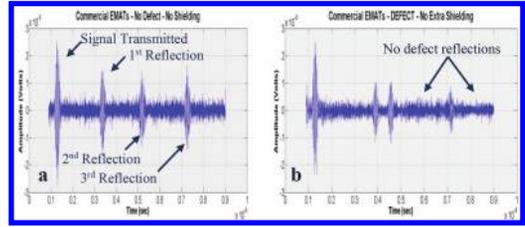
Figure 3. Signal received from (a) defect-free area with no extra shielding (b) defective area with no extra shielding.

From the first set of experiments, there are four case studies that should be investigated. **Figure 3a** shows the signal received from a defect-free area

with no extra shielding having been used. In this figure the first reflection is the signal transmitted from the transmitter to the receiver, the second reflection comes from the edge of the plate closer to the receiver (first plate edge reflection), the third reflection bounces at the edge closer to the transmitter and goes back to the receiver (second plate edge reflection) and the fourth reflection is the same wave with the third reflection propagating further and bouncing at the edge close to the receiver as well (third plate edge reflection). In this case the noise level is high and the amplitude of all the reflections is low, leading to a low SNR. **Figure 3b** illustrates the signal received when the defective area was tested without the shielding. Similarly with above, the signal transmitted and the three reflections from the edges of the plate are clearly obvious in the signal received. However, no reflections from the defect are obvious. **Figure 4a** demonstrates the signal received when the EMATs test the defect-free area with the use of shielding. In this case, the amplitude of the reflections increased, the noise level decreased and as a result the SNR increased five times more. **Figure 4b** shows the signal received from the defective area when shielding was also used. Similarly with **Figure 4a**, the SNR of the signal increased four times more compared to the signal shown in **Figure 3b**. Actually, in **Figure 4b** both reflections from the crack are clearly obvious as well as the reflections from the adjacent defect as well. Consequently, shielding proved to be significantly beneficial as far as quality of the signal

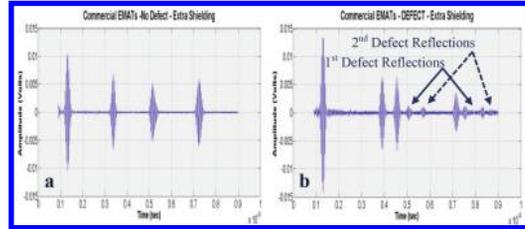
Figure 4. Signal received from (a) defect-free area with extra shielding (b) defective area with extra shielding.

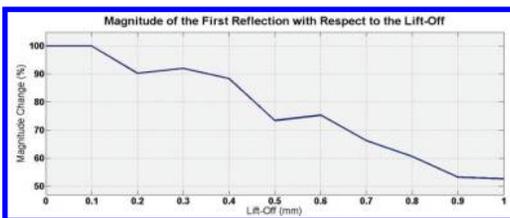
Figure 5. Magnitude change of the first reflection with lift off.

Figure 5 illustrates how the magnitude of the first reflection changes (%) with respect to the lift-off. According to literature EMATs are sensitive to lift-off (Jian *et al.*, 2006) and therefore their efficiency decreases with the increase of lift-off. The magnitude of the first reflection decreases almost linearly with the lift-off increase; when the lift-off is equal to 1 mm only the first reflection can be clearly observed. This confirms the high sensitivity of EMATs to lift-off. A parameter that influences the performance of EMAT regarding lift-off is the impedance of the coil. The impedance changes with lift-off as well as with the material properties of the specimen.

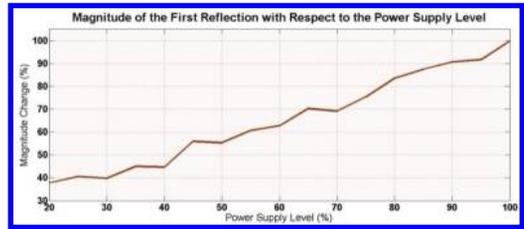
Figure 6. Magnitude change of the first reflection with power supply increase.

An experimental evaluation of these EMATs regarding their power requirements was also conducted. The power level decreased gradually from 100% to 20% with a step of 5%; as no useful information could be retrieved from the signal received when the power level was smaller than 20%. Figure 6 shows how the magnitude of the first reflection increases with power supply increase; it can be observed that the magnitude increases almost linearly with power increase. Similarly with lift-off, the impedance of the coil affects the power requirements of EMATs. If the pulser/receiver unit drives the EMAT transmitter through an output resistor, the magnitude of the impedance of the coil should be equal to this output resistor of the pulser unit, so that the voltage drop in the coil will be minimized. Therefore, impedance matching is

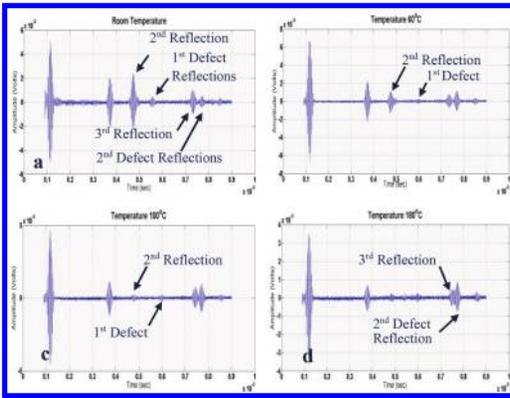
Figure 7. Signal received (a) at room temperature (b) at 60°C c) at 100°C d) at 180°C.

The EMATs were tested from ambient to 180°C with a step of 10°C; the maximum operating temperature of these EMATs is 250°C and therefore they were tested up to 180°C only, so that any serious and irreversible damage will be avoided. The EMATs were continuously exposed to the heat source with zero lift-off during the rise in temperature. Figure 7a-d show the signal received at room temperature, 60°C, 100°C and 180°C respectively. Firstly, in the signal obtained at room temperature both the reflections from the plate edges and the reflection from the first defect are clear. However, it is obvious that the amplitude of the second reflection from the plate diminishes greatly after 60°C, while at 100°C and 180°C it can hardly be noticed. Similarly, the amplitude of the first reflection from the defect and the fourth reflection from the plate decreases with the increase in temperature. Figure 8 shows how the amplitude of the signal transmitted decreases with temperature rise; it is clear that the amplitude dwindles almost linearly with rise in temperature. Time shifting is also observed, as it was expected due to the change in the wave velocity at high temperatures. The third reflection from the plate shifts in time and starts coming closer to the second reflection from the crack leading to the increase of the magnitude of the latter. Consequently, temperature compensation should take place and both the Time of Flight of the reflections as well as the drop of their amplitude may be two features that can be further

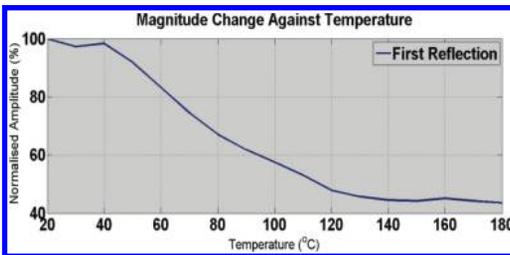
Figure 8. Amplitude of the signal transmitted with temperature.

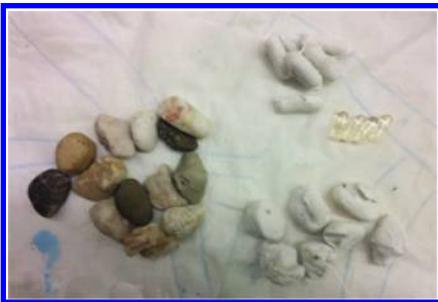
Figure 1. Gelatin capsules coated with IPC, both in a cylindrical shape and granulate shape. One can see the gelatin capsules (middle on the right side) and the original granulates (left).

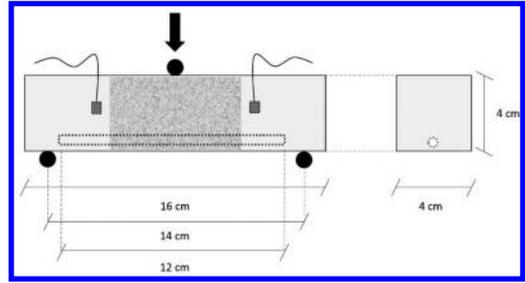
Figure 2. Three-point bending setup with two AE sensors and a speckle pattern on the front of the mortar beam for the DIC, inside the beam the self-healing system is embedded, in this case a capsule.

A total of 8 experiments were conducted and breaking of the tubes happened in 100% of the cases. The experimental setup is the same as in Figure 2 but with a longer tube (approximately 100 mm). In comparison to the specimen containing a self-healing capsules, the higher rate of successful breaking of the embedded self-healing mechanism is due to the bigger stresses that can be achieved on a long tube than on a short capsule. Breaking of these tubes caused strong and characteristic wave-signals picked up by AE. By means of DIC it was also confirmed that the crack path goes through the position of the tubes.

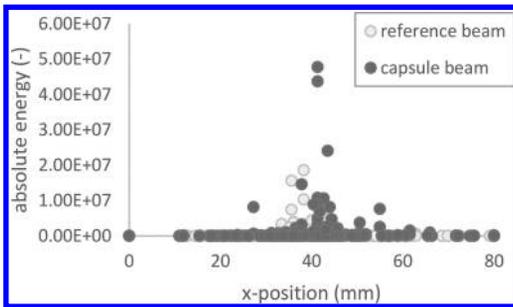
Figure 3. The energy from the reference beam, with only mortar, is smaller than the energy from a beam containing a self-healing capsule.

A total of 21 experiments were conducted. On 100% of the specimens, debonding between the capsules and concrete was observed (Figure 5). Comparing the signal of a reference mortar beam and a mortar beam with a capsule, the latter delivers a stronger signal (Figure 3).

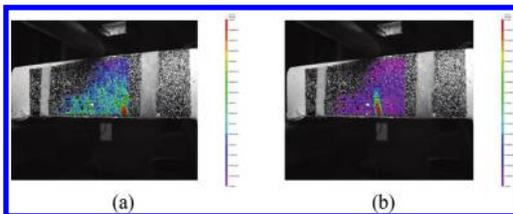
Figure 4. Two DIC images just before cracking (a), the biggest strain are at the right side, moments after the crack appears at the center beneath the capsule (b).

With DIC it was observed that the crack path went towards the position of the capsules. This is visually confirmed on the samples, Figure 4 and Figure 5.

Comparing the DIC images from Figure 4 and Figure 8, proof of the shift of the crack location can be found. Due to the accuracy of the sensors this is only a small indication. The events with high energy are concentrated near the center, the events with low energy or more scattered.

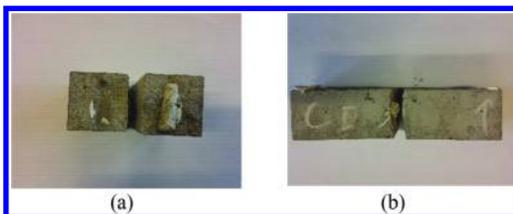
Figure 5. (a) Cross section of the two parts after three-point bending. The capsule did not break. (b) Plan view on the same specimen as figure 3 where the debonding of the capsule and mortar can be seen.

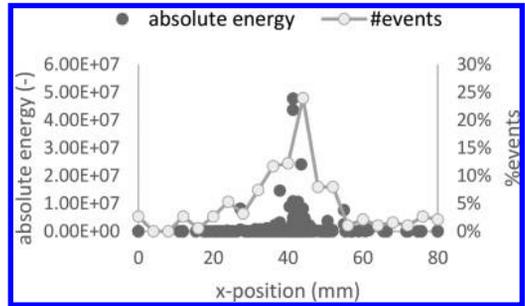
Figure 6. Light: absolute energy versus the x-position of the signal, dark: the relative amount of signals originated from one position.

By means of AE it was confirmed that the crack appeared towards the center of the mortar beam. This can be seen on Figure 6 and is confirmed by the DIC images. On the DIC figures it can be seen that a first big strainfield arises at a different loca-

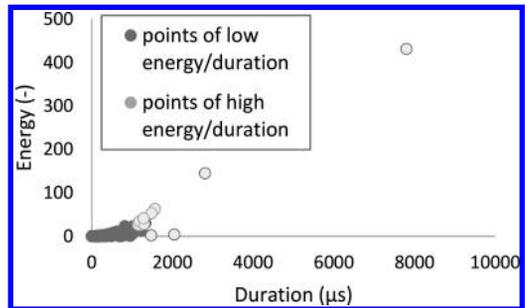
Figure 7. Energy versus duration graph showing AE-signals with greater energy due to cracking.

tion of where the crack will actually appear. On Figure 7 points with high energy and duration are selected.

From Figure 7, a duration versus energy plot made by the software NOESIS, it can be observed that mortar beams containing a capsule tend to have more AE-hits with much longer duration and energy in comparison to the reference (no capsule) beams. A distinction is made between datapoints with a higher energy and longer duration than was found in the reference beams.

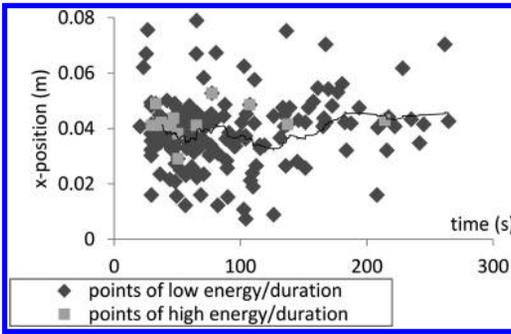
Figure 8. Displaying the event source location in time. The trend line takes the mean of 50 successive data points.

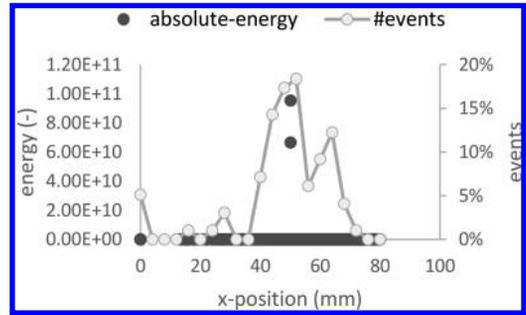
Figure 10. Absolute energy versus the x-position of the signal, the relative amount of signals originated from one position. The crack position evaluating both parameters is around 50 mm.

On Figure 10 it can be seen that the crack is around the center of the specimen based on the AE

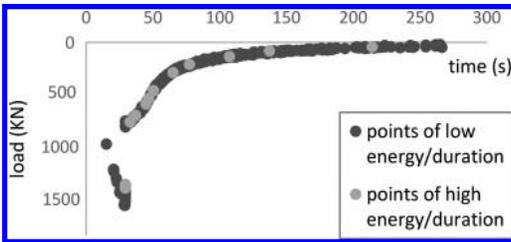
Figure 9. Load—time graph showing that the points with high energy occur just before and after the load-jump.

On Figure 9 it can be seen that the signals with a high duration and energy only appear after crack initiation.

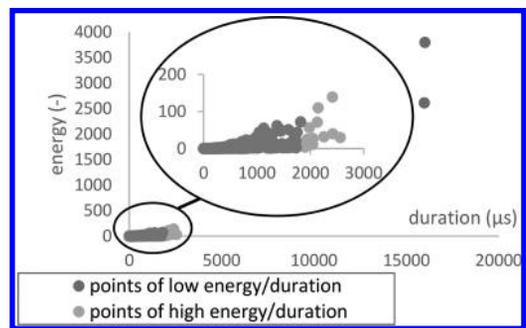
Figure 11. The energy versus duration graph shows 2 points with a very high energy and duration comparing to the other signals. A zoom on the remaining signals identify a group of signals with a duration above 2000 μ s.

On Figure 11 points with a higher duration and/or energy are highlighted. In order to compare this graph with Figure 7 the circled area was zoomed into. Most of these points are due to fracture of the mortar as can be seen on the load versus time graph (Graph 8). This location shift was also observed in other specimens but was not witnessed in the reference beams without an embedded tube.

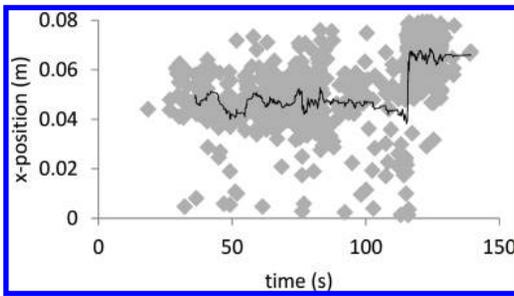
Figure 12. Displaying the AE hits in time and its correlated position. This graph shows a move of position of the signal's origin visualized by the trend line which takes the mean of 50 data points.

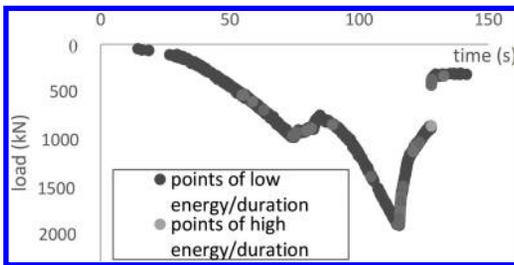
Figure 13. Load versus time graph, comparing to the reference and the capsule beams the load jump takes longer due to the tubes acting as tensile reinforcement.

Figure 13 the load versus time graph shows that the points of high energy occur after 50 seconds. Most of the points are registered after the peak load.
