Emerging Technologies in Non-Destructive Testing VI

Editors

D.G. Aggelis & D. Van Hemelrijck

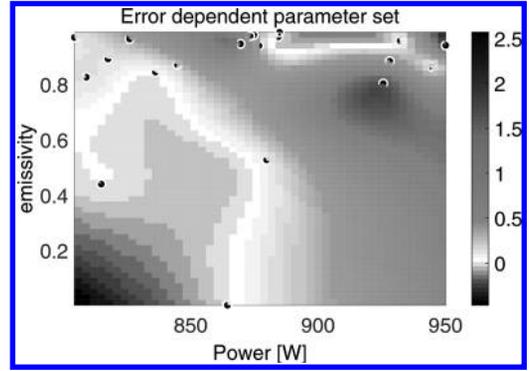
Figure 2. Error plot of the first parameter set of Table 1 with in white all solutions with equal error value.

The choice of a suitable parameter set is one of the most critical steps in the optimization routine as mentioned in Peeters, Arroud & et al. (2014). This is also shown in Figure 2 which is a result of the first parameter set of Table 1. As we can see, there are several values which result in a minimal error value. This means that the solution is not unique

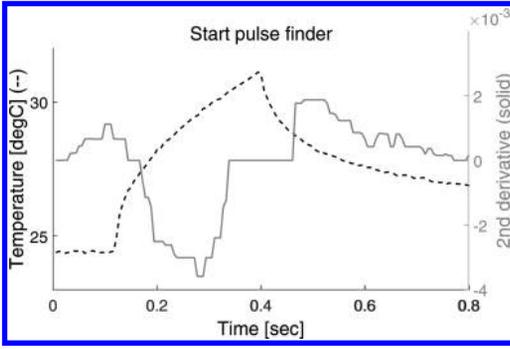
Figure 3. Mathematical detection of the start of the pulse time from experimental Aluminum test case.

1. The pulse start time is a result of the second derivative calculation of the experimental data as shown in Fig. 3, which forms the input of the global optimization routine. The start pulse is located 0.11 s after the beginning of the measurement, which corresponds at a framerate of 180 frames per second (fps) with a delay of 20 frames. The lamp coordinates are calculated out of triangulation measurements.

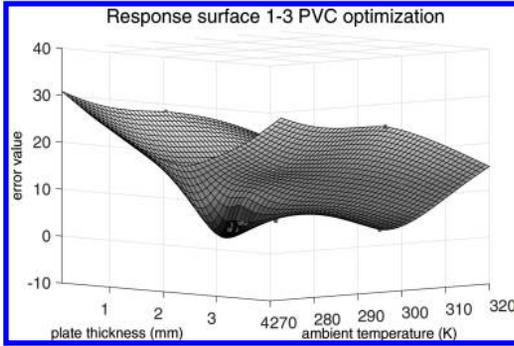
Figure 4. The response surface of the ambient temperature versus the material thickness.

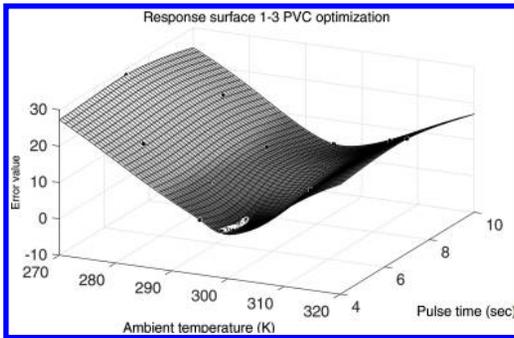
Figure 5. The response surface of the ambient temperature versus the pulse time.

response surface is plotted for the ambient temperature and the pulse time parameter.

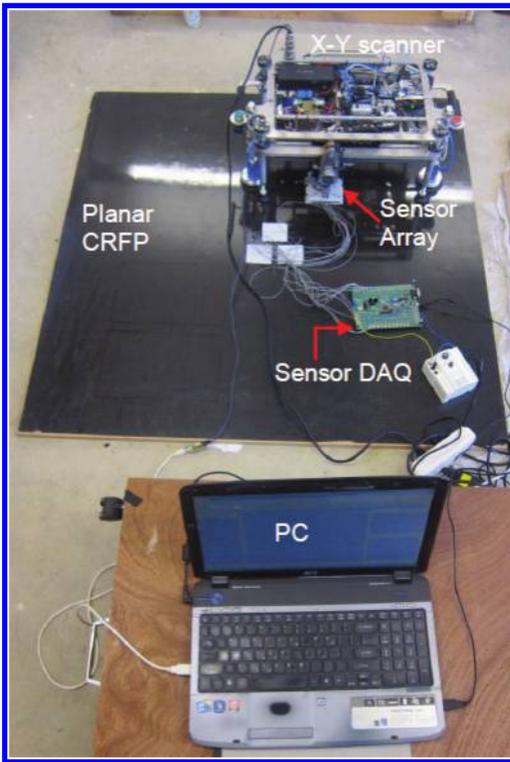
Figure 1. NDT scanner setup.

The whole NDT system, as shown in Fig. 1, consists of the scanner with a sensor arm, data acquisition board (DAQ), and a PC station.

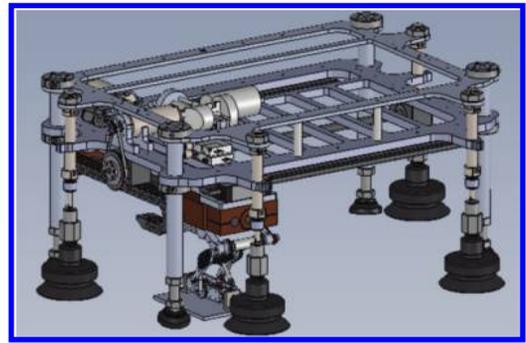
Figure 2. Scanner platform with XY precision translators, sensor arm and vacuum sucks.

One of major objectives was to minimize a scanner's weight, while providing high scanning rates, good resolution, positioning repeatability in both absolute and relative coordination systems, involving the minimum degrees of freedom. For that reason, an important functional requirement was the development of an ergonomic portable chassis with the weight less than 10 kg. Furthermore, it should provide the necessary space for seamless integration of all modalities that will implement the requested functional requirements of the scanner. Based on the aforesaid, the scanner frame was designed and manufactured through the use of two aluminum plates as presented on a schematic design in Fig. 2. The chassis was secured via the application of four tubes with collars that interconnect the two layers of aluminum plates. The aluminum plates were pre-cut with all necessary cut-outs and bores so as to be able to attach all necessary parts, gantry, motor supports, electronics, and pneumatic systems. The chassis structure has the advantage that all parts are accessible and can be removed readily for repair or replacement. It can be easily disassembled, machined if modifications are necessary during service period and

reproduced on request. The overall size of the chassis frame is $600 \times 400 \times 250 \text{ mm}^3$.

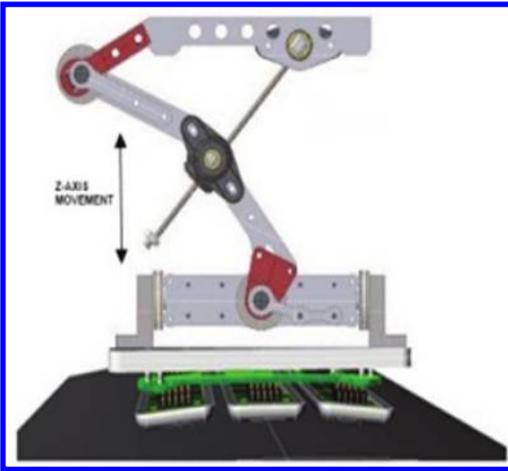
Figure 3. Sensor flexible arm.

Sensor arm, as shown in Fig. 3, is a mounting platform for the array of RF sensors. It is made of aluminum housed with bearings, pivot brackets, and springs to produce a lab jack mechanism with better conformance of the sensors to the MUT's surface. RF sensors are placed in PA6 plastic protection pads, which are mounted to a holder arm with the aid of a plastic holder plate to prevent any large metallic parts in the vicinity of the sensors. Although mounting pads indicated in Fig. 4 fit precisely to the plastic protection pads, the attachment can be further enhanced with thermoplastic adhesive. The dimensions of the holder plate are $100 \times 120 \text{ mm}^2$ with a thickness of 8 mm.

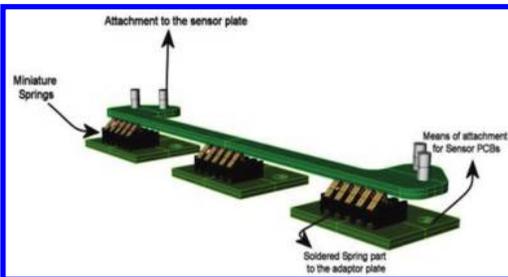
Figure 4. Mounting pad of RF sensors.

Vertical force pushing the sensors to the CFRP surface is provided by the lab jack mechanism that drives a passive spring on the outside of a telescopic pair shown in Fig. 4. An exerted force over the sensor plate is adjusted by the use of springs in

order to maintain a firm contact with the MUT's surface during a sliding movement of the sensors. The total travel distance on the z-axis is 40 mm, enabling the application of proper pressure to the sensor plate, in order to ensure its smooth conformance on curved surfaces. The vertical displacement can be monitored with an integrated absolute encoder.

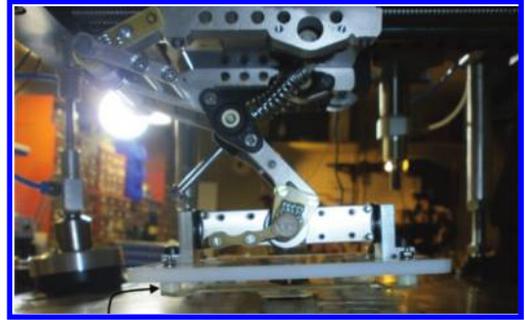
Figure 5. Photograph of a sensor arm.

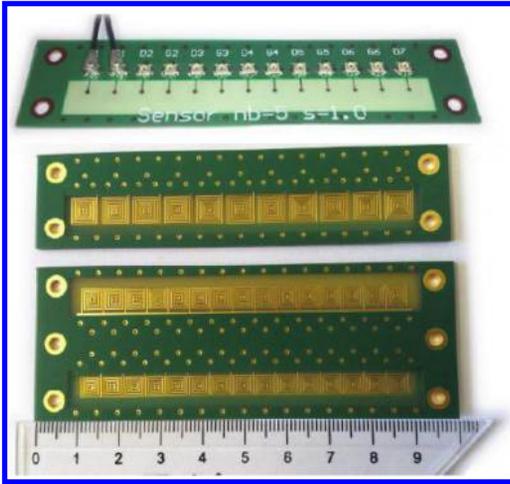
Figure 6. Exemplary RF sensors.

Each channel is also equipped with its individual logarithmic wideband power detector. As a result, each measurement shot provides the whole spectrum of power transmission through each coupled sensor pair, as indicated in Fig. 6.

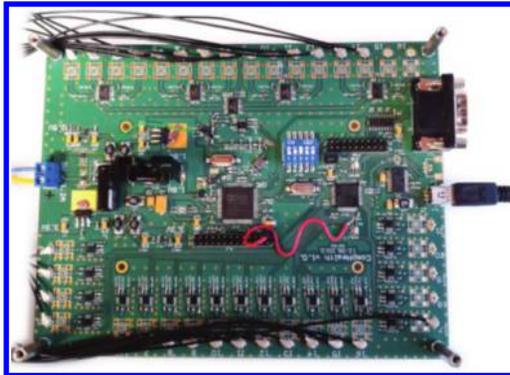
Figure 7. Data acquisition board.

In the view of the above considerations of the frequency range of operation of the RF sensors, electronic circuitry, dedicated to the measurement of the number of individual sensor channels, has been developed (see Fig. 7). The main role in that system is played by a Direct Digital Synthesizer (DDS), controlled with a 32-bit microcontroller, which also serves as an interface with a PC host station. DDS generates signals spanning from 20 MHz up to 300 MHz, as this is the spectrum where the largest sensitivity to defects buried in ca. 1 mm thick CFRP panels is expected. The signal is multiplexed to all measurement channels in a sequential form.

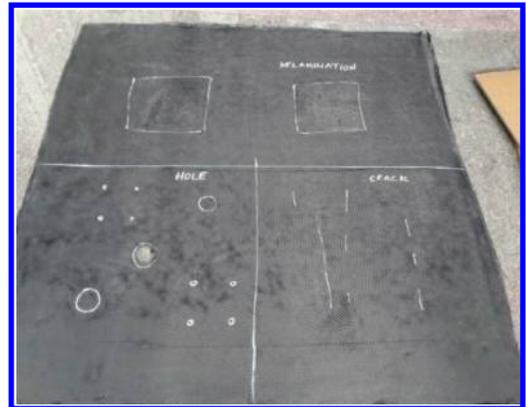
Figure 8. Flat CFRP panel.

The flat CFRP panel is shown in Fig. 8. As it can be noticed, a few types of defects have been intentionally introduced, such as holes, bubbles, cracks, and delamination. Figure 9 shows RF images stored at two distinct frequencies. The image at 50 MHz clearly indicates a large hole, which is not visible at

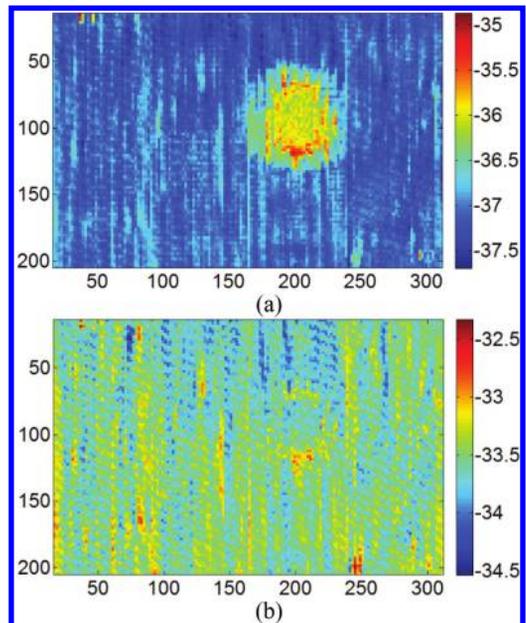
Figure 9. Hole buried in the CFRP sample shown in Fig. 8a measured at (a) 50 MHz and (b) 200 MHz.

the front surface of the panel. It can be partially confirmed by the lack of the hole at the RF image at 200 MHz, which due to a substantially decrease penetration depth is sensitive mostly to the CFRP features, which are shallowly buried under the top surface of the panel. In particular, regular fracture appearing in Fig. 9b is correlated with the orientation of the front CFRP twill.

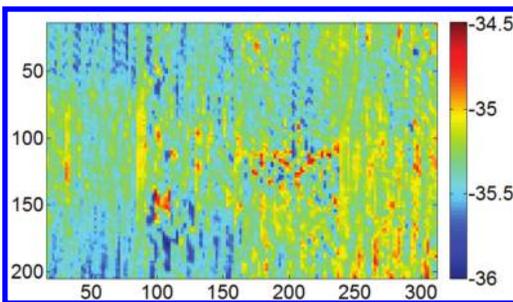
Figure 10. Specific bubbles buried in the CFRP sample shown in Fig. 8a measured at 20 MHz.

Figure 10 indicates an RF image measured at 20 MHz at the areas of the flat CFRP panel shown in Fig. 8, where buried bubbles are introduced by the manufacturer. Indeed, several tiny fluctuations can be observed in the central part and the right side of the image, while the changes at the left side of the image are rather smooth and results mostly due to slight misalignments of the CFRP twill.

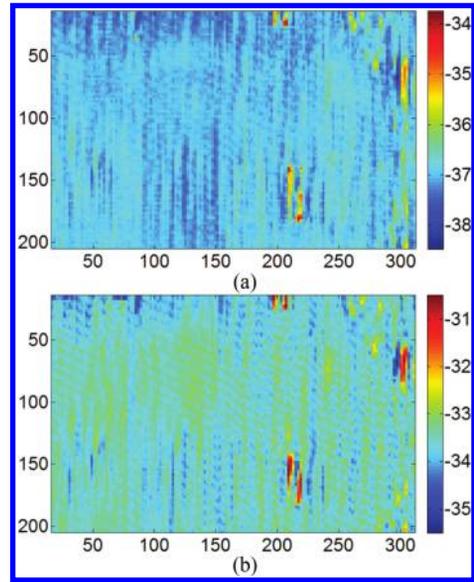
Figure 11. Cracks buried in the CFRP sample shown in Fig. 8a measured at (a) 20 MHz and (b) 300 MHz.

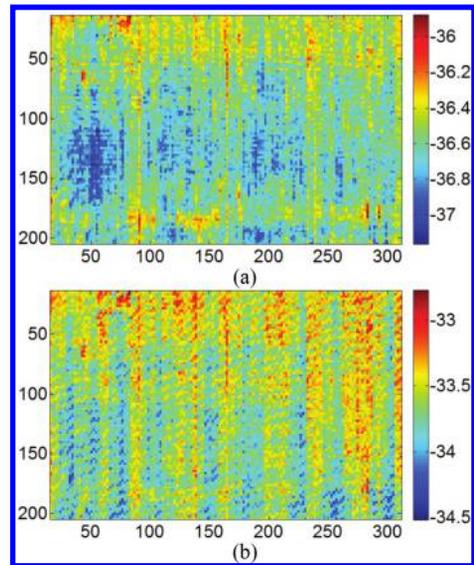
Figure 12. Delamination buried in the CFRP sample shown in Fig. 8a measured at (a) 20 MHz and (b) 300 MHz.

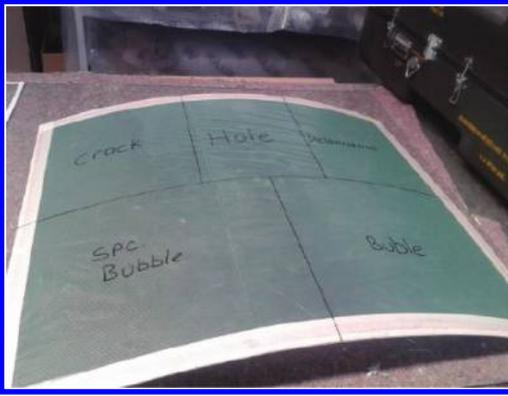
Figure 12. Curved CFRP panel.

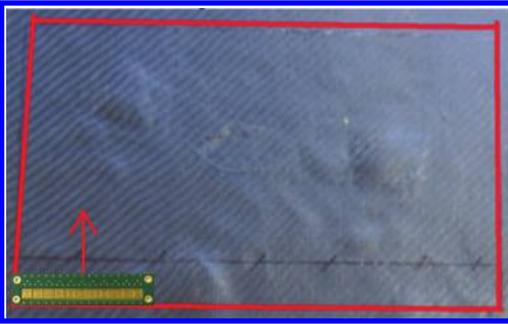
Figure 13. Specific bubbles on the curved CFRP sample shown in Fig. 12.

stripes due to the chosen direction of the sensor indicated in Fig. 13. Figure 14 shows the obtained RF image, where those four stripes are well visible due to the aforementioned uneven attachment of the sensor line to the curved surface. Fortunately, it results in a linear trend occurring in power transmission measured across the sensor line, so it can

be estimated and removed at a post-processing stage. Consequently, Fig. 14b is smoother enabling better recognition of the bubbles, the location of which corresponds very well with those shown in Fig. 13.

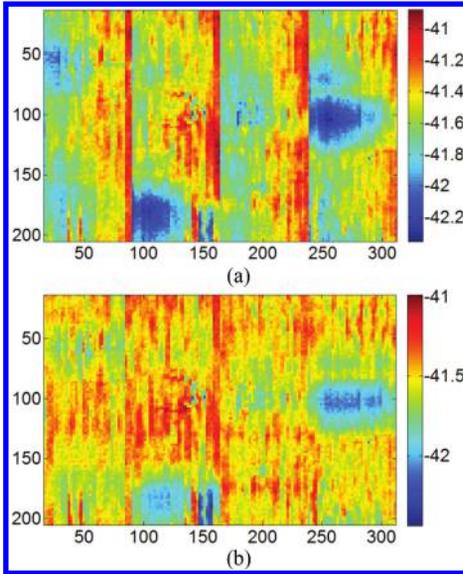
Figure 14. Specific bubbles on the CFRP sample shown in Fig. 13 and measured at 20 MHz. (a) Raw data. (b) Linear trend removed.

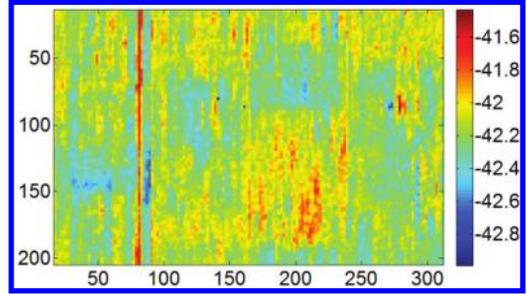
Figure 15. Delamination buried in the CFRP sample shown in Fig. 13 measured at 20 MHz. Linear trend is removed.

Figures 15–17 show another types of defects measured with the RF scanner at 20 MHz. In the case of delamination, it can be seen in the middle of the image in Fig. 15. In addition to that, there is also some vertical defect visible at the left side of the RF image shown in Fig. 15, which may be some buried crack unintentionally introduced by the manufacturer.

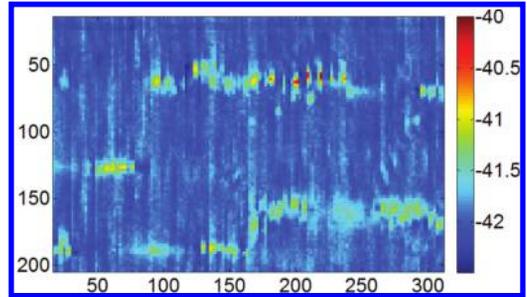
Figure 16. Cracks buried in the CFRP sample shown in Fig. 13 measured at 20 MHz. Linear trend is removed.

Subsequently, Fig. 16 indicates several cracks measured on the curved CFRP sample, while a hole can be clearly observed in the top right corner of the image in Fig. 17. Similarly to the unintentional crack depicted in Fig. 15, there is a horizontal fault visible in Fig. 17, which has not been explicitly highlighted by the manufacturer.

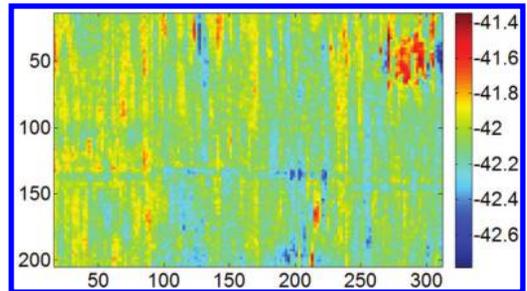
Figure 17. Holes buried in the CFRP sample shown in Fig. 13 measured at 20 MHz. Linear trend is removed.

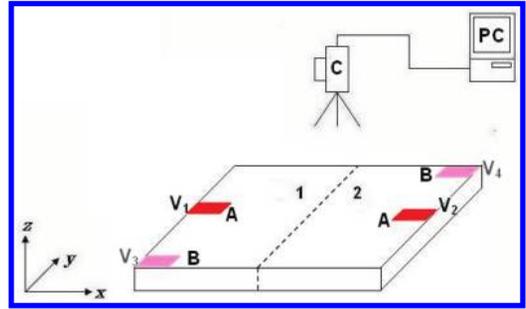
Figure 1. Schematic diagram of the experimental facility: 1: Section 1 of inspected work-piece, 2: Section 2 of the work-piece, V_1 and V_2 : position A of the electrodes, V_3 and V_4 : position B of the electrodes, C: infrared camera, PC: computer.

(position B in Fig.1). In the former case, both the current flow and the heat flow are perpendicular to the separating boundary, while in the latter the current and heat flow are oblique to the separating boundary.

When the electrodes are placed at position A, the heat flow within the plate is parallel to the X-axis (Fig. 1), i.e. it is mainly perpendicular to the interface between the two metals. On the contrary, when the electrodes are placed at position B (Fig. 1), the heat flow is mainly oblique to the interface. In that case, the isotherms give only a vague indication about the interface. The interface is sharper if the temperature derivative norm distributions are depicted. Iso- D_2T lines at $t = 2$ s, are illustrated in Figure 5 and iso- D_1T lines at $t = 50$ s, are illustrated in Figure 6. Notice that at $t = 2$ s (Fig.5) the indication of two existing regions is limited within the central region of the plate, while at $t = 50$ s (Fig.6) the indication extends over the whole length of the interface.

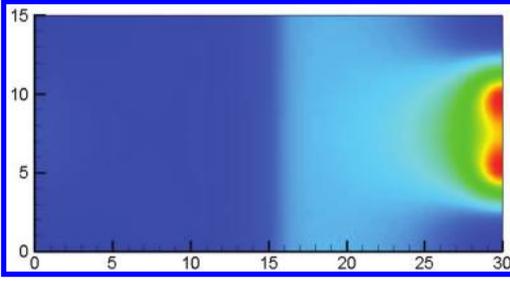
Figure 2. Isotherms in the case of the copper—brass plate at $t = 2$ s (electrodes at position A).

Isotherms in the case of the copper—brass plate at $t = 2$ s, when the electrodes are placed at position A (see Fig.1), are illustrated in Figure 2.

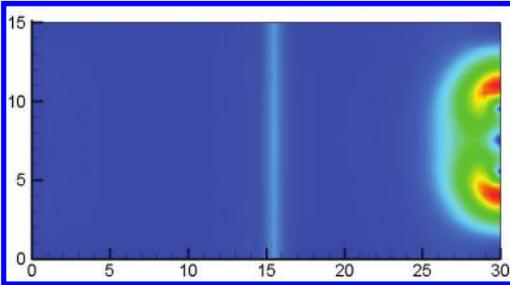
Figure 3. Iso- D_1T lines in the case of the copper—brass plate at $t = 2$ s (electrodes at position A).

The depiction of the temperature derivative norm distributions removes (totally or partially) the effect of non-uniform heating of the plate. In that case the interface between the two metals is clearer. Iso- $D_1 T$ lines (norm of the 1st spatial derivative of temperature, given by eq.7), and iso- $D_2 T$ lines (norm of the 2nd derivative of temperature, given by eq.8), at $t = 2$ s, are illustrated in Figures 3 and 4, respectively.

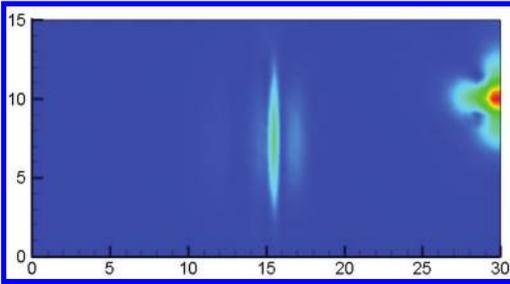
Figure 4. Iso- D_2T lines in the case of the copper—brass plate at $t = 2$ s (electrodes at position A).

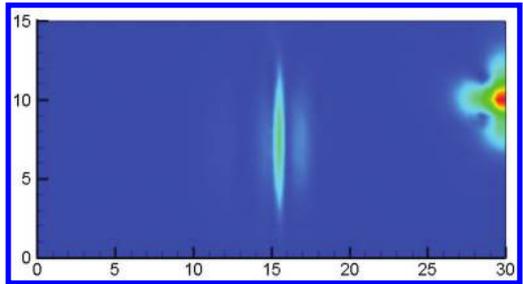
Figure 5. Iso- D_2T lines in the case of the copper—brass plate at $t = 2$ s (electrodes at position B).

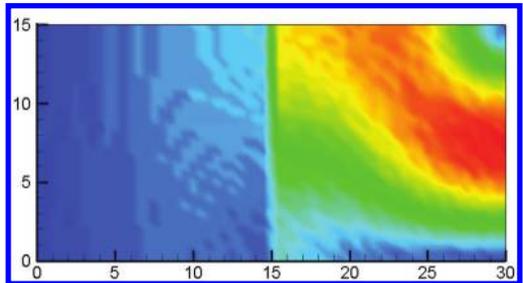
Figure 6. Iso- D_1T lines in the case of the copper—brass plate at $t = 50$ s (electrodes at position B).

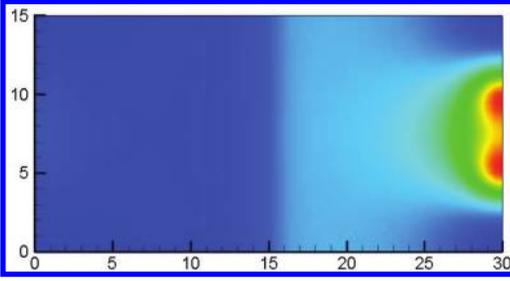
Figure 7. Isotherms in the case of the iron—stainless steel plate at $t = 10$ s (electrodes at position A).

Isotherms, iso- D_1T lines and iso- D_2T lines at $t = 10$ s in the case of the iron—stainless steel plate, when the electrodes are at position A (Fig. 1) are illustrated in Figures 7, 8 and 9 respectively.

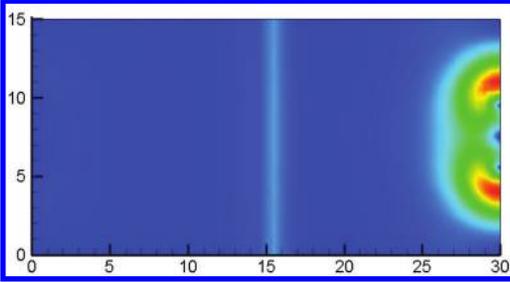
Figure 8. Iso- $D_1 T$ lines in the case of the iron—stainless steel plate at $t = 10$ s (electrodes at position A).

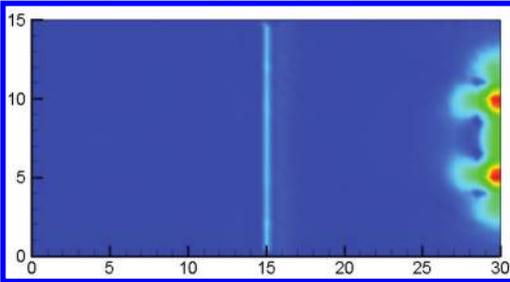
Figure 9. Iso- $D_2 T$ lines in the case of the iron—stainless steel plate at $t = 10$ s (electrodes at position A).

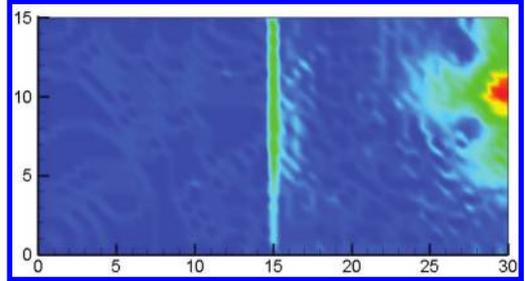
Figure 10. Iso- $D_2 T$ lines in the case of the iron—stainless steel plate at $t = 50$ s (electrodes at position B).

If now the electrodes are placed at position B (Fig. 1), the heat flow is mainly oblique to the interface. In that case, similarly to the corresponding case for the copper—brass plate, the isotherms give only a vague indication about the interface. The indication is clear when the temperature derivative norm distributions are depicted. Iso- D_2T lines at $t = 50$ s, in the case of the iron—stainless steel plate are illustrated in Figure 10.

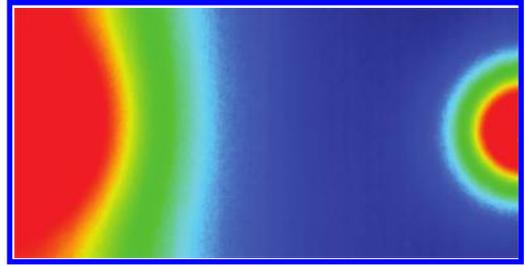
Figure 11. Thermogram in the case of the iron—stainless steel plate, at $t = 3$ s (electrodes at position A).

Isotherms (thermogram) at $t = 3$ s in the case of the iron—stainless steel plate, when the electrodes are placed at position A, are illustrated in Figure 11.

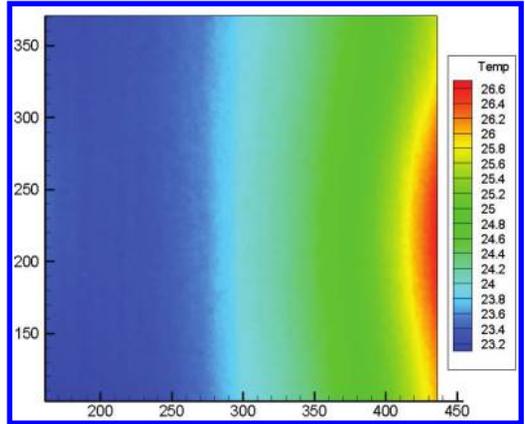
Figure 12. Mean value of temperature over the time period 3–4 s in the case of the iron—stainless steel plate (the central part of the plate is depicted).

In order to compact the most useful information of a sequence of thermal images in a single image, the mean value of temperature over a time period is depicted. If t_w is the time window and m is the frame rate, then the number of images to be analyzed is $N = m t_w$. Let $T(x, y, n)$ be the temperature at a particular location (x, y) of the n th thermogram in the image sequence ($1 \leq n \leq N$). The mean value of temperature $T_{\text{mean}}(x, y; t_w)$ at (x, y) over the time period t_w is computed as:

The mean value of temperature over the time period: $3 \text{ s} \leq t \leq 4 \text{ s}$, in the case of the iron—stainless steel plate, is illustrated in Figure 12.

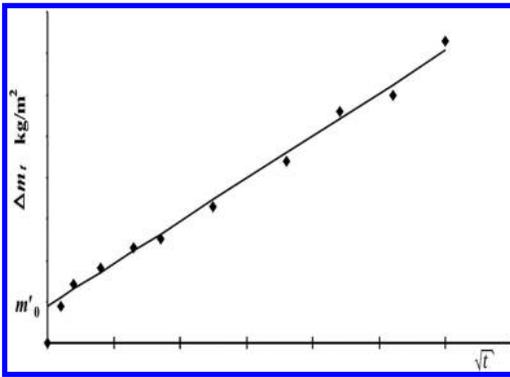
Figure 1. Graph of water absorption plotted to root of time (EN ISO 15148).

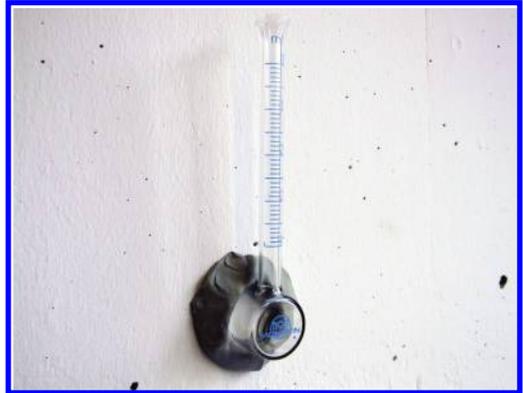
Figure 2. Vertical application of Rilem test method no. 11.4 RILEM tube is fixed on wall.

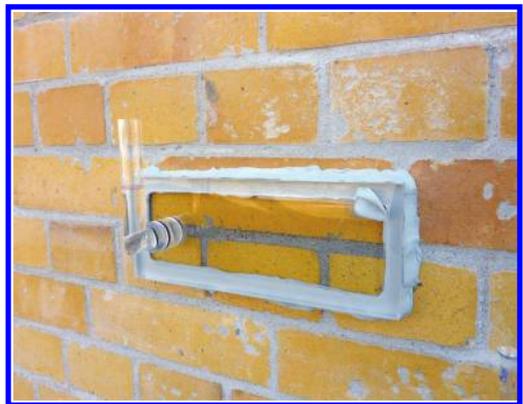
Figure 3. Testing panel for water permeability as per Prof. Franke is used on a historical fair-faced masonry façade.

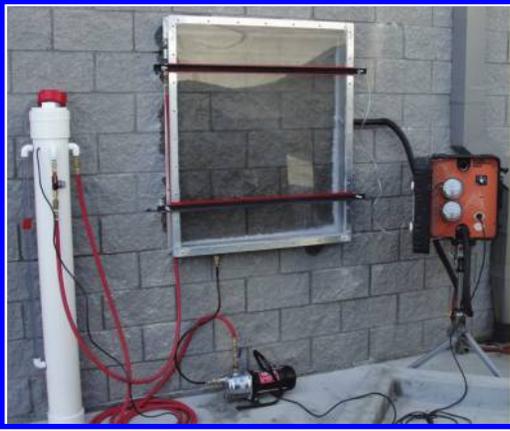
Figure 4. Measuring instrument determination of water absorption of masonry facades after ASTM C1601 (BDG-USA 2015).

gets artificially sprinkled with water. The loss of water corresponds to the amount resorbed water by the masonry façade. It is necessary to anchor the testing box on the masonry façade. The representative absorption surface area of 1 m^2 is being examined. The measurement duration is about 4 hours. Inside the device the air pressure is being artificially increased by a blower. Towards the reading of the amount of water absorbed by the façade, the water level is monitored in a container. The accuracy during a reading is $\pm 0.1 \text{ l}$. In contrast to the two methods, described before, the field study is working with significant lower pressure. The ASTM C1601 is a complex and time-consuming procedure. Furthermore it is a partially destructive testing method.

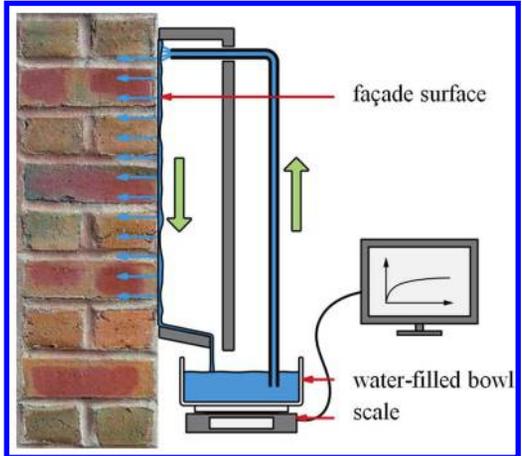
Figure 5. Schematic sketch of the principle of developed “Water-Absorption-Measurement” instrument.

A schematic sketch of the principle is shown in figure 5. This new developed measurement method is based on the principle of ASTM C1601. Contrary to ASTM C1601 it has a smaller reference surface of 0.2 m^2 . Furthermore a gravimetric principle of measurement is used in the “Water-Absorption-Measurement” instrument. For measuring process the “Water-Absorption-Measurement” instrument is fixed directly on the surface of the masonry façade with a special sealing compound. Additionally the instrument can be attached to the façade directly on the scaffold or on a hook.

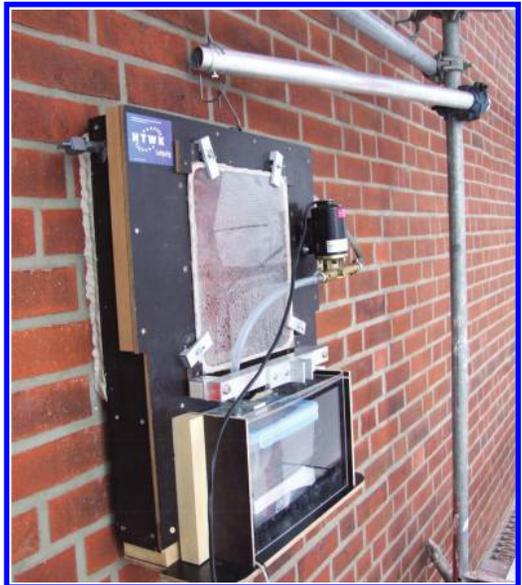
Figure 6. Prototype of developed “Water-Absorption-Measurement” instrument at a historical fair-faced masonry façade.

The prototype of the “Water-Absorption-Measurement” instrument is shown in figure 6. The result is a waterproofed area with the dimensions of $0.40 \times 0.51 \text{ m}$. With the help of a pump the area of the façade can be artificially sprinkled. A closed water film is formed in the surrounded façade area. Depending on the quality of the masonry façade a part of the water gets absorbed. The rest flows back through a vent into the water container. A water circulation with just one way out over the surface of the façade is consisting. The weight of

water container is measured permanently with a scale underneath. The loss of mass corresponds to the water absorbed by the masonry façade. The gravimetric measurement principle achieves a reproducible accuracy of $\pm 8.3 \times 10^{-4} \text{ kg}/(\text{m}^2 \times \sqrt{\text{s}})$. With the innovative procedure a representative area of $0.40 \times 0.51 \text{ m}$ is measured. Especially for fair-faced masonry façades this possibility of an integral measurement of the water absorption coefficient yields over more than one stone and joint layer. In the end of a measurement the “Water-Absorption-Measurement” instrument is removed without leaving a trace on the façade. One measurement duration is taking usually 3.600 sec, however this is not depending on the measurement principle. For instance a strongly sucking underground can already lead to a significant result after 1.200 sec.

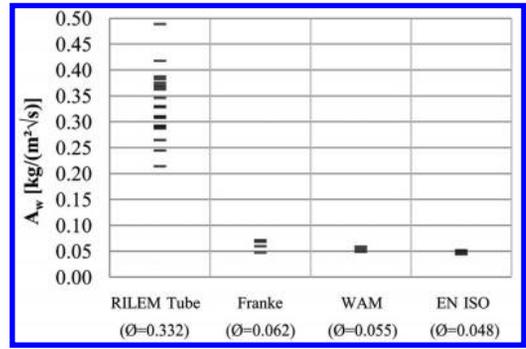
Figure 7. Measuring results of calcareous sandstone by laboratory experiment.

The following section contains results of tests with in-situ-devices that are explained before. In a laboratory experiment the RILEM tube, the testing panel for water permeability as per Franke and the “Water-Absorption-Measurement” instrument were compared to the standard test EN ISO 15148. The Surrounding temperature was about $22 \pm 3^\circ\text{C}$, relative air humidity ranges between 35% —r.h. and 50% —r.h. Calcareous sandstone and autoclaved aerated concrete material were used. For this test bricks without separations were utilized. The size of the test specimens is about $0.51 \times 0.57 \times 0.115 \text{ m}$. Both materials are artificial and homogeneity, therefore ideal conditions for experiments in a laboratory are created. For fixing the devices an elastic sealing was used. Before the devices were added, the test specimens were dried in a furnace. The testing time of each individual measurement of the various devices was all in all 60 minutes. The A_w -values were determined in accordance to

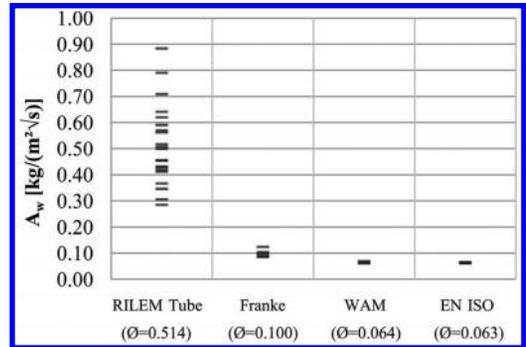
Figure 8. Measuring results of autoclaved aerated concrete by laboratory experiment.

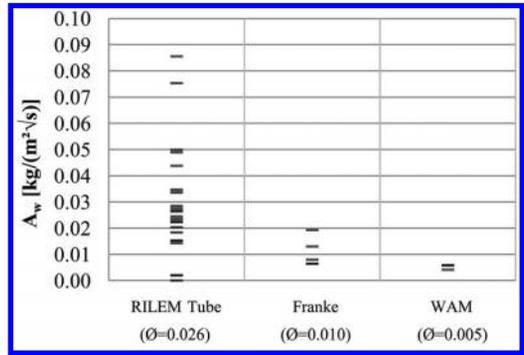
Figure 10. Measuring results of field experiments for determinate water absorption coefficient at historical masonry façade.

The measured values for the RILEM tube are excessive scattering. In contrast to results of the laboratory experiment the average value for the RILEM tube is substantial smaller. The scatter of the testing panel for water permeability as per Franke and the “Water-Absorption-Measurement” instrument are significantly smaller. The WAM instrument has, compared to the method as per Franke, a lower absolute value. Nevertheless the absolute A_w -value of the method as per Franke is twice as big as the absolute A_w -value of the WAM instrument. As a cause for these results the different sized measuring surfaces within the methods can be named. A relatively larger measuring size

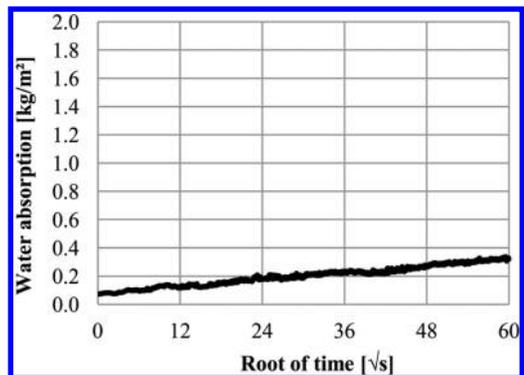
Figure 11. Raw data of “Water-Absorption-Measurement” instrument at testing described masonry façade, resulting A_w value is $0.004 \text{ kg} / (\text{m}^2 \times \sqrt{s})$.

Now the façade was flatly grouted with a mortar-sludge. Finally the clinkers were cleaned by rests of mortar. The main aim of these tests is to quantify the quality of wind-driven-rain-resistance. Therefore the main criterion is the averaged water absorption coefficient of the façade surface materials. The research object got a renovated historical façade as fair-faced masonry. To define the water absorption coefficient of the façade, it is necessary to measure clinker and mortar. Especially at the RILEM tube the measuring results are weighting by part of clinker and mortar. During the measurement no difficulties occurred. Figure 10 contains the results of the in-situ-tests. A typical graph of measuring data by the “Water-Absorption-Measurement” instrument is shown in Figure 11.

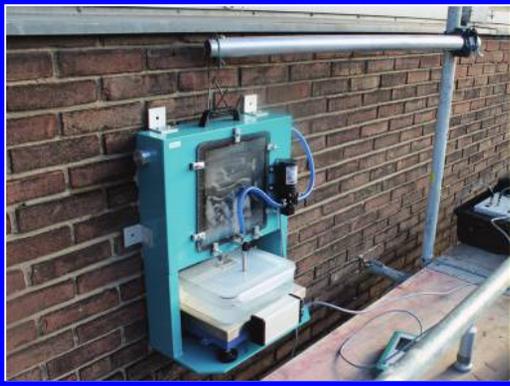
Figure 12. Further development of „Water-Absorption-Measurement” instrument, ready for series production version, WAM 100 B.

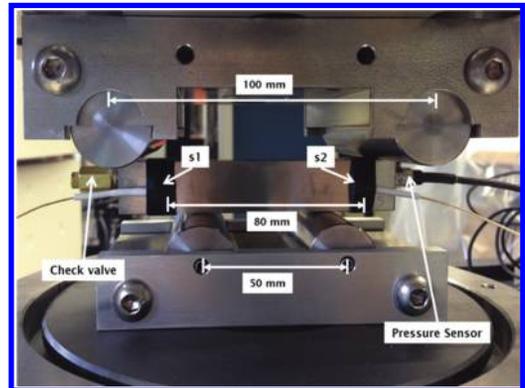
Figure 2. Four-point bending setup with the AE and the pressure sensors placed on the specimen.

recorded by the acquisition board with sampling rate of 10 MHz (micro-II, 8 channels). The threshold was set at 40 dB and the acoustic coupling was improved by vaseline grease between the sensors and the metal specimen. The sensors were secured by means of tape during the loading.

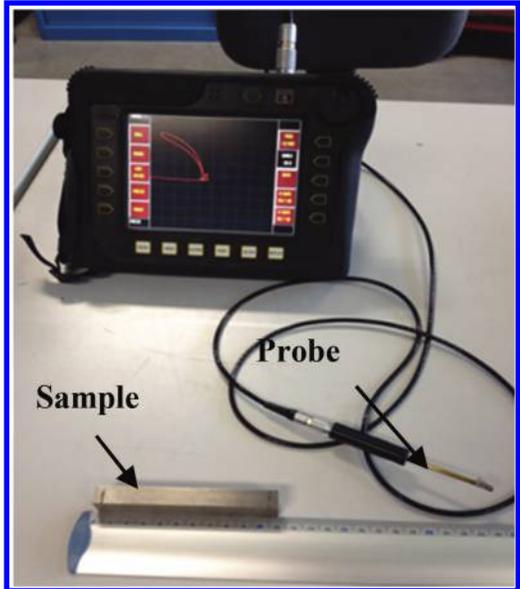
Figure 3. Eddy current set-up during detection of the location of a crack on one of the samples that are inspected.

Eddy current inspection is used in order to locate surface and near-surface (few mm below the surface) defects (Garcia-Martin et al. 2011). In general, the eddy current technique is used to examine rather small surface regions. The probe design and test parameters must be determined with a good understanding of the defect. In order to locate the cracks by eddy current, a NORTEC 500 Series eddy current flaw detector from Olympus was chosen with a probe of 2 MHz (Figure 3). The locations of the cracks were nicely detected and this will be also confirmed later by LPI level 2 under loading conditions.

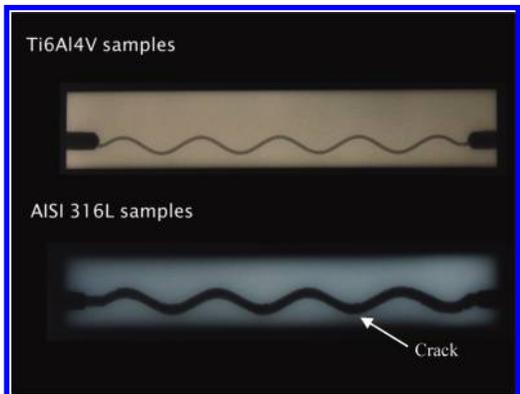
Figure 4. Radiographic images of the four-point bending specimens after the crack detection of the eSHM system.

first sample of Ti-6Al-4V is shown. The crack is clearly shown in AISI 316L and it is located on the lower part of the sinusoidal capillary. However, the crack in Ti-6Al-4V could not be detected by radiographic images. The difficulties on the detection may associate with the angle between the crack and the radiation. If the radiation is not parallel with the defect, the defect may appear distorted, out of position and less visible in the image.

information on the internal state of a sample (Rometsch et al. 2014). It requires the projection and penetration of radiation energy through an inspected material. The radiation energy is absorbed homogeneously by the material, except in the regions where thickness or density variations arise. The energy that cannot be absorbed passes through to a sensing medium (film) that captures an image of the specimen. For the current study the equipment that was used is of Baltospot 200 kV type. In Figure 4 the radiographic images of the first sample of AISI SS316 and the

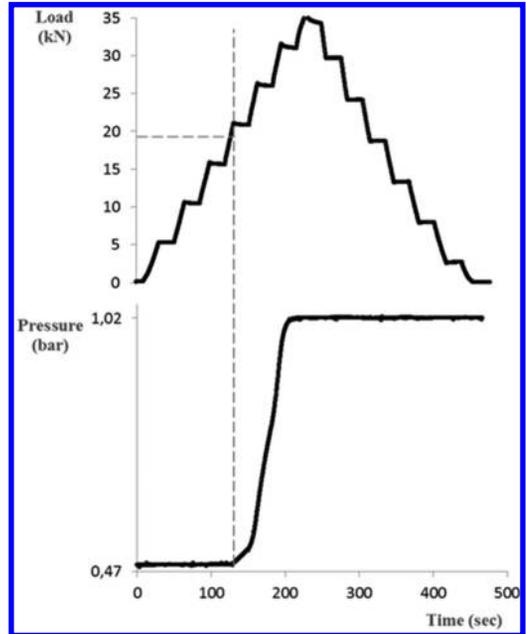
Figure 5. Load history and pressure vs. time for one of the two LMD specimens.

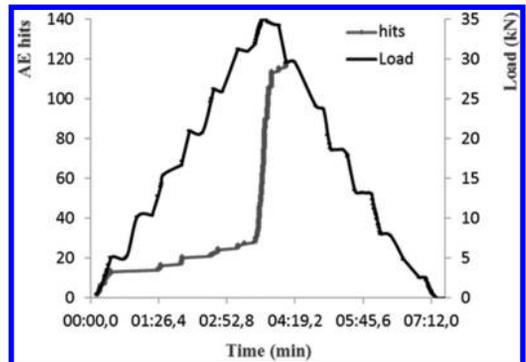
In Figure 6 the cumulative AE hits and the load vs. time are depicted for the first LMD sample. The hit rate is moderate throughout the initial stages of loading and suddenly reaches a maximum value at the load of 34 kN which is the load level of the crack detection during fatigue loading according to the eSHM system. It is also characteristic that the cumulative number of AE hits is 28 hits until 32 kN and up to 34 kN the population has already increased to 120.

Figure 6. Load history and AE history vs. time for the first LMD sample.

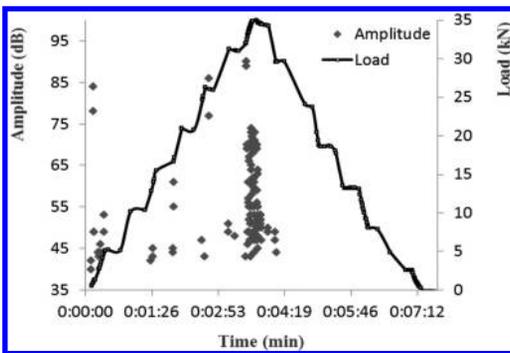
Similar results are also observed in Figure 7, where the amplitude and the load history vs. time are presented. Until the load of 32 kN hits exceeding the amplitude of 50–60 dB were scarce. However, after that point there is also a large population of signals above that level. It is clearly observed that the AE hits with the highest amplitudes are appearing on the moment where the load is reaching the maximum value of the load of the crack detection (between 30 and 34 kN). This behavior indicates possible crack propagation during static loading. It is mentioned that the absence of strong AE for the low levels of load is in relation to the “Kaiser effect” (Kaiser 1950), that states that while reloading an intact specimen, no AE is recorded until the previous maximum load has been overpassed. In this case the activity during the static reloading started at 32 kN, 2 kN lower with respect to the previously applied load. This is a logic behaviour considering the fact that the initially introduced damage originated from a fatigue test.

Figure 7. Load history and amplitude vs. time for the first LMD sample.

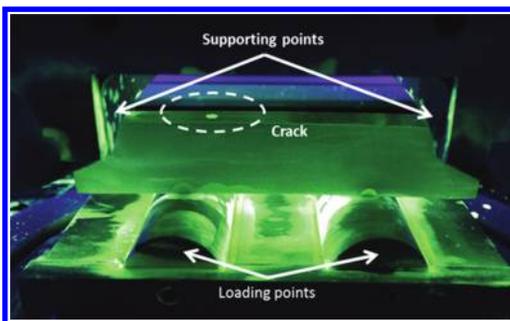
Figure 8. Crack location on additive manufactured samples by means of LPI level 2 under static loading.

to the eSHM system during the previous static loading and not during fatigue, the crack opening happened in both LMD samples at the load level of 20 kN and for the SLM sample at the load level of 14.5 kN. This new round of loading is important in order to confirm the presence of the crack by LP that was not possible in stress-free conditions. Initially, the specimens were loaded statically. At a certain load level, the specimens were coated by liquid penetrant. All the cracks were accurately located as it is demonstrated for the second LMD specimen in Figure 8.

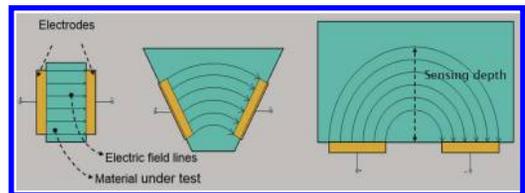
Figure 1. Transition from parallel plate capacitor (left) by opening up the face-to-face parallel electrodes(middle) until coplanar fringing field capacitor (right).

Most common capacitive sensors are based on the use of parallel plate electrodes or interdigital electrodes. For a parallel plate system, the Material Under Test (MUT) is sandwiched between two electrodes to form a capacitor. Care should be taken when using parallel plate system: the distance between the electrodes should be kept constant throughout the experiment; A/d (A :area of the plate(s), d :distance between the plates) ratio should be reasonably large for the impedance measurement system to give enough sensitivity; the electrodes should be present on both sides of the mould (or other production environment). Interdigital electrode refers to a digit-like or finger-like periodic pattern of parallel in-plane electrodes used to build up the capacitance or impedance associated with the sensitive coating or embedding material, into which the electric field penetrates. In contrast to parallel plate electrodes, the geometry of the system is more stable as both anode and cathode are on the same plane supported by the substrate layer. Moreover, due to the coplanarity of electrodes, one side access to the material is possible, this makes the embedding of the sensor less troublesome in many cases. Figure 1 shows the transition of parallel plate capacitor to a coplanary interdigital sensor and illustrates interdigital sensor's principle of operation.

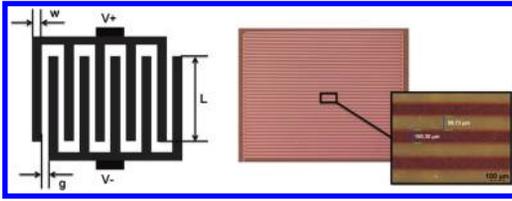
The simplified geometry of an IDC is shown in Figure 2(left). When an electric potential is applied between the anode and cathode of the sensor, an

Figure 2. Simplified schematic of an interdigital capacitive sensor (left): where w stands for the width of each finger, g stands for the gap (spacing) between fingers, and L stands for the finger length, and a home-made sample (right) realized by flexiblecircuit board technology.

electric field is created between the fingers, and extended to the space on both sides of the finger structure to a certain distance. The distance that the majority of the fringing electric field is able to reach is usually called the penetration depth of the sensor, determined by the spatial wavelength ($w+g$) of the structure. Further details on interdigital sensor can be found in the paper of Mamishev et al (Mamishev, Sundara-Rajan, Fumin, Yanqing, & Zahn 2004). To establish a relationship between capacitance value and permittivity, these parameters were studied by mathematical models, Finite Element Analysis and experimental measurements. FEA and the model proposed by Igreja et al (Igreja & Dias 2004) agree well with the experimental work; model proposed by H. Engan (Engan 1969) has a large deviation from experimental result, as the model includes only one dielectric in the formula, whereas for the capacitive sensor at least two dielectric were present (substrate of the capacitive sensor and material under test).

The interdigital sensor, used in this study, is fabricated in-house by patterning copper structure on flexible substrate (PI/PET/PEN) via lithography and wet etching process. Organic Solderability Preservative (typical thickness 0.15–0.3 micron) coating is then applied on top of electrodes to protect the sensor surface from oxidation. Figure 2(right) shows the fabricated capacitive sensor. The resulted sensor is 68 μm in thickness, and 180 mm^2 in size. The area and thickness of the sensor is quite critical for initiating delaminations and local damage within the laminate. In order to evaluate the impact of our sensor on this and find the optimal substrate for the application, sensor on different flexible substrate (PI/PET/PEN) has been made. As a future work, we will evaluate their adhesion to the matrix materials.

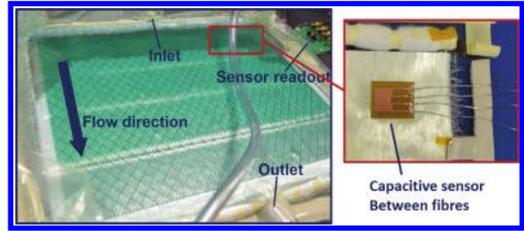
A vacuum assisted resin infusion process to fabricate glass fibre reinforced composites is shown in Figure 3. Six layers of UDO ES 500 UD Glass

Figure 3. Experimental setup for the vacuum assisted resin in fusion process, with the capacitive sensor embedded in between glass fibre reinforcement of the composites.

Fibre textile were layered up on top of a flat glass mould, the plate was sealed on the 4 edges with vacuum bag. An interdigital sensor and a temperature sensor were embedded between the middle layers. The epoxy matrix system used in this study (from Momentive), is a two part system consisting of the EPIKOTE MGS RIMR 135 resin and the EPIKURE MGS RIMH 137 hardener. The mixing ratio is 100:30 by weight. 300 g of RIMR135 (epoxy) and 90 g of RIMH137 (hardener) were thoroughly mixed by a mechanical blender, degassed, and infused into the vacuum bagging through the resin inlet, the outlet was connected with a tube to the vacuum line, and once the resin reaches the outlet, both tubes were clamped in order to stop the resin flow and keep the bag under vacuum. The composite plate is cured at room temperature for 24 h, followed by a post cure in an oven at 80 $^{\circ}\text{C}$ for 16h as recommended by the datasheet. A capacitive sensor, and two thermocouple were installed for capacitive and temperature measurement respectively throughout the curing. An HP 4284 A Precision LCR meter performed the capacitive measurement with frequency sweep ranging from 100 Hz to 1 MHz with 10 points per decade. The time required per sweep was approximately 16 seconds. One thermocouple was installed next to the capacitive sensor for local temperature measurement, and another one outside the vacuum bag for ambient temperature measurement.

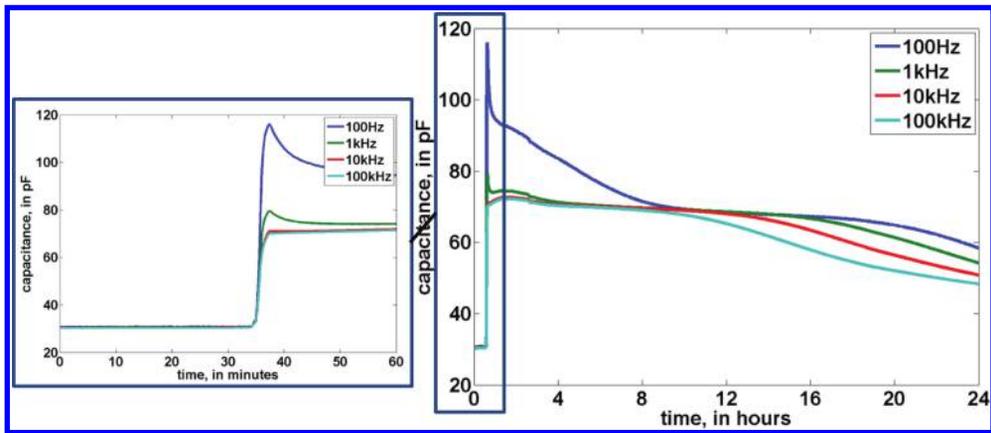
Figure 4. Capacitive measurement of beginning of curing (left) and whole curing (right).

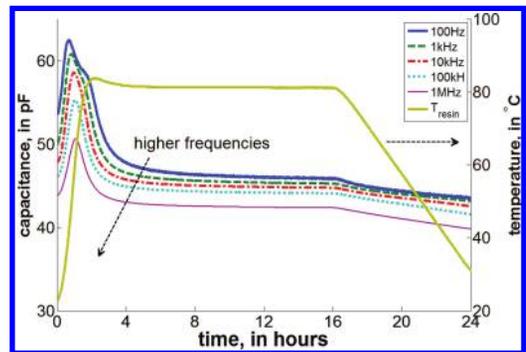
Capacitive and temperature data for the post curing are shown in Figure 5. As suggested by the datasheet, a heat treatment is required to achieve a fully cured sample. When the oven is raised from room temperature to 80 °C, further cure or polymerization happens within the laminates. A large increase in capacitance, which possibly indicates further polymerization within the resin, is observed in the beginning of post curing. After the peak, the capacitance decreases and saturates to nearly stable values, suggesting the slowdown of post-curing. After 16 h, the oven is turned off. The decrease in temperature causes the drop in capacitance, as the

Figure 5. Capacitive and temperature measurement from post curing phase.

dielectric property is temperature dependent. However, the change in absolute value is much smaller compared to the peak observed at the beginning of post-curing or the change during the curing stage. On the other hand, temperature measurement follows the programmed heating profile of the oven during the whole post curing process. There is a lack of correlation between temperature changes and degree of cure. As can be seen from the plot, the capacitance measurement gives information about resin that is mostly related to degree of cure rather than the influence of the ambient environment, whereas the temperature measurement reveals little information about cure itself.

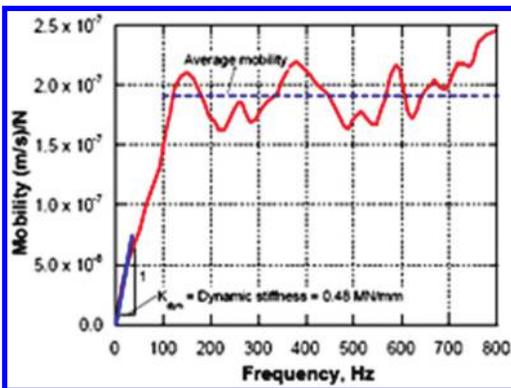
Figure 1. Mobility Diagram.

tip. The impact causes vibrations in the element and stimulates primarily flexural form. A velocity receiver set adjacent to the point of impact, records the response. The load cell and the velocity receiver are connected to a laptop computer and by using appropriate software the results are analyzed.

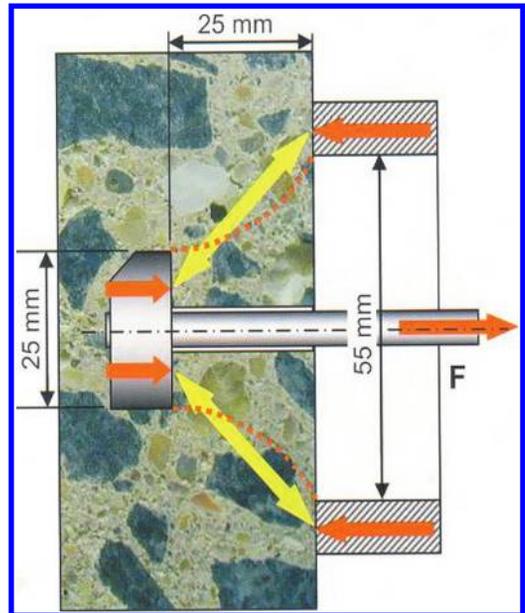
In the process of the test, a recess (slot) is routed in the hole to a diameter of 25 mm and at a depth of 25 mm, through an 18.4 mm hole that is made perpendicular to the surface. A split ring is expanded in the recess and pulled out using a pull machine reacting against a 55 mm diameter counter pressure ring. The concrete in the strut between the expanded ring and the counter pressure ring is

Figure 2. Pull out test method and damage.

in compression. Hence, the ultimate pullout force F is related to the compressive strength of cubic or cylindrical specimens, via a correlation curve.

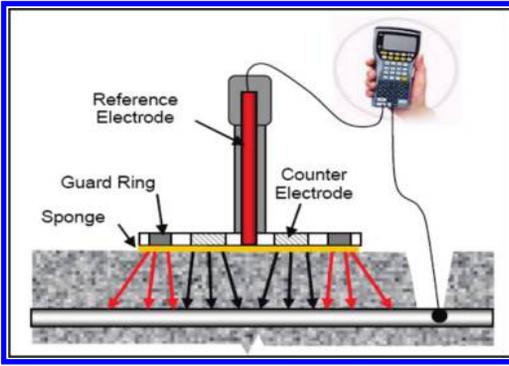
Figure 4. Galva Pulse device setup.

exposure of the reinforcement) and the reference electrode, which contacts the outer surface of the concrete. The measurements are taken by a voltmeter which is also connected to the circuit. The reference electrode used during the test can be Cu/CuSO_4 , Ag/AgCl , $\text{Hg}/\text{Hg}_2\text{Cl}_2$ etc. The contact with the concrete is achieved by using a sufficiently wet sponge. The setup of the device is shown in figure 2.

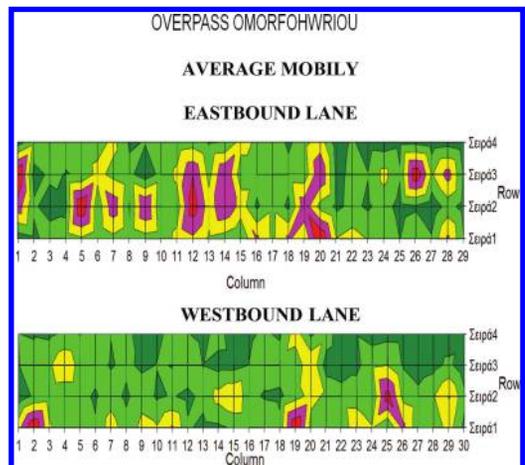
Figure 5. Impulse—Response method testing direction.

The road surface of the bridge was examined using the impulse-response method on a grid of 4 test positions on each lane, every 2,5 m, in order to check the waterproofing of the deck. This test investigated the seating uniformity of the asphalt layer on the concrete structure and the existence of flaws in the membrane between them that might have caused local anomalies.

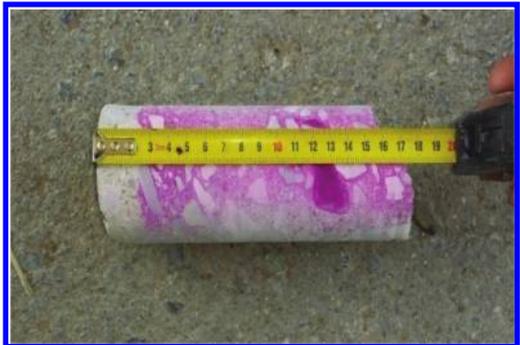
Figure 7. Carbonation depth measurement on concrete core.

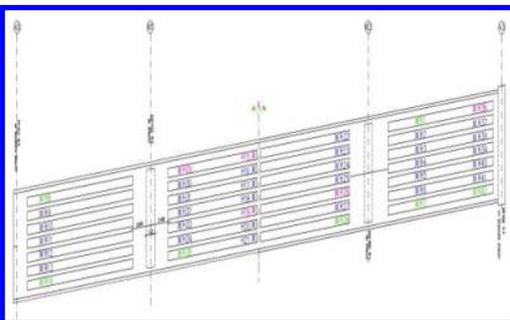
Small amounts of water (a few drops up to a few liters) were found at the holes H15, H19, H26, H29, H36, that are marked with magenta color.

Big amounts of water (holes draining at maximum supply for up to 20 minutes) were found at the holes H1, H7, H8, H14, H28, H35, H42, that are marked with green color.

Figure 8. Draining hole positions.

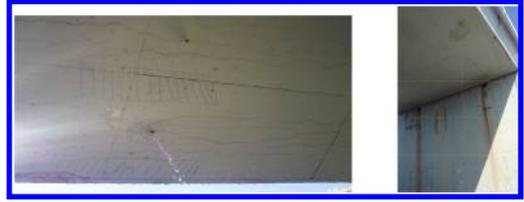
Figure 9. Large amounts of water draining from drilled holes.
