Emerging Technologies in Non-Destructive Testing VI

Editors

D.G. Aggelis & D. Van Hemelrijck

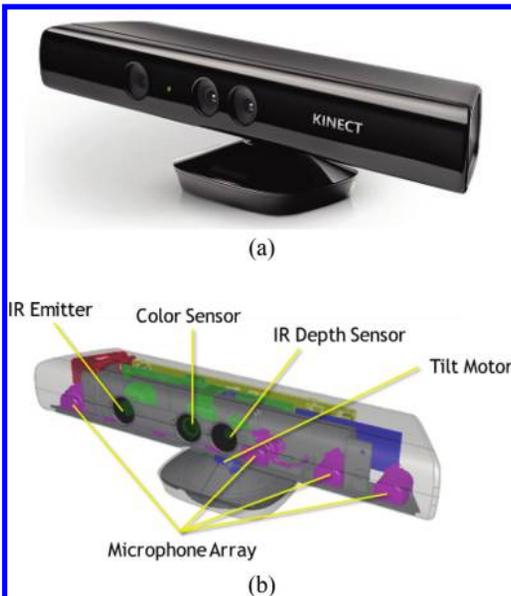
Figure 1. a) The Microsoft Kinect sensor and b) the structure of the sensor.

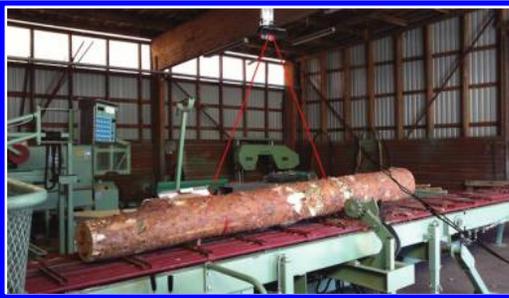
Figure 2. The single sensor setup at the sawmill (Antikainen & Verkasalo 2013).

The single sensor version was tested in real sawing mill environment. The used logs were measured using the calipers (Fig. 5) before the actual 3D measurements. The 3D measurements were done during the log rotation on the sawing table. Because of the limited scanning region of one Kinect sensor the logs were measured in four separate parts to achieve reasonable resolution. The full model of the log was reconstructed from the separate scans using the Meshlab software. The same software

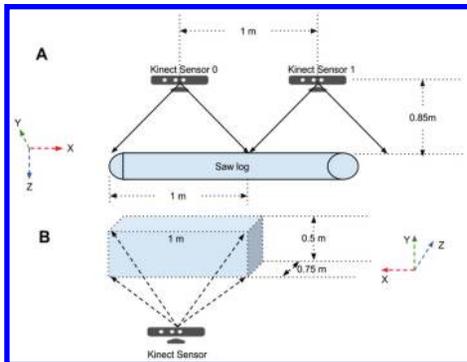
The measurement locations are divided to several blocks. (Fig. 3) Each Kinect sensor measures one single block at the time. The size of the block

Figure 3. Measurement setup for the multiple sensor system.

changes if the distance of the sensor changes. After the measurement has completed the software combines acquired blocks to one single model. This model can be analyzed in the software or the model can be stored and analyzed afterwards with external software such as MeshLab.

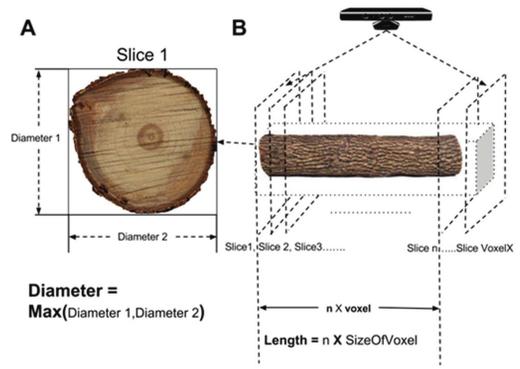
Figure 4. Dimensional measurement methodology (Xiaolei 2014).

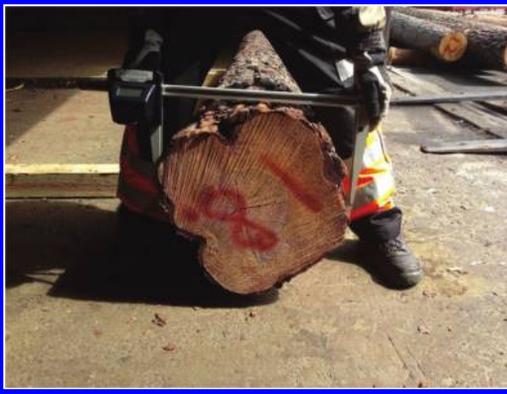
Figure 5. Logs were measured using calipers before the 3D scanning.

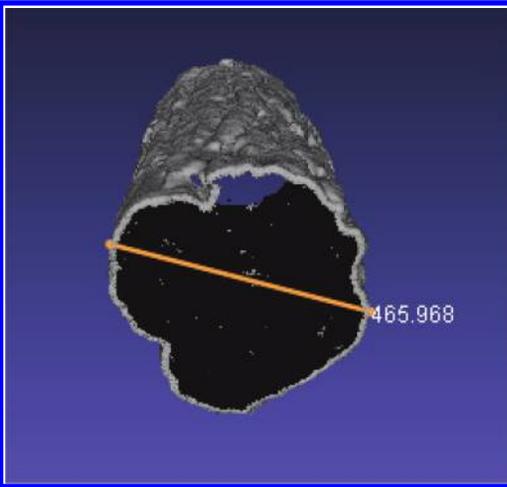
Figure 6. Measured model was analyzed with MeshLab software.

was used to analyze the dimensions of the measured model (Fig. 6).

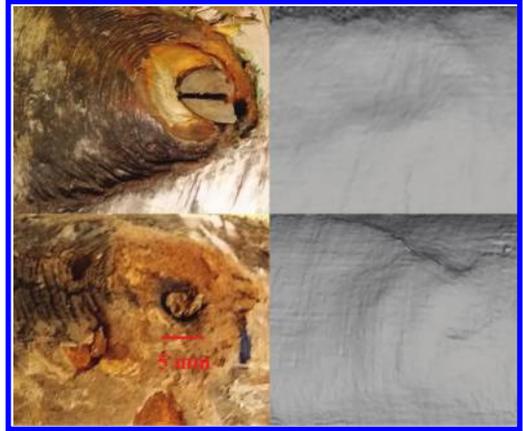
Figure 7. Left side shows the RGB images of small knots and the right side shows the result of the measurement system.

were evaluated against the physically measured dimensions and visually determined defects. The error for the diameter between the physical measurements and model analysis was 2.3% which was higher than single sensor setup. Reason for this might be the smooth surface of the log (birch) or the reconstruction was delayed due the higher computation time compared to single sensor system. The multiple sensor measurement system was also tested for external defect detection. Figure 7 shows one result of the accuracy evaluation for small knot detection.

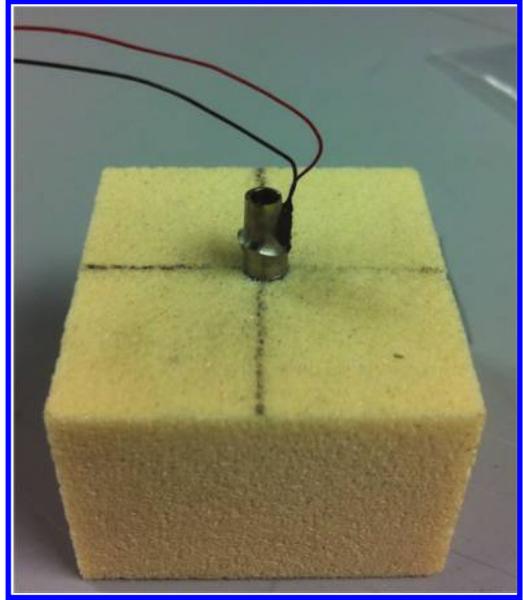
A square piezoelectric transducer (PSI-5A4E $2 \times 2 \times 0.267 \text{ mm}^3$) was glued to the implant using the JB Weld epoxy resin. The photo of one sample ready for testing is shown in Fig. 1. To approximate the process of osseointegration that naturally occurs at the interface between the implant and the bone after the surgical therapy, the implant itself was removed and screwed in blocks of different densities. To build a pool of data statistically meaningful the eight blocks per density were considered.

Figure 1. Photo of one test sample.

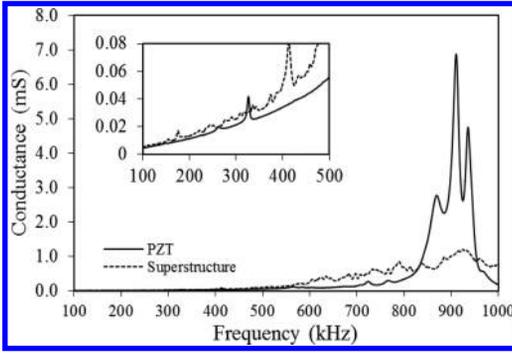
To ease the comprehension of the methodology, the conductance as a function of the actuation frequency of the free PZT and of the free superstructure is presented in Figure 2. Here, the superstructure represents the PZT bonded to the abutment screwed to the implant. For the free PZT one main peak and two side peaks are visible at around 920 kHz. They are associated with the resonance characteristics of the piezoelectric

Figure 2. Conductance as a function of the excitation frequency under free boundary conditions for the PZT patch and the superstructure.

material. The inset presented in Fig. 2 represents a close-up view of the subrange 100–500 kHz. In the inset, the vertical scale is two orders of magnitude smaller. Two peaks at 260 kHz and 335 kHz are visible. The electrical conductance of the superstructure drastically decreases because the force provided by the PZT is the same but the resulting velocity is smaller. More peaks also appear as can be seen observing the close-up view at the 100–500 kHz; these new peaks are associated with the vibration of the superstructure and are not related to the resonance of the piezoelectric material.

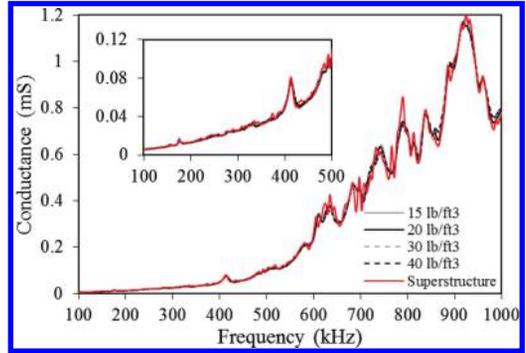
Figure 3 shows the conductance as a function of the excitation frequency when the specimens sat on the work bench. The values relative to the four densities are the average of the conductance associated with the eight samples. The conductance of the free superstructure is superimposed. Overall the interlock between the implant and the Sawbones block reduces the number of structural peaks although the frequency at which these peaks occur is similar. A close-up view of the 100–500 kHz range is presented in the inset of Fig. 3.

Figure 3. Conductance as a function of frequency. Each plot is the average of the measurements associated with the eight samples for each density. The conductance of the free-superstructure is overlapped. The inset presents the close-up view of the same graph in the sub-range 100–500 kHz.

As the differences between the curves cannot be ascertained, a few statistical features were extracted from Fig. 3. They were the root mean square (RMS) across the frequency range of interest, and the amplitude and the corresponding frequency of the largest peak. Figure 4 shows these features as a function of the sample density. The average value of the eight samples per density and the corresponding standard deviation are presented. The results do not reveal any monotonic trend that univocally associates the EMI-based feature to the density of the sample, i.e. the features cannot consistently indicate that the stability of the implant increased with the foam density. This occurs despite the fact that the compressive and shear moduli increase with greater foam density. We believe that the effect of the local stiffness on the structural vibration of

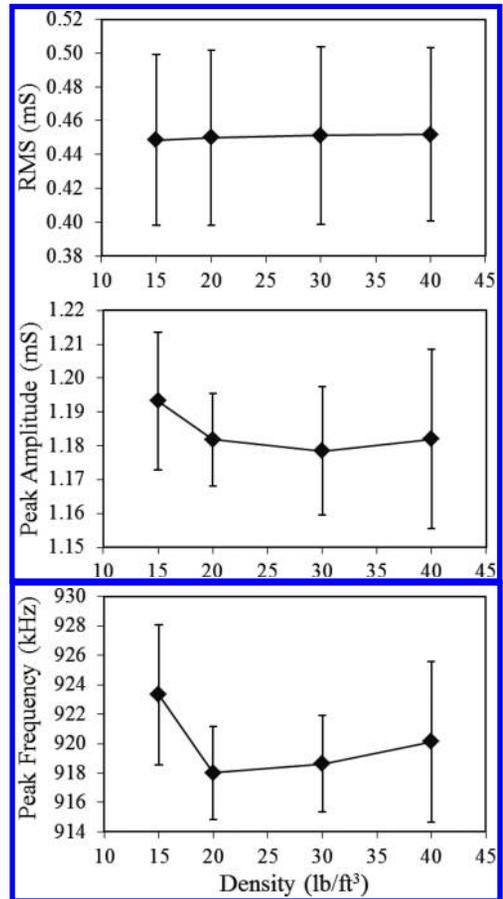
Figure 4. Selected features as a function of the density calculated in the excitation range 100–1000 kHz. (Top) RMS, (Middle) Peak amplitude, (Bottom) Peak frequency.

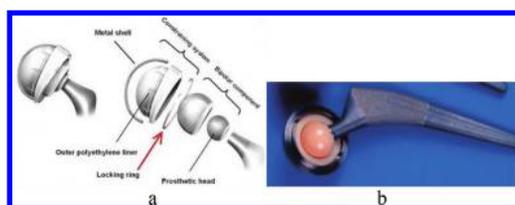
Most of the implants are modular (Fig.1a), assuring the possibility to adapting the geometry of the prosthesis to the joint morphology of the patient, providing more flexibility during primary surgery and simplified revision procedures (Dzaja et al. 2014).

At the moment, there are no long-term studies evaluating the newest ceramic hip replacements. Furthermore, the metal and plastic implants are work very well and have an excellent track record. While the ceramic hip replacements may be better, there is a little proof to support that idea. Generally, in total hip implants, the ceramic femoral heads are prepared with a tapered bore in which the projected male counter face of the metallic stem is filled to fix the head with stem (Fig. 1b).

Figure 1. Hip implants: a) modular principle; b) photo.

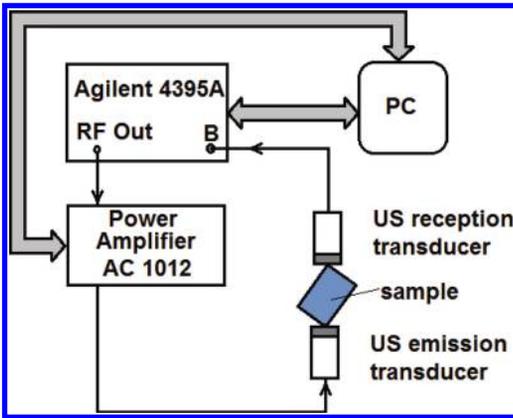
The measurements are carried out with transducers with contact. The coupling of the transducer with the specimen influences which modes are measured. When the sample is pinned on its edge, more modes are excited and the modes are better defined than when the transducers are placed on the ends of the cylinder (Fig. 2).

The probe is fixed between the emission and reception transducers in order to accomplish the condition of stress free surface. The equipment allows the setting so that for the established position of the cylindrical sample, the contact on the edge assures the excitation of a maximum number of possible resonances for the fixed geometry.

Figure 2. Experimental set-up for RUS.

A Network/Spectrum/Analyzer 4395 A Agilent USA generates a sweep frequency between 80 kHz and 250 kHz in 1 kHz step. The signal is amplified into a Power amplifier AC 1012 AG&TC Power Inc. USA and applied to an US emission transducer P111.O.06P3.1 type, selected for the large bandwidth. The signal delivered by the reception transducer, identical to the emission one, is applied to the B port of the 4395 A Agilent, the spectrum being acquired by a PC that is used also to program the functioning of the equipment with a numerical code developed in Matlab, via PCIB interface. The command of the power amplifier is made with the same PC via RS232 interface.

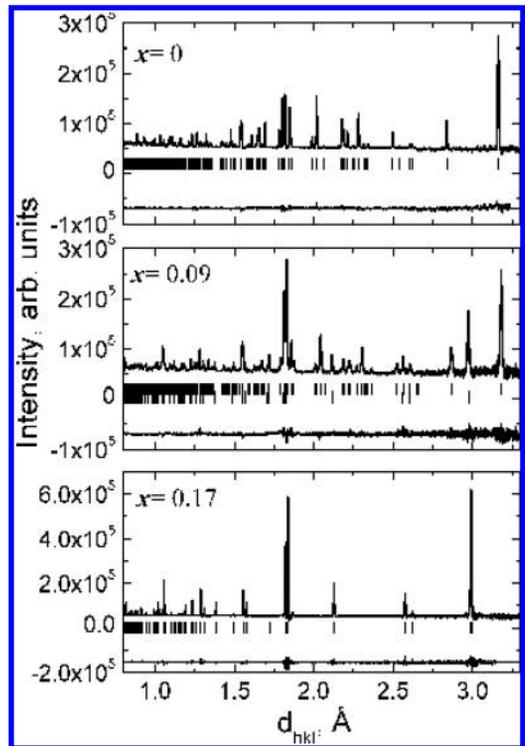
Figure 3. Diffraction pattern of $Zr_{1-x}Ce_xO_2$ samples measured at the HRFD at room temperature and treated with Fullprof programme.

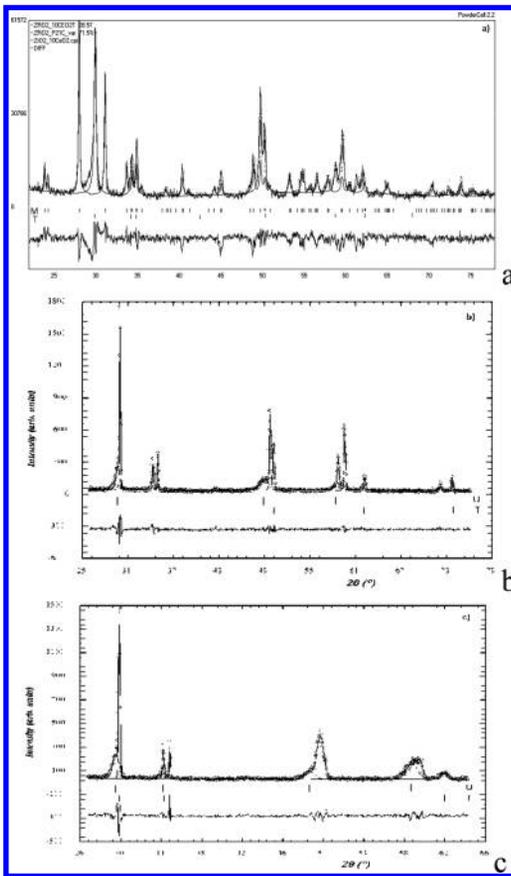
We should take into account that only a thick layer at the surface of the sample which can be studied by means of XRD. For $x = 0.09$ we observed a mixture of tetragonal phase ($P4_2/nmc$, GS 131) and monoclinic phase ($P2_1/nmc$, GS 14), Figure 4a.

Figure 4. The diffractograms correspond to $x = 0.9$ (a), $x = 0.13$ (b) and $x = 0.17$ (c). The vertical bars correspond to monoclinic phase (M) and tetragonal phase (T) (4a, PowderCell), to tetragonal phase (T), (4b and 4c) and unknown phase (U), (4b and 4c, Fullprof).

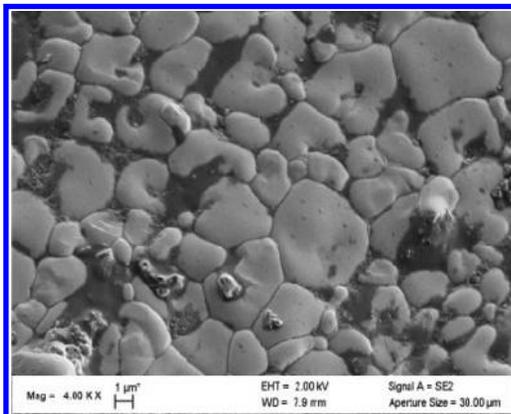
Figure 5. Electron microscopy (SEM) for the sample corresponding to $x = 0.13$.

In the SEM micrographs, it can be clearly observed that from the cutting procedure has resulted into a thin layer small amount of residue depositing between/on the crystallites (Figs 4–6). SEM micrographs emphasize, in all cases, the three dimensional aspects of the crystallites. The crystallites sizes vary considerably, between 2 and 4 μm and are characterized by a high degree of faceting, a consequence of the heating procedure thermal treatment at 1500°C. Moreover, in agreement with Carter & Norton (2013), the 3D characteristics of the crystallites belonging to the samples which were treated at high temperature, are depending on the chemical composition of the sample and the treatment temperature.

The microstructure of the material is displayed in Figures 5 and 6.

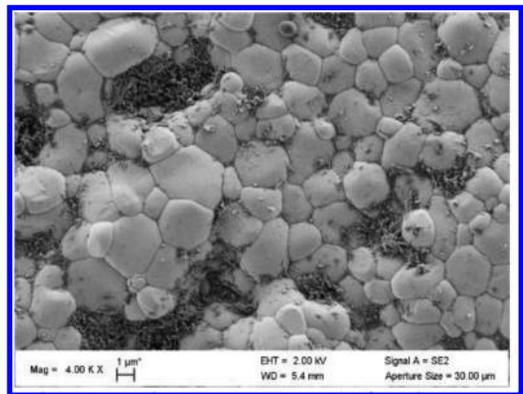
Figure 6. Electron microscopy (SEM) for the sample corresponding to $x = 0.17$.

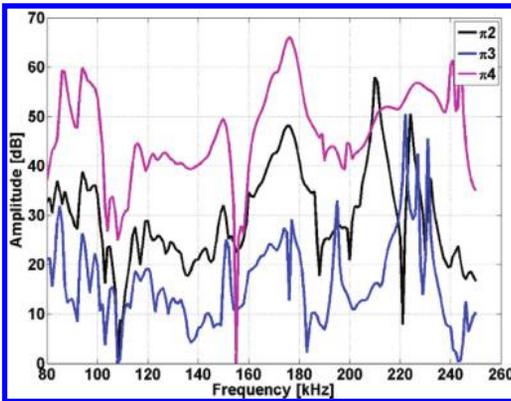
Excess loading can cause the two members of the doublet to experience different frequencies shifts so that a single peak can be distorted into two distinct peaks in a loaded sample. This can also occurs due to the poor sample preparation or inhomogeneities such as small cracks or inclusions. Figure 7 presents the resonance spectra for the studied samples.

Figure 7. Resonance spectrum for the samples Π2-Π4.

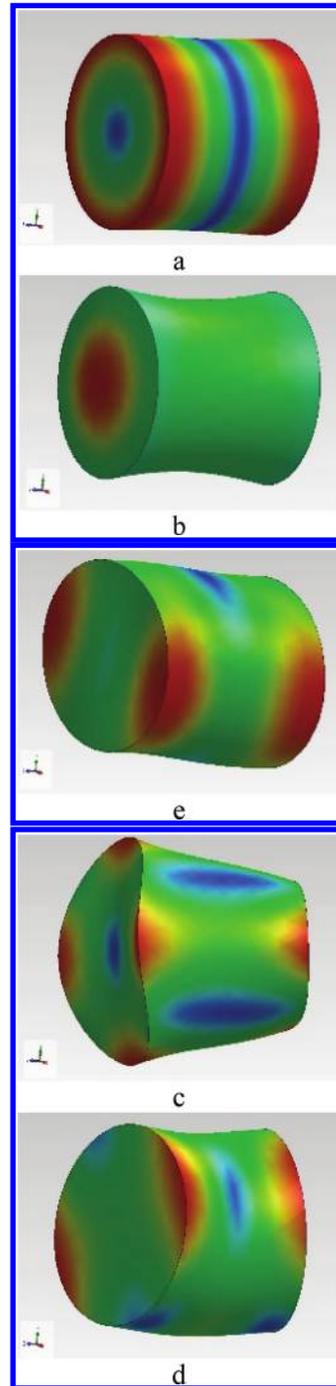
Figure 8. Aspects of few resonant modes for sample Π2:
a) extensional mode $f = 163$ kHz;
b) extensional mode $f = 236$ kHz;
c) flexural mode $f = 185$ kHz;
d) flexural mode $f = 208$ kHz;
e) flexural mode $f = 214$ kHz

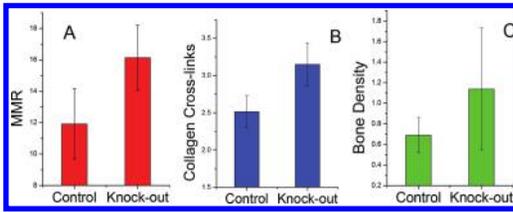
Lumbar vertebrae from apoE-deficient mice were studied with Raman spectroscopy in order to evaluate the quality of bone in comparison with age-matched controls. Mineral to matrix ratio calculated from Raman spectra (figure 1a) exhibited a small but statistically significant increase. Calcium (per mass unit) measurements with Atomic

Figure 1. Raman metrics for the lumbar vertebrae: (a) Mineral to matrix ratio (MMR), (b) Collagen cross-links, (c) Bone density.

Absorption spectrometry (AAS) showed no considerable difference between knock-out and control samples. On the other hand, Thermal Gravimetry analysis (TGA) revealed reduced collagen content (per mass unit) for the gene deficient mice. AAS and TGA results are in accordance with the Raman results. Mineral content (calcium) remains stable but matrix (collagen) reduces so the MMR ratio finally appears increased.

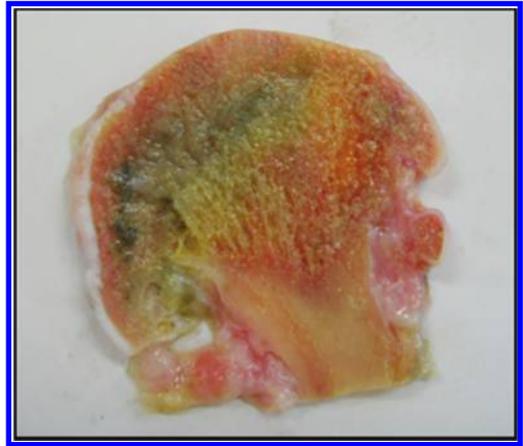
Healthy and osteoarthritic areas on the femoral head section were tracked down by visual inspection (figure 2). Away from the center and near the neck, a layer of intact cartilage can be seen. Moving towards the center of the ball, the layer appears worn out or disappears completely, leaving the subchondral bone exposed. This is the result of the friction due to movement in the hip joint and the evidence of osteoarthritis.

Figure 2. Section of a human femoral head.

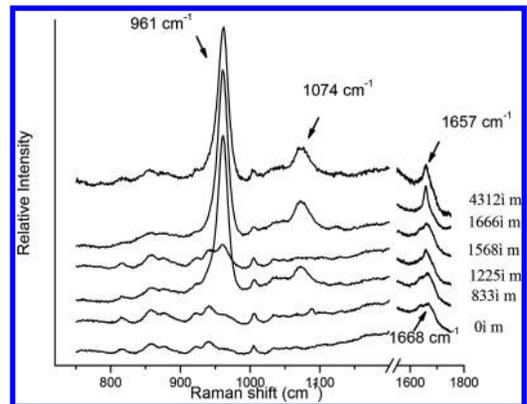
Raman spectra recorded from successive spots in healthy area of the section, revealed the existence of pure unmineralized collagen (0–833 μm). When the laser moved from the unaffected cartilage towards the adjacent interior, an abrupt transition from cartilage to subchondral bone was recorded. This change involves a sudden increase

Figure 3. Raman spectra from a healthy area on the femoral head section.

of bioapatite phosphates (961 cm^{-1}) and carbonates (1074 cm^{-1}) peak intensity (1225–4312 μm). The transition from cartilage to subchondral bone is also revealed by the change in the amide I band ($1550\text{--}1750\text{ cm}^{-1}$) morphology. This change refers to the replacement of the wide peak at 1668 cm^{-1} in articular cartilage by a narrow peak at 1657 cm^{-1} which is attributed to lipids (figure 3).

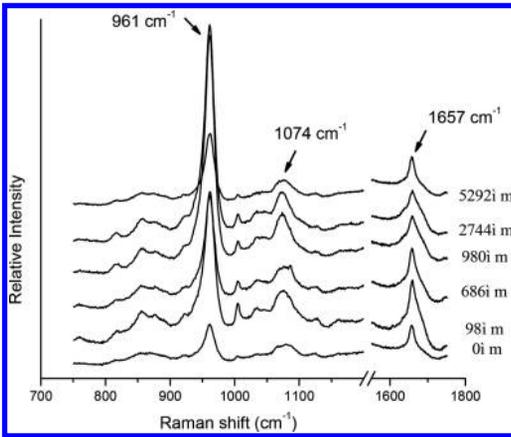
In the osteoarthritic area, around the center of the femoral head, the spectral characteristics of bone mineral (vibrations of phosphate and carbonate) are recorded in the superficial layers (figure 4). This is in agreement with the observation of the total disappearance of the protective cartilage layer and the exposure of subchondral bone in osteoarthritis. An additional spectral feature is the characteristic

Figure 4. Raman spectra from an osteoarthritic area on the femoral head section.

peak of lipids which overwhelms the amide I spectral area. Overall, the spectral characteristics of the osteoarthritic area are in accordance with those of the subchondral bone underlying articular cartilage in healthy area of the femoral head.

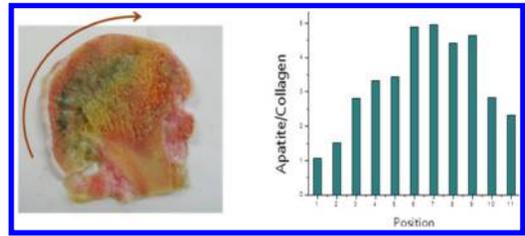
Figure 5. Raman metrics for distinguishing different stages of osteoarthritis in femoral heads.

and carbonate peaks as well as lipids were traced. It is concluded, thus, that the two situations can be discerned. The question is whether various degrees of the disease, i.e. osteoarthritis in a premature stage, can also be diagnosed. The intensity ratio of the phosphate to amide I peak was calculated for various spots on the perimeter of the femoral head and found to receive lower values for the healthy spots and increased in osteoarthritic spots. Furthermore, the higher values correspond to more damaged spots (figure 5). It can be concluded that different degrees of the disease progress can be discerned in case of in vivo application.

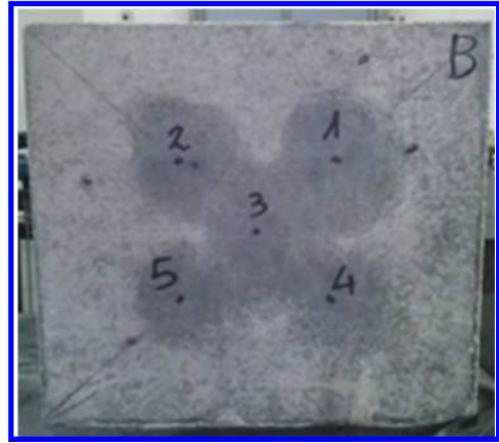
Figure 1. Grid points for UT measurements.

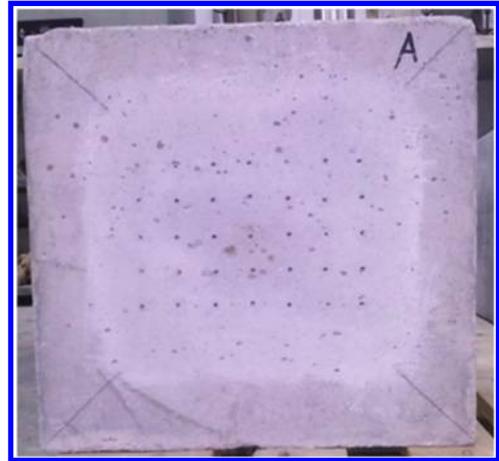
Figure 2. Grid points for RHT measurements.

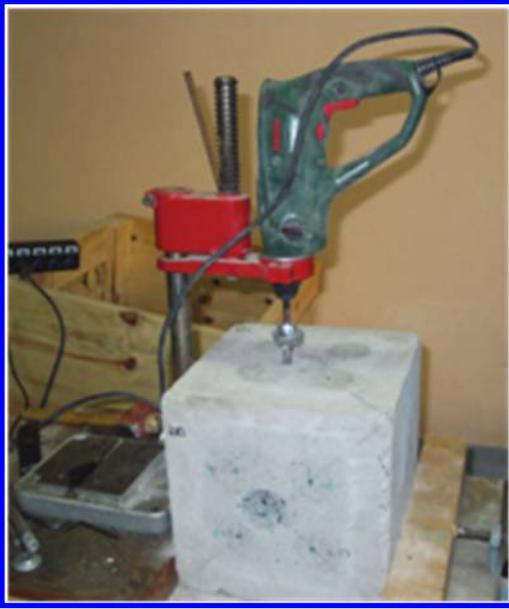
Pull out testing is a standardized partially-destructive testing method for estimating a mean value of concrete compressive strength. PT measures

Figure 3. Pull out testing on concrete cubic specimen.

the force required to extract from a hardened concrete element a steel insert with an enlarged head (Fig. 3).

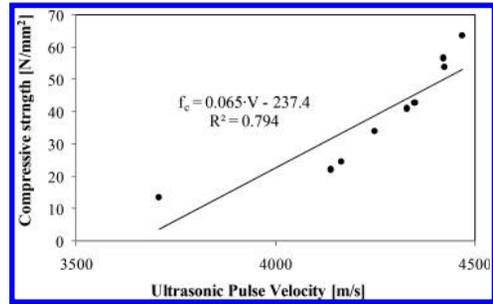
Figure 4. Correlation between concrete compressive strength and ultrasonic longitudinal pulse velocity.

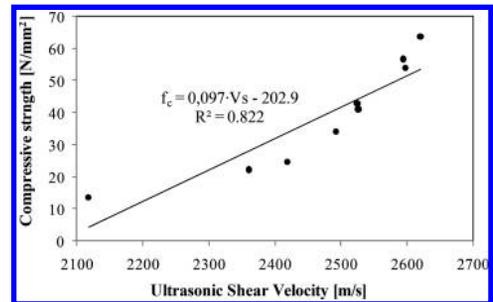
Figure 5. Correlation between concrete compressive strength and ultrasonic shear velocity.

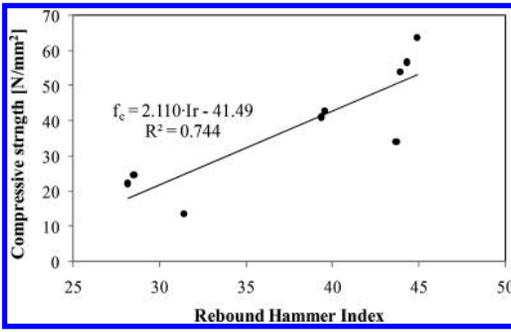
Figure 6. Correlation between concrete compressive strength and rebound hammer index.

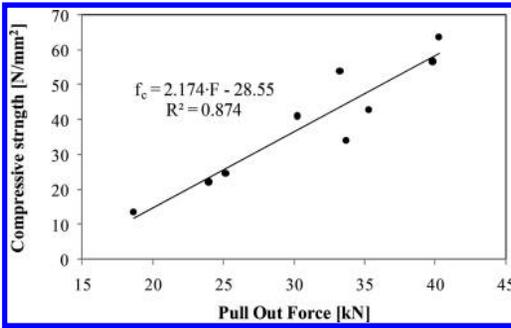
Figure 7. Correlation between concrete compressive strength and pull out force.

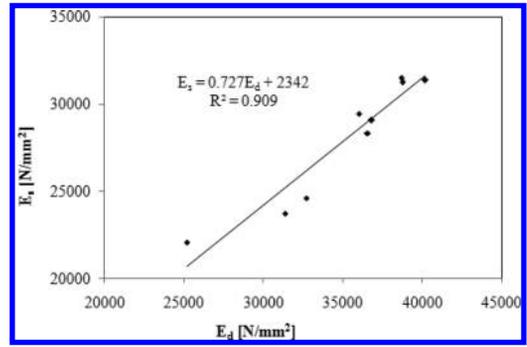
Figure 8 shows the correlation between the static modulus of elasticity E_s (cores) and the dynamic modulus of elasticity E_d (cubic specimens). A very high correlation has been achieved.

Figure 8. Correlation between dynamic and static modulus of elasticity.

It is worth noting that UT leads to a prediction of E_s better than that of f_c .

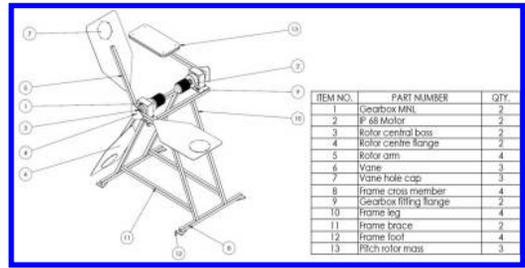
A mock-up has been designed to generate AE and vibration representative of a full scale tidal power system (Figure 1). The rotating equipment of a main power take off and a pitch control system were represented by two motor/gearbox assem-

Figure 1. Mock up designed to validate the CM system.

blies, driving rotors which were designed to replicate the operational loading on these assemblies when working under water. All these components were supported by a frame and the whole structure formed a test bench for defect detection on rotating machinery using AE and vibration techniques. All the parts of the mock-up are described below.

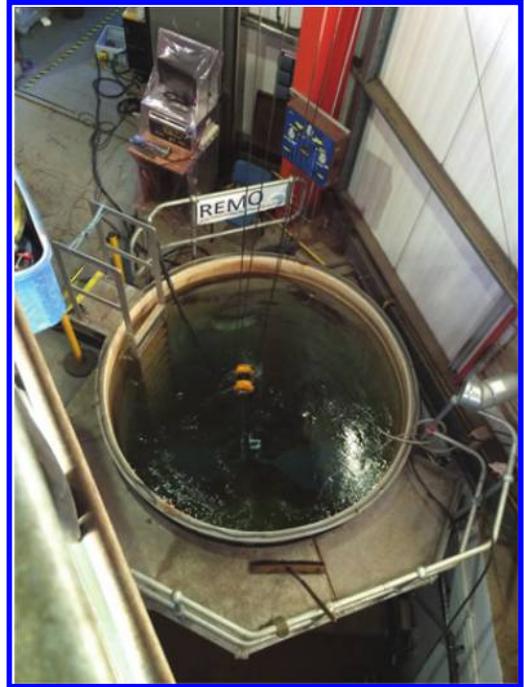
Figure 2. Water tank used in the experiments.

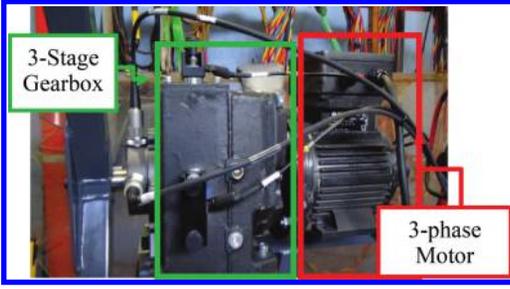
Figure 3. 3-phase motor/gearbox.

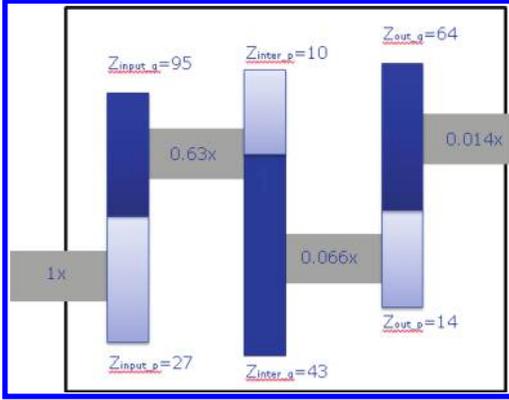
Figure 4. Shaft and gearbox forcing frequencies.

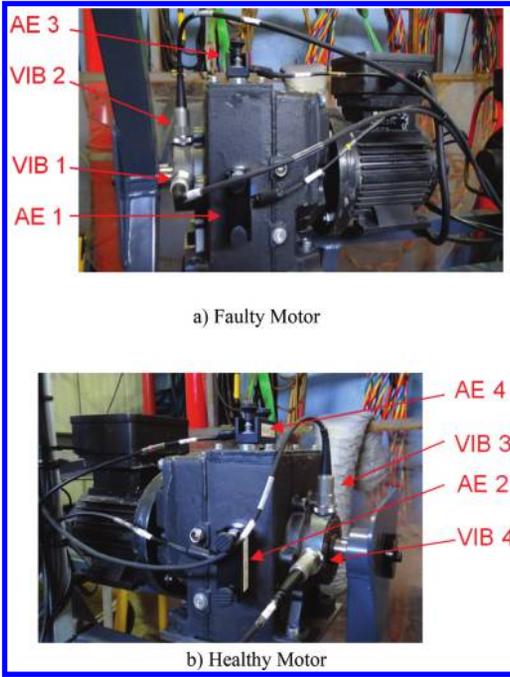
Figure 5. Location of the sensors.

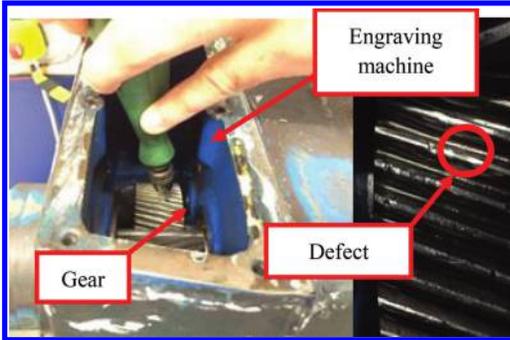
Figure 6. Defect creation and example of defect created on the gear.

One of the gearboxes of the mock-up was kept in healthy condition while multiple defects were created in the gear teeth of the other gearbox using an engraving machine (Figure 6).

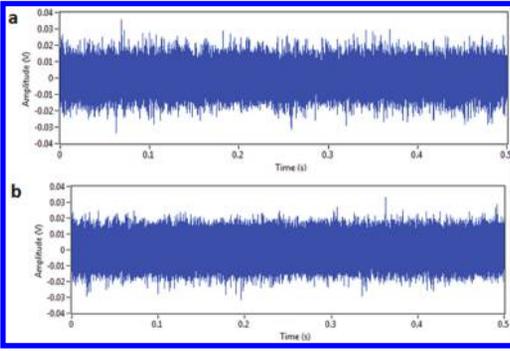
Figure 7. AE time domain signals captured from a) Healthy gearbox b) Faulty gearbox.

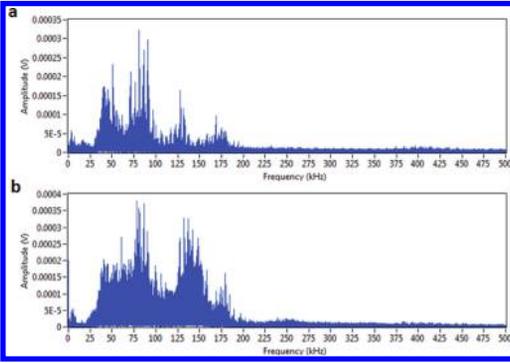
Figure 8. AE Frequency domain signal captured from a) Healthy gearbox b) Faulty gearbox.

A typical frequency domain AE signal acquired from the sensors installed in the healthy and faulty gearbox is shown in Figure 8 (a) and (b) respectively. These graphs show that most of AE activity was concentrated in the 30–200 kHz range. Therefore, to increase the SNR of the AE signals analysed a band-pass filter was applied in that frequency band.

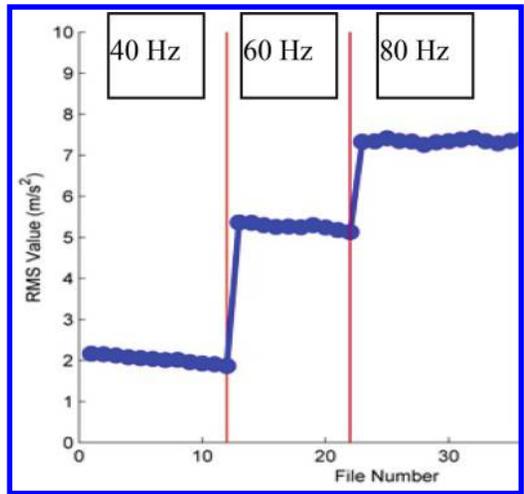
Figure 9. RMS' variation as the speed is increased.

The first test run underwater was without loading in both of the gearboxes. The output shafts were run free at three different speeds (40 Hz, 60 Hz, 80 Hz and 100 Hz). Figure 9–11 show how the RMS value, the peak value and the counts parameter increased with motor speed. These three graphs are divided into three areas representing the features at different speeds.

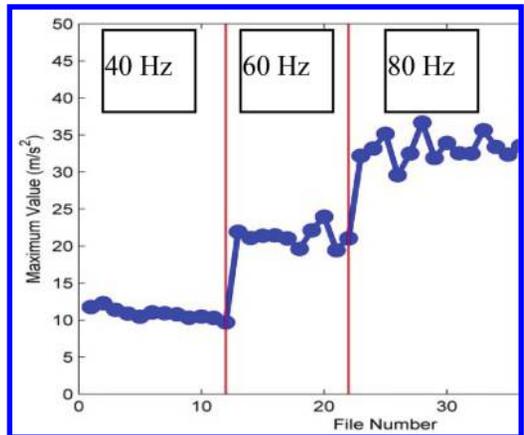
Figure 10. peak value's variation as the speed is increased.

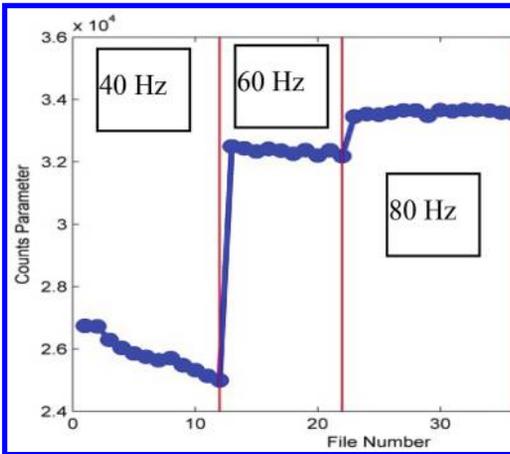
Figure 11. Counts parameter's variation as the speed is increased.

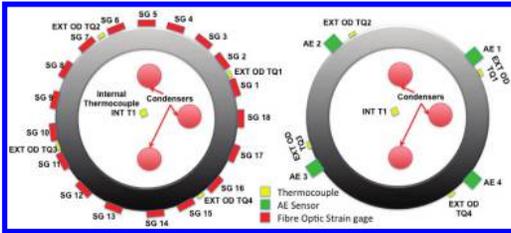
Figure 1. Layout of fibre optic strain gauges, acoustic emission sensors, & thermocouples (plan view).

The experimental setup was modified to remedy heating symmetry and stability difficulties in the previous experiment [4]. The current investigation uses a slightly different experimental setup schematized in Figure 1. Heating to 155°C is achieved using 3 individual heat sources controlled from a single temperature controller. The heat is applied with the use of two BriskHeat® manufactured heat tapes wrapped circumferentially around the top and bottom of the pipe sample and one heat blanket which is attached to the bottom plate using high temperature adhesive. These locations were selected as to not overheat the areas where the strain gauges and acoustic emission are located. The heating locations were then insulated using standard fibreglass insulation. Four monitoring thermocouples were mounted on the OD surface of the pipe on the weld crown to report OD weld temperatures. One centralized fluid thermocouple is utilized to monitor

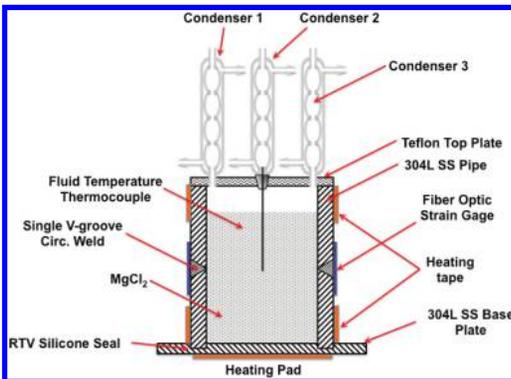
Figure 2. SCC MgCl₂ Cell set-up (X-section).

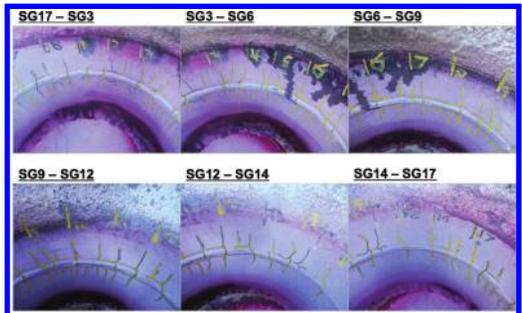
Figure 3. Close-up of DP results from second full scale SG run—Indications overlaid with paint markings.

Figure 3 shows the ID surface of the pipe after teardown of the experiment and removal of the MgCl₂. The ID of the pipe was inspected using Dye Penetrant (DP) to reveal indications of cracking, and the indications found overlaid with paint marker. It can clearly be seen that cracking is indicated over the majority of the ID circumference, centered around the Heat Affected Zone (HAZ) of the welds, as would be expected for SCC cracking. Note that cracking occurred both in the circumferential and axial directions.

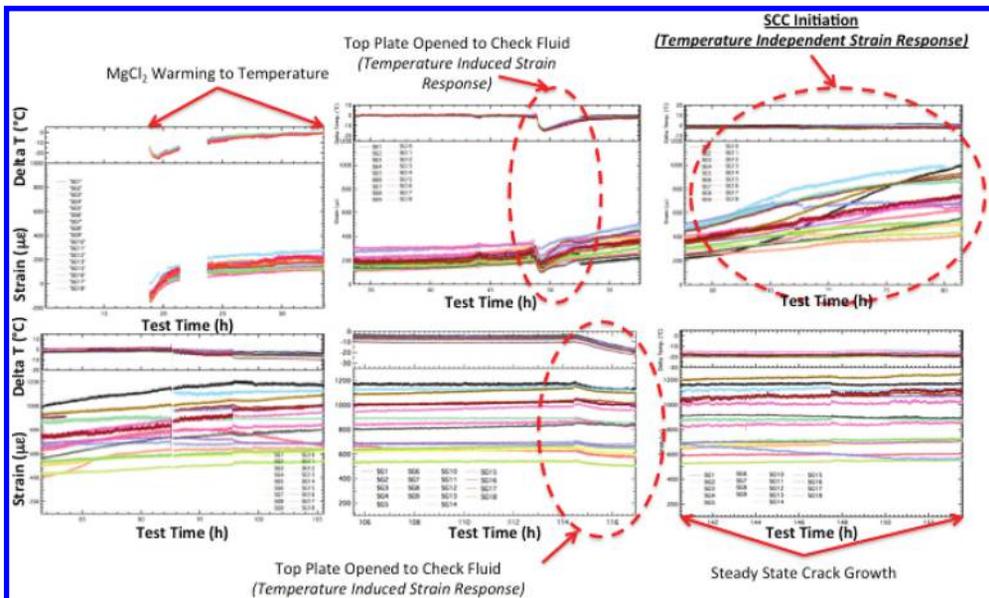
Figure 4. Summary of early stages of the full scale SG run.

Figures 4–5 show a summary of the results from the experiment. Figure 4 highlights the early portion of the experiment from 0 h–154 h. This is the most significant section of the results. The Figure shows the affect of the $MgCl_2$ solution being warmed to temperature, with an associated strain response. Note that portions of the data are missing from the start up due to limitations in the data recording software.

The first drop in temperature was due to the opening of the observation window in the top plate to check $MgCl_2$ fluid levels. Again, there is a strain response to the drop in temperature. The most significant portion of the Figure is the third pane, from ~57.5 h–81.5 h. This is where SCC initiation occurred in this experimental run. Note the temperature independent increases in strain from all of the gauges during this time period. There are no corresponding thermal events occurring during this time period. DP inspection indicated cracking had occurred around the majority of the ID surface, hence a response of roughly equal magnitude from all the gauges around the OD would be expected upon initiation. This response is similar to the “steady state growth” response observed in the first experimental run [4]. The difference in this experi-

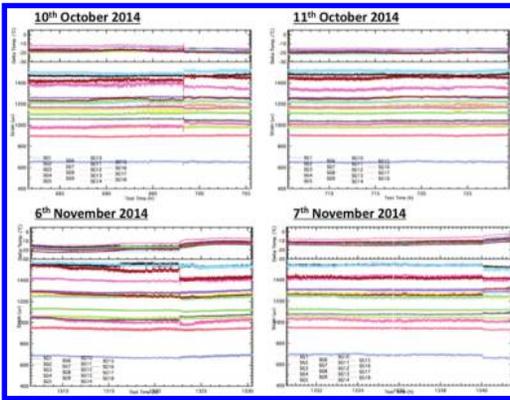
Figure 5. Full scale SG experiment 2: Mid—end experiment.

After this time period, the strain values level off. This is shown throughout the remainder of the experiment. Figure 5 shows snippets of the data from the middle and at the termination of the experiment. At all times, the strain response is steady with little/no changes observed. This suggests that the strain gauge technique employed may be insensitive to continuous SCC growth after initiation. This distinction was not possible in the previous experimental run [4], as the temperature control was inferior to this experiment, and the fact that it only ran for a period of 12 days, whilst this experiment was run for approximately 2 months.

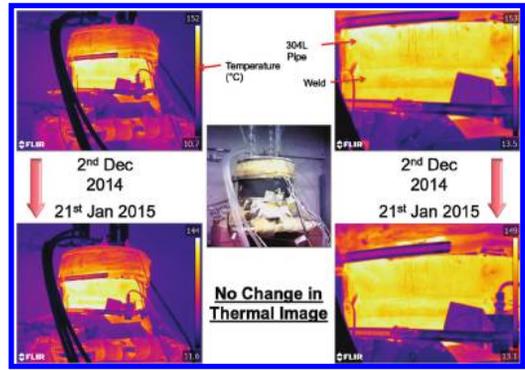
Figure 6. Summary of thermography data (25th Nov. 2014–21st Jan. 2015).

Figure 6 summarizes the results of the thermography data. An infra-red image of the same region of the weld at the pipe OD on a roughly daily basis throughout the course of the experimental run (~2 months). Both an overall and a zoomed image were taken of this region each time. The theory was that as an ID crack initiated and progressed through the wall of the pipe, then the effective wall thickness from the tip of the crack to the OD of the pipe would become smaller and smaller. The aim of the thermography experiment was to determine if such a localized “wall thinning” could produce a “hot spot” visible on the OD of the pipe owing to the higher internal fluid temperature than general OD pipe temperature. Unfortunately, as Figure 6 shows, this was not observed. It can be concluded that the infra-red camera had insufficient resolution to capture such

a small and highly localized temperature change, and would not be an effective method with which to detect SCC.

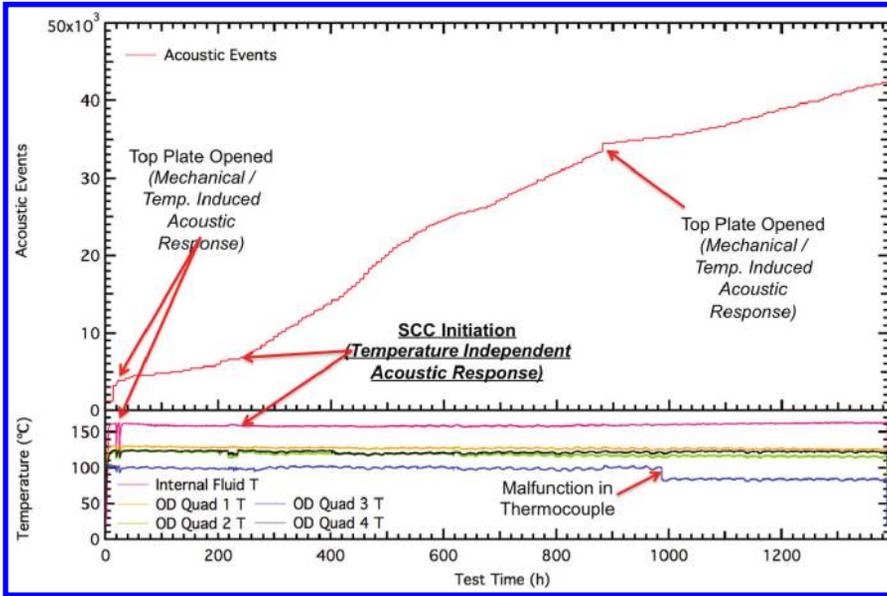
Figure 7. Summary of AE data (25th Nov. 2014–21st Jan. 2015).

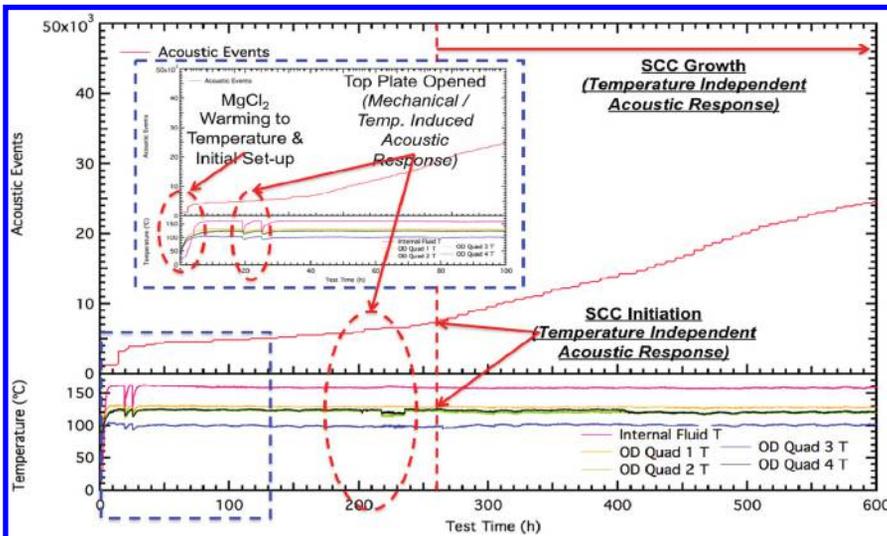
Figure 8. Summary of initial stages of AE data (25th Nov. 2014–20th Dec. 2014).

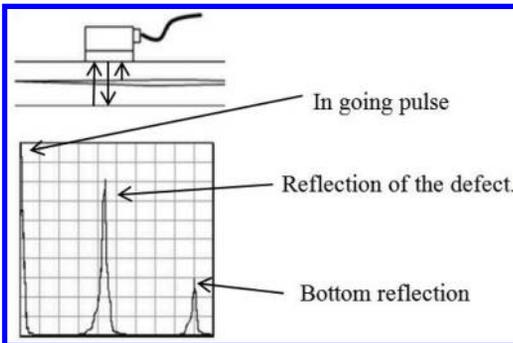
Figure 1. Working principle of the echo pulse technology (Arroyo et al. 2014).

Both C-scan and OmniScan methods use an ultrasonic transducer and a piezo-electric crystal to produce the ultrasonic sound needed for the detection. The crystal deforms according to the voltage. This creates an ultrasonic sound wave signal with a certain pattern. In the OmniScan method, the signal is reflected by the back wall of the material

(back-wall echo) or a possible defect, and returns to the transducer. The signal now deforms the piezo-electric crystal and thus creates a voltage that can be interpreted. By measuring the time between sending of the pulse and receiving of the reflection it is possible to detect the location of the defect in the material.

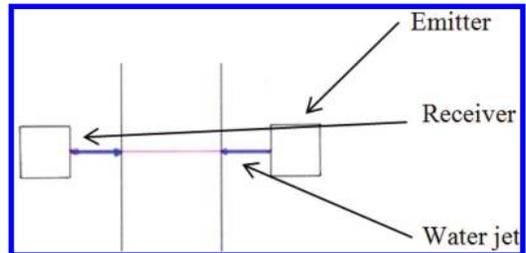
Figure 2. Working principle of the C-Scan method (Pieczonka et al. 2014).

In the C-scan method, the transducers are placed on opposite sides of the material. The emitter sends a signal through the test piece, guided by a water jet. Any anomalies in the test piece will affect the amount of energy that reaches the receiver.

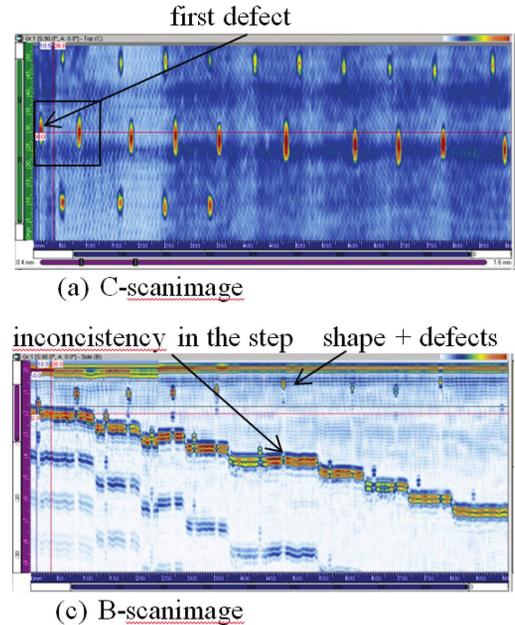
Figure 3. Showing the differences between the different scans.

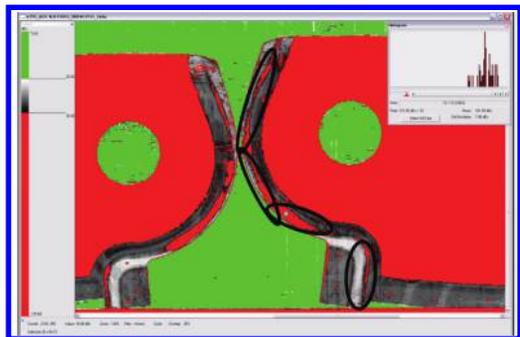
Figure 5. Defects on the monolithic parts.

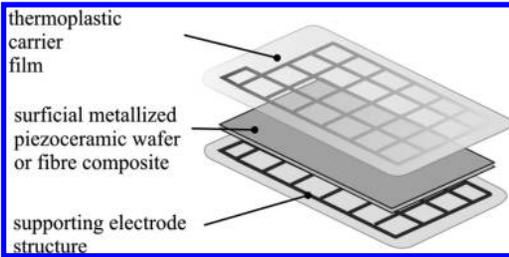
Figure 1. Schematic build-up of used TPM (d31-type).

layer (wafer or piezofibre composites) as illustrated in [Figure 1](#).

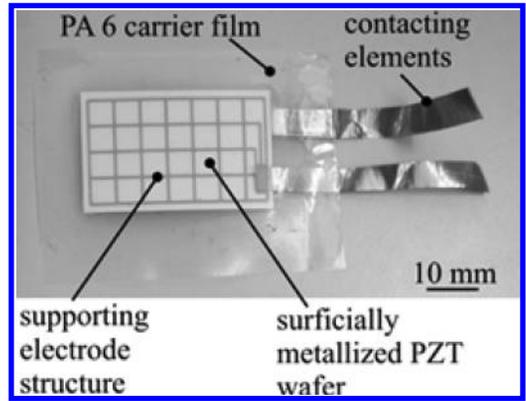
Figure 2. Contacted TPM for embedding into composite structures.

These modules are manufactured in an efficient roll-to-roll process, which bases on an automated printing of the electrodes to the carrier films, the feeding of the piezoceramic layers, and an adapted hot pressing process for the consolidation of the modules by melting the covering carrier films. In a subsequent step these modules are electrically contacted and polarized. For the presented studies the modules are poled by a voltage of 360 V for 5 min. The TPMs used for the presented investigations include a monolithic PZT wafer with a width of 22 mm, a length of 35 mm and a thickness of 0.18 mm. This wafer is surficial metallized by a screen printed silver electrode. Furthermore, this metallization is supported by a printed electrode structure at the thermoplastic carrier films. Due to the surficial electrodes these TPMs are working in d31 mode, which means a principal deflection normal to the polarisation direction. In [Figure 2](#) a contacted TPM as used in the investigations is illustrated.

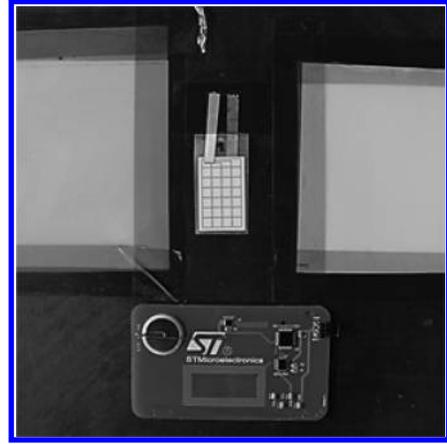
Figure 3. TPM placed onto mould surface, surrounded by pressure sensitive films and sensor for temperature measurement.

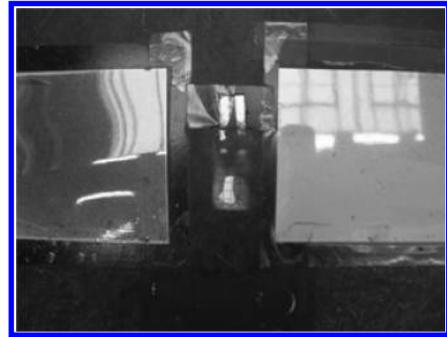
Figure 4. Demoulded composite structure with back-foamed TPM and discoloured films.

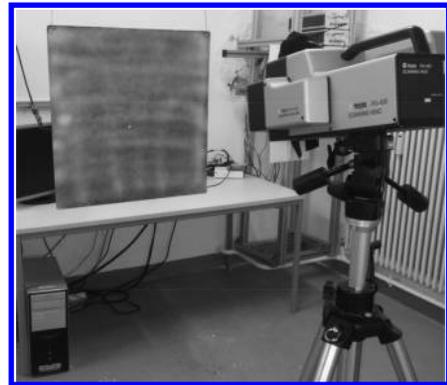
Figure 5. Test setup for analyzing the vibration behavior of the samples.

points was used. The free mounting of the investigated plate was realized by vertically hanging using thin and light ropes, see test setup illustrated in Figure 5.

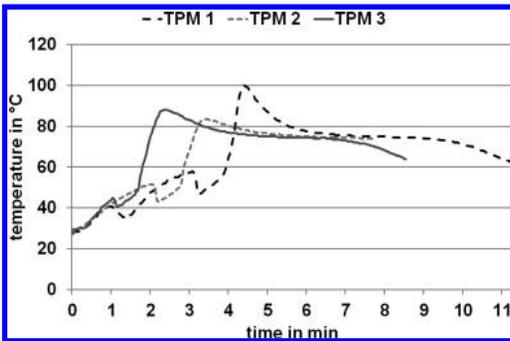
Figure 6. Temperature profile during curing of the composites.

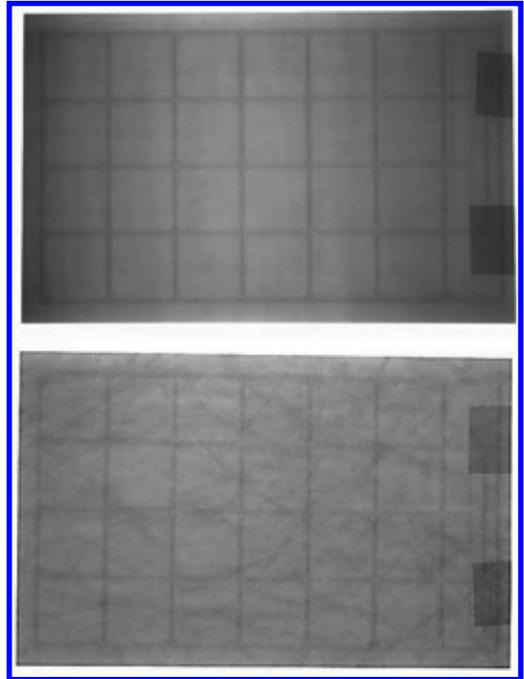
Figure 7. X-ray scan of TPM integrated in composite specification 1 before (above) and after embedding (bottom).

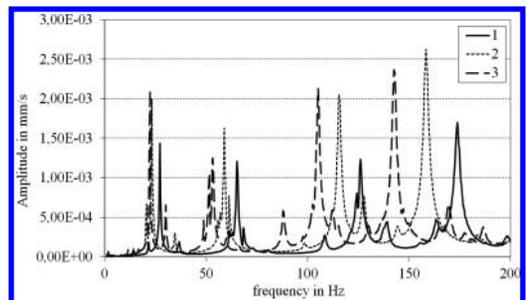
Figure 8. Determined spectrum of surface velocities for different composite specifications.

Due to the clear curve progression a coupling of the TPM to the structure is given. Furthermore, the shift of the resonance frequencies to higher values corresponds to the density of the investigated samples. By this experimental test the functionality and excitation of the TPM, as well as coupling to the structure is distinguishable.

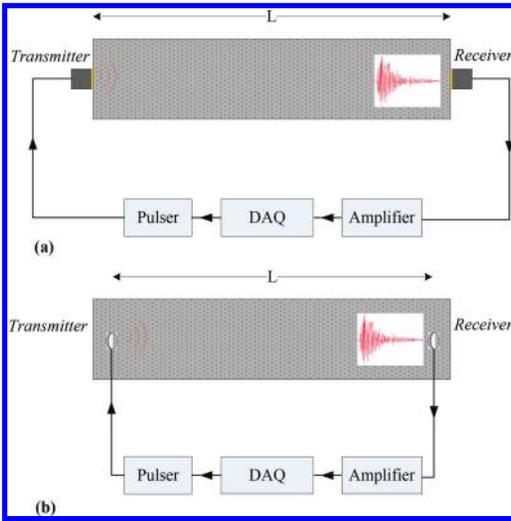
Figure 1. UPV system using (a) bulky external piezoelectric transducers and (b) small-size and low-cost piezoelectric transducers.

early age, as well as to estimate its strength and detect the developed damage in its hardened state. Monitoring the time-of-flight T of the longitudinal ultrasonic stress wave (i.e P-wave), it is feasible to estimate the mechanical properties of the concrete such as the dynamic modulus of elasticity. The commercially available monitoring system is based on bulky external piezoelectric transducers which need to be placed on two opposite faces of the tested concrete specimen (Fig. 1a). The main limitations of the technique are the need for a coupling agent and flat surfaces as well as the lack of flexibility in the transducers arrangement. This usually limits the application to through thickness transducers arrangement and the technique is not adapted for on-line applications. Instead of using the bulky external piezoelectric transducers, embedded small-size and low-cost piezoelectric transducers can be successfully used for monitoring the concrete hydration as well as tracking the cracking formation and its healing (Fig. 1b).
