Emerging Technologies in Non-Destructive Testing VI

Editors

D.G. Aggelis & D. Van Hemelrijck

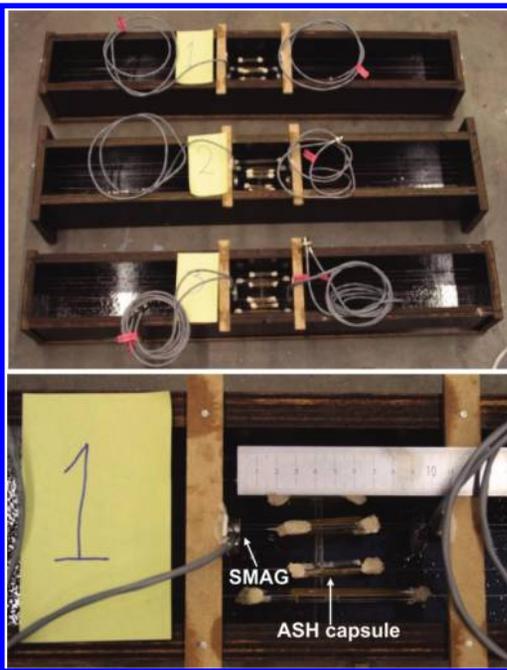
Figure 3. Preparations of the beams with the ASH system (glass capsules filled with healing agent) and the SMAGs.

glass capsules (50 mm long with 3 mm inner diameter) filled with a two-component polyurethane based healing agent. Four, eight and eight couples of glass capsules filled with the healing agent were embedded in the first, second and third concrete beam respectively. The capsules were equally distributed in the monitored area between the SMAGs through a grid made of very low stiffness plastic wire which was attached on the walls of the mold. In the first and second beams, one couple of SMAGs was embedded in each of them (SMAGs 1, 2 and SMAGs 3, 4 respectively) with a distance between them equal to 100 mm and at a height of 35 mm from the bottom of the beams. In the third beam, the monitoring system consists of two couples of SMAGs which were embedded with the same distance of 100 mm. The first couple (SMAGs 5 and 6) was placed at a height of 20 mm and the second one (SMAGs 7 and 8) at a height of 50 mm from the bottom of the beam.

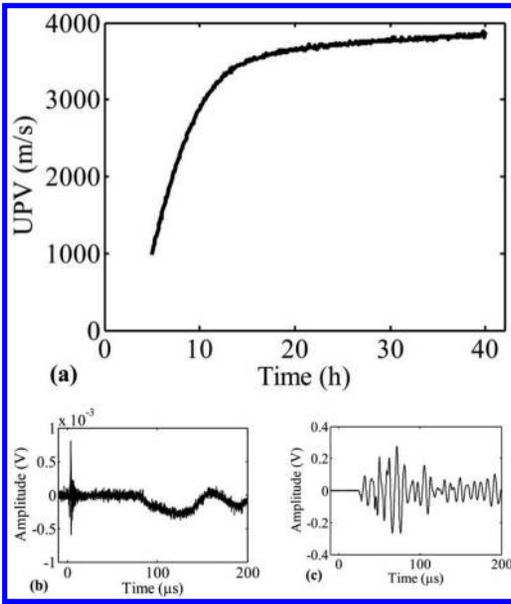
Figure 4. (a) Evolution of the P-wave velocity as a function of time and the recorded time signals (b) at the 5th hour and (c) at the 40th hour after concrete casting in the first beam.

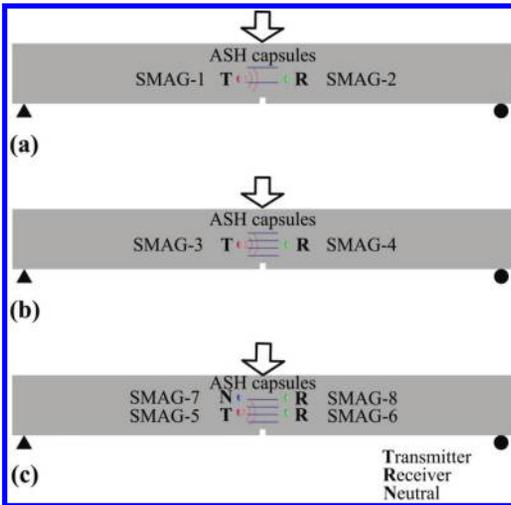
Figure 5. Testing set-up of (a) the first beam, (b) the second beam and (c) the third beam.

testing machine, until wide cracking opening, rupture of the glass capsules and filling of the cracking voids with the healing agent were achieved (Fig. 5). Following that loading rate, ten ultrasonic wave measurement tests every fifteen seconds were

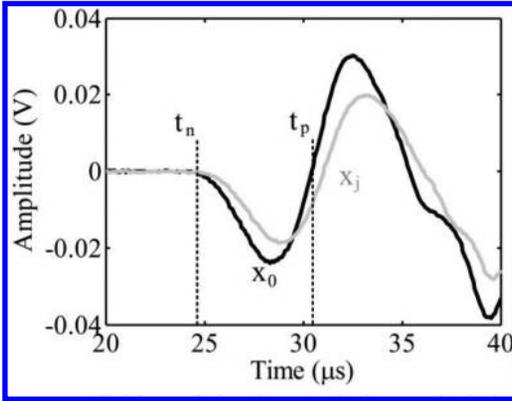
Figure 6. Definition of the damage index: arrival time of the healthy and damaged signals and the first half-period of the healthy signal.

where $x_j(t)$ corresponds to the amplitude of the damaged signal (loaded structure) and $x_0(t)$ is the amplitude of the healthy one (sound material), t_n is the arrival time of $x_0(t)$, and $t_p - t_n$ corresponds to the duration of the first half-period of the healthy signal (Fig. 6).

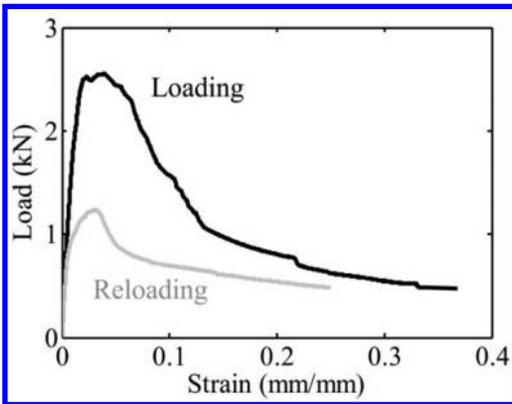
Figure 7. Load vs strain of the loading and reloading tests of the first beam.

In Figure 7, the applied load (kN) vs strain (mm/mm) curves corresponding to the loading and reloading tests of the first beam are shown. Strain is the normalized data (mm/mm) received by the crack mouth opening displacement (CMOD) gauge which was placed on the notch limits of the beams. Before testing, the initial opening of the gauge is fixed at 10 mm. Additionally, the gradual evolution of the early part of the recorded signals with increasing load corresponding to the reloading test of the first beam is shown in Figure 8.

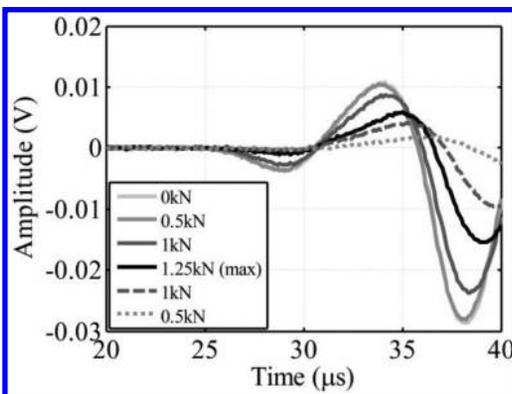
Figure 8. Evolution of the early part of the measured signals of the first beam.

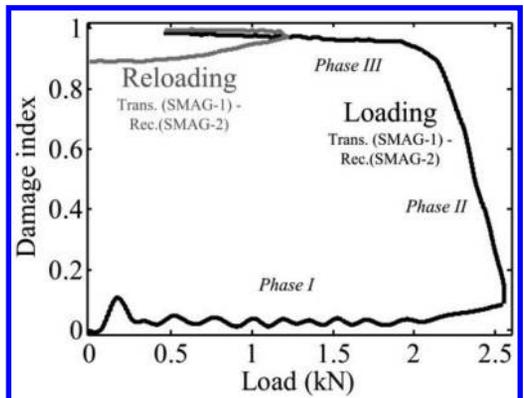
Figure 9. Damage index vs load of the loading and reloading tests of the first beam.

In the reloading test of the first beam (Fig. 9), the initial d.i. value is close to one and that is a sign of no healing of the cracked concrete and that could be attributed to the deficient quantity of the healing agent. In the second beam (Fig. 10), initially and until almost 1 kN of loading, the d.i. value (≈ 0.6) reveals that the beam is partially healed. Then, a sudden increase of the d.i. value leads the beam to the complete failure. Concerning the third beam (Fig. 11), the results seem quite reasonable. The higher placed SMAG-8 measured lower damage than the lower placed SMAG-6, because the crack was thinner at the top. This is a good indicator that the present method could be also used to track the healing of the developed cracking.

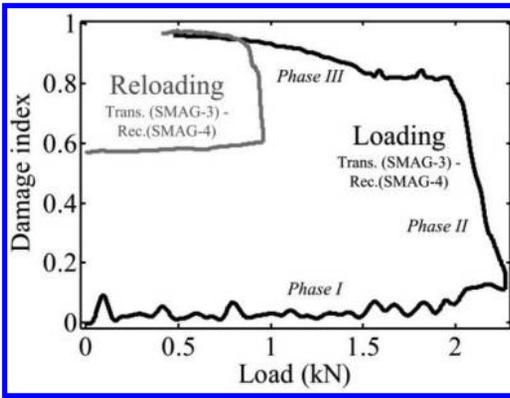
Figure 10. Damage index vs load of the loading and reloading tests of the second beam.

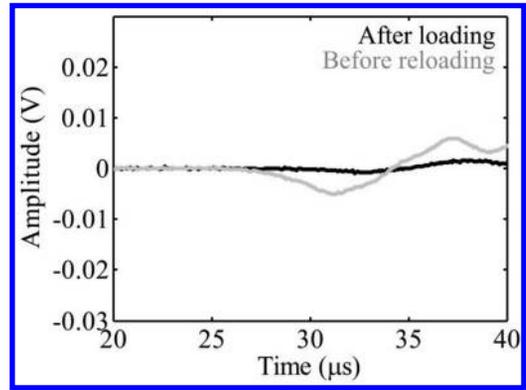
Figure 13. Early part of the received signals by SMAG-8 of the third beam.

Through the recorded signals of the third beam shown in Figures 12, 13, in the end of the loading test and just before the reloading one, the presence of the healing agent could be reliably detected. In both ‘before reloading’ graphs shown in Figures 12, 13, the wave arrival time has decreased and its absolute amplitude has increased compared with the respective ‘after loading’ graphs, due to the presence of the dry healing agent which has filled the voids of the monitored cracking area.

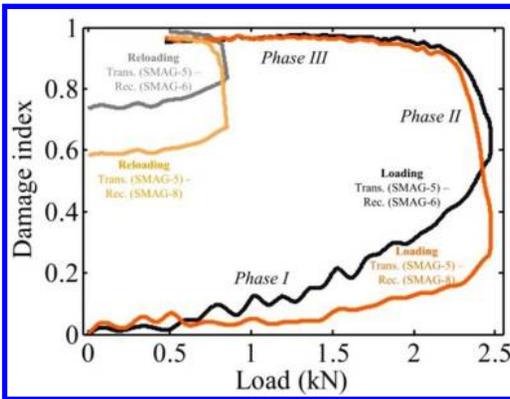
Figure 11. Damage index vs load of the loading and reloading tests of the third beam.

captured by the proposed d.i., which is plotted as a function of the applied load (Figs 9–11).

In all the loading tests, the d.i. evolution graphs clearly consist of three similar phases. In ‘Phase I’ (early damage initiation) the d.i. is very low but non-zero and this is partially attributed to a certain level of noise in the received signals. The d.i. starts to increase noticeably at around 2 kN. The initiation and evolution of the cracking correspond to ‘Phase II’. The severe failure of the concrete corresponds to ‘Phase III’, where the d.i. is close to one. Additionally, in the third beam, the d.i. calculated by the lower placed SMAG-6 (Fig. 5c) grows faster and earlier than the one calculated by the SMAG-8. Taking into account that the cracking initiated closer to the SMAG-6 than the SMAG-8, that is a solid proof that the present NDT technique could be also successfully used to qualitatively monitor the cracking extension.

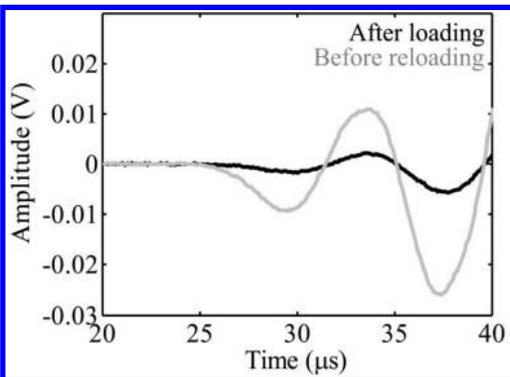
Figure 12. Early part of the received signals by SMAG-6 of the third beam.

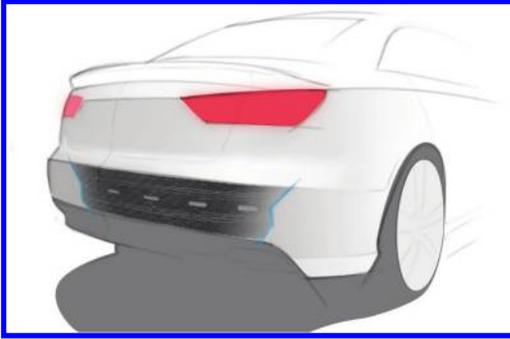
Figure 1. Schematic illustration for ultrasonic distance measurements.

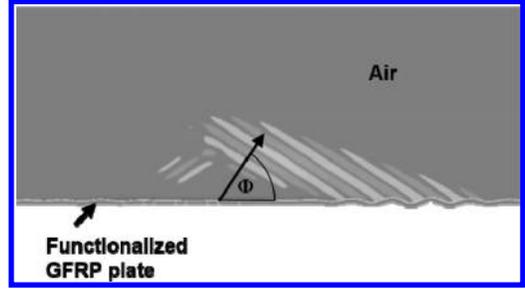
Figure 2. Radiation of the ultrasound wave from the functionalised TRTC plate at an angle Φ .

$$\phi = \arccos \frac{\lambda_F}{\lambda_p} = \arccos \frac{c_F}{c_p}$$

where in c_F is the speed of sound in the fluid and c_p is the phase velocity of the bending wave in the plate. For the investigated glass fibre-reinforced polyamide 6 (GF/PA6) plate (thickness 2 mm) the dispersion curves—describing the relation between the wave speed and the excitation frequency—can be calculated analytically (see e.g. Rose 1999) by assuming isotropic material properties (Young's modulus $E = 20$ GPa, mass density $\rho = 1800$ kg/m³, Poisson's ratio $\nu = 0.3$). Figure 3 shows the dispersion curves with the phase velocities and the group velocities of the A_0 - and the S_0 -modes.

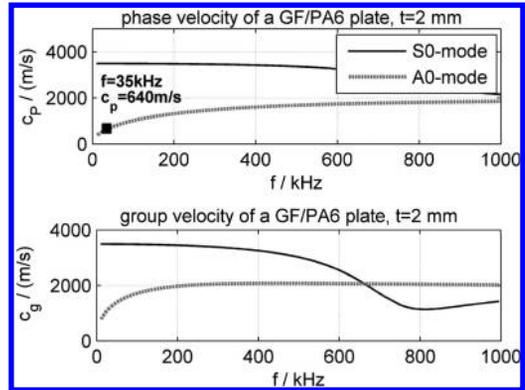
Figure 3. Dispersion diagram for a GF/PA6 plate.

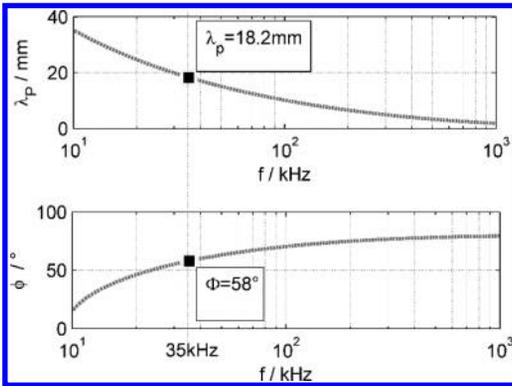
Figure 4. Wavelength of the A_0 -mode in a 2 mm thick GF/PA6 plate and resulting angle for the radiation of sound waves in air.

The wavelength calculated from the phase velocity of the A_0 -mode is shown in the upper chart in Figure 4 as a function of the excitation frequency. For the radiation in the air ($c_F = 340$ m/s) the radiation angle is shown in the lower chart in Figure 4.

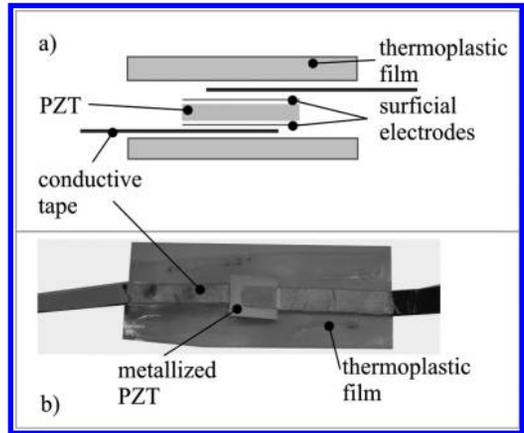
Figure 5. Prototypic TPM-configuration: a) built up, b) consolidated TPM (d_{31} mode).

PZT 5 A1) with a square area of 100 mm^2 and a thickness of 0.2 mm were used (see Figure 5b). The outer surfaces of the wafers were metallised by silver printed electrodes and contacted by conductive copper tapes. This lay-up was embedded into two PA 6 carrier films with a thickness of 0.1 mm (see Fig. 5a). The TPMs are polarised in thickness direction and work in d_{31} mode, which means a principal deflection normal to the polarisation direction.

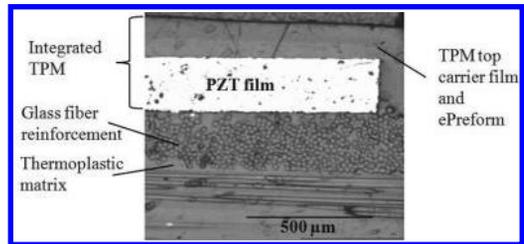
Figure 6. Micrograph of a material homogeneously integrated TPM.

A major precondition for the embedding of the TPMs into the composite structures is the use of identical thermoplastic materials for the TPM carrier films and the matrix of the fibre-reinforced structure. During the consolidation, the module will be material homogeneously integrated into the composite structure. Compared to adhesively bonded modules the integration of TPM enables efficient coupling of the piezoceramic layer to the reinforcement as shown in Figure 6.

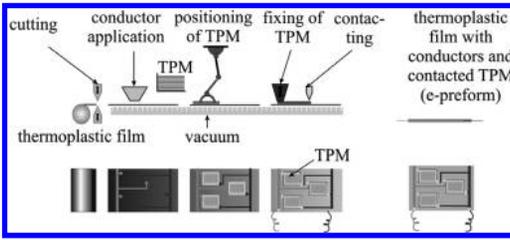
Figure 7. Schematic *ePreforming* process.

a thermoplastic film, the precise positioning and fixing of TPMs, the application of conductive paths and the accompanied electrical contacting (see Fig. 7).

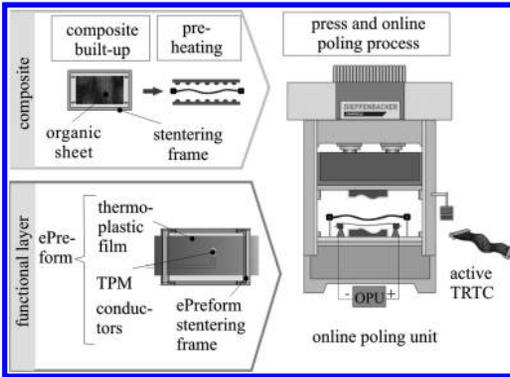
Figure 8. Schematic manufacturing process of active TRTC.

The conceptual manufacturing process for active TRTC, which bases on a press technology, starts with the first process step, the so called *ePreforming process*. It comprises the rollup and cutting of

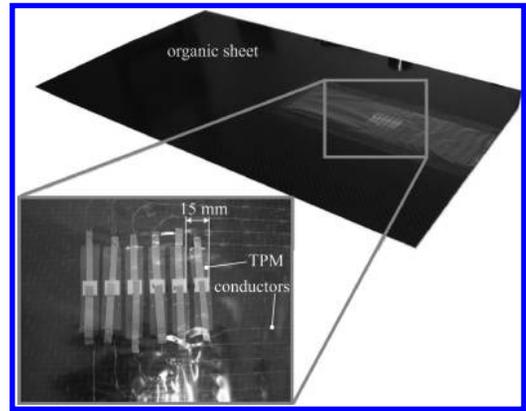
Figure 9. Organic sheet, *ePreform* with TPM pattern and conductors (thermally stapled).

In regard to the manufacturing of the *ePreform* an especially developed *ePreforming* unit was used. In order to assure the automated assembly of thermoplastic films with TPM and the necessary conductors. The transfer of TPM from storage to the predefined position is realised by a vacuum gripper whereas the fixation to the thermoplastic film can be realised by thermal stapling or ultrasonic welding. In this investigations the TPM were fixed by thermal stapling. The conductors are automatically rolled up from the wire coil, fixed by thermal welding points and cut at the end of the conductive paths. In these studies the conductors consists of tin coated copper wires with a diameter of 0.21 mm. Furthermore the TPMs, shown in Figure 5, are arranged to a linear pattern of six elements which have an offset of the piezoceramic wafers of 15 mm (see Fig. 9).

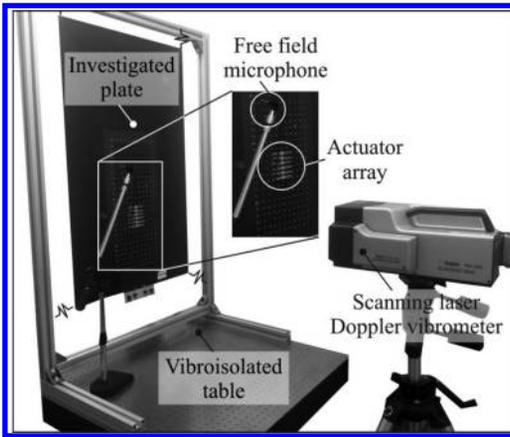
Figure 10. Experimental setup for the determination of propagation of induced mechanical and acoustical waves.

tion, the LDV has been positioned normal to the analysed plate. In order to assure to high reflection of the laser light and hence a high signal-to-noise ratio, large section on the plate surface was covered with a reflective spray paint. A regular spatial distribution of 55×97 discrete measuring points in approximately 2 mm distance has been selected to guarantee reliable capturing the wave spatial and time development. The investigated plate was hung vertically using a thin light rope (Fig. 10)

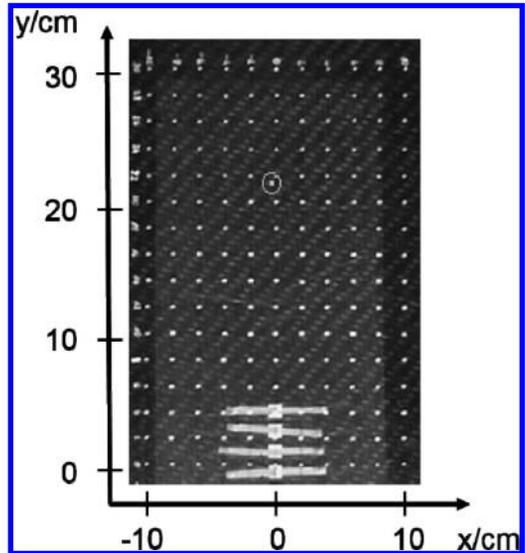
Figure 11. Coordinate system for the microphone measurement (origin at the first transducer of the array).

different heights (1 cm, 3 cm, 7 cm) over the plate. The raster of the discrete measuring points in each height was set to 2 cm. Figure 11 shows the planar coordinate system in the plate plane, whereupon the origin was set to the end of the first transducer element.

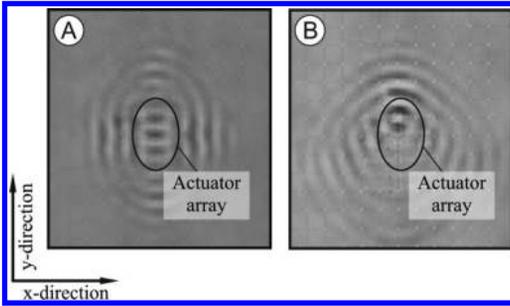
Figure 12. Out-of-plane velocities for different time delays. (A) for zero seconds. (B) for 24 milliseconds.

Mainly, the impact of the time delay between the actuator initialisation has been studied. The wave propagation front for cases with zero time delay and optimal time delay are presented in Figure 12. In this context, an optimal time delay of $24 \mu\text{s}$ was experimentally determined. The difference of $0.6 \mu\text{s}$ between theoretical and experimental delay times (see section 2) are effected by uncertainties and tolerances of the geometry and the material properties of the experimental setup.

It is clearly observable that while for the zero time delay the wave propagates equally in positive and negative y-direction, for the case with optimised

time delay the wave propagates mainly in positive y-direction. Additionally the wave amplitude of the latter case was twice as much as in the first case. In order to generate an evidence, that such wave fronts cause a directed sound wave, the signals recorded using the microphone were analysed.

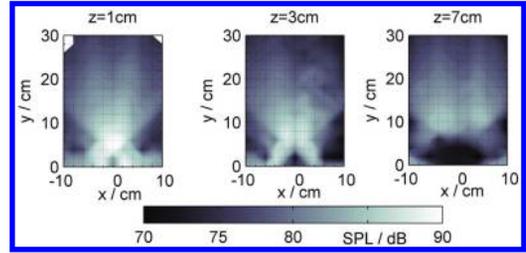
Figure 13. Measured maximum sound pressure level of the radiated ultrasound burst in different heights ($z = [1, 3, 7]$ cm) over the plate.

On closer examination of the results the lateral emission of ultrasound (side lobes) is recognisable. This is caused by the side lobes of the plate waves discussed in the previous section. These side lobes can be suppressed or prevented by a modified array design.

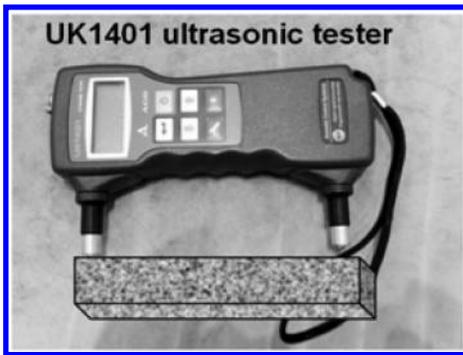
Figure 4. The SURFER ultrasonic detector.

First of all, the SURFER device was used for mapping 4 specific surfaces of the monument (the back surface, the convex one upon the back surface, the dome and the entrance of the tomb), by taking a big amount of measurements, approximately 459, (Figure 6).

As it was mentioned before, the SURFER device gives the opportunity of determining the depth of the cracks of the surfaces

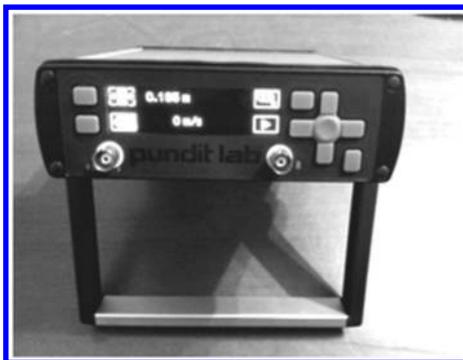
Figure 5. The PUNDIT ultrasonic device.

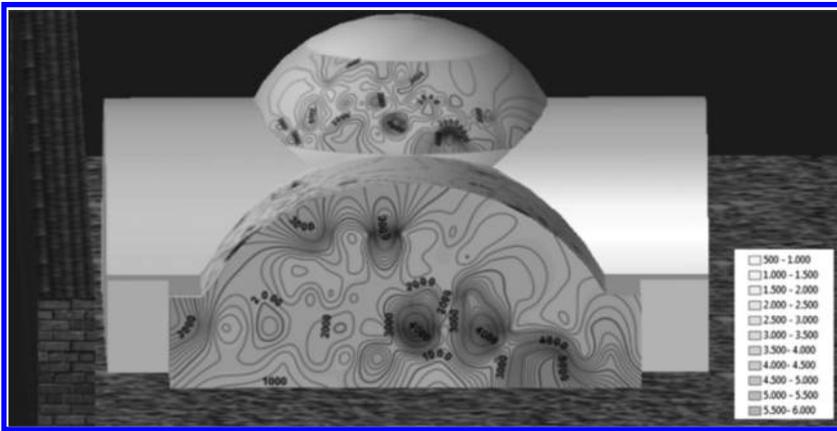
Figure 7. The back surface of the monument (the maps were made with ARC GIS 2010 and the depiction of the maps was made upon the model, by the use of the AUTOCAD 2012). The legend is the same for all the maps, showing the ultrasound velocities V_p (m/sec).

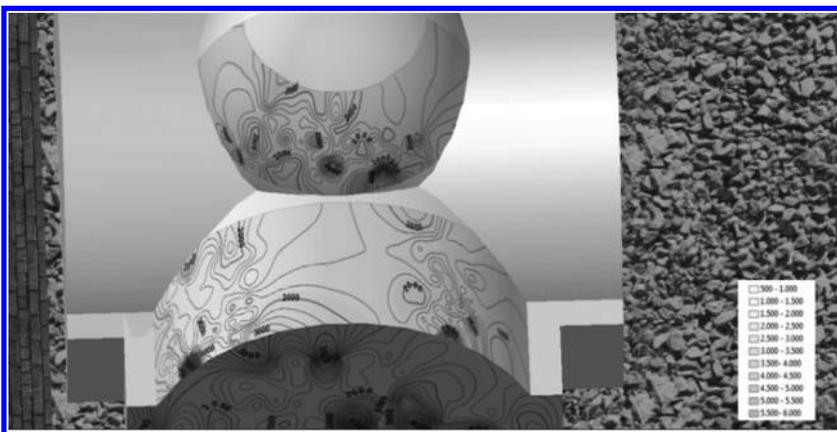
Figure 8. The convex part upon the back surface, (the maps were made with ARC GIS 2010 and the depiction of the maps was made upon the model, by the use of the AUTOCAD 2012). The legend is the same for all the maps showing, the ultrasound velocities V_p (m/sec).

At the same way, along the convex part, upon the back surface appears clearly the weathered part, the values of which range in lower levels than those in the back surface, with $V_p = 500\text{--}2000$ m/sec (Figure 8).

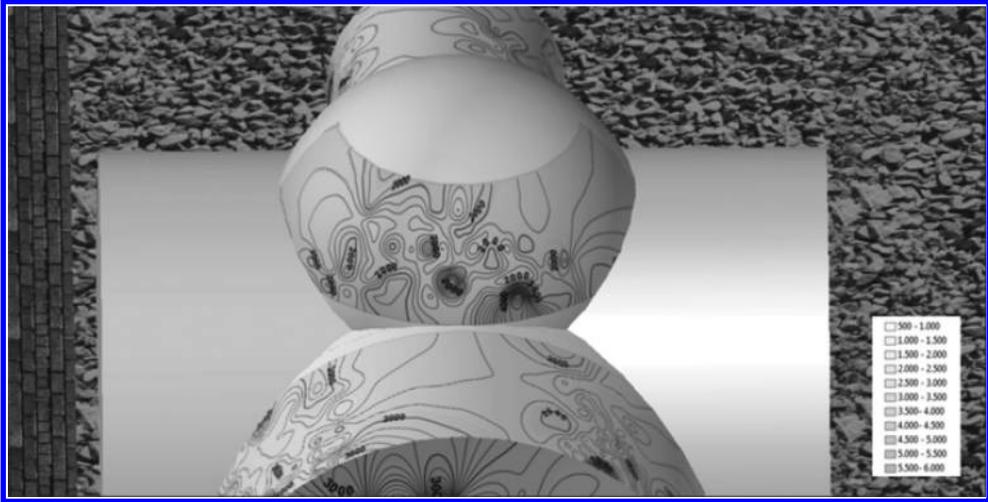
Figure 9. The dome of the monument, (the maps were made with ARC GIS 2010 and the depiction of the maps was made upon the model, by the use of the AUTOCAD 2012). The legend is the same for all the maps showing, the ultrasound velocities V_p (m/sec).

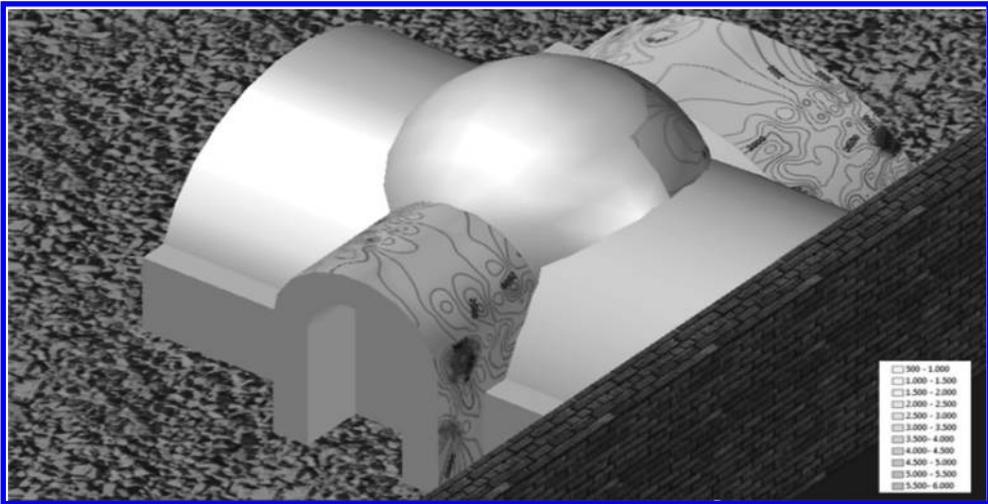
Figure 10. The right part of the entrance, (the maps were made with ARC GIS 2010 and the depiction of the maps was made upon the model, by the use of the AUTOCAD 2012). The legend is the same for all the maps showing, the ultrasound velocities V_p (m/sec).

Finally, at the entrance of the tomb, there are distinguished 2 weathered areas that appear to have the same values both in the right and in the left semicircular part. The values of the velocity range at a width of $1800\text{--}2000$ m/sec, (Figure 10,11).

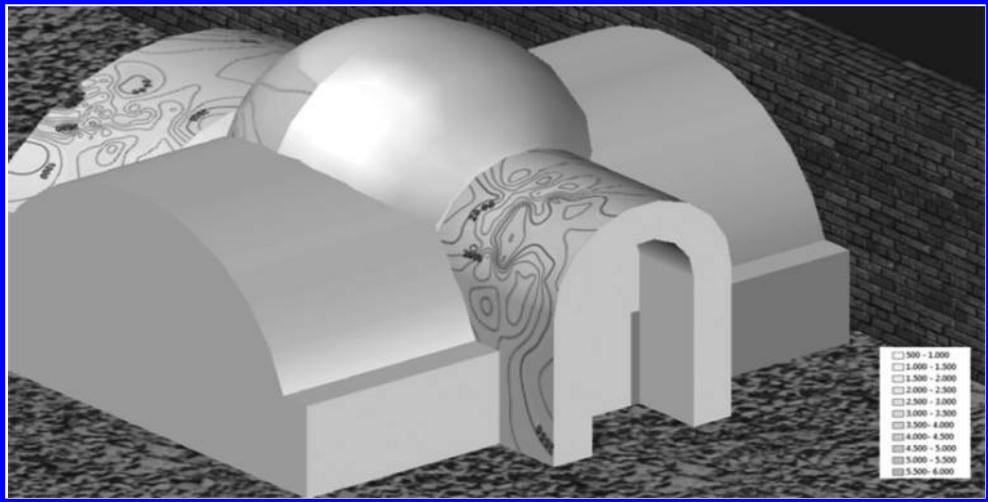
Figure 11. The left part of the entrance, (the maps were made with ARC GIS 2010 and the depiction of the maps was made upon the model, by the use of the AUTOCAD 2012). The legend is the same for all the maps showing, the ultrasound velocities V_p (m/sec).

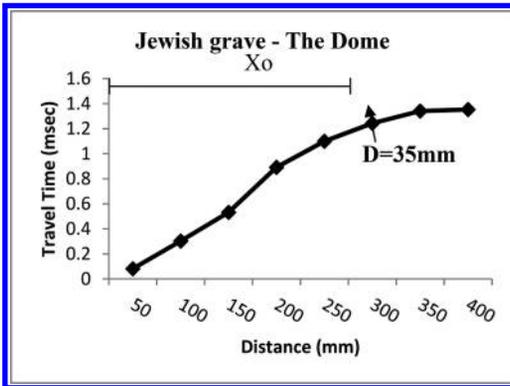
Figure 12. Estimation of the weathering depth on the surface of the dome in the Jewish grave.

devised in two areas: in the first area the depth was calculated in $D = 66$ mm, while in the second one was $D = 92.4$ mm. At the same way, the depth of the weathering at the convex part upon the back surface is about $D = 83$ mm and at the dome as it is shown in the following plot (Figure 12), the travel time of P-waves is constant in depth higher than $D = 35$ mm.

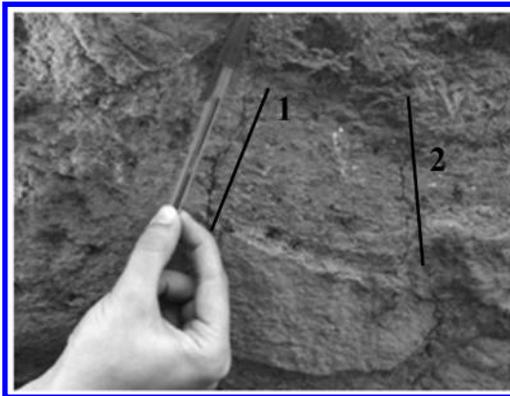
Figure 13. The two cracks on the back surface.

On the back surface of the monument are distinguished two cracks (Figure 13), the depths of which were measured as follows: for the first crack the depth is $D = 88$ mm, while for the second one is $D = 45$ mm.

Finally, two cracks were located and measured on the back surface of the monument, with the SURFER device and the depth of which was determined in $D = 88$ mm and $D = 45$ mm.

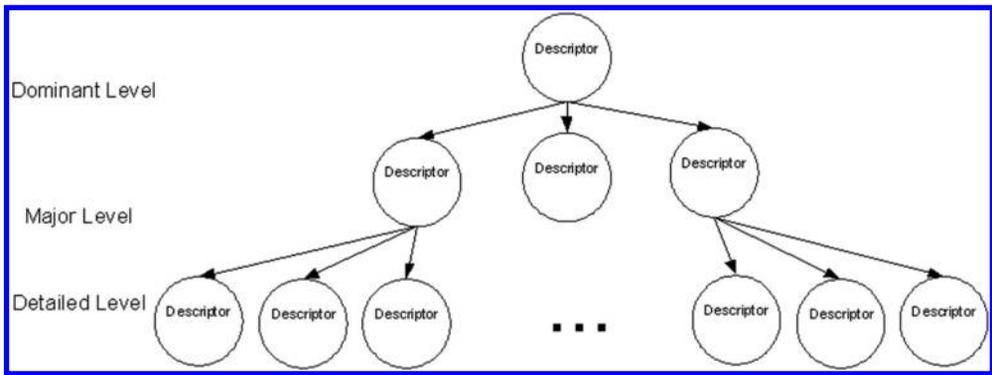
Figure 8. An example of scalable descriptor organization.

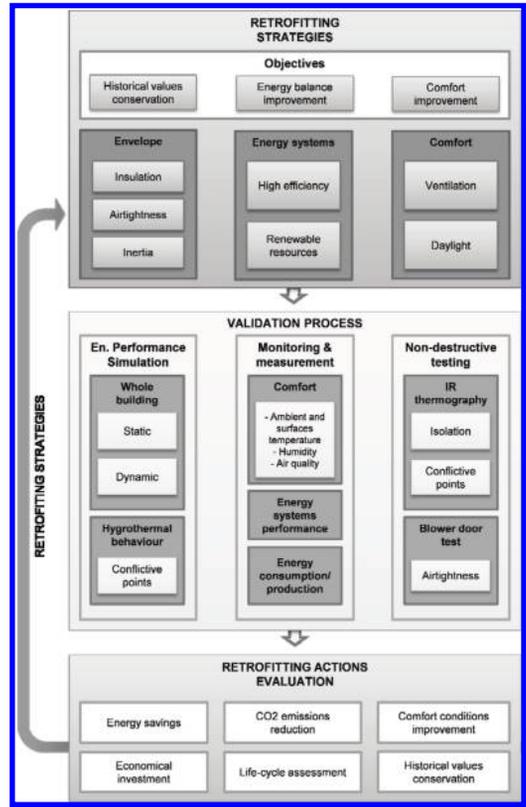
Figure 1. Diagram of the proposed methodology.

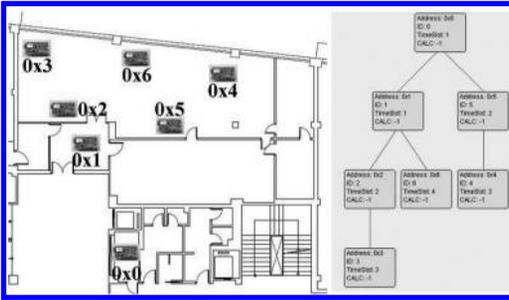
Figure 2. Deployed sensor network in the case study.

With the purpose of covering the requirements in the 3ENCULT project, a novel ZigBee sensor, hereafter 3ENCULT WSN, was developed by DEI, Bologna University. This system is able to sense the building climate parameters (temperature, lighting, humidity and CO₂, among others), energy consumption through extension cards and collect the

measurements in a central server unit (Balsamo, 2013). 3ENCULT WSN is designed under the plug-and-play pattern and its small size reduces the aesthetic impact in cultural heritage. Moreover, the system is embedded, working in a long operative time (up to two years), with reduced maintenance and remote configuration, management and update possibilities (Balsamo, 2013).

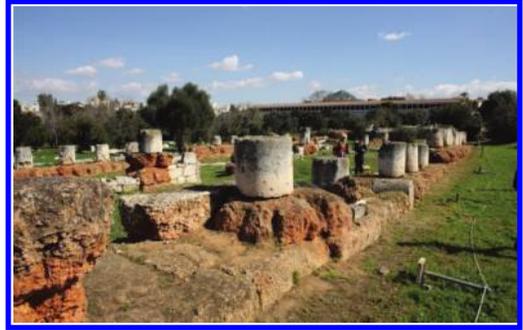
Figure 4. The foundations of the Middle Stoa.

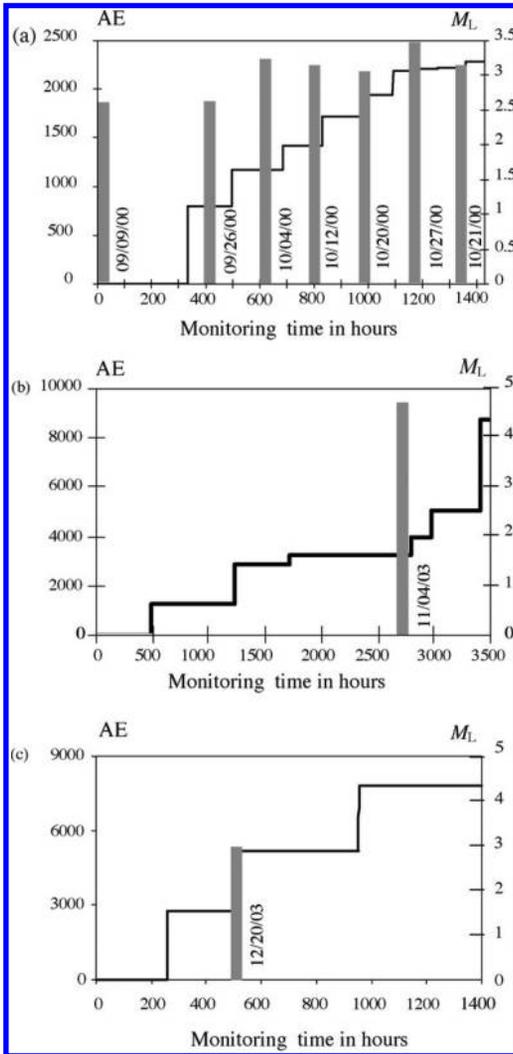
Figure 3. AE counting number and seismic events in local Richter scale magnitude (M_L): (a) Torre Sineo, (b) Torre Astesiano, (c) Torre Bonino.

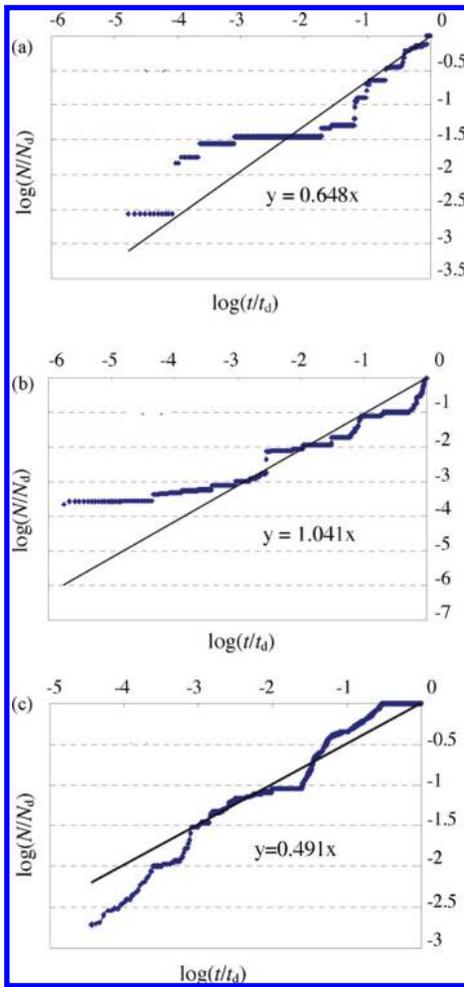
Figure 4. Evolution of damage: (a) Torre Sineo, (b) Torre Astesiano, (c) Torre Bonino.

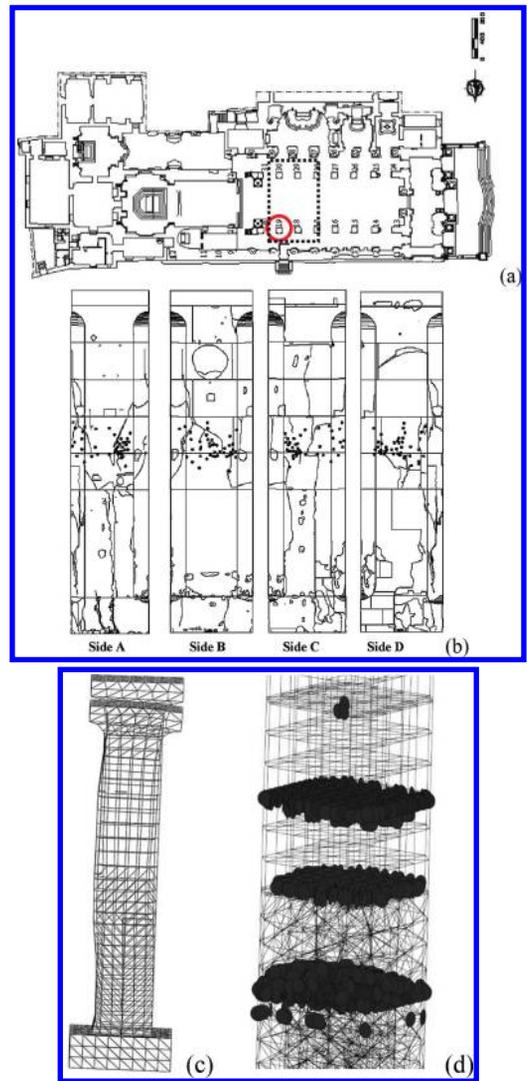
Figure 5. Plan of the Syracuse Cathedral and most critical pillars (a), Cracking pattern and localization of AE sources (b), deformed mesh under the seismic acceleration (c), cracking in the pillar when subjected to the seismic load (d).

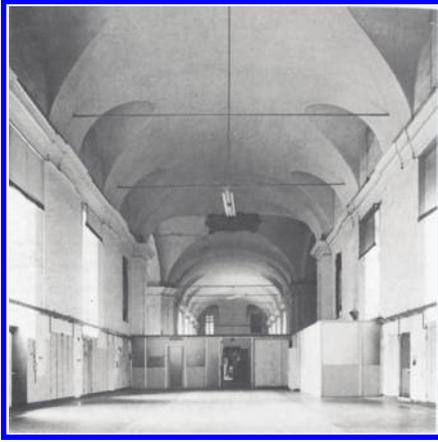
Figure 6. Ospedale San Giovanni: photograph inside the vault.

Due to this change of use, an assessment of the structural load capacity of the masonry vault beneath the first floor was necessary because the fossil collection involves a sensible increase in the vault load. During the in situ load test, we recorded the acoustic emissions from the vault, as well as

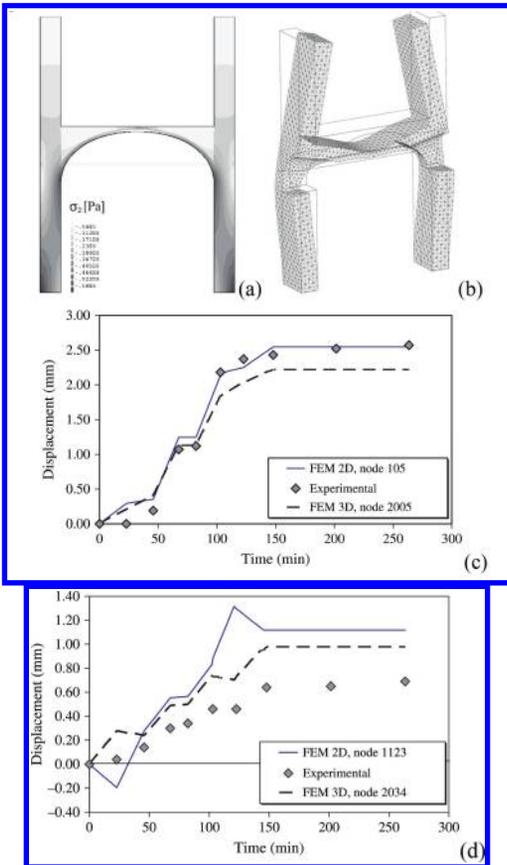
Figure 7. Vault subjected to the dead load: principal compression stress contour (a), 3D vault deformed mesh (b), time-displacement diagrams at the springing (c), and close to the keystone (d).

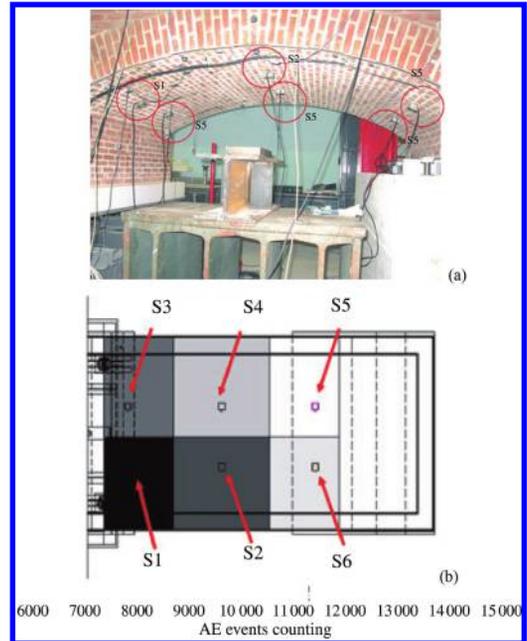
Figure 8. Positioning of the Acoustic Emissions transducers, and their competence areas (a), number of acoustic events in each competence area (b).

The bridge geometry and the structural details, included the masonry bricks and mortar joints, are realized in the scale 1:2 (Figure 8). The model bridge has been subjected to incremental settlement of the pile, which was sustained on a mobile support. During the first stage of the settlement, the AE counting has been recorded. Based on the interpretation of the AE rate, it is possible to monitor the criticality of the ongoing process.

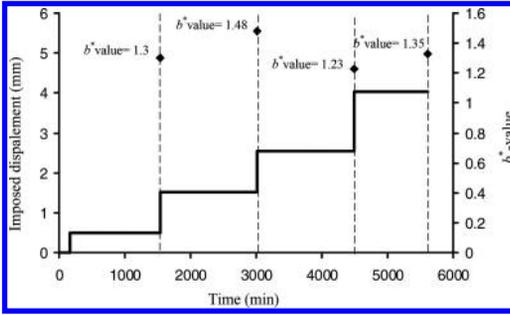
Figure 9. b^* -value trend during the incremental settlements of the pile.

In addition, thanks to the AE equipment, it has been possible to localize the main damaged zones. The statistical properties AE time series have been analyzed using an estimation of the b^* -value of the Gutenberg—Richter (GR) law permitting to determine the damage level reached in the model (Figure 9).

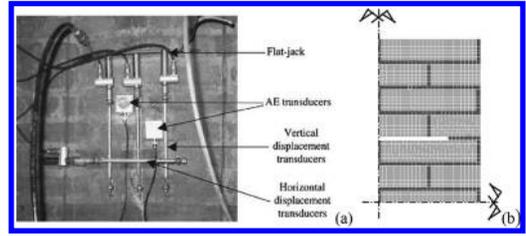
Figure 10. Double flat jack experimental set (a), and numerical discretization exploiting the double symmetry (b).

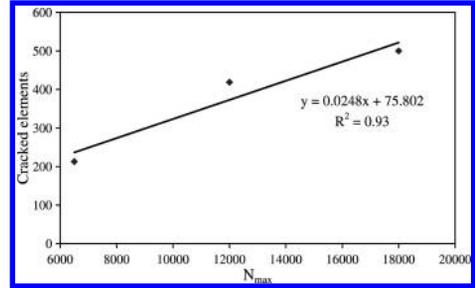
Figure 11. Proportionality between N_{max} and the number of cracked finite elements.

The numerical model accounts for the detailed mesostructure of the masonry texture. Although it is not possible to obtain an easy direct relation between the acoustic emission and the amount of cracking; nevertheless, it is possible to state that the two quantities are proportional to each other when increasing sizes are considered (Figure 11).

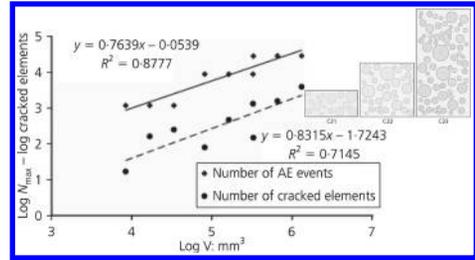
Figure 12. Proportionality between N_{max} and the number of cracked finite elements.

matrix and aggregates (Invernizzi et al., 2013a). In this way the volumetric scaling of AE was obtained numerically (Figure 12).

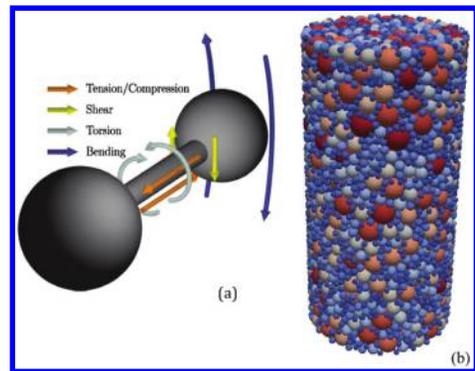
Figure 13. Scheme of the bonded interaction between two particles (a); view of the specimen particle size distribution (b).

The propagation of micro cracks can be put in direct correspondence with AE events adopting a particle strategy according to the distinct element method (Invernizzi et al., 2013b). In this case, every single aggregate is modeled as a particle of appropriate size distribution, while a reciprocal lattice of beams simulates the matrix.

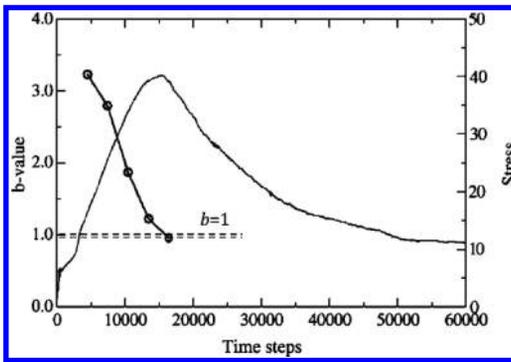
Figure 14. Evolution of the simulated b -value (circles) with time compared with the stress level.

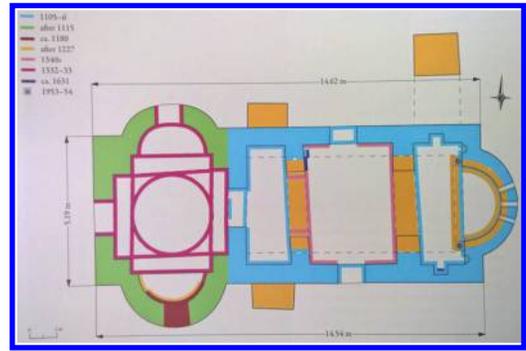
Figure 2. a) Ground Plan of the Church Panagia Phorbiotissa where the colours correspond to the various eras-phases of the church construction, wall paintings and restorations [2].

Take as example the "maniera cypria" style that displaced around the 1340s by a more exuberant manner that, while still strongly affected by the Mediterranean interchange of the Crusader era, was responsive to Palaiologan developments, as well. A restoration work cycle started in the 1950s resulted in reinforcing the side walls, grouting of the cavities in the rubble fill, ringing the 12th century portion of the building with a reinforced collar to withstand the thrust of the roof beams, which were also repaired [2]. The phases of construction, wall paintings and restoration have been illustrated by Andreas Nicolaides in Figure 2a.

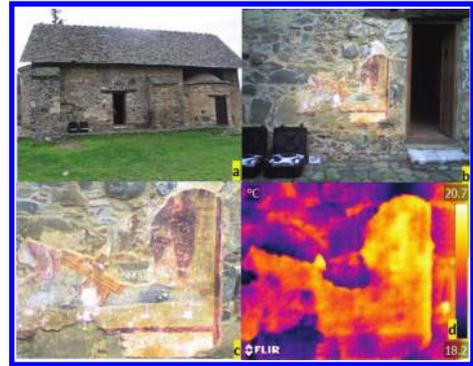
Figure 3. a) North aspect of Asinou Church b) Fresco next to the door of the north side c) Regular photo of the fresco d) Fresco Thermograph.

In the present work, the particular surfaces on which IRT and FOM measurements were conducted were 1) the Churches' arches, 2) the fresco outside the church (Figure 3) next to the north entrance 3) the outer surface of the east masonry of the church (Figure 4) and 4) the frescoes inside the church.

Regarding the fresco on the north outer masonry illustrated in Figure 3, the present study indicates the incompatible integration of outside plasters; most probably with the use of plasticizers that trigger the exfoliation of the original plaster. Possible mixture of the cement (concrete) in the repair mortar is accelerating the decay of the porous stone. Based on the thermographic inspection of the fresco (Figure 3c), there are evident diversified temperatures on the fresco area (different colors represents different temperatures according to the scale on the right in Figure 3d) that could be attributed to the conservation varnish, which does not allow the fresco surface to respire causing irreversible damage on it. The exfoliation-flaking mechanism of the outer layer of the fresco has as a consequence the detachment of the pigments (scheduled under the secondary crystallite calcite of the outer surface) revealing the substrate without painting.

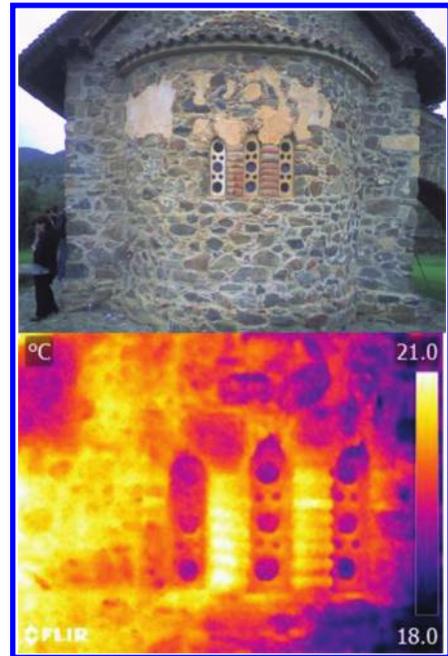
Figure 4. Masonry of East Arch—Different temperatures in the Thermograph suggest Incompatible Intervention Materials.

In Figure 4, the Thermograph from the east outer masonry (arch) reveals the different temperatures among the various materials have been used in maintenance interventions and the historic materials of the monument. Like before, this measurement suggests that the intervention took place with incompatible materials which comes in agreement with the general conclusions made about the monument in *Dumbarton Oaks Studies* book [2].

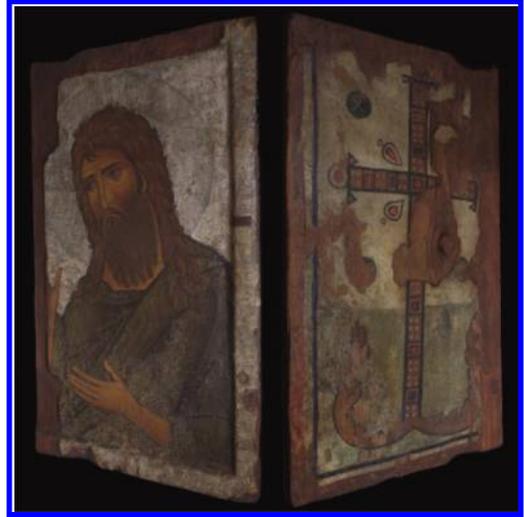
Figure 5. Both sides of 3D model of the John the Baptist Icon.

A Canon EOS 1000D 10.10-megapixel camera with a pre-calibrated 18–55 mm f/3.5–5.6 zoom lens and CMOS sensor size of 3888 × 2592 pixels was used for the acquisition of both objects. The images were captured in RAW format and the lens was fixed at 55 mm f/5.6 in order to ensure the best image quality could be achieved. Coded targets and scales were utilized to ensure the correct scale of the object was recorded as well as proper image alignment during post processing. A total of 246 images were taken of the John the Baptist icon (Figure 5) and 903 images of the larger, and more

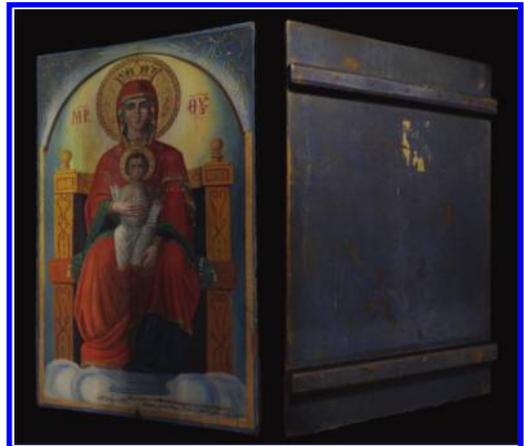
Figure 6. Both sides of 3D model of the Current Asinou Icon.

geometrically unique, icon dating from the 19th century (Figure 6).

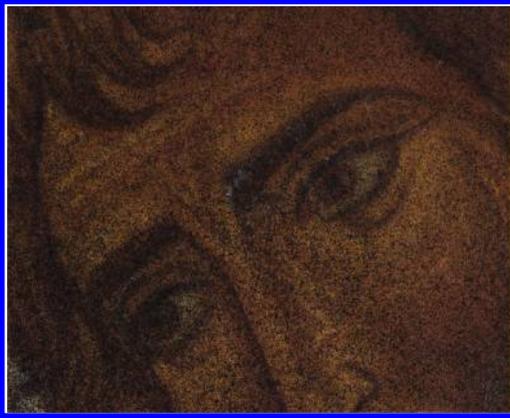
Figure 7. Close-up view of 3D point cloud of John the Baptist Icon produced by SURE.

Photogrammetric processing was accomplished with two software packages. Agisoft Photoscan Professional release 1.1.1.2009 (<http://www.agisoft.com>) was used for the principle processing stages of image alignment, dense image matching, and textured mesh interpolation. The SURE software package version 1.0.9.38 (<http://www.nframes.com>), which is provided free for academic purposes, was utilized to produce an optimal 3D geometric record of each cultural object [16] (Figure 7). This

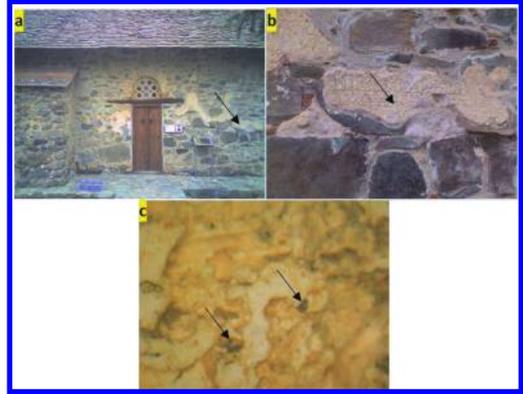
Figure 8. Masonry mortar next to the front door on the South (a, b) – Grey-green crust observed when mortar is magnified (x50) with FOM (c).

In Figure 8, a magnified picture (x50) of the yellow mortar (c) next to the central church entrance (a, b) has been measured by FOM. A grey/green crust is observed in certain areas(c), suggesting biochemical activities (biogenic decay). For validation, sample has to be distracted and measured with analytical techniques (in-lab).

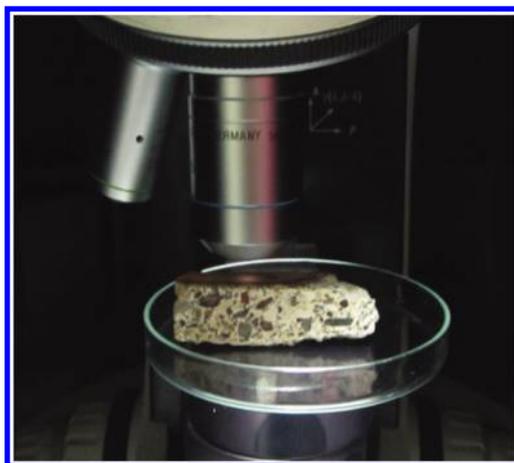
Figure 1. Collecting Raman spectra from a core extraction using micro-Raman.

For the detailed mapping a Renishaw spectrometer coupled with an optic microscope (Renishaw, InVia, Raman microscope) was used (Fig. 1). A laser line at 785 nm (diode laser) was used for excitation. The system was equipped with a Charge-Coupled Device (CCD) air-cooled detector. Raman spectra were acquired from various points of the specimen under the same conditions, by focusing the laser line through the objective lens (50x) of the optic microscope onto the sample’s surface.

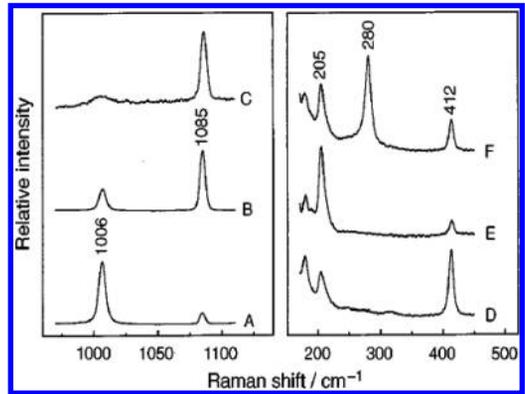
Figure 2. Raman spectra of: A, 20 mol% calcite-80 mol% gypsum; B, 80 mol% calcite-20 mol% gypsum; C, sulfated marble sample; D, 20 mol% aragonite-80 mol% gypsum; E, 80 mol% aragonite-20 mol% gypsum; and F, 40 mol% calcite-30 mol% aragonite-30 mol% gypsum.

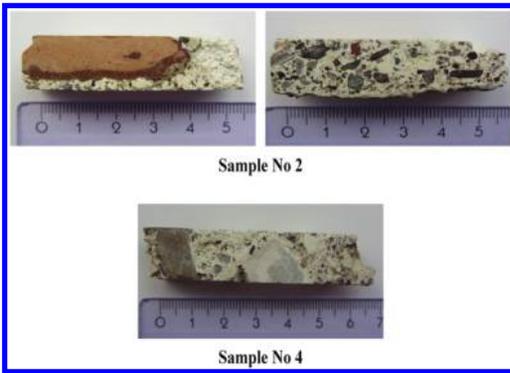
Figure 3. Core extractions from the castle of Nafpaktos.

Core extractions (a mosaic of different building materials including stones, mortars and clays) from the outer wall of castle of Nafpaktos were analyzed by means of Raman spectroscopy. Two

randomly selected samples are in [figure 3](#). Before data acquisition, specimens were placed under a stereoscope (DFC295, Leica) for a better and more in-depth observation of the variations from point to point of the cores.

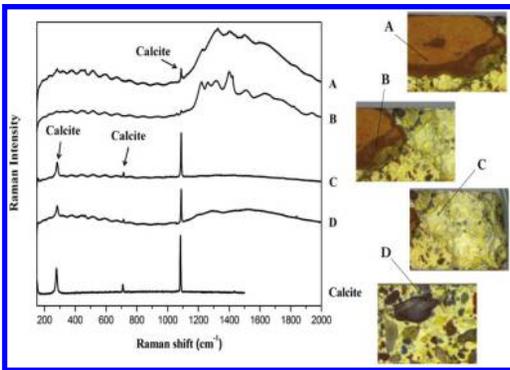
Figure 4. Raman spectra of core No 2. At the right side a photo from the stereoscope showing the exact location where the laser beam of micro-Raman spectrometer was focused.

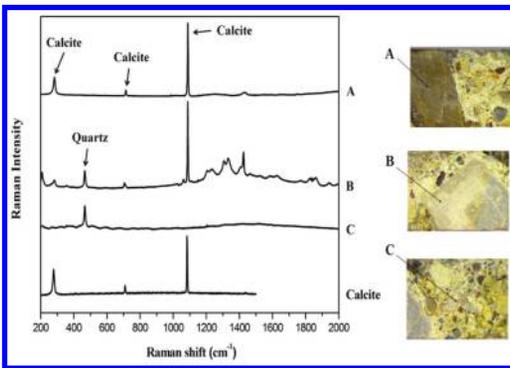
Figure 5. Raman spectra of core No 4. At the right side a photo from the stereoscope showing the exact location where the laser beam of micro-Raman spectrometer was focused.

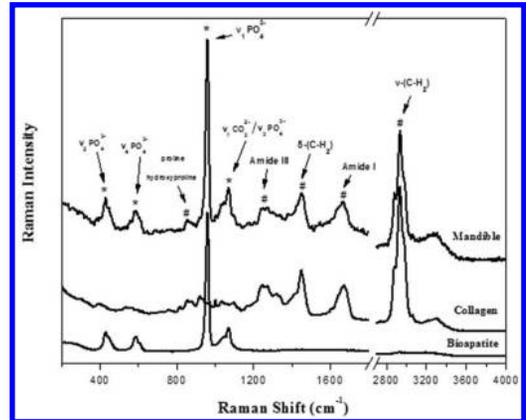
Figure 7. Raman spectrum of mandible, collagen and bioapatite. Peaks marked with (*) stem from bioapatite, while those marked with (#) from collagen.

Raman spectroscopy was used for the study of the quality of a human mandible ([Fig. 6](#)). [Figure 7](#) shows a Raman spectrum of the specimen which is dominated by the ν_1 stretch modes of PO_4^{3-} of bioapatite at 960 cm^{-1} (Penel et al., 2005). Characteristic bands at 1244 cm^{-1} and 1271 cm^{-1} , as well as at 1667 cm^{-1} , represent the amide III and amide I modes of collagen (Dehring et al., 2006, Tarnowski et al., 2004). Bands at 855 and 878 cm^{-1} are assigned to the $\nu(\text{C-C})$ ring modes of proline and hydroxyproline respectively (Mandair et al., 2009).
