Emerging Technologies in Non-Destructive Testing VI

Editors

D.G. Aggelis & D. Van Hemelrijck

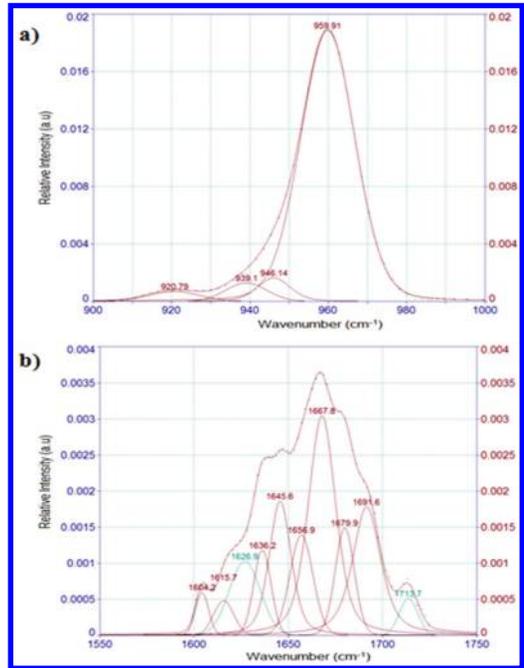
Figure 9. Deconvolution and band fitting under the: a) $902\text{--}990\text{ cm}^{-1}$ region (bioapatite) and b) the $1590\text{--}1720\text{ cm}^{-1}$ region (amide I) on Raman spectra of the mandible.

The ratio of bioapatite to collagen (Mineral to Matrix ratio) and the ratio of non-reducible to reducible cross links were determined in order to monitor the differentiation of bone quality point to point of the mandible (Morris and Mandair, 2011). In the first case, the Mineral to Matrix ratio was calculated using the intensities of the bands at 960 cm^{-1} for bioapatite (Fig. 9a) and at 855 cm^{-1} , 875 cm^{-1} and 920 cm^{-1} for proline and hydroxyproline of collagen [I ($960\text{ cm}^{-1})/(855\text{ cm}^{-1} + 875\text{ cm}^{-1} + 920\text{ cm}^{-1})$]. For the calculation of the ratio of collagen cross-links, the amide I envelope was used (Fig. 9b) and particularly the intensities of the bands at 1658 cm^{-1} and 1668 cm^{-1} for non-reducible cross-links and at 1680 cm^{-1} and 1690 cm^{-1} for reducible cross-links [I ($1658\text{ cm}^{-1} + 1658\text{ cm}^{-1})/(1680\text{ cm}^{-1} + 1690\text{ cm}^{-1})$] (Kohn et al., 2009). Diagrams were constructed showing the changes of bone quality within the same mandible. Variations from side to side or point to point of the bone were observed, as it is expected, which may be related to various reasons, such as chewing habits.

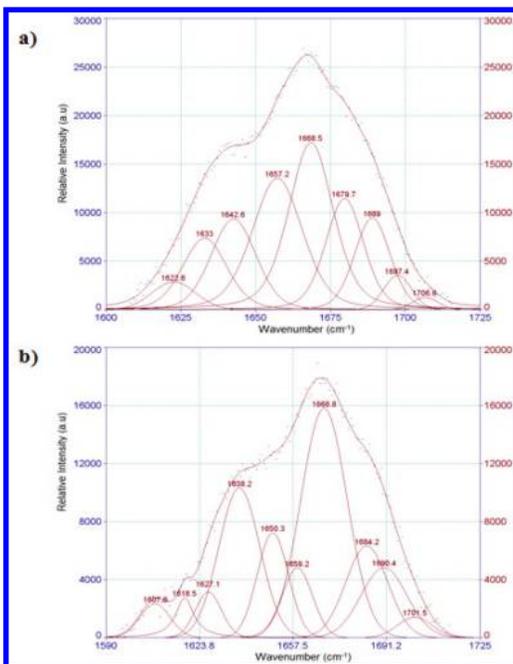
Figure 8. Deconvolution and band fitting under the amide I envelope ($1590\text{--}1720\text{ cm}^{-1}$) on Raman spectra of the mandible a) before and b) after the immersion in PBS solution.

and $(1658\text{ cm}^{-1} + 1668\text{ cm}^{-1})/1690\text{ cm}^{-1}$. The results showed that the presence of the band at 1658 cm^{-1} was due to dehydration and that immersion in PBS can rehydrate the collagen, partially at least.

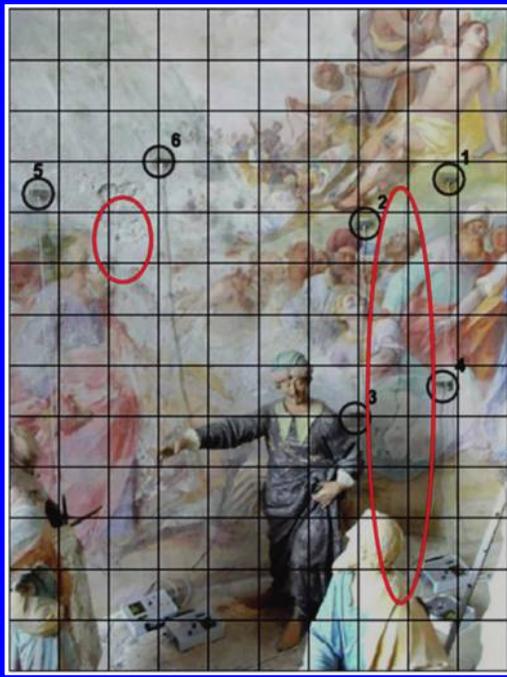
Figure 3. Chapel XVII. View of the monitored areas. Left side: sensors 5, 6, and the frescos detachment. Right side: sensors 1–4 and the vertical crack.

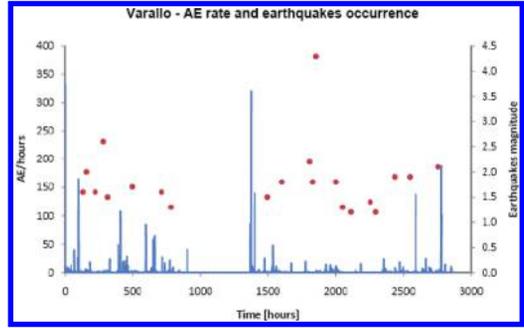
Figure 4. Chapel XVII. AE rate and nearby earthquakes occurrence as functions of time. Seismic events are indicated by red dots.

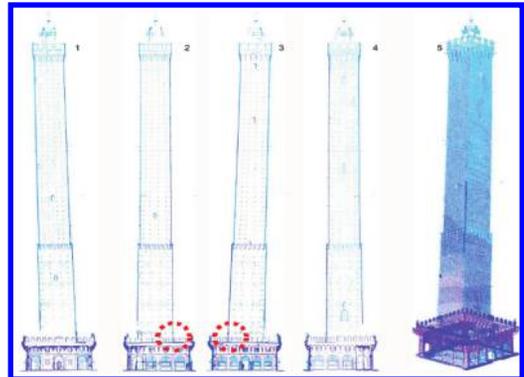
Figure 5. Front views and axonometric view of the Asinelli Tower. Faces (1) South; (2) East; (3) North; (4) West; (5) Axonometric view. The AE transducers were applied to the north-east corner of the tower, in the zones marked with a circle.

average height of ca 9.00 m above ground level, immediately above the terrace atop the arcade. In this area, the double-wall masonry has an average thickness of ca 2.45 m (Fig. 5). AE monitoring began on 23 September 2010 and ended on 10 January 2011, for a total duration of about 16 weeks. From the monitoring process carried out on a significant part of this tower, it was possible to evaluate the incidence of vehicle traffic, seismic activity and wind action on the progress of fracture and damage phenomena within the structure (Carpinteri *et al.*, 2011). In this case among all regional seismic events we considered 43 earthquakes with Richter magnitude ≥ 1.2 , having epicenter within a radius from 25 to 100 km from Bologna, as the most likely to affect the tower stability. The strongest earthquakes were the 4.1 magnitude event occurred on October 13, 2010 at 11:43 PM in the Rimini area (epicenter about 100 km far from

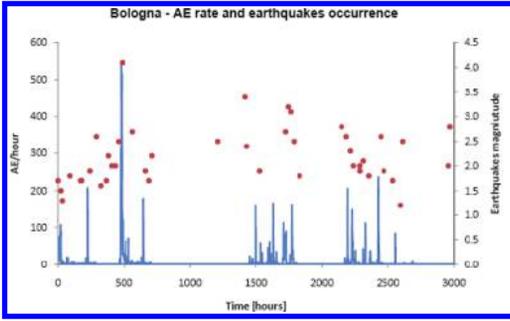
Figure 6. Asinelli Tower. AE rate and nearby earthquakes occurrence as functions of time. Seismic events are indicated by red dots.

Bologna) and the 3.4 magnitude event on November 21, 2010 at 4:10 PM in the Modena Apennines (epicenter about 50 km far from Bologna). The AE instantaneous rate (averaged over 1 h) and the sequence of the earthquakes obtained during the monitoring are displayed in Figure 6. Also in this case a correlation between peaks of AE activity in the structure and regional seismicity can be observed (Fig. 6). The tower, in fact, as in the case of the medieval towers of Alba, is very sensitive to earthquake motions (Carpinteri & Lacidogna, 2006; Carpinteri *et al.* 2007). The two silent windows for the AE rate evidenced in Fig. 6 (around 1000 and 2000 h), are probably due to the attenuation phenomena of the ultrasonic signals, that do not always reach the sensors during their propagation in the monitored structure.

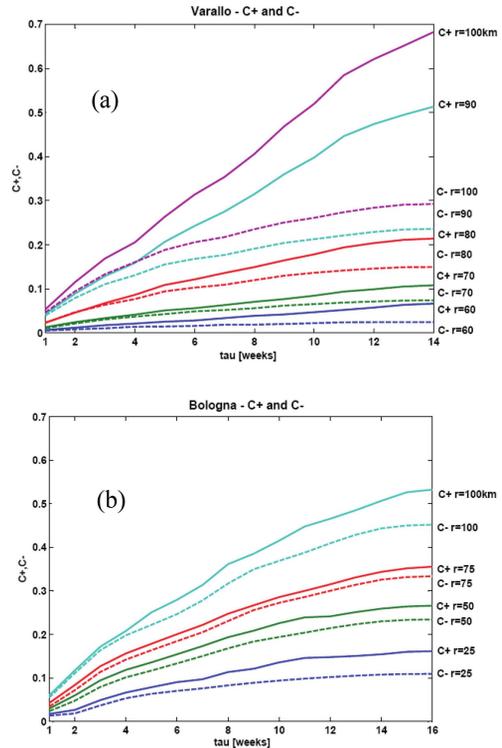
Figure 7. Evolution of the modified correlation integrals, both considering AEs as earthquake “precursors” C_+ or as “aftershocks” C_- , as a function of the radius of interest and for different time windows, during the monitoring period. (a) Chapel XVII and area around the City of Varallo; (b) Asinelli Tower and area around the City of Bologna.

As shown by the figures, everywhere we find $C_+ > C_-$. Therefore, it can be easily recognized that the filtered signals always have a greater probability to be seen like seismic precursors. In practice we see, as already found in Carpinteri *et al.* (2007a), that the monitored structures behave as a sensitive seismic receptors.

In the diagrams of Figure 7a and b, the cumulative probabilities $C_{\pm}(r, \tau)$ were not represented in the first week of the monitoring periods. Therefore,

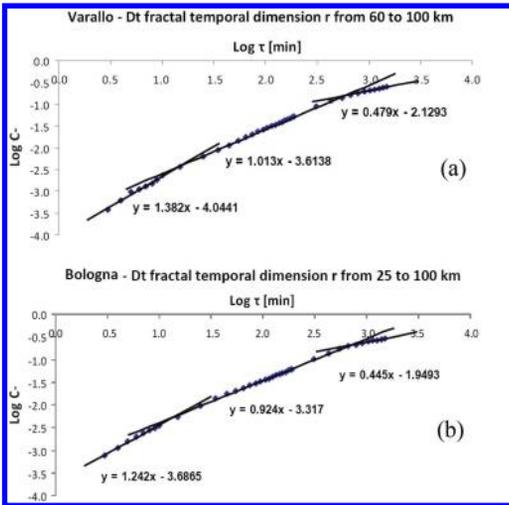
Figure 8. Analysis of the distribution over time by the parameter Dt , described in Eq. (3), of the AE events considered as “seismic aftershocks” (C_-). The time window amplitude τ is comprised between 3 min and 24 hours. The selected seismic events are all those considered during the defined monitoring periods. (a) Chapel XVII (Varallo); (b) Asinelli Tower (Bologna).

As mentioned in Section 4, the Dt parameter of Eq. (3) characterizes the clustering features of the events in time. Studying by this parameter the time coupling of AE activity to regional seismicity, the AE events as “seismic aftershocks” (C_-) are found to have a non-uniform distribution over time. This is evidenced by the three regression lines of the plotted data in bi-logarithmic scale (see Fig. 8a and b).

For short time delays, $\tau = 3\text{--}10$ minutes, AEs are short-term correlated to earthquakes, as described by the higher value of $Dt = 1.38$ and 1.24. This means that AEs following an earthquake are more likely to happen within $\tau = 3$ minutes after the seismic event diagrams. These short time delays clearly suggest that such AE activity is due to growing damage in Chapel and in the Tower, provoked

by seismic activity. While for $\tau = 1.0 \times 10^3$ to 1.440×10^3 minutes lower values of $Dt = 0.48$ and 0.45 are obtained, this means that about one day after the earthquakes seismic shocks have almost no effect on the structural damage.

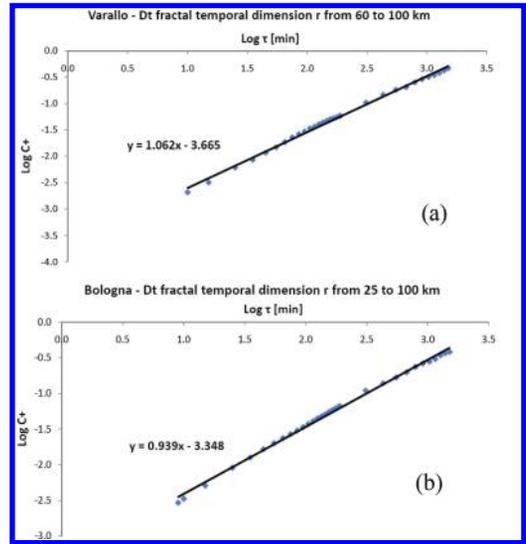
Figure 9. Analysis of the distribution over time by the parameter Dt described in Eq. (3), of the AE events considered as “seismic precursors” (C_+). The time window amplitude τ is comprised between 10 min and 24 hours. The selected seismic events are all those considered during the defined monitoring periods. (a) Chapel XVII (Varallo); (b) Asinelli Tower (Bologna).

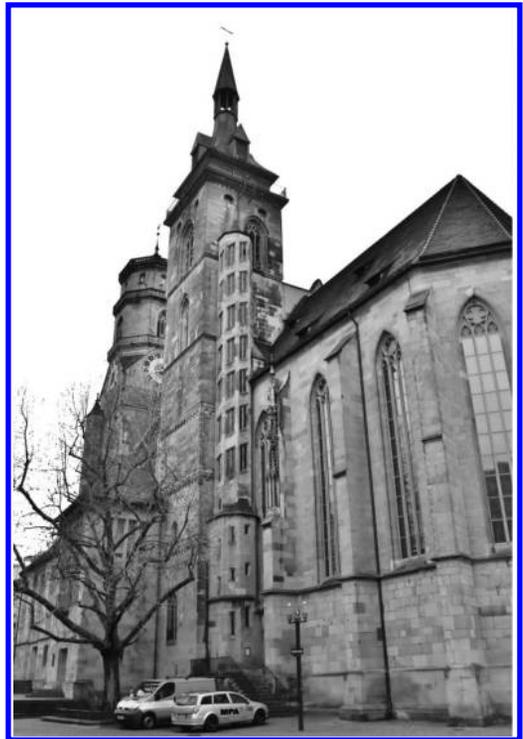
Figure 1. Stiftskirche Stuttgart. The examined southern tower and façade is shown in the picture's center. The exemplary radar measurements were carried out on the 4th floor (height of the adjacent cullis).

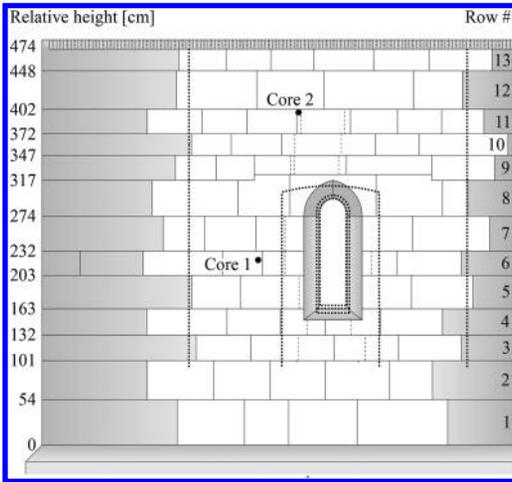
Figure 2. Measurement area on the 4th floor. The stone rows are consecutively numbered starting from the bottom. The light area marks the measured stone blocks. The dotted lines correspond to the window niche with a reduced wall thickness and the approximate extension of the interior room.

To examine the internal structure and condition of the tower's wall, an exemplary façade on the 4th floor (Figure 2) was assessed with radar. Based on the results, two cores were subsequently extracted at locations of former patch work for calibration and verification. The cores were additionally used for a salt analysis. For the radar assessment, each row was separately scanned in horizontal direction. Although this would have already been sufficient for an initial interpretation, the wall was also scanned vertically to gather supplementary data. A GSSI 1.6 GHz antenna was selected for the measurements.

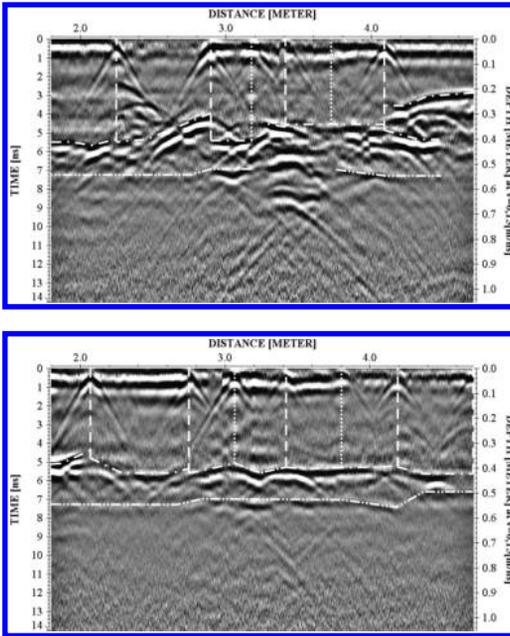
Figure 3. Radargrams from stone rows 4 (top) and 2 (bottom). The vertical dashed lines correspond to the joints, the dotted lines correspond to the cracks on the surface. The horizontal dash-dotted lines indicate reflection horizons. The wave speed in the sandstone was assumed with 0.15 m/ns according to the angle of the diffraction hyperbolas.

lines in both figures. This visibility is one of the key elements for measurements on structures made of natural stone. Although the reflections from the joints superpose the radargrams, they are also used to relate any found anomaly to the specific stone within the collective. The data interpretation can usually be based on the assumption that the stone dimensions act as geometric boundaries. That is, a significant change in the measured thickness can naturally only occur in the joints. If this is not the case, some particularity may be present.

Some obvious cracks in the stone surface were recorded during the measurements and are visible in the radargrams, similar to joints. They are marked with vertical dotted lines. It is generally not possible to draw conclusions about the crack depth from radargrams, although it could be assumed that cracks went through the entire stone. For one thing they extend into the stones parallel to the main direction of wave propagation, therefore only producing recordable reflections at salient steps. Moreover, the crack face distances are most likely rather narrow, which results in a poor visibility in the graph.

A considerable reflection is found in the very right stone in the upper graph, which suggests a strongly different thickness compared to the other stones. However, the stone is most likely not

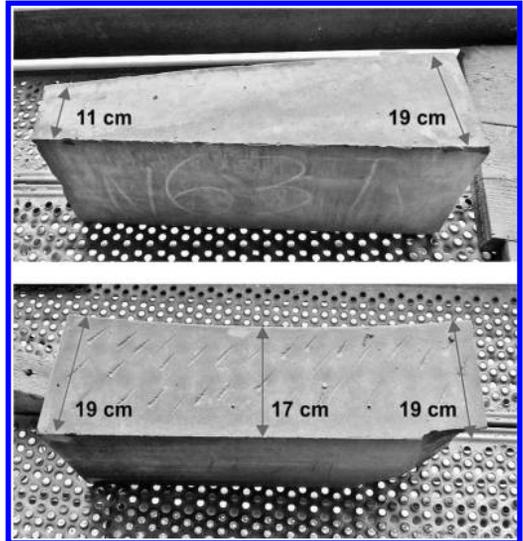
Figure 5. Sandstone ashlars used to calibrate the radar measurements and as model for stone blocks without mortar backfill.

The knowledge of actual stone thickness was not explicitly required for the data evaluation regarding their embedment conditions. In order to check the data for plausibility it is nevertheless desirable to obtain the wave speed of the tested material. Two sandstones of the same variety already on site for substitutions (Figure 5) were used to calibrate the measurements. Although having been freshly cut and thus most probably exhibiting slightly different properties compared to the installed ashlar, they can be used for a fair estimation of the velocity. Furthermore it was possible to use the stones as model for a block without connection, showing the same reflection characteristics as equivalent built-in ones.

The velocity was determined to be 0.137 m/ns for the fresh stones, which corresponds to typical values for dry sandstone. For an assumed thickness of 25 cm, a deviation of 0.02 m/ns would result in an inaccuracy of about ± 3.6 cm, which is acceptable for the given task.

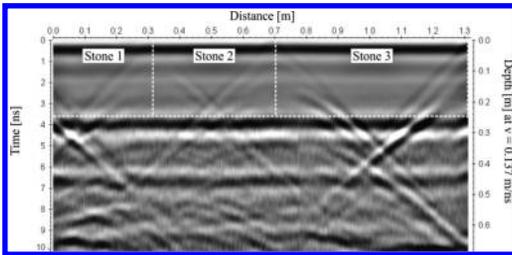
Figure 6. Example for a radargram with all three stones marked as intact.

the outermost stone layer, i.e. the curtain wall. In the data review, it was differentiated between three categories of reflection and hence three levels for possible voids. Figure 6 shows the unfiltered radargram of three intact stones with a close connection to the mortar in the vertical joint towards the structural wall. The signals are very clear up to the depth of the joint, which results from the notably plan stone surface and homogeneous stone. An ashlar with some peculiarity, in detail a greatly decreased thickness of only about 12 cm, is shown in Figure 7. However, the reflection amplitude is not as strong as it would be expected from a void. A probable explanation is a comparatively thin stone with a good contact to the mortar. Figure 8 is an example for a radargram including a stone without backfill mortar. It is easily recognized by

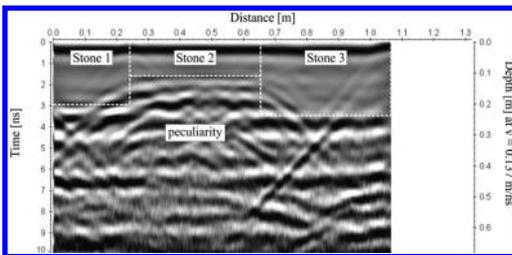
Figure 7. Example for a radargram featuring a peculiar stone.

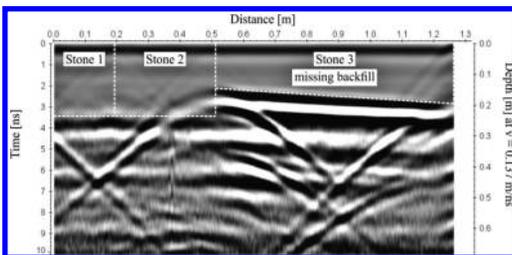
Figure 8. Example for a radargram with the typical reflection produced by a stone with missing backfill.

the strong reflection between 14 to 18 cm. One complementary classification was introduced to mark peculiarities which were detected well behind the curtain wall (Figure 9).

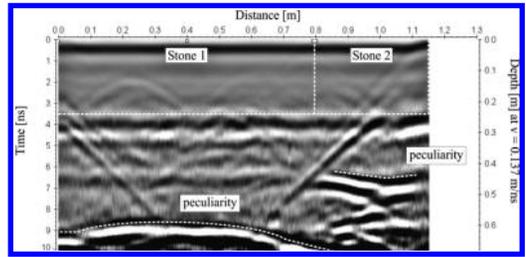
Figure 9. Example for a radargram with a detected peculiarity in a larger depth.

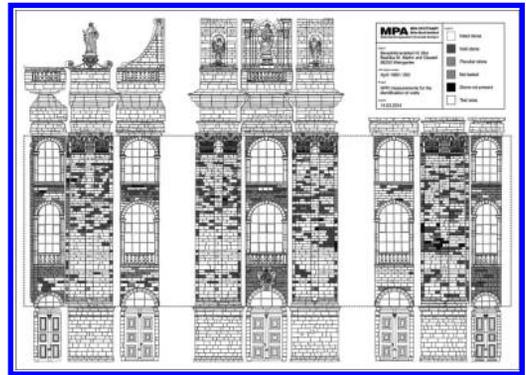
Figure 10. Overview charts of the measurement results, pinpointing the individual stones which require further attention.

The evaluation using categories allowed the creation of a readily understandable, color-coded overview chart, which maps the stone blocks according to their determined condition as “intact”, “peculiar” or “void” (Figure 10). It could be used to plan and to carry out the further constructional measures.

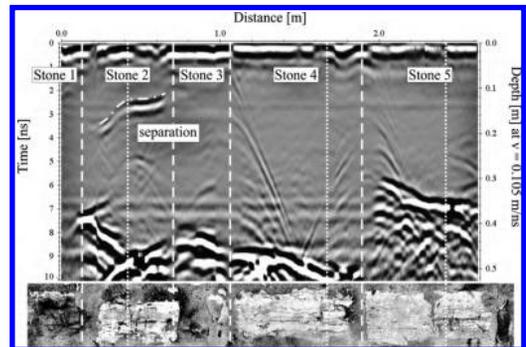
Figure 12 . Radargram of a wall section at the tower Blauer Turm. Stone 2 shows a separation in about 10 to 18 cm depth.

A picture of the measurement area is mapped below the radargram for easy comparison. The vertical dashed lines mark the joints between successive stones in both parts of the figure. Dotted lines indicate cracks that were visible on the surface. Some of the reflections from the cracks or joints seem to deviate from the straight vertical. The reason can either be an actual incline, which seems reasonable, or a tilt of the radar antenna, which is likewise a probable cause with regard to the quarried surface.

Most importantly for the evaluation, a shallow separation can be noticed in approximately 10 to

18 cm depth in stone number 2. None of the other ashlar show a hint for a similar defect. For stones two to five, the thickness can be read from the collected data to be about 45 cm. Stone five has a depth of 10 cm less. The reflection amplitudes are comparatively strong, which is a bit surprising, since limestone and lime mortar should have a similar electromagnetic wave speed. An explanation would be the existence of an air filled gap after the outer shell of the double wall. The phase information, however, is not well-defined in most parts. Only stone 5 features a black-white wiggle trace, which here stands for a reflection at an interface towards air.

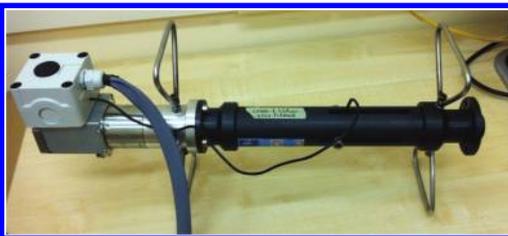
Figure 1. Penetrometer.

The penetrometer consists of: pin, drum, cylinder, worm screw, gearmotor, stepper motor, load cell, encoder, connecting cable (Figure 1). The pin is made of steel, has a diameter equal to 3 mm and a conic tip with angle equal to 27.5° . It is lodged into the drum, which slides inside the cylinder. The drum is driven, through the worm, by the gearmotor, which in turn is operated by the stepper motor. The cylinder head guarantees the correct alignment of the pin and enables to clamp the penetrometer to the plate, which in turn is anchored to the wall to be tested. The load is measured by a button load cell located between the end of the worm and the drum. The displacement of the pin is measured by the encoder. During the test, the penetrometer is linked to the control unit by the connecting cable.

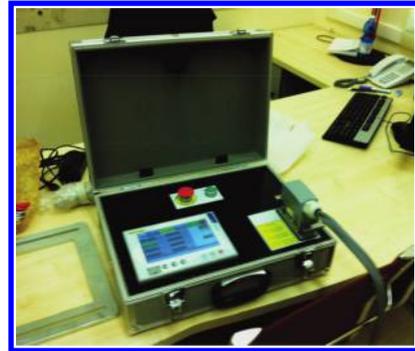
Figure 2. Control unit.

The control unit consists of: computer, batteries, multifunction plug (Figure 2). The control unit, featuring a touch screen, allows specifying the settings of the test (speed, acquisition step, initial and final displacements, maximum load), acquires the data during the test (displacement and applied load), pulls back the pin to the home position at the end of the test, records the data on a flash USB unit, enables to manually operate the pin, either at high or low speed, both configurable. During the test, the control unit displays in real-time the displacement of the pin and the applied load. The batteries allow executing the test without resorting to an alternating current supply. The batteries are charged through a proper cable connected to the multifunction plug.

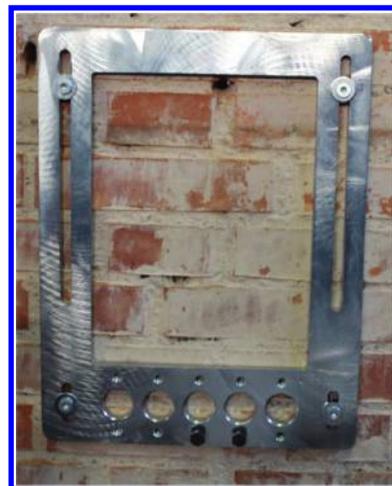
Figure 3. Lock plate.

The lock plate (Figure 3) is made of steel and is anchored to the masonry through expansion screws. The penetrometer is bolted to the plate. The

penetrometer can be mounted on the plate in five different positions, in order to perform as many penetrations on an individual joint. At the end of the test, the penetrometer is removed from the plate, which in turn is removed from the masonry, together with the expansion screws which can be reused.

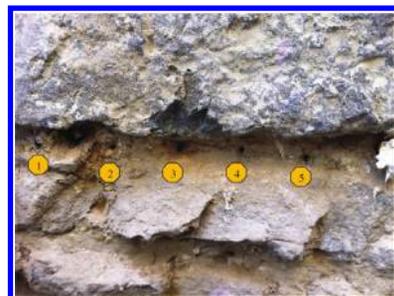
Figure 5. Residential building, Avigliano, panel A, detail after the test.

For the test on panel A (Figures 4–5) the end displacement has been limited to 60 mm. The load has been acquired at displacement step 0.10 mm.

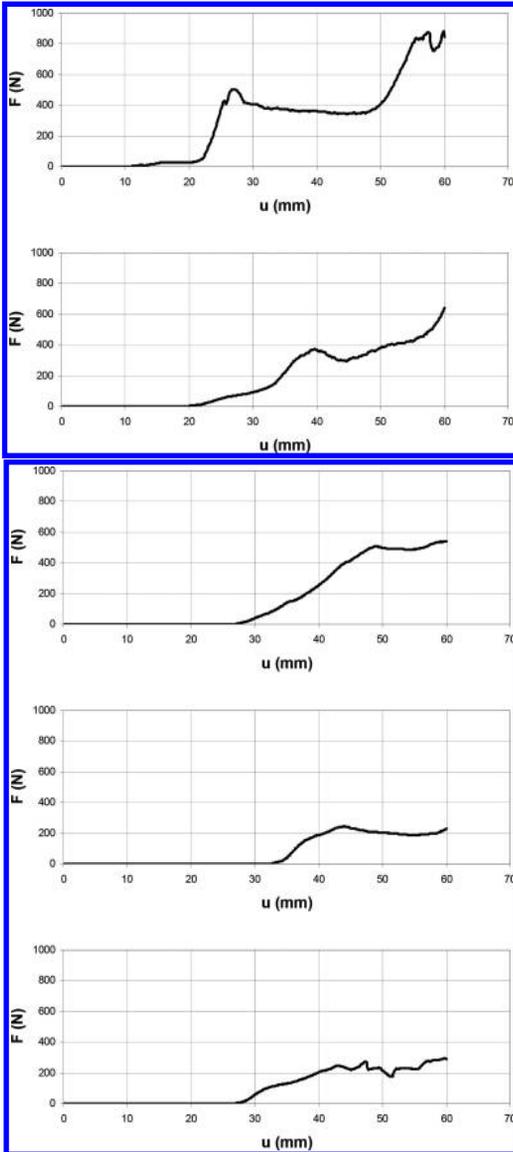
Figure 6. Load-displacement diagrams, residential building, Avigliano, panel A.

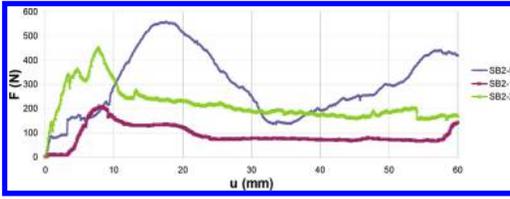
Figure 9. Load-displacement diagrams, San Biagio, Calimera, panel SB2.

Figure 9 shows the load-displacement diagrams of panel SB2. These put in evidence a different behaviour in the first 10–15 mm, corresponding to the repointing layer made by cement mortar, which is characterized by high stiffness and applied load, compared to the lower values found at deeper penetration, corresponding to lime mortar (15–60 mm).

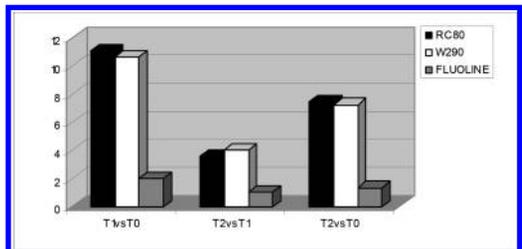
Figure 1. ΔE calculated by the values presented in Table 2 Ca' Granda Building. Milan.

the treatment (T_1) and monitored after 3 years of natural ageing (T_2). In *fig. 1*, the values of ΔE are reported: T_1 vs T_0 represents the difference induced by the application of the product; T_2 vs T_1 represents the difference induced by the ageing; T_2 vs T_0 represents the actual difference induced by the application, at the time of monitoring.

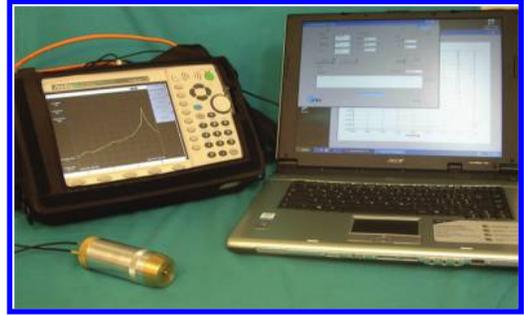
Figure 2. Measurement setup of SUSI instrument.

The proposed system measures both the real part and the imaginary part of permittivity in the microwave frequency range by evanescent field method (Evanescent-Field Dielectrometry) (Olimi, 2006). The support is investigated by the electric field that spills out from the aperture of the opened resonant cavity (a microstrip line short-circuited on one side and closed on a truncated coaxial line on the other side). In this case, the sensor is a truncated coaxial line closed on one side on the resonant circuit and on the other side opened on the material under investigation. *Fig. 2* shows the setup of the measurement system. It consists of a vector network analyzer (on the left in the picture), a probe (on the right in the picture), and a notebook on which is installed the software to control the instrument, as well as for the real time elaboration.

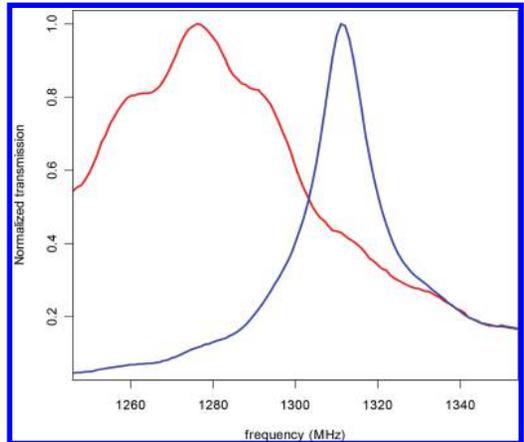
Figure 3. Normalized response of the resonant sensor on plaster with low moisture content and low salts content (blue line), and with high moisture content and high salts content (red line).

On *Fig. 3* is shown the sensor response, and it is characterized by the resonant frequency (the peak of the curve), and by the width of the bell curve (bandwidth). The permittivity is determined starting from these electrical parameters, and by a dedicated algorithm are derived the diagnostic parameters: moisture content (MC) and salts index (SI).

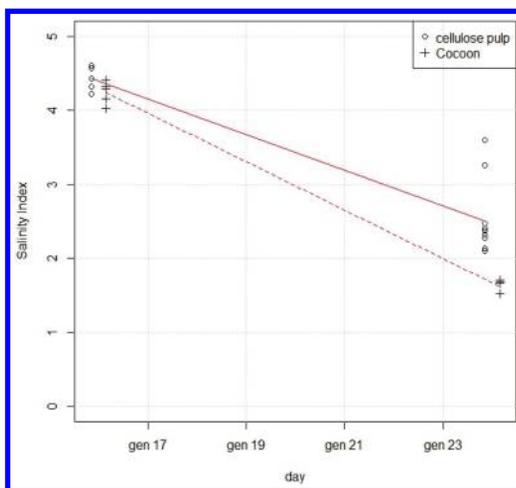
Figure 5. Plots of Salinity Index for two kinds of extractive poultices.

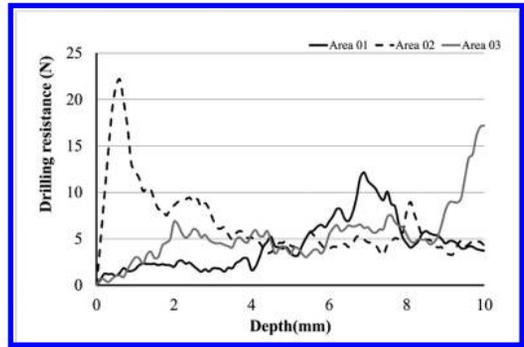
The results for all areas show a great heterogeneity, because of the presence of lithic fragments and/or scoria behind the surface (highlighted by peaks of cohesion profile with values of about 12–15 N), of superficial crusts and of different state of conservation (highlighted by different value of drilling resistance). The following specific situations were identified (Fig. 7):

Area 1: poor state of conservation of the external part with mean value of drilling resistance ranging from about 2–3 N in the outer layer to about 6 N in the inner part; Area 2: good state of conservation of the external part with the presence of a crust (maximum value 22 N) even if not homogeneously present. It is no clear if this crust is natural, due to

Figure 7. Drilling resistance profiles of the different area in Sovana archaeological site (Grosseto-Italy).

dissolution/re-precipitation phenomena, or artificial due to previous consolidant treatments; Area 3: medium state of conservation with average value of the drilling resistance of about 6–7 N, but with a surface layer showing lower cohesion features (about 3 N). On the basis of the drilling resistance data and by observing the different cohesion profiles the following maintenance suggestion can be drawn for a consolidating treatments and its monitoring: 1. the treatment is indicated only for Area 1 and 3 being the Area 2 in good state of conservation and does not needing a consolidation; 2. the concentration of consolidating treatment applied for the two areas must be different due to the different state of conservation, being more concentrated for Area 1. To monitor the treatment effectiveness during time a drilling monitoring every second year is suggested. Anyway it should be taken into account the high number of drilling tests to overcome the great heterogeneity of the material.

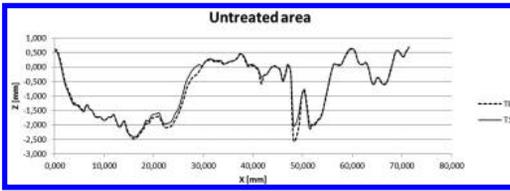
Figure 8. Comparison of the horizontal profiles at T_0 and T_1 of the untreated surface.

entire surface has been carried out on the area to be treated. After one month from the application of the product, the same area was investigated proposing the same shooting conditions: distance between the camera and the surface, acquisition step (the distance between the snapshot). The two models were subsequently superimposed: a special procedure in MathLab, developed specifically to improve the alignment of the models, allowed to extract the profiles of surface roughness to verify the modifications of the surface. The same procedure was also repeated on an untreated area close to the treated area, in order to use it as a control. The comparison of the profiles shows that at one month after the application the untreated area presents a light loss of material (Fig. 8), on the contrary for the treated area there were no changes on the surface (Fig. 9).

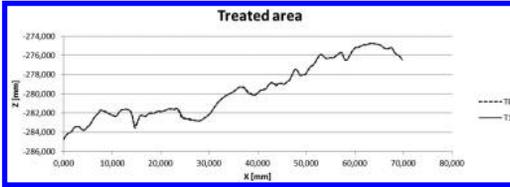
Figure 9. Comparison of the horizontal profiles at T_0 and T_1 of the treated surface.

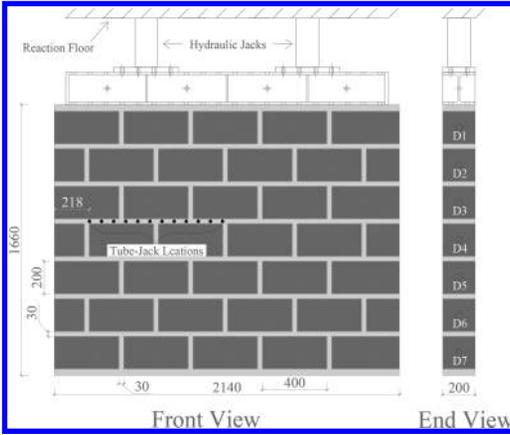
Figure 1. Design, loading configuration of the regular masonry wall, and location of tube-jacks, dimensions in mm (Manning et al., 2014b).

The masonry wall used for the tube-jack test was loaded using two hydraulic jacks centered on a steel profile above the wall, as shown in Figure 1. Before, during and after the test the load was checked and maintained. The stress level at the joint used for the test, the 4th joint up from the base of the wall, was calculated to be 0.22 MPa based on the pressure in the hydraulic jacks and the weight of the masonry above the joint.

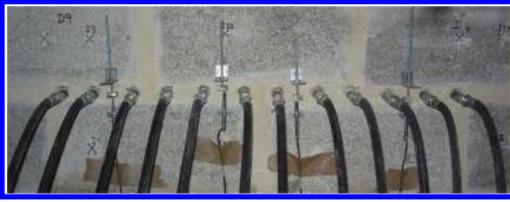
The holes for the tube-jacks were spaced approximately 7.5 cm from center to center. Eight linear variable displacement transducers (LVDTs) were used, four on the front of the wall and four on the back. The placements of the LVDTs were between

Figure 2. Tube-jacks inserted into holes drilled in the 4th horizontal mortar joint and spacing of LVDTs.

the 2nd and 3rd holes, between the 5th and the 6th holes, between the 7th and the 8th holes, and between the 10th and 11th holes, on both sides of the wall. They were labelled LVDT 1 through 4, respectively, on the front of the wall and LVDT 5 through 8, respectively, on the back of the wall.

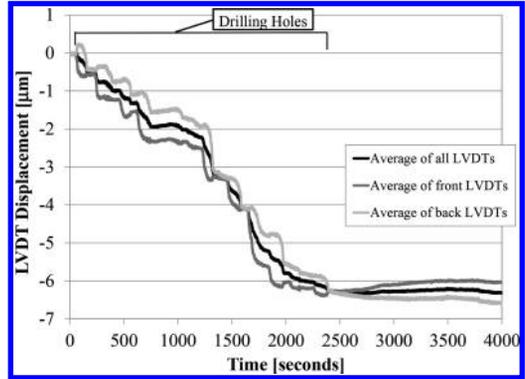
The results of the hole drilling are presented in Figure 3. Since the difference between the average LVDT displacement on the front and the back of the wall is relatively small, the hole drilling did not cause bending or uneven downward displacement of the wall.

Figure 3. Average LVDT results during drilling of the holes (Manning et al., 2014b).

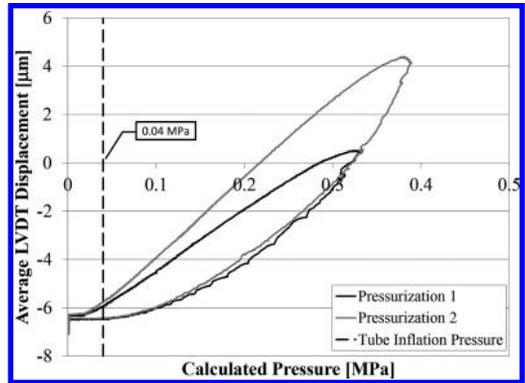
After the movement of the LVDTs had reduced to nearly zero, the rubber tube-jacks were inserted into the holes and pressurized. The results are shown in Figure 4. The calculated pressure takes into account the jack calibration factor and the area correction factor. Two pressurization cycles were conducted; the first one to 0.33 MPa calculated pressure (0.50 MPa water pressure) and the second to 0.39 MPa calculated pressure (0.60 MPa water pressure). The tube-jacks were consistent in loading the wall in both pressurization cycles as shown by the two curves overlapping during

Figure 4. Tube-jack test results: calculated pressure versus average LVDT displacements. (Manning et al., 2014b).

the loading phase. The average LVDT displacements return to zero at a calculated pressure of 0.32 MPa. Given the tube inflation pressure of 0.04 MPa, the estimated local state of stress for this test was 0.28 MPa. Further research is currently being done to better understand the difference between this state of stress result from the tube-jack test, 0.28 MPa, and the calculated state of stress, 0.22 MPa (difference of 0.06 MPa).

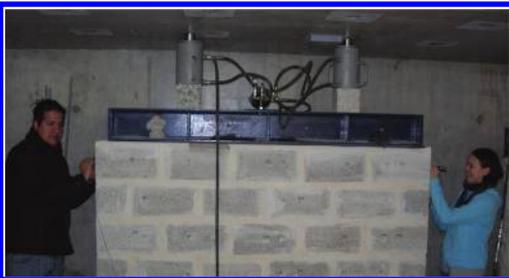
Direct and indirect sonic tests were performed using these points. In the direct tests, the sonic wave was transmitted by hitting the point on one end of the wall and receiving the wave at the same level on the other end of the wall with an accelerometer (Figure 5). To distinguish the direction of travel of the waves, the point combination was labeled with point name, the side of transmission, and then the side of reception, “L” for left and “R” for right. For example, a wave transmitted from point D1 on the left end of the wall to point D1 on the right end of the wall would be labeled, “D1 LR”.

Figure 5. Direct sonic testing on the regular masonry wall.

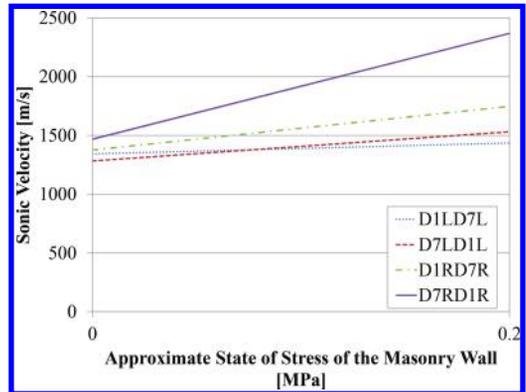
The vertical indirect sonic tests performed on the ends of the wall at 7 weeks showed an increase in sonic velocity when the stress level was increased from zero to 0.2 MPa. The amount of increase varied greatly between the four point combinations (Figure 6).

Figure 6. Results of the indirect sonic velocity tests performed at two different stress levels, 0 MPa and 0.2 MPa, 7 weeks after the construction of the wall.

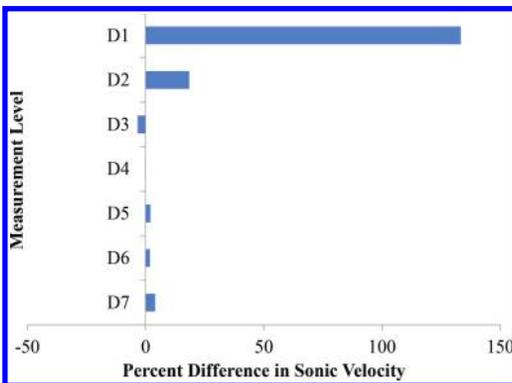
Figure 7. Results of the direct sonic velocity tests performed 7 weeks after the wall was constructed: percent difference in sonic velocity when the stress was increased from zero to 0.2 MPa.

One possibility for the difference in sonic velocity at the top of the wall is that the waves passing through the top levels of the masonry were affected by the steel profile above the wall. However, the steel profile was positioned on top of the wall before any of the tests were conducted. Another possibility for the increase in sonic velocity at both the top and bottom of the wall is the confinement of the masonry at these levels. The steel beam and the concrete floor beneath the wall both confine the masonry when load is applied to the wall.

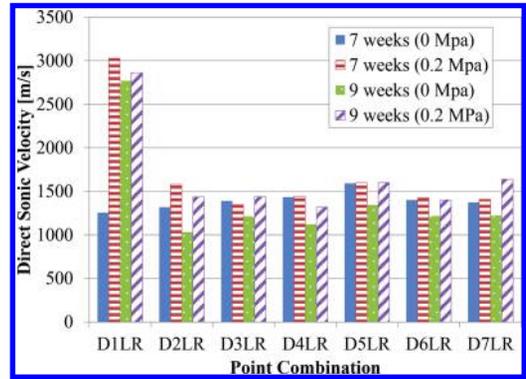
Figure 8. Comparison of direct sonic test results for stress levels of zero and 0.2 MPa at 7 and 9 weeks after construction.

Finally, the results of the direct tests performed from the left side of the wall to the right side of the wall were compared for both stress levels at 7 weeks and 9 weeks (Figure 8). The results show that for almost all point combinations the direct sonic velocity decreased between the 7th week and the 9th week. This could be due to cracks or voids forming as the mortar between the joints continued to harden. The results also show that the direct sonic velocity increased for all point combinations when the wall was loaded to a stress level of 0.2 MPa at 9 weeks.

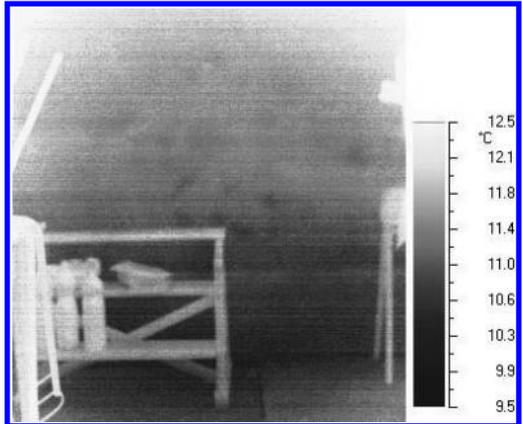
Figure 3. IRT of the northern side of the Sacristy, the colder area at the bottom of the wall indicates the presence of moisture, as the results of the gravimetric tests confirmed.

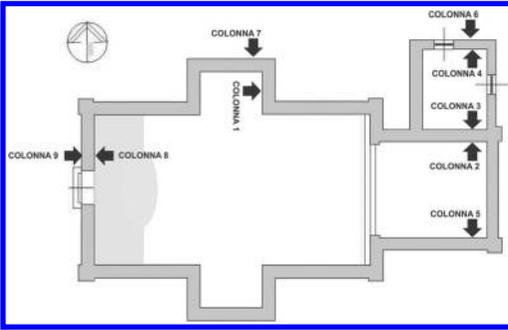
Figure 4. Location of the samples of the gravimetric tests.

The samples 1.1, 4.1 and 4.2 have very high water content.

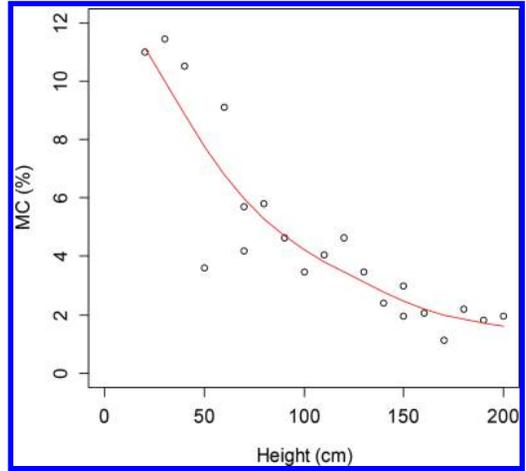
Figure 6. Vertical behaviour of MC on the Sacristy wall.

EFD measurements in the Sacristy have been conducted on a vertical axis passing through the sample locations and on three horizontal axis located at 25, 60 and 130 cm from ground. The results are shown in Figures 6 and 7. The moisture content, as expected, decreases with the increase of the height from the floor.

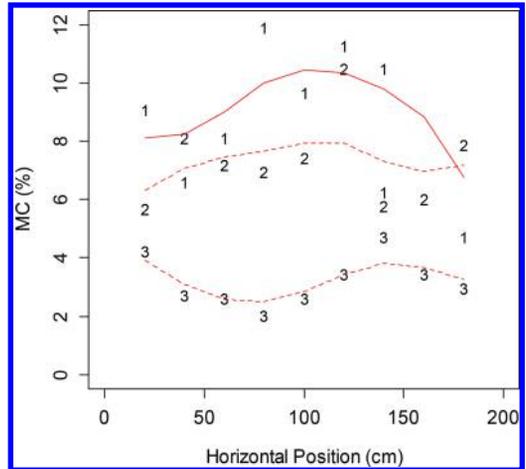
Figure 7. Horizontal behaviour of MC on the Sacristy wall.

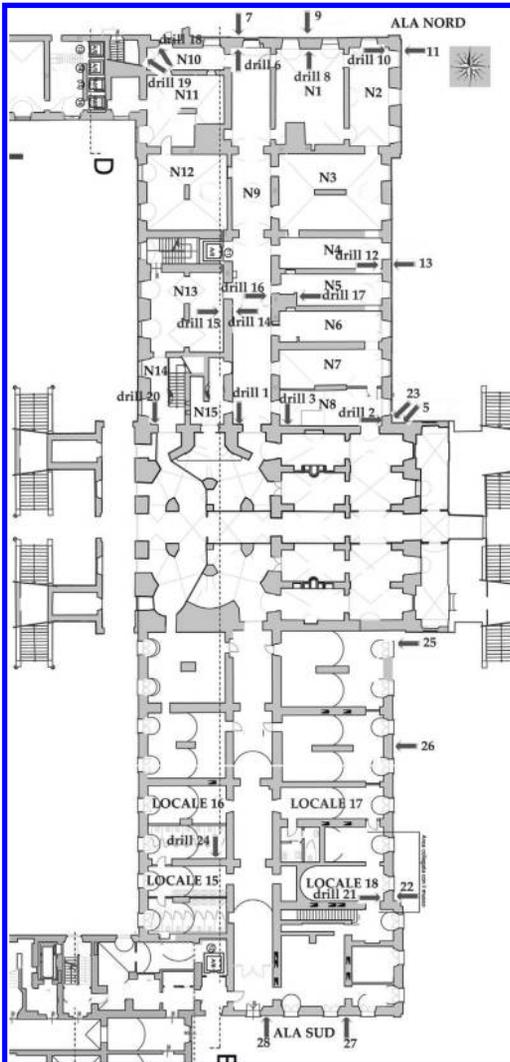
Figure 8. Royal Villa, location of the samples of the gravimetric tests at the underground level.

Gravimetric tests permitted to distinguish the areas where really rising damp occurred, especially in the rooms n 1, 2, 5 and 13 at half of the northern wing, at level -1.

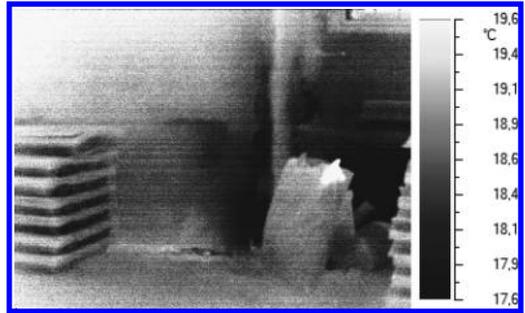
Figure 10. Royal Villa, composite of thermograms the interior of room n.1.

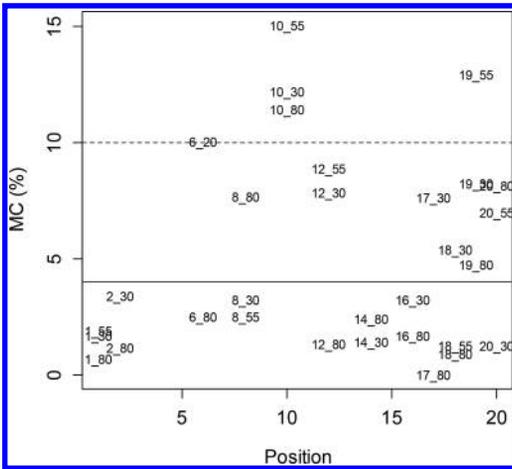
Figure 11. Deep MC on internal walls measured by MRM.

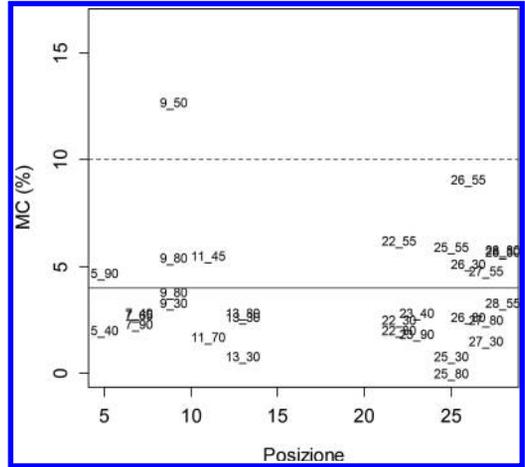
Figure 12. Deep MC on external walls measured by MRM.

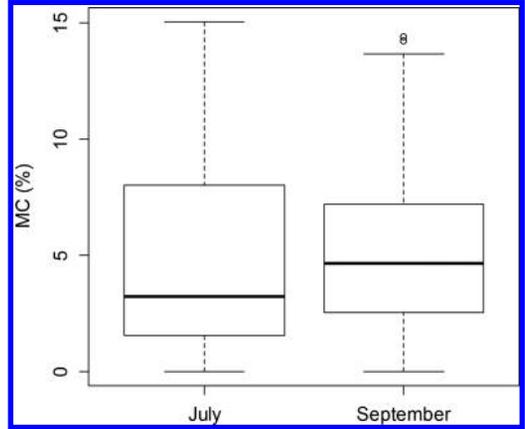
Figure 13. Season statistical distribution of deep MC on internal walls.

Moisture measurements have been repeated at the end of the summer period, to verify the changes in the MC distribution in the internal and external walls. From MRM measurements the statistical distribution of internal MC's appears unchanged from July to September, while the external distribution is clearly shifted to higher MC values (see Figure 13 and 14).

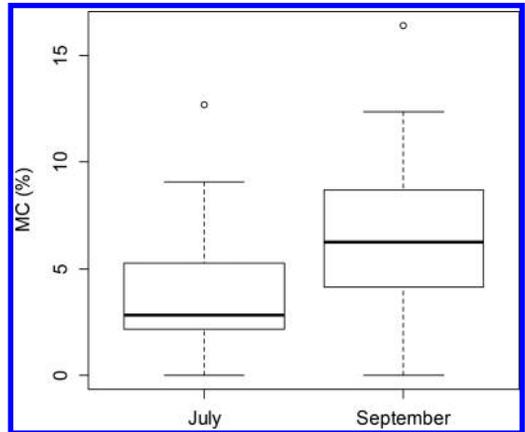
Figure 14. Season statistical distribution of deep MC on external walls.

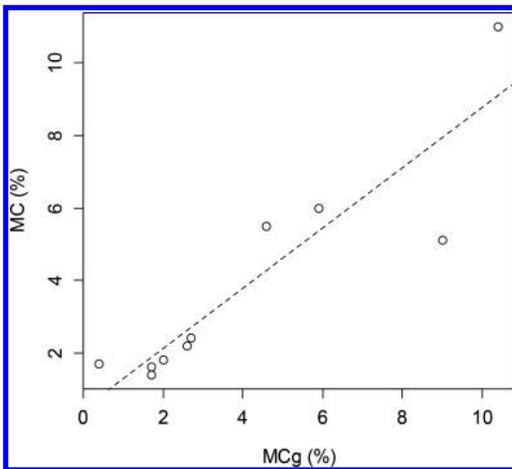
Figure 15. Correlation between dielectric (MC) and gravimetric (MCg) moisture content.

the case of high values of Wc (above 8%) and in the case of very low Wc (below 3%) for porous materials as lime mortars, bricks and highly porous stones. The agreement for sub-superficial measurements (depths up to 2 cm) is very good also for intermediate values, in particular when in presence of an homogeneous material having a flat surface, as in the first case study. Figure 15 shows the correlation between gravimetric and dielectric MC in that case: the R^2 is higher than 0.8.

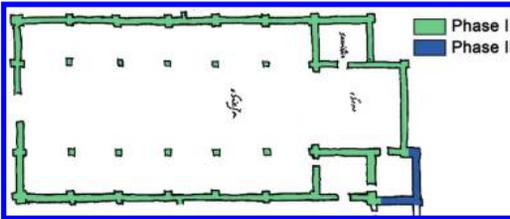
Figure 2. Building phases in a plan dated back to 1572.

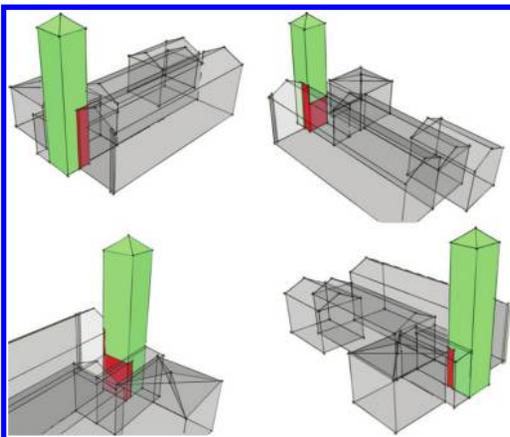
Figure 3. Reconstruction of the interaction between the Church apse and the Bell-Tower.

In more details, the analysis of the discontinuities highlights that the bell tower is composed, from the base up to about the height of the church, from portions of walls not connected: during the construction of the tower (Fig. 3 and 7), its load-bearing walls were just leant against the existing walls of the church (but not toothed or linked) in the south, east and north part. The discontinuities due to the building phases look very sharp,

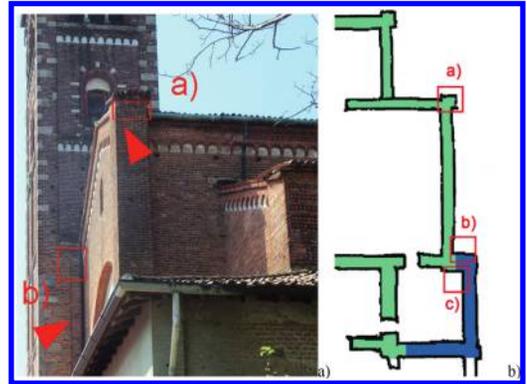
Figure 4. Localisation of the decoration of the first building phase.

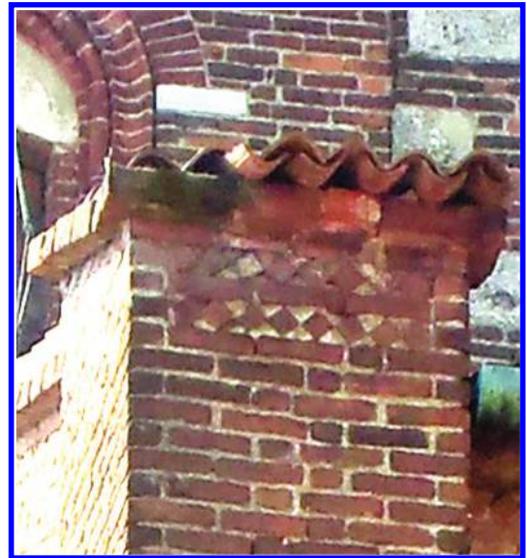
Figure 5. Detail of the decoration of the first building phase called a) in Figure 4a, b.

The direct survey led to this conclusion, observing the masonry discontinuities and the traces of brick decoration on the pilaster of both the church apse and embedded in the tower walls (Figs. 5–7).

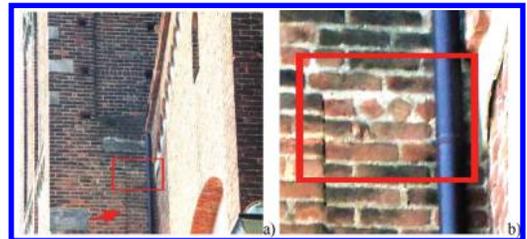
Figure 6. Localisation (a) and detail (b) of the decoration of the first building phase in the position b) in Figure 4a, b.

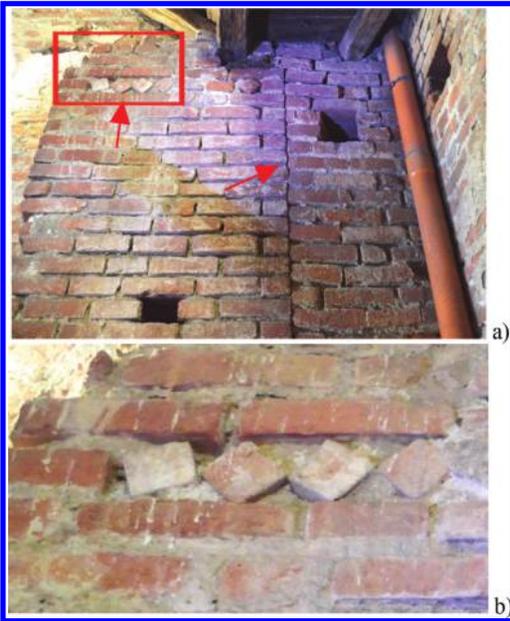
Figure 7. Localisation (a) and detail (b) of the decoration of the first building phase in the position c) in Figure 4a,b in the indoor and of the sharp discontinuity due to the building phase.

demonstrating the lack of connection between the portions (Fig. 7). Above the church height, the masonry texture seems homogeneous from the structural continuity point of view, even if several cracks are present.

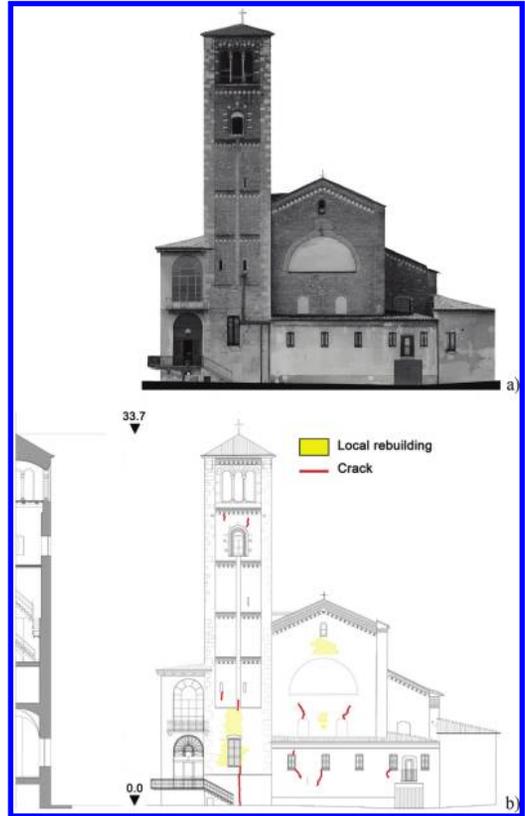
Figure 8. Orthoplane (a) and geometric survey of the East front of the Bell-Tower and of the Church apse. Cracks and local rebuilding are mapped.

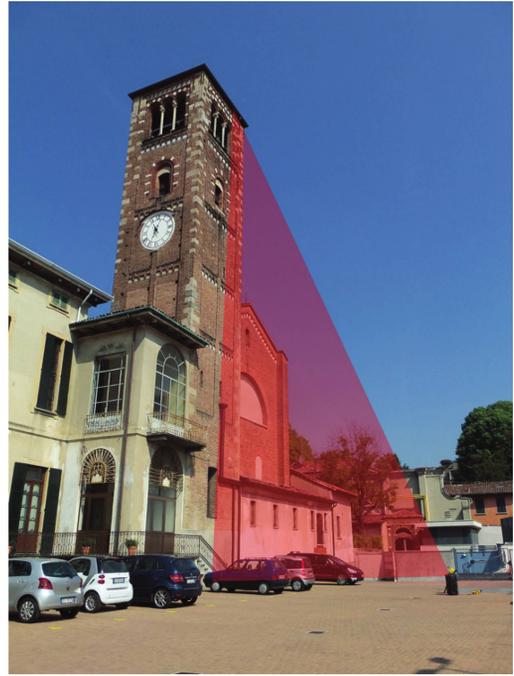
Figure 10. Test layout.

Simultaneously measuring the displacement of several points on a large structure, by using a radar, involves two key steps (Gentile & Bernardini 2008, Gentile 2010): (a) acquiring consecutive radar “images” of the structure (Fig. 10) at an appropriate sampling rate, with different points of the structure being individually observable in each image; (b) using the phase variation of the back-scattered microwaves coming from each detected target point at different times to evaluate the displacement. Hence, the main information provided by the radar technique are the synthetic image of the scenario and the time histories of the points in the scenario that characterized by a good electromagnetic reflectivity.

and to the tower front toward the underground car park (Fig. 10). The investigation identified the first dominant vibration mode of the tower in the East-West direction equal to 1.93 Hz.
