Emerging Technologies in Non-Destructive Testing VI

Editors

D.G. Aggelis & D. Van Hemelrijck

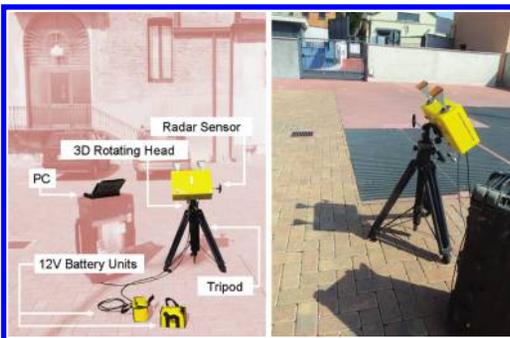
Figure 9. View of the microwave interferometer (IDS, model IBIS-S).

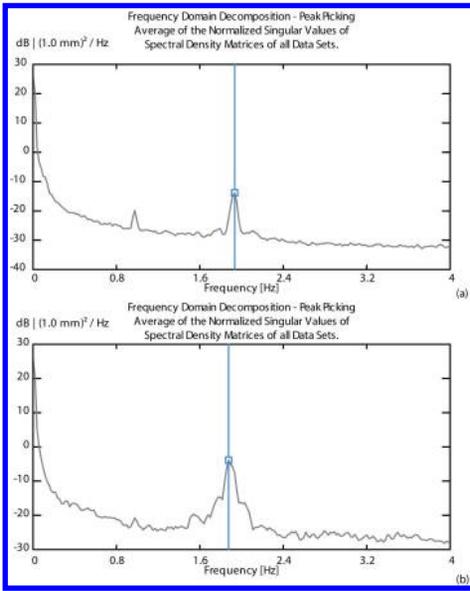
Figure 11. Singular Value Line and identification of the fundamental frequency from radar data: (a) micro-tremors; (b) random swinging of bells.

and to the tower front toward the underground car park (Fig. 10). The investigation identified the first dominant vibration mode of the tower in the East-West direction equal to 1.93 Hz.

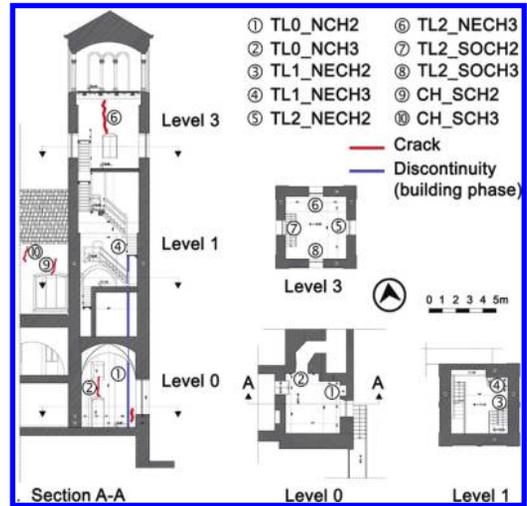
Figure 12. General layout of the monitoring system.

The damage observed on the repaired cracks suggested the monitoring of the main cracks. In order to control the opening variations of the macroscopic cracks, 10 displacement transducers were installed at different level of the tower and connected to a wireless data logger for the automatic data acquisition, storage and transmission by modem GSM-GPRS. Figure 12 shows the general layout of the monitoring system in the tower, installed on June 2014 and still active.

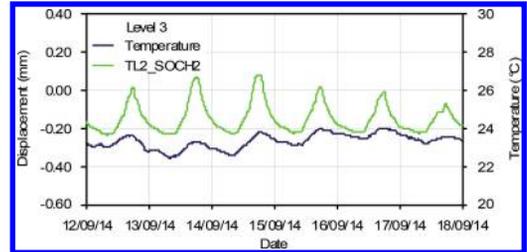
Figure 13. Temperature and TL_SOCH2 displacement variation measured between 12.9.2014 and 18.9.2014 at Level 3.

Figure 13 shows the great influence of daily variation of temperature on the width variation of some cracks (Fig. 14). Dominant temperature behaviour affects the cracks on the South side of the Church, with nearly linear correlation.

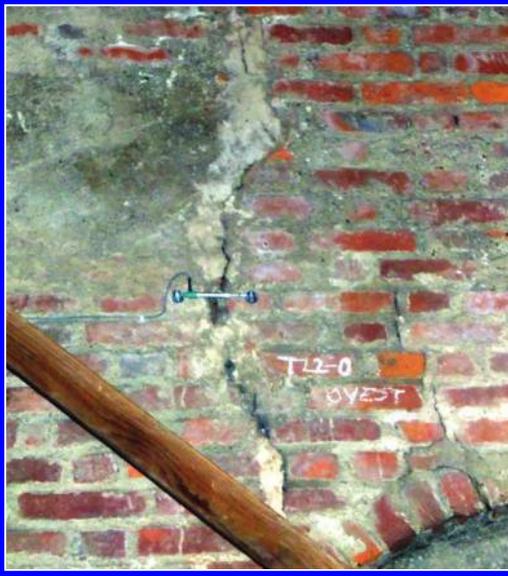
Figure 14. Detail of the localisation of the TL_SOCH2 transducer at Level 3 (Fig. 12).

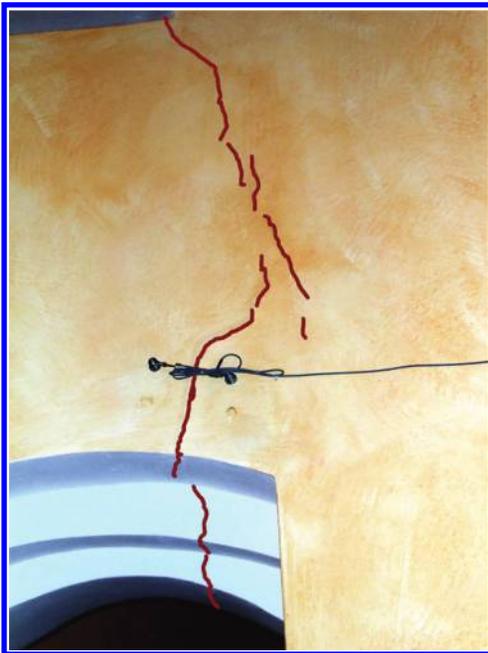
Figure 15. Detail of the localisation of the TL0_CH2 transducer at Level 0.

After 10 months, the most considerable opening of the cracks seems affecting the ground level (Fig. 15). Despite the temperature influence, with a slightly closing with temperature increasing (Fig. 16), an incremental trend of the measured displacements is recognizable by plotting the displacement vs temperature. The trend of the displacement measured by the two sensors shows a

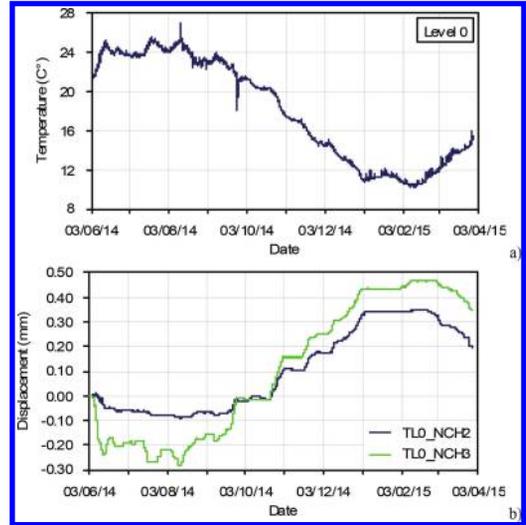
Figure 16. Temperature (a) and displacement measured at Level 0 in 10 months.

good agreement between the two set of data. This seems to confirm the movement at the foundation level and the effect induced by the underground structures.

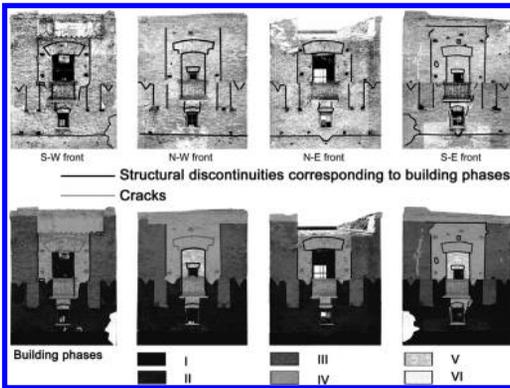
Figure 3. Map of the structural discontinuities and of the supposed building phases: (i) main building up to about 46.0 m; (ii) subsequent addition; (iii) adding of 4 corner piers; (iv) opening infilling and construction of the windows, crowning and the new roof; (v); repair of the South corner.

least six main building phases (Fig. 3) and a clear change of the brick surface workmanship at about 8.0 m from the top. Visual inspection performed by using a movable platform after the Italian seismic sequence of May 2012 (Saisi & Gentile 2015) highlighted two different structural conditions for the tower: (a) in the main part of the building, up to about 46.0 m from the ground level, no evident structural damage is observed and the materials are mainly affected by superficial decay (b) the upper portion of the tower (i.e. the top 8.0 m) is

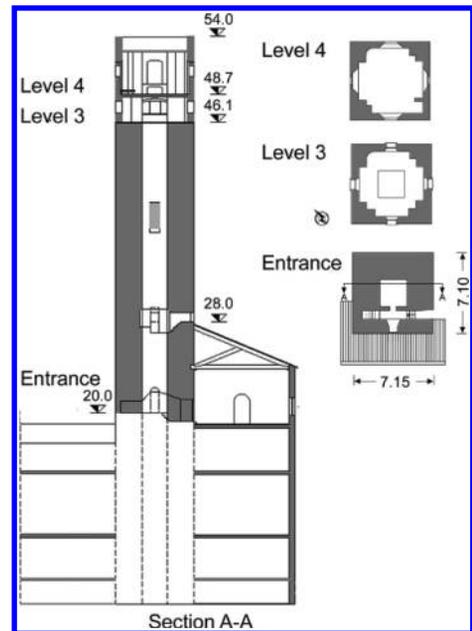
Figure 5. Section of the *Gabbia* Tower.

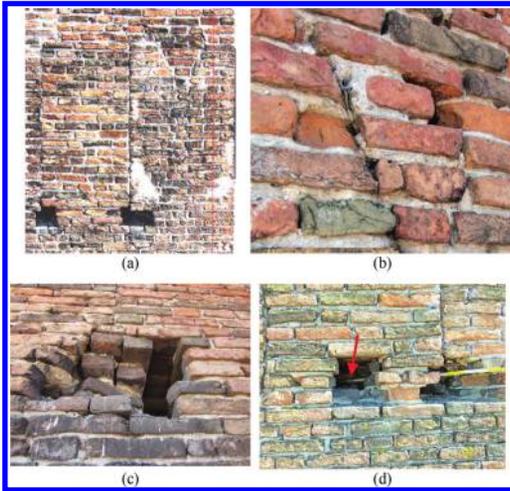
Figure 6. Details of the typical damage and discontinuities on the top of the tower: (a) discontinuities due to the merlons embedded in the masonry texture; (b) weakness of the connections; (c)-(d) infillings between the supposed merlons on the N-W front.

characterized by extensive masonry decay, traces of past structures on all fronts and merlon-shaped discontinuities (Fig. 3). The poor state of preservation and the vulnerability of the top levels of the structure were confirmed by the results of pulse sonic tests.

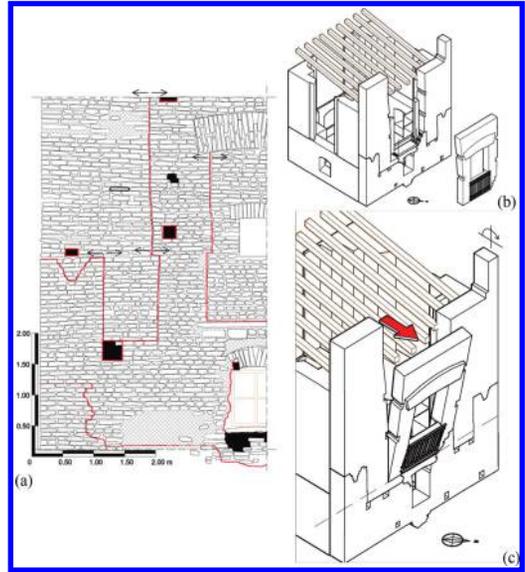
Figure 7. (a) Example of map of the structural discontinuities; (b) identification of the weakly restrained masonry portions and (c) of the possible overturning mechanisms due to seismic actions.

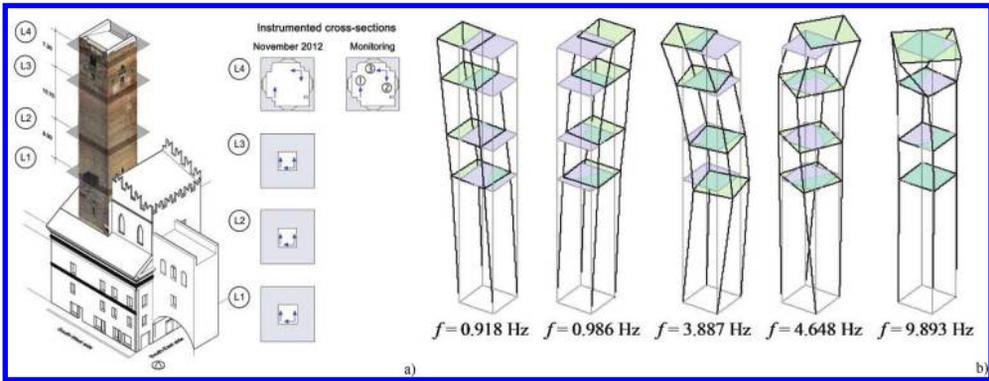
1. two closely spaced modes were detected around 1.0 Hz. These modes are dominant bending (modes B_1 - B_2) and involve flexure in the two main planes of the tower, respectively;
2. the third mode (mode B_3) involves dominant bending in the N-E/S-W plane with slight components also in the orthogonal N-W/S-E plane;
3. the fourth mode (mode T_1) is characterized by dominant torsion until the height of 46.0 m and coupled torsion-bending of the upper level. The local behavior of the top region of the tower, which alters what would otherwise be classified as a pure torsion mode, can be conceivably associated to the effect exerted by the wooden roof, laying directly on the weakest part of the structure;
4. a local mode (L_1) was identified at 9.89 Hz and involved torsion of the top levels of the tower. The presence of a local mode provides

Figure 8. (a) Sensors layout (dimensions in m) adopted in the preliminary AVTs and in the continuous dynamic monitoring of the *Gabbia* tower; (b) Vibration modes identified in the preliminary AVT (SSI-Data, 27/11/2012).

(Fig. 8a). The mentioned presence of a metallic scaffolding and a wooden roof allowed to install all the accelerometers on the inside of the load bearing walls.

The modal identification was performed using time windows of 3600 s and applying the data-driven Stochastic Subspace Identification method (SSI-Data, van Overschee & de Moor 1996) available in the commercial software ARTEMIS (SVS 2012). Notwithstanding the very low level of ambient excitation, 5 vibration modes could be identified within the frequency range 0–10 Hz (Fig. 8b):

It should be further noted that the wooden roof, even if very light, is not only directly supported by the weakest structural part of the tower but is also slightly inclined in the N-E/S-W direction (as schematically shown in Fig. 8a). The roof slope, the redundant connection with the masonry walls and the thermal effects might induce not negligible thrusts on the structural walls, already very vulnerable due to the extensive decay and the lack of connection between the different additions.

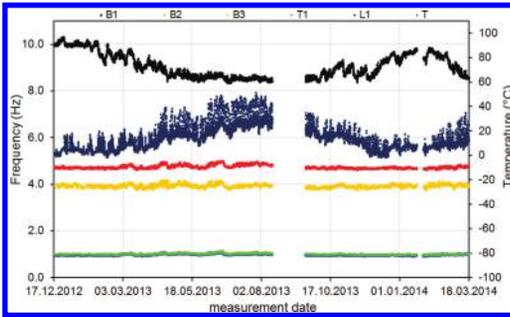
Figure 9 shows the evolution in time of the outdoor temperature on the S-W front and of the automatically identified modal frequencies. The temperature tracking reveals large fluctuations, between -2°C and 45°C , with significant daily variations in sunny days. A closer inspection also highlights that the natural frequencies of the global modes (B1-B3 and T1, Fig. 8b) seem to vary accordingly with the outdoor temperature. This relationship can be better investigated by plotting each frequency with respect to the recorded temperature. Figure 10 shows the results obtained for modes B1 and B2 along with the best fit lines.

Figure 9. Variation of temperature and identified natural frequencies between 17/12/2012 and 17/03/2014.

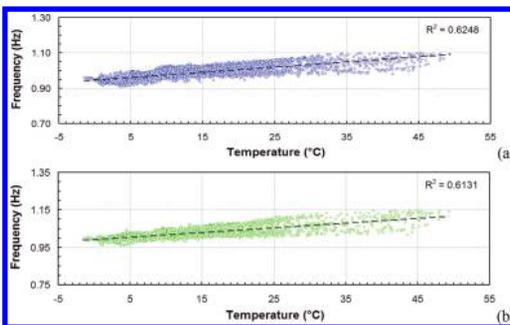
The two plots, referred to the period between 07/01/2013 and 14/06/2013, confirm that the frequency of global modes tends to increase with increased temperature. This behavior, observed also in past experiences on masonry towers (Ramos et al. 2010, Gentile et al. 2012), can be explained through the closure of superficial cracks, minor masonry discontinuities or mortar gaps induced by the thermal expansion of materials. Hence, the

Figure 10. Natural frequency of modes B₁ (a) and B₂ (b) versus outdoor temperature between 07/01/2013 and 14/06/2013.

temporary “compacting” of the materials induces a provisional increase of stiffness and modal frequencies, as well.

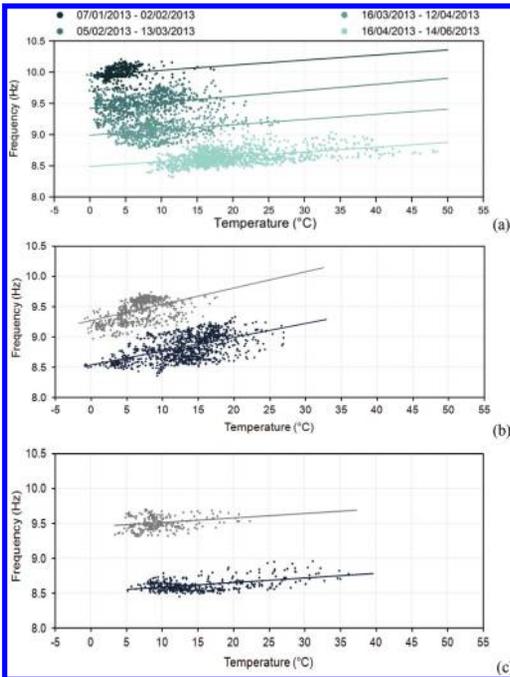
Figure 11. Natural frequency of mode L_1 plotted versus outdoor temperature in the time intervals: (a) 07/01/2013–14/06/2013; (b) 15/10/2013–15/01/2014; (c) 10/02/2014–17/03/2014.

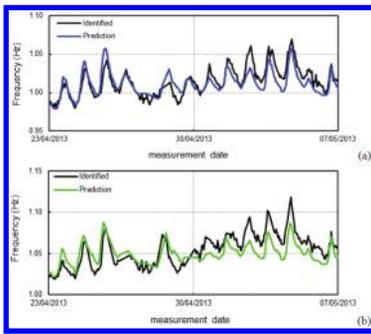
The comparison between identified natural frequencies and corresponding numerical predictions (Fig. 12) highlights a very good accordance, providing a sound validation of the selected model.

Figure 12. Typical prediction of natural frequencies obtained from a dynamic regression model: (a) Mode B1; (b) Mode B2.

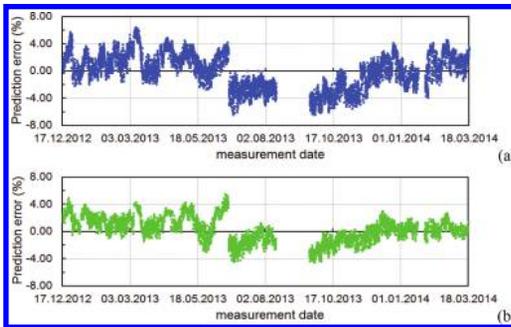
Figure 13. Change in the prediction error induced by the seismic event of 21/06/2013: (a) Mode B1; (b) Mode B2 (Dynamic regression model calibrated using data collected from 17/12/2012 to 20/06/2013).

changes. In the present application, natural frequencies have been predicted from 21/06/2013 to 17/03/2014, in order to detect possible structural effects due to the earthquake. Typical results are presented in Figure 13 for modes B1 and B2.

1. before the seismic event, the prediction error is characterized by fluctuations between -2 and 5% and does not exhibit sudden drops;
2. a clear drop of the prediction error is detected corresponding to the seismic event; in particular, the error increases (exceeding the -2% limit and reaching -4%) and departs from the previous trend. Furthermore, the error no longer oscillates around 0% but is now characterized by a negative offset;
3. during the following weeks, the prediction error neither decreases nor gets back to the original trend. At the opposite, it hovers around the new offset for few weeks and further increases after the summer period (from -4% to -6%);
4. from mid-November 2013 the difference between experimental and predicted natural frequency

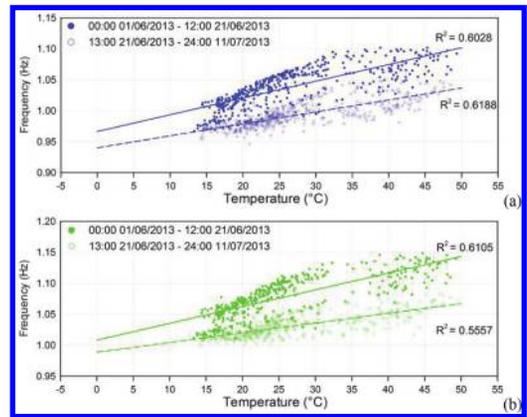
Figure 14. Change in the frequency-temperature correlation induced by the seismic event of 21/06/2013: (a) Mode B1; (b) Mode B2.

decreases, as the outdoor temperature decreases too. This behavior can be better understood by inspecting the frequency-temperature relationship before and after the earthquake. The results of this check are summarized in Figure 14, where 3 weeks before and 3 weeks after the earthquake have been considered: the regression lines exhibit a remarkable variation after the seismic event, with the range of temperature variation being almost unchanged. It can be also observed that the difference between the experimental frequencies identified before and after the earthquake decrease with a decreased temperature. As a consequence, for low temperatures, the regression model calibrated over the first 6 months of monitoring still provides quite accurate predictions.

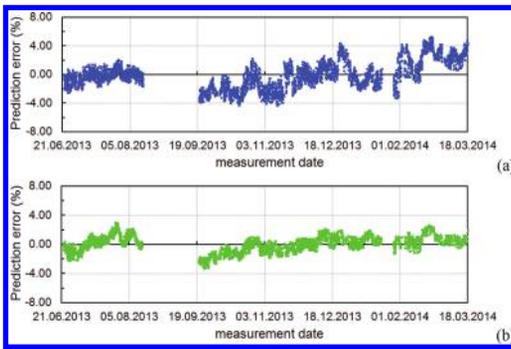
Indeed, a new dynamic regression model has been calibrated between 21/06/2013 and 06/01/2014 and used to predict the natural frequencies until 18/03/2014. The prediction error obtained for modes B1 and B2 (Fig. 15) allows the following comments:

1. the previously observed negative offset is no longer detected as the error oscillates around 0% ;
2. the prediction error now exhibits smaller fluctuations, between -4 and 4% for mode B1 and between -3 and 3% for mode B2;
3. after the summer period, a minor drop can still be detected. This behavior might suggest possible

Figure 15. Change in the prediction error induced by the seismic event of 21/06/2013: (a) Mode B1; (b) Mode B2 (Dynamic regression model calibrated using data collected from 21/06/2013 to 06/01/2014).

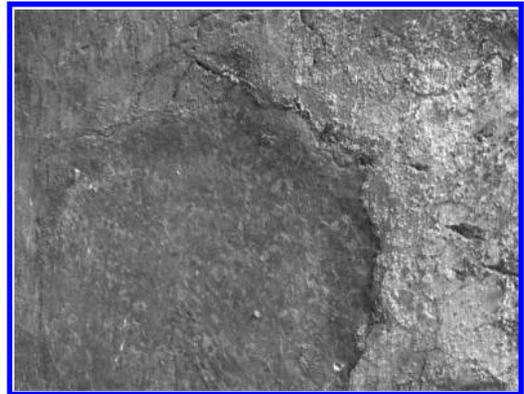
Figure 1. Sample 1 C. White efflorescences are concentrated alongside the border of a patch which is composed by a different cement mix respect to the surrounding matrix.

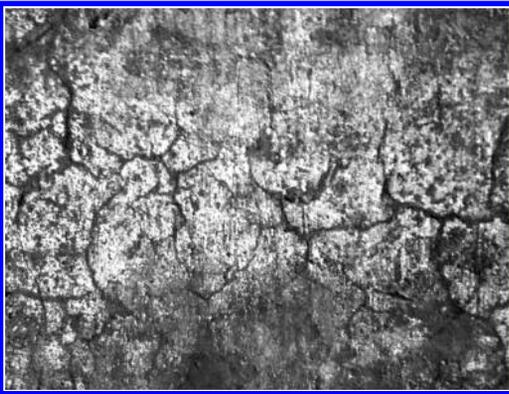
Figure 2. Sample 1. White efflorescences analysed by X Ray Diffraction (see Fig. 3).

The soluble salts formed whisker-like arrangements mostly localized in the outer plaster surface close to recent cement plaster. The authors sampled the surfaces and analysed the samples by means of X Ray Diffraction (X PanalyticalX'Pert PRO). Nitratine (sodium nitrate NaNO_3) resulted the main component of efflorescences (fig. 3 shows the diffractogram). Gypsum ($\text{CaSO}_4 \cdot 2\text{H}_2\text{O}$) and magnesium sulphates (both Hexahydrate $\text{MgSO}_4 \cdot 6\text{H}_2\text{O}$ and Epsomite $\text{MgSO}_4 \cdot 7\text{H}_2\text{O}$) are also present

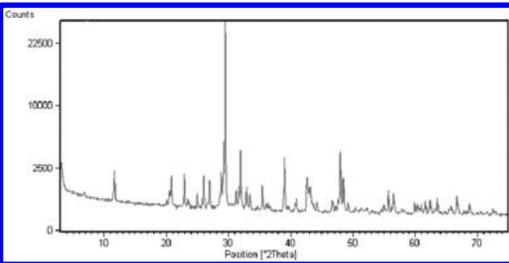
Figure 3. Sample 1, X Ray Diffractogram of powder coming from efflorescence. The pattern shows the presence of Nitratine and gypsum as soluble salts. Other insoluble mineral components are present coming from the plaster (barite and a clay).

as minor components. Nitratine efflorescences are mostly present in the proximity of the north-eastern window, on the monochrome surface. On the contrary, the sulphate salts result diffused in a lower amount in each sample coming from the hall, witnessing a diffuse sulphation of the plaster. Fragments of the original plaster have been analysed by means of Ionic Chromatography (Dionex DX 100). The obtained results corroborated XRD outcomes, quantifying the concentration of ions in the plaster; for what concern nitrates they reach 1% w/w, and their amount increase in the depth of the plaster. On the contrary, sulphates reach their maximum around 0.3% w/w at the surface of the plaster.

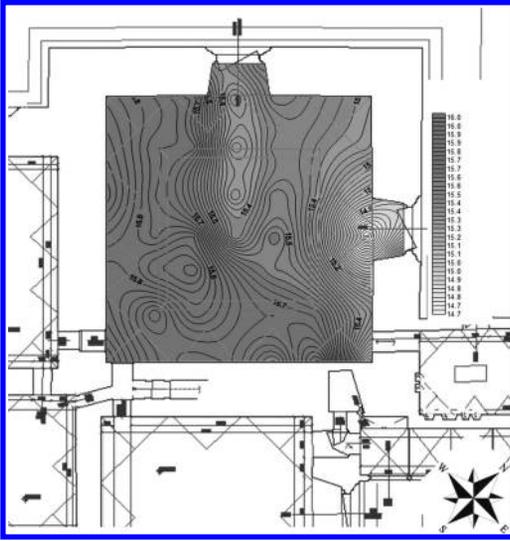
Figure 4. Map of air Temperature distribution, December 19, 2013, h 4,30 pm.

The psychrometric maps showed that the highest unbalances are close to the windows and doors leading towards other rooms that have major air exchange with the exterior.

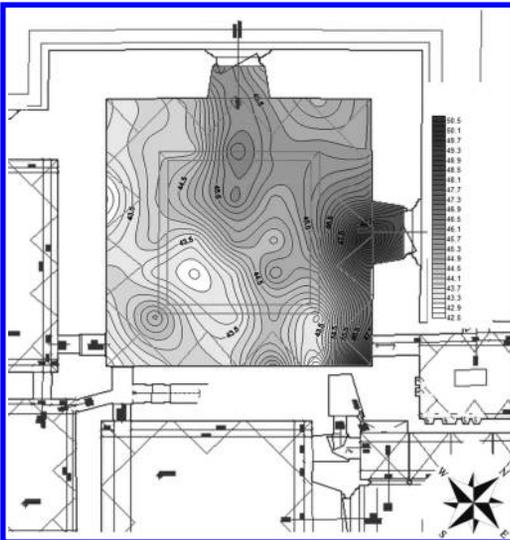
Figure 5. Map of Relative Humidity distribution, December 19, 2013, h 4,30 pm.

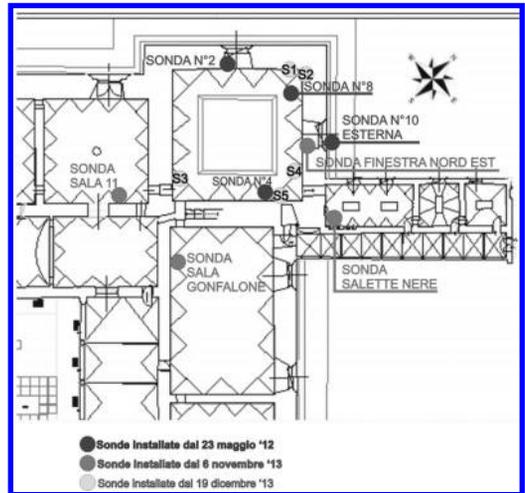
Figure 6. Map of the probes' localization.

further 8 probes at different heights and in the nearby rooms (Sala del Gonfalone, Salette Nere, Figure 6).

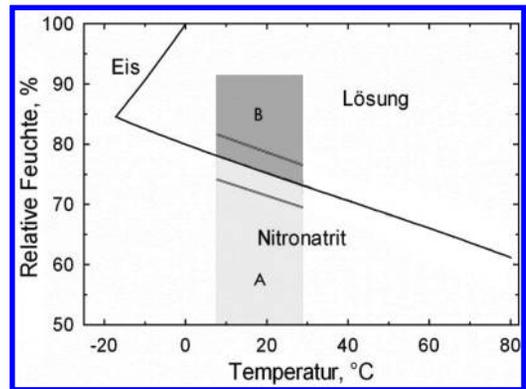
Figure 7. Crystallization curve of Nitratine (reference www.saltwiki.net/Hans-JuegenSchwarz).

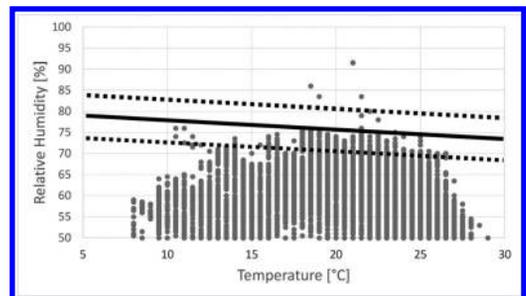
Figure 8. Scatter graph of the data acquired from 23rd May 2012 to 10th October 2013 by probe n 2.

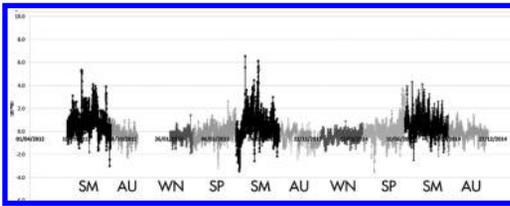
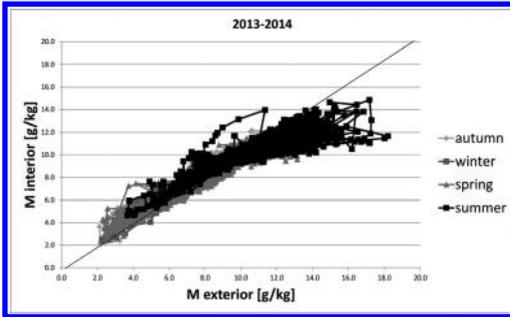
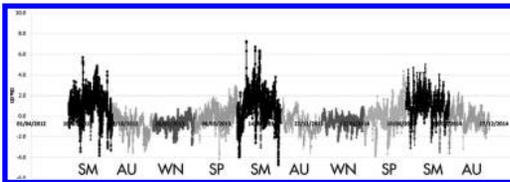
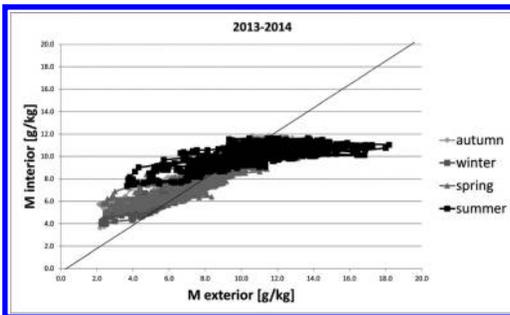
Figure 9. Differences of mixing ratio versus time between exterior (probe n 10) and interior (probe n 2).

Figure 10. Exterior mixing ratio (probe n 10) and interior one (probe n 2), year 2013–2014.

Figure 11. Differences of mixing ratio versus time between exterior (probe n 10) and interior (probe n 8).

Figure 12. Exterior mixing ratio (probe n 10) and interior one (probe n 8), year 2013–2014.

On the contrary, there are not very apparent connections when the variations are fast. The calculations regarding the air mixing ratio (Camuffo, 2014) are in Figures 9, 10, 11 and 12.

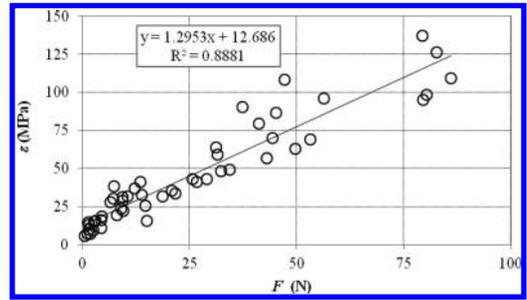
Figure 1. Correlation of the micro-drilling test results, expressed by drilling resistance force (F), with the scratching test results, expressed by the intrinsic specific energy (ϵ) (after Theodoridou et al. 2015).

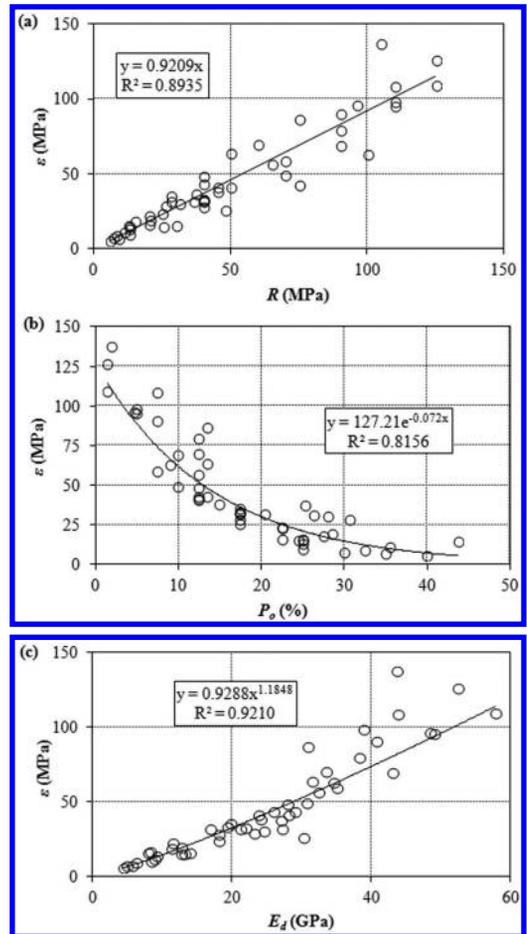
Figure 2. Correlation of the scratching test results of stones, expressed by the intrinsic specific energy (ϵ), with (a) uniaxial compressive strength (R), (b) open porosity (P_o) and (c) dynamic Young's modulus (E_d) (after Theodoridou et al. 2015).

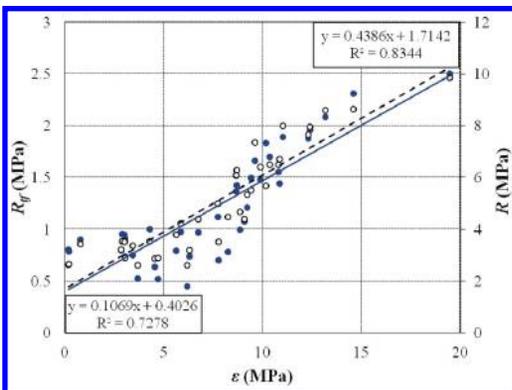
suggested linear relationships between the intrinsic specific energy and the flexural and uniaxial compressive strengths (Fig 3), with high R^2 values (equal to 0.73 and 0.83 respectively). The same type of regression line (linear) correlated the drilling resistance with the flexural and uniaxial compressive strengths ($R^2 = 0.70$ in both cases). As with the study on natural stones, the relationship between the intrinsic specific energy and the drilling resistance force was again found linear ($R^2 = 0.66$), confirming the significant interdependence of the two aforementioned parameters.

Figure 3. Correlation of the scratching test results of mortars, expressed by the intrinsic specific energy (ϵ), with flexural strength (R_f , solid line) and uniaxial compressive strength (R , dashed line) (after Kyriakou 2015).

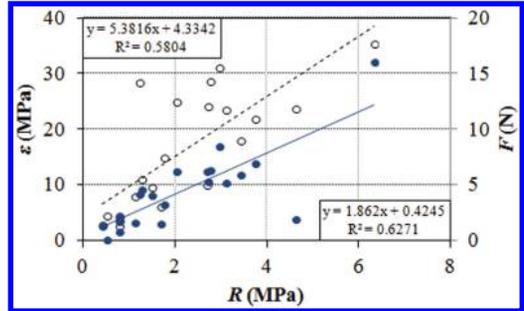
Figure 4. Correlation of uniaxial compressive strength of adobes (R) with the scratching test results, expressed by the intrinsic specific energy (ϵ , dashed line) and micro-drilling resistance, expressed by drilling resistance force (F , solid line) (after Eftychiou 2013).

Adobe bricks of various compositions, produced in the laboratory, were also tested using the scratch tool and the DRMS (Eftychiou 2013). Linear correlations were observed between the intrinsic specific energy, the drilling resistance force and the uniaxial compressive strength, determined using conventional laboratory testing procedures (Fig. 4). Despite the fact that the number of samples in this case was rather small, bearing in mind the inherent inhomogeneity of adobes, the results are promising and further prove the potential of the two techniques in the characterization of composite heritage materials. Nevertheless, additional research is needed to expand the database of results on adobes.

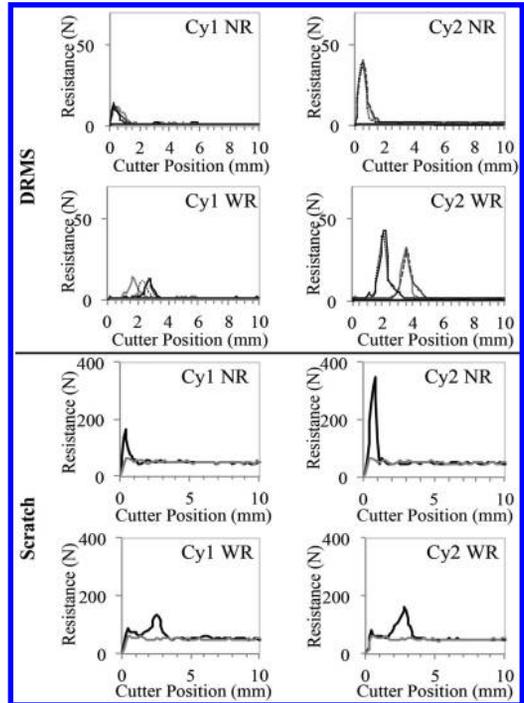
Figure 5. DRMS and scratch tool patterns for samples impregnated with Na_2SO_4 and dried at $70^\circ C$ (2 crystallization cycles). DRMS: — reference pattern; all other lines correspond to individual drilled holes. Scratch: — average salt contaminated pattern; — average reference pattern. Cy: cycle; NR: no water repellent; WR: with water repellent. Resistance refers to recorded resistance experienced on tool. X-axis origin corresponds to the upper surface of samples (after Modestou 2012).

Both techniques successfully highlighted the difference in the crystallization mode and location of $MgSO_4$ and Na_2SO_4 . Na_2SO_4 crystallized either at the evaporative surface of non-treated samples, or right behind this surface of samples treated with water repellent (Fig. 5). In $MgSO_4$ contaminated samples, cutting resistance peaks were detected well beneath the evaporative surface, irrespectively of the presence of water repellent (Fig. 6); this was attributed to the higher density/viscosity of the $MgSO_4$ solution, which resulted in its slower motion towards the evaporative surface upon drying.

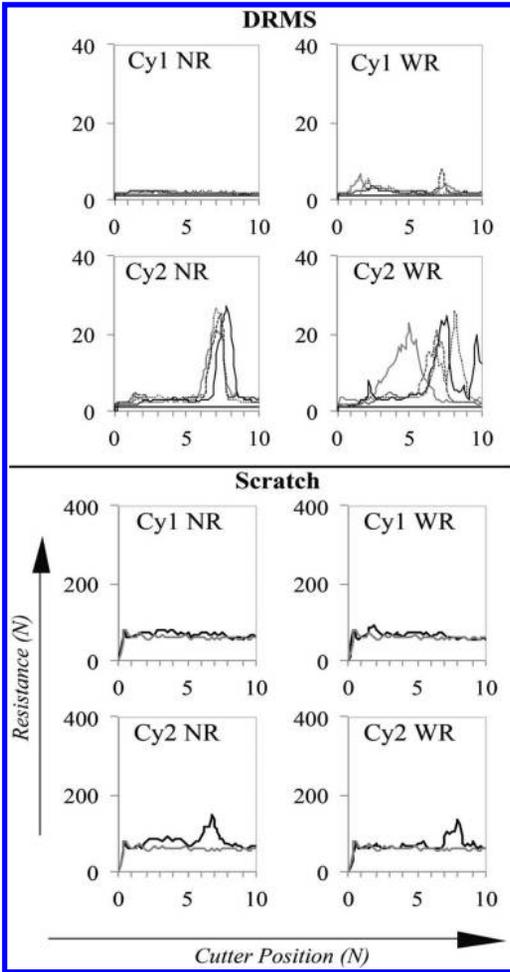
Figure 6. DRMS and scratch tool patterns for samples impregnated with $MgSO_4$ and dried at $70^\circ C$ (2 crystallization cycles). DRMS: — reference pattern; all other lines correspond to individual drilled holes. Scratch: — average salt contaminated pattern; — average reference pattern. Cy: cycle; NR: no water repellent; WR: with water repellent. Resistance refers to recorded resistance experienced on tool. X-axis origin corresponds to the upper surface of samples (after Modestou 2012).

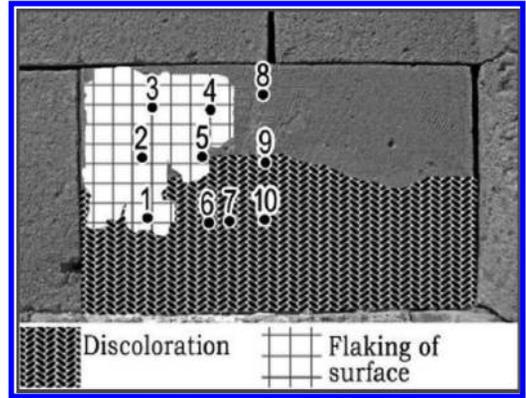
Figure 7. In-situ DRMS testing on Lymphia stone masonry block. Drilling holes and weathering forms; at hole 1 both types of weathering exist (after Modestou 2012).

In-situ DRMS measurements were also performed on a 110-year old masonry church (Fig. 7), built with stone of the same provenance (i.e. Lymphia stone). Micro-drilling measurements performed on the discoloured area (holes 1, 6, 7, 9, and 10) corresponded to higher peak force values (Fig. 8a).

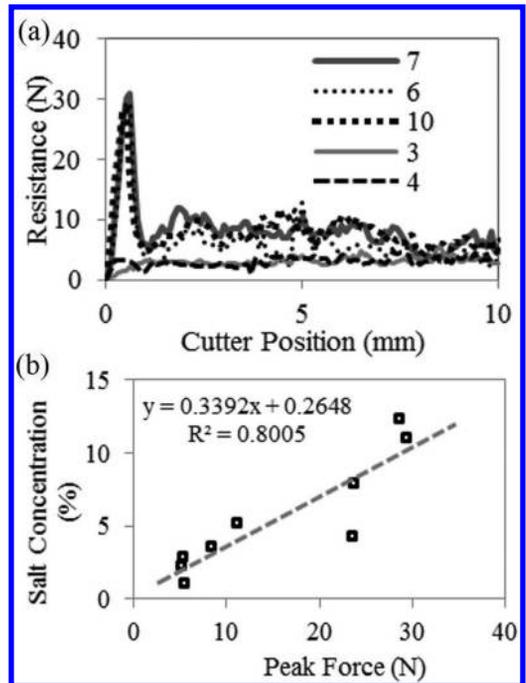
Figure 8. Results from in-situ DRMS testing. (a) Selected DRMS patterns (see Fig. 7 for hole location). (b) Relationship between peak drilling resistance and concentration of gypsum for each drilling location—no sample collected from drill hole nr. 7 (after Modestou 2012).

This was attributed to the presence of salt crystals blocking the pores of the stone. Holes on the section suffering from material loss (holes 2, 3, 4, 5, and 8) showed little or no cutting resistance peaks, likely reflecting the tendency of surface scale loss to also remove salts. Qualitative and semi-quantitative XRD analysis of the rock powder from each individual drill hole indicated a good correlation between the salt (gypsum) concentration, and the recorded drilling resistance (Fig. 8b).

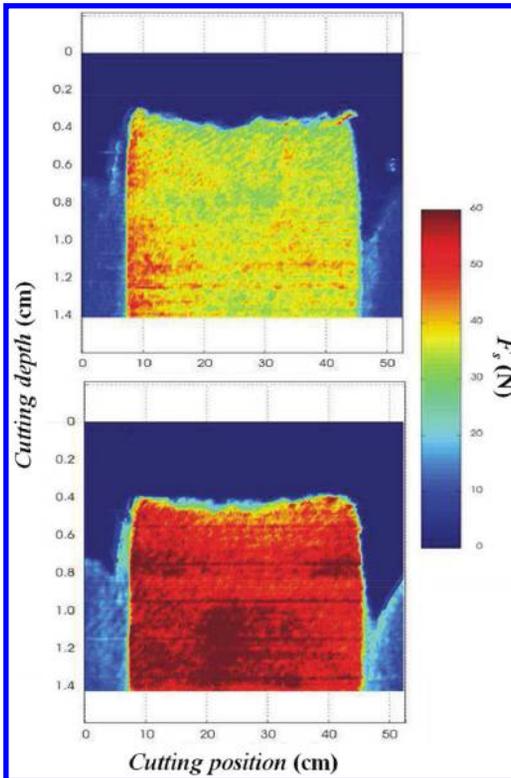
Figure 9. Tomographic visualization of Lympia stone before (up) and after (down) consolidation treatment. The colour code corresponds to the tangential force component (F_t , $\approx 40 \text{ N}$ for non-treated specimen and $>50 \text{ N}$ for treated specimen) required to scratch the material (after Dagrain et al. 2013).

Scratch tool results were also used in the framework of another study (Dagrain et al. 2013) to develop a tomography image of samples treated with consolidants, in order to assess their effectiveness. A colour code was applied to the tomography data to visualize the mechanical strength of the test specimens in two dimensions, thus mapping and characterizing the extent of altered regions inside them (Fig. 9). The results provided strong evidence that scratching based tomography may indeed be used to characterize the effectiveness of consolidation treatments used in heritage conservation. This novel technology enables the assessment of consolidant penetration depth and of the increase in material strength; both parameters are fundamental to the evaluation of consolidation treatments.

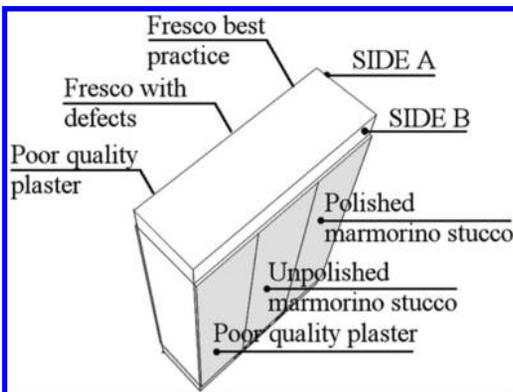
Figure 1. Scheme of position of finishing strips on wall.

The wall was plastered on both main faces, applying a fresco preparation on side A and a *marmorino* (marble plaster or stucco) on side B. Each side was composed by three vertical strips finished with different degrees, in order to check the influence of defects in execution and composition on mechanical damage. In particular, one of the end strips was executed in compliance with the best working practice, the central one included defects or limits in composition or finishing, and the last one was a poorly executed plaster, particularly poor in binder. The two qualities of strip for the two types of plaster and the worst layer were positioned on corresponding sides of the wall (Figure 1).

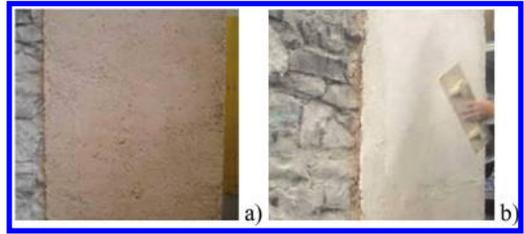
Figure 2. Plastering on side B: rough cast coat (a) and *intonachino* layers (b).

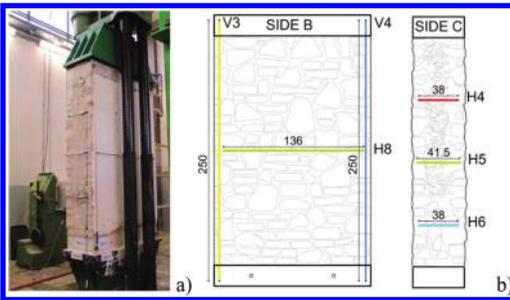
Figure 3. Test setup (a) and example of layout of potentiometers on two sides of panel (b) (dimensions in cm).

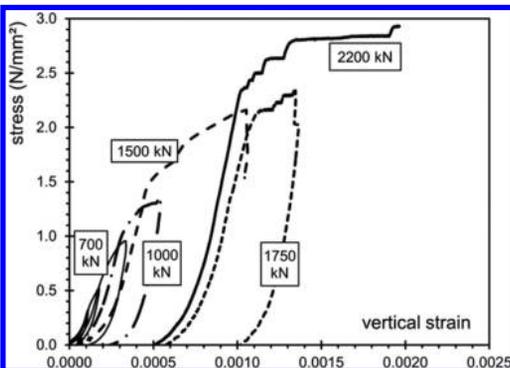
Figure 4. Cyclic behavior of panel (mean vertical deformations).

The load was applied at increasing steps from 0 to a maximum of 2290 kN, which corresponded to the failure of the wall. At each step the panel was unloaded and moved out the machine to perform the visual inspections. Figure 4 shows the stress-strain curves for the main load steps applied to the wall.

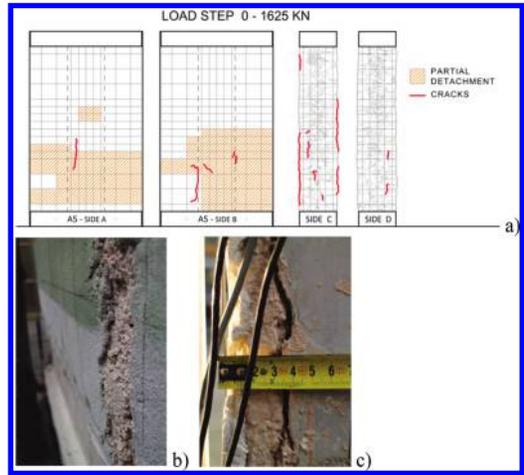
Figure 5. Distribution of damage at the first significant phase of loading: general view (a), spalling at side A (b), detachment at side B (c).

plane behavior started. For increasing load steps, in side A (fresco) some cracks appeared; in side B the *marmorino* started to detach from the substrate (Figure 5 and Figure 6). The most cracked zone was the one covered by the poorest finishing, i.e., the poor quality plaster. In general, the detachment occurred in the rough cast layer, thus avoiding the disaggregation of the upper plaster strata. At the very last load capacity, although the wall was severely crushed, the two well-executed strips of *marmorino* were able to stand compact until

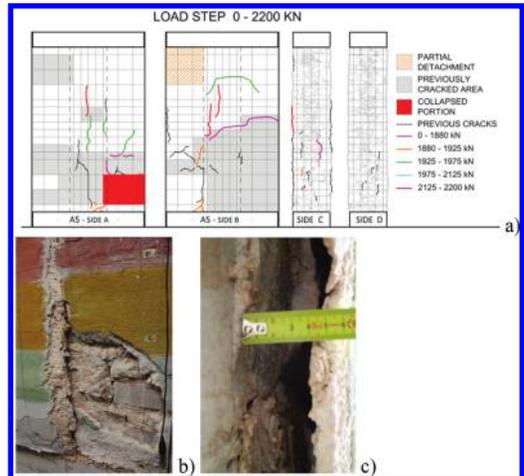
Figure 6. Distribution of damage at the last significant phase of loading: general view (a), rupture at side A (b), large separation of interface at side B (c).

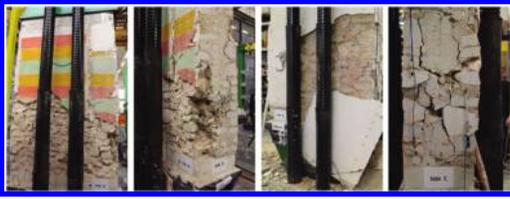
Figure 7. View of sides of panel at masonry failure.

the end; the fall down of a large portion occurred because of the high out-of-plane expulsion of the wall (Figure 7). This confirmed the importance of care in the phases of selection of material, preparation and execution of the layers, in order to avoid the damage of valuable finishes.

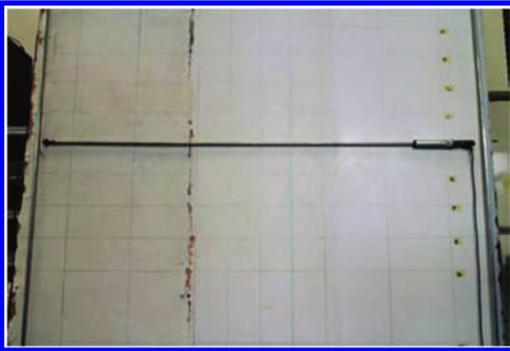
Figure 8. Portion of wall inspected with NDTs.

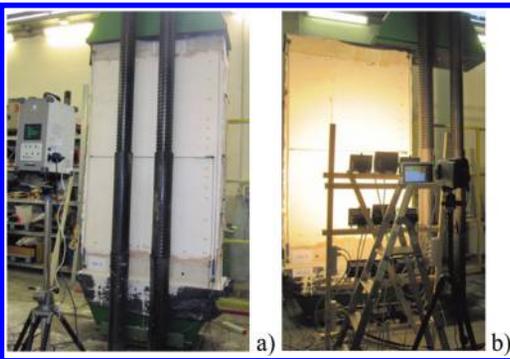
Figure 9. Preparation of tests with laser scanning (a) and IR thermography (b).

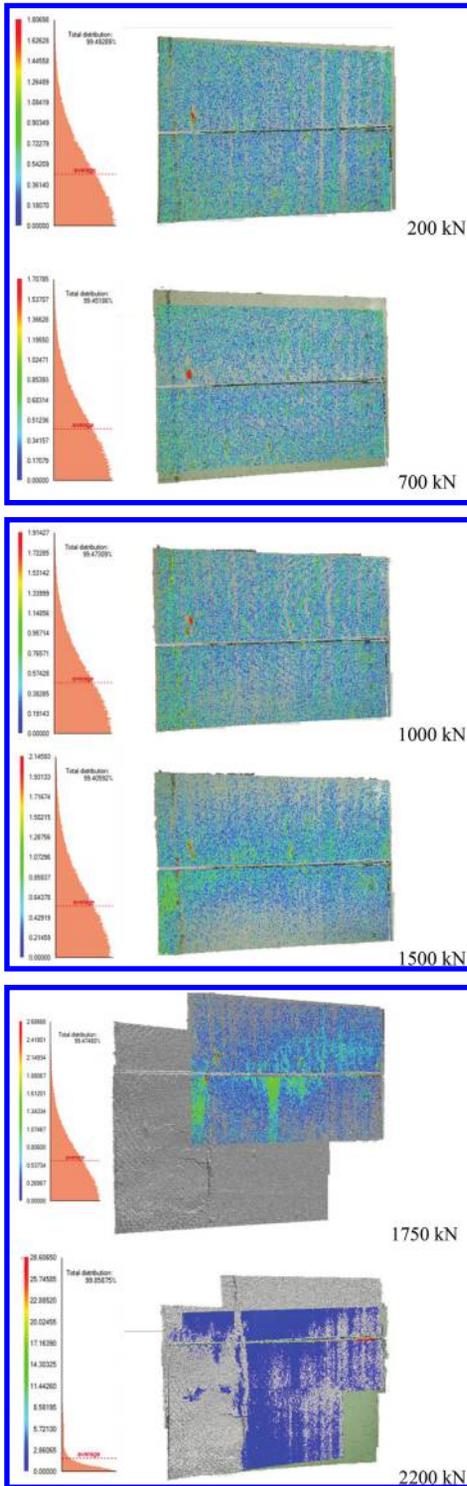
Figure 10. False color mapping of shell-shell deviation as distance between corresponding points for two close scans (red lines refer to cracks).

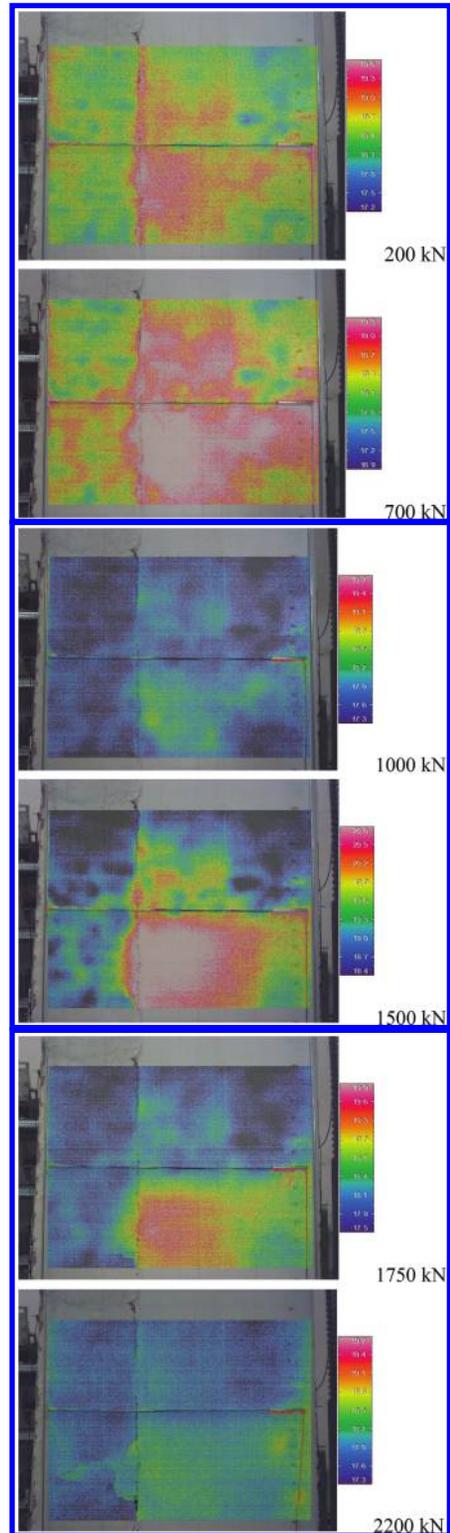
Figure 11. IR frames collected at various load steps.

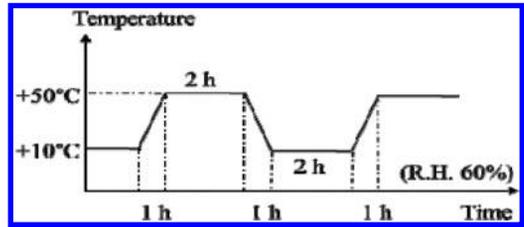
Figure 1. Hygrothermal exposure cycle.

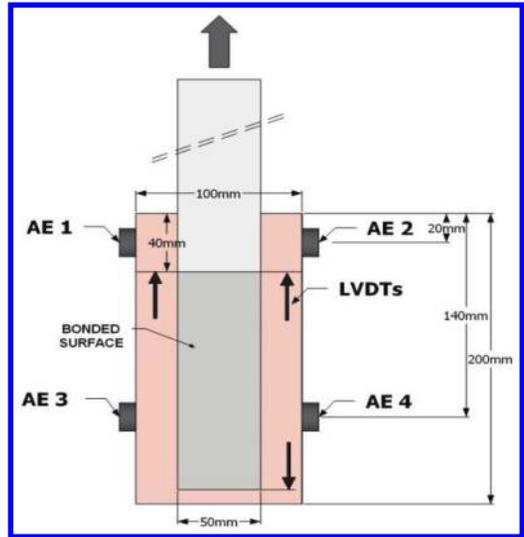
Figure 2. Single-lap shear bond test: test instrumentation and specimen dimensions.

Single-lap shear bond tests were performed using a closed-loop servo-controlled testing machine with maximum load capacity of 50 kN. A rigid supporting steel frame was used to support the specimens and avoid misalignments in the load application. The specimens were pulled monotonically with a speed rate of 5 $\mu\text{m}/\text{sec}$ under displacement control and the resulting load was measured by means of a load cell. The relative slip between the composite material and the brick was measured with two LVDTs glued at the loaded end and one LVDT glued at the free end, (Figure 2). Four 150 kHz resonance AE sensors were attached two by two on opposite sides of the bricks.

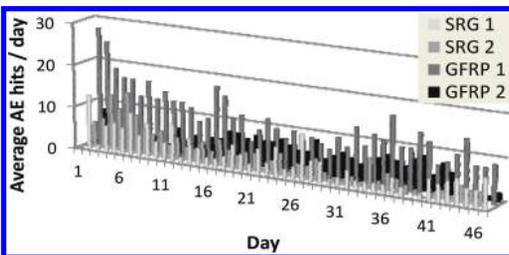
Figure 3. Average number of AE hits per day, recorded on 2 SRG-strengthened and 2 GFRP-strengthened specimens during environmental ageing test.

Damage progress was monitored by means of acoustic emission detection on two SRG—and two GFRP-strengthened bricks. The average number of AE hits per day recorded for each specimen within a period of 45 days is presented in Figure 3. Limited AE activity is recorded for each type of specimen and, as a first observation, it can be mentioned that not much difference is observed between the SRG—and GFRP-strengthened specimens.

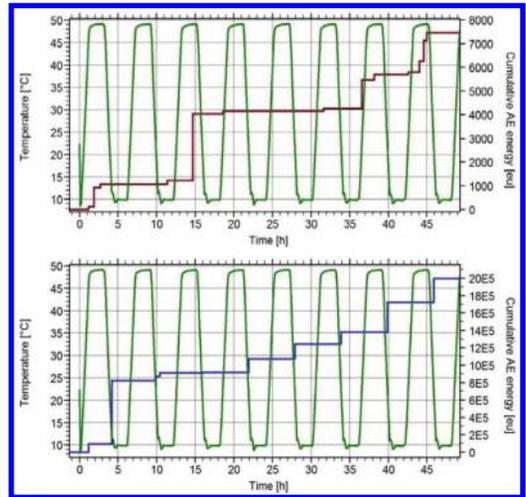
Figure 4. SRG-strengthened specimen: typical temperature fluctuation and random emission of AE energy (above); GFRP-strengthened specimen: typical temperature fluctuation and periodically emitted AE energy (below).

When the moments of AE energy emission are compared for both types of specimen, an important difference is observed. AE emissions in the SRG-strengthened specimens occur randomly, while for the GFRP-strengthened bricks, the majority of AE energy is emitted during temperature decrease (Figure 4). This is an indication of the different damage sources. The AE hits which are detected from SRG-strengthened specimens probably originate from the further hardening, shrinking or cracking of mortar. In the GFRP-strengthened bricks, the AE output during temperature decrease is a manifestation of the thermal

incompatibility between the epoxy glue and the brick. Since the thermal expansion coefficient of epoxy can be up to 10 times larger compared to brick, the temperature cycling causes stress concentrations which might lead to damage propagation at the brick-GFRP interface.

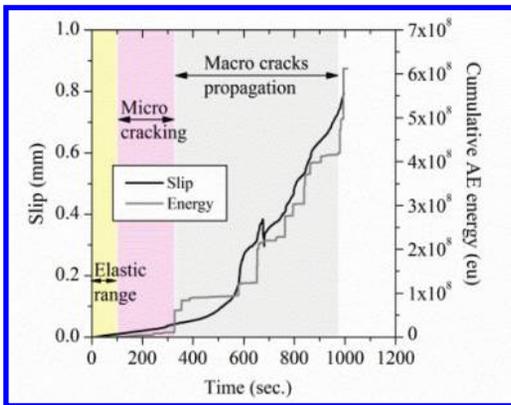
Figure 5. Typical AE results in a GFRP-strengthened brick specimen with cohesive/ adhesive failure mode: evolution of slip and cumulative AE energy.

Typical AE results obtained from the debonding tests on GFRP-strengthened brick specimens are presented in Figures 5–6. The results in Figure 5 are presented for a specimen with mixed cohesive/adhesive failure mode, in terms of cumulative AE energy and slip development during the test. Generally, the debonding phenomenon can be divided into three main regions: elastic range, micro-cracking range, macro-cracking and progressive fracture. In the elastic range, the system deforms without any crack generation or AE activity. The small displacement measured at this stage is due to the elastic deformation of the FRP composite. As the applied force increases, micro-cracks appear in the interfacial region and they can be distinguished by initiation of AE activity with low emitted energies. As the debonding progresses, macro-cracks are formed and propagate along the interface with higher fracture energy being released. The cumulative AE energy increases with a stepwise pattern in which each sudden jump can be attributed to macro-fracture events. A sudden release of AE energy is also observed at the moment of full debonding at the end of the test. The cumulative AE energy

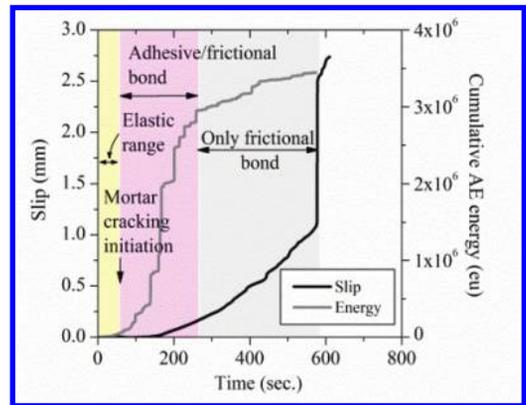
Figure 7. Typical AE results in an SRG-strengthened brick specimens: evolution of slip and cumulative AE energy.

Figure 7 presents a typical result obtained from an SRG-strengthened brick specimen, which failed with slipping of the steel fibers and mortar cover separation. Mainly, three regions representing different mechanisms can be observed during the debonding process. AE activities before the first cracking of the mortar are negligible. During the mortar cracking, the rate of AE activities increases and high AE energy is detected as the force increases. The resisting mechanisms in this region are adhesive bond and friction between the steel fiber and mortar. Detachment of the bond is accompanied by releasing relatively high fracture energies, observed as sudden jumps in the AE cumulative energy curve. As the debonding progresses, the bond diminishes and friction governs the failure mechanism resulting in a reduction of the detected AE energy rate. The debonding occurs with a sudden force reduction and slip increase. In contrary to the GFRP-strengthened specimens, no direct relation can be observed between the measured slip and AE cumulative energy.

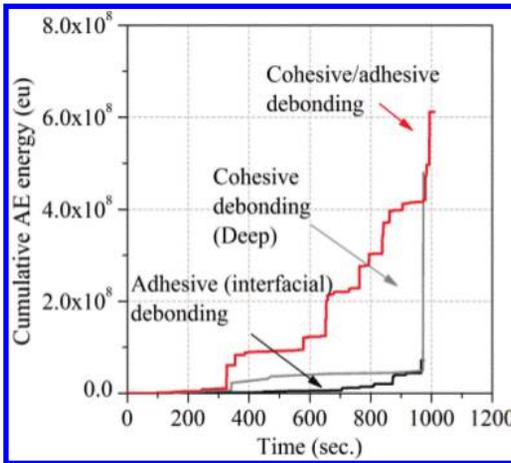
Figure 6. Comparison of AE output for different failure modes in GFRP-strengthened bricks.

The effect of failure mode on the AE outputs is investigated in Figure 6. A clear distinction is found between AE outputs of specimens with different failure modes. In the specimen with cohesive debonding, the AE energy release remains relatively low throughout the test, accompanied by a sudden and large amount of AE energy release when debonding occurs at the end of the test. The observed behavior confirms the brittle and sudden nature of the cohesive debonding. In the specimen with cohesive/adhesive failure, a progressive release of energy is observed during the test. In the specimen with adhesive debonding mode, progressive detection of AE energies is observed until complete debonding. However, the magnitude of

the detected energies is much lower than the ones detected in the specimens with cohesive failure mode, due to the different nature and fracture properties of brick and FRP/brick interface.

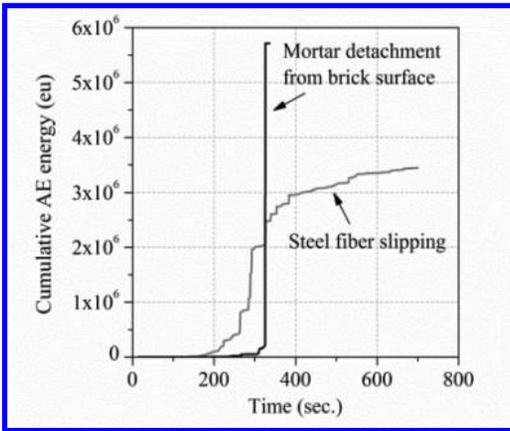
Figure 8. Comparison of AE output for different failure modes in SRG-strengthened bricks.

In Figure 8, a comparison is made between two SRG-strengthened specimens with different failure modes, namely brick/mortar detachment and fibers slipping. A brittle behavior is observed in the specimen with brick/mortar detachment failure. The detected AE energy level in this specimen is very low during the test followed by a sudden release of energy at the moment of debonding. On the other hand, the fibers slipping failure mode produces a progressive release of energy during the test while the adhesive bond diminishes, followed by a reduction of the AE energy rate in the stage
