Emerging Technologies in Non-Destructive Testing VI

Editors

D.G. Aggelis & D. Van Hemelrijck

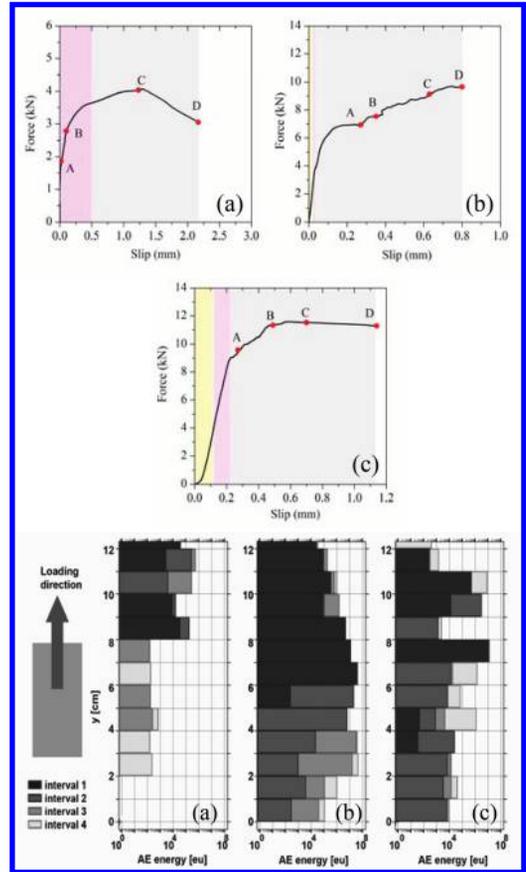
Figure 9. Cumulated energy of located AE events on SRG-strengthened specimen (a), GFRP-strengthened specimen with progressive cohesive/adhesive debonding (b) and with predominantly adhesive debonding (c). Time intervals 1 to 4 refer to the moments indicated on the force-slip curves (e.g. from the start to A is interval 1, from A to B is interval 2).

This downshift of located AE events as a function of time is illustrated in Figure 9, which presents the total energy of all AE events located in zones of 1 cm perpendicular to the loading direction. The energy plots are made at specific time intervals, as indicated on the force-slip curves. Progressive debonding can more distinctively be observed for the specimen with predominantly cohesive debonding (= progressive cohesive/adhesive debonding) and the cohesive debonding phenomenon typically produces more and higher-energy AE sources.

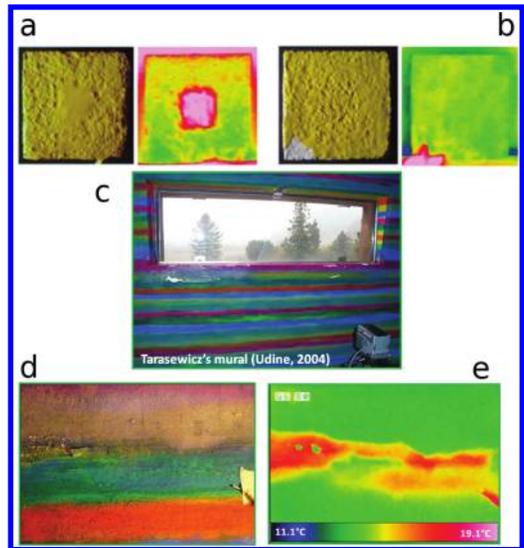
Figure 1. a, b: raking light and thermal images of lab models. C, d, e: pictures and thermal images of Leon Tarasewicz painting in the Perusini's Tower of Corno di Rosazzo, Udine.

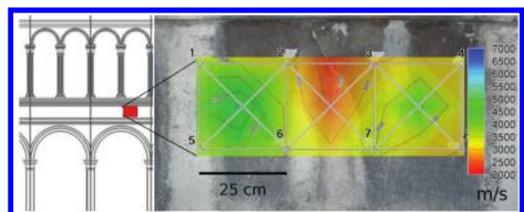
Figure 2. 2D US tomography of Arch nr. 50, “Procuratie Vecchie” of Saint Mark's Square in Venice.

Also UltraSound (US) measurement of the external surfaces could indicate the presence of concealed detachments. In 2009–2010 US investigation of arches 49–50 of the “Procuratie Vecchie” of Saint Mark's Square in Venice was commissioned by the Superintendence for Architectural and Landscaping and done by Arcadia Ricerche S. r. l. The measurements were carried out with a Controls 58-E4800 UPV with indirect configuration of the measurements. Figure 2 show the surface tomography of the upper part of arch 50; it is possible to notice the lower US wave speed in correspondence of a discontinuity/ detachment of the stone.

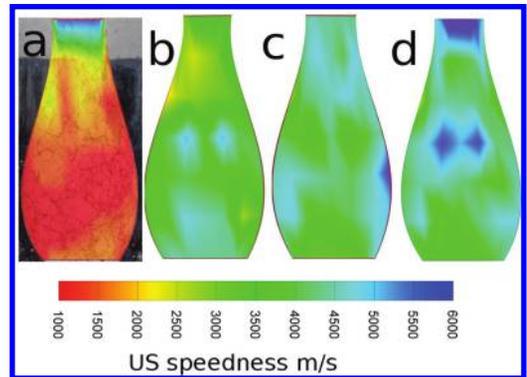
Figure 3. a, b: ‘Loggia dei Viretti’ at the Sacra di San Michele near Turin; c, d: 2DUS tomography of a column before and after consolidation.

homogeneous distribution of the consolidation resins and grouts used (Sciola 2010). Other two interesting examples of consolidation assessment and monitoring are the US investigations of ‘Loggia dei Viretti’ at the Sacra di San Michele near Turin (Driussi 2012) and of the Ghirlandina Tower in Modena (Cadignani 2009, Driussi 2014). In both sites, 2D US tomography allowed the evaluation of the consolidation intervention and of the distribution and depth reached by the consolidation product. The intervention methodologies involved in both cases a timely assessment of the conservation state by visual observation, elaboration of decay maps, US investigation, static survey, and in the case of Ghirlandina Tower thermographic laser scanner survey. An experimental/applicative phase followed, with individuation of suitable consolidation and protection products thanks to in-lab and in-situ tests. The restoration phase was followed by the assessment of the effectiveness of the treatment by different NDTs, among them, 2D US tomography. In the case of Ghirlandina Tower a virtuous management allowed to dedicate a part of the budget for the post-intervention monitoring and all documented and observation materials have been systematically collected in the web-GIS SICaR program. In “Loggia dei Viretti” a consolidation treatment of the columns by impregnation under vacuum with acrylic water-based emulsion was necessary in order to reestablish a sufficient coherence of the stone. The 2D US tomography done on the columns of the Loggia before and after the intervention allow to evaluate the effectiveness of the treatment by measuring the higher material density reached after the consolidation under vacuum and the notable continuity of the US speed within the stone even in vertical sections (Fig. 3). Also in the case of Ghirlandina tower (Fig. 4) the 2D US tomography evidenced the effectiveness of

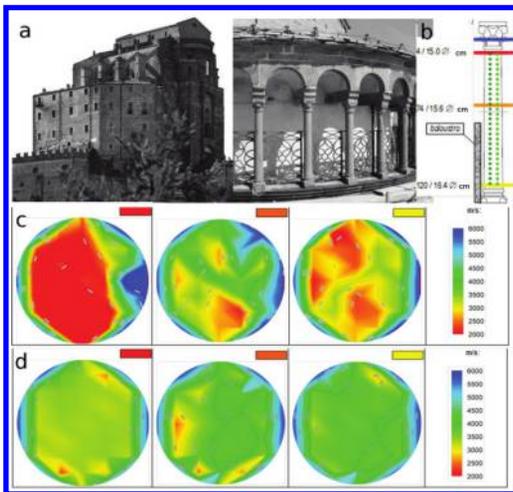
Figure 4. 2D US tomography of a column of Ghirlandina Tower balustrade, a: before the intervention (June 2009), b after the intervention (September 2011), c (July 2012), d (July 2013).

the treatment on the columns of the upper balustrades, furthermore the repeated measurement allow the monitoring of the intervention and testify the enduring effectiveness of the consolidation over time, till 5 years (last monitoring: September 2014).

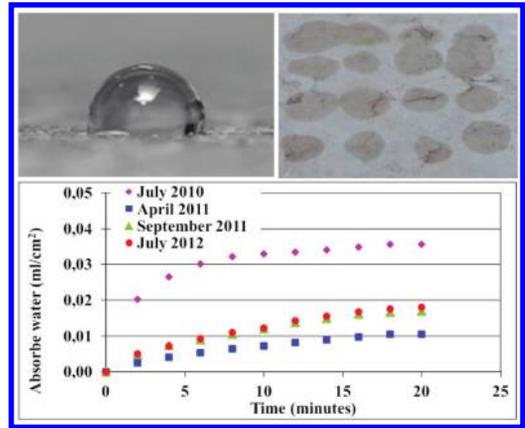
Figure 7. Contact angle and capillary water absorption at low pressure measurement at Ghirlandina Tower, Modena.

Recalling the case of the upper balustrades of the Ghirlandina Tower (Driussi 2014, Cadignani 2009), the wettability of the surfaces before and after the application of protection products have been assessed on horizontal surfaces by in-situ measurement of contact angle and water absorption at low pressure, obtaining both the external water repellency and a more massive determination of water uptake capacity. The measurements (Fig. 7) highlighted the effectiveness of the protective in reducing the stone wettability and absorption after the intervention and the permanence of a sufficient protection and compatibility over the last five years (restoration intervention in 2010), even if in the last monitoring campaign (September 2014) the water-repellency of the more exposed surfaces was reduced.

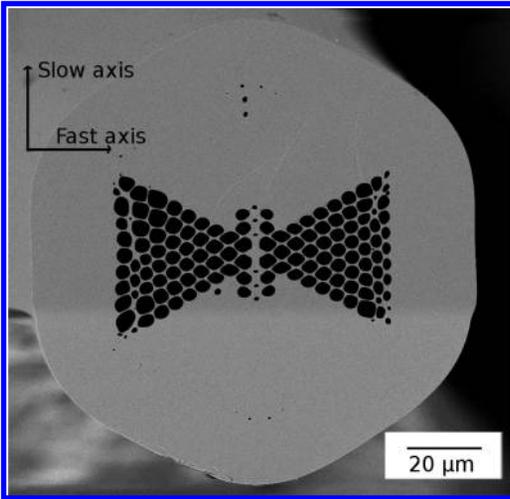
Figure 1. Scanning Electron Microscope photograph of the cross-section of the fabricated Butterfly MOF.

Because of the specific shape of the microstructure in our MOF we refer to this fiber as the butterfly MOF (Martynkien 2010). This MOF is highly birefringent (on the order of 10^{-3}) and therefore contains two orthogonally polarized modes that can operate individually (Fig. 1). The central part

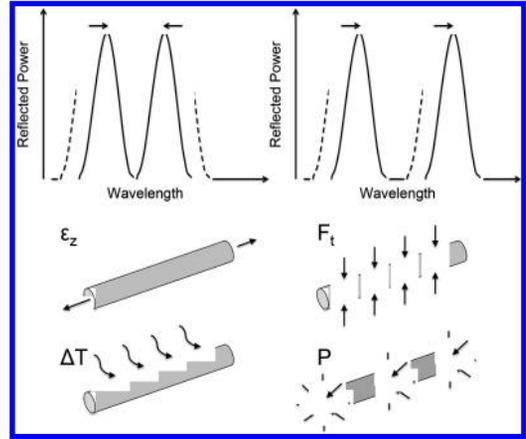
Figure 2. Sensing principle of the butterfly MOFBG. Load applied transversally to the fiber is encoded in the spacing $\Delta\lambda$ between the two Bragg peaks. (Left) Response of the sensor to temperature changes or axial strain—both peaks move in the same way and $\Delta\lambda$ remains unchanged. (Right) Response of the sensor to transverse load—the peaks move in opposite direction and $\Delta\lambda$ changes.

When the fibre experiences a transverse load, the Bragg peaks will move towards or away from each other. On the other hand $\Delta\lambda$ is practically insensitive to temperature and to longitudinal strain (Sonnenfeld 2011). By doing so the combination of a highly birefringent micro-structure with a mechanically asymmetric side micro-structure allows bringing a selectivity mechanism to MOFBG-based sensors (Fig. 2).

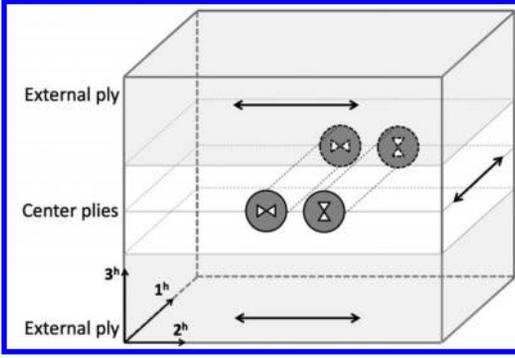
Figure 3. Illustration of 2 closely space MOFBGs embedded in the middle of a laminate composite (not drawn to scale) with the longitudinal direction of the optical fibers aligned with the reinforcement fibers of the embedding plies. The left MOFBG is oriented with $\alpha = 0^\circ$, whilst the right sensor is oriented with $\alpha = 90^\circ$. The 2 MOFBGs are stripped over a few centimeters at the grating location. The axis system ($1^h, 2^h, 3^h$) represents the coordinate system within the host composite material. The directions of the carbon reinforcement fibers in the plies are indicated by the black double arrows.

the 3 directions of space inside a Carbon Fiber Reinforced Polymer (CFRP) composite material. To do so, one needs to relate the normal strains in the 3 directions of space in the composite material to the measured changes in the 4 Bragg wavelengths returned by two closely spaced parallel MOFBG sensors embedded in a composite coupon with different angular orientations of their microstructure with respect to the through-the-thickness direction of the composite laminate. This configuration is illustrated in Figure 3.

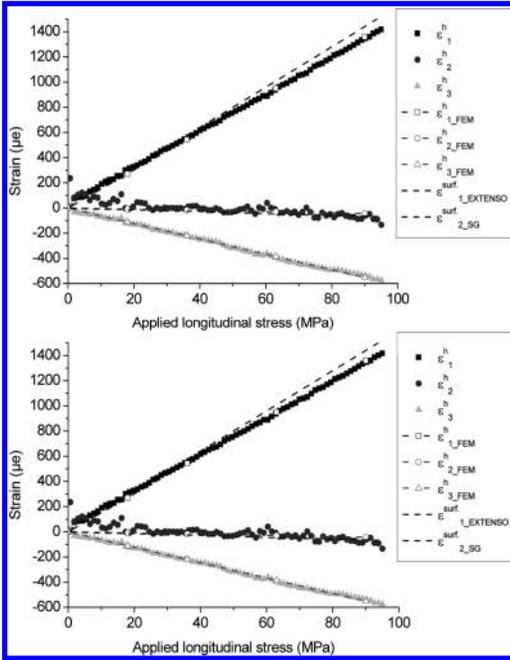
Figure 4. Measured strains in $[90/0]_{2s}$ and $[0/90]_{2s}$ laminates as a function of the applied longitudinal (top) and transverse out-of-plane (bottom) stress. ϵ_1^h , ϵ_2^h and ϵ_3^h have been calculated with Equation (4). $\epsilon_1^h_{FEM}$, $\epsilon_2^h_{FEM}$ and $\epsilon_3^h_{FEM}$ are the results of our finite element simulations. $\epsilon^{surf}_{1_EXTENSO}$ is the strain measured by the extensometer and $\epsilon^{surf}_{2_SG}$ is the strain measured by the strain gauge glued onto the sample.

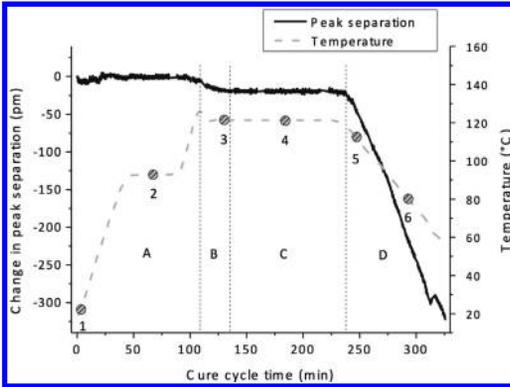
Figure 5. Changes in the temperature and in the peak separation $\Delta\lambda$ during the entire cure cycle. Adapted from (Sonnenfeld 2013).

Since it is possible to efficiently integrate Butterfly MOFBG sensors in Carbon Fiber Reinforced Composite (CFRP) material in the lay-up phase, these sensors also allow to monitor its manufacturing process. Figure 5 shows a first drop of $\Delta\lambda$ (part B), which corresponds to the polymerization

of the sample. The cooling phase (part D) features a large decrease of $\Delta\lambda$ associated with the build-up of residual strains during the consolidation phase. Since the phase modal birefringence of the But-

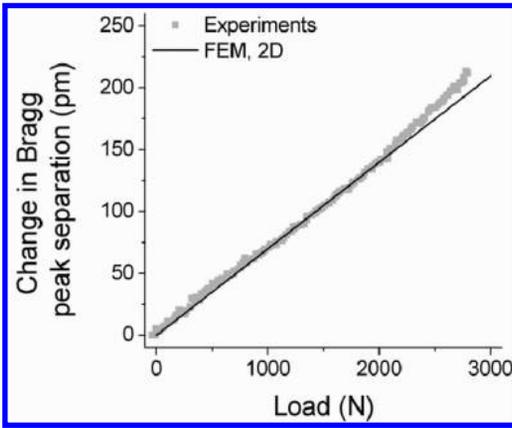
Figure 7. The Bragg peak separation increases due to tensile loading with a sensor response of 67.4 pm/kN. Results from 2D FEM modeling of the SLJ are in very good agreement with the experimental results.

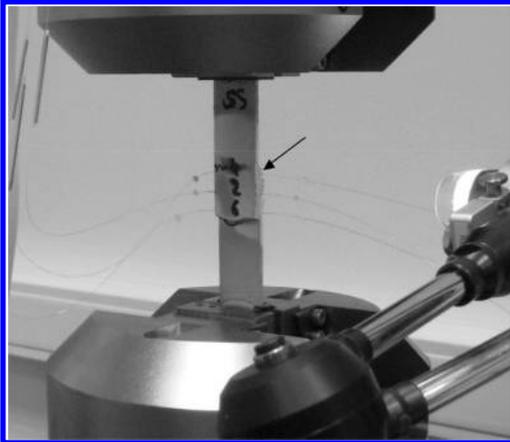
Figure 8. Photograph of the sample placed in the tensile loading test setup.

The combination of multiple shear stress sensors can provide insight in the existence and propagation of disbonds in SLJs. To demonstrate that ability, we have embedded three butterfly MOFBG shear stress sensors in a SLJ at the specific locations where the magnitude of the peel stress is minimal (in the center and near the edges). We subjected the sample to a cyclic tensile loading test the response of the 3 sensors and their (collective) ability to detect disbond initiation and propagation by monitoring their response throughout the fatigue test (Fig. 8).

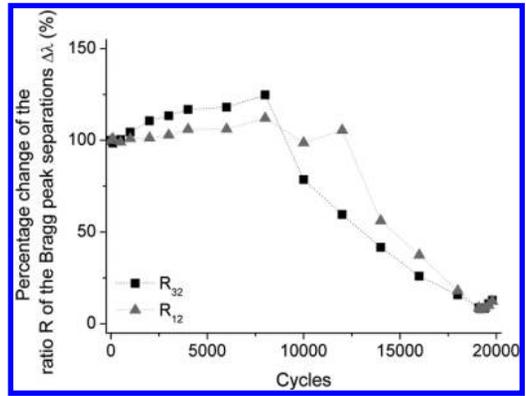
Figure 9. Evolution of the ratios R_{12} and R_{32} , of the Bragg peak separations of the different sensors. These ratios change significantly when cracks start to propagate.

By reconstructing the response of the sensors through 2D FE analysis, we could derive the length of the cracks on both sides of the SLJ. Indeed, as long as the bond line remains intact, the ratios R_{12} and R_{32} (representing the response of a MOFBG shear sensor at the edge of the SLJ compared with that of a sensor in the center of the SLJ) will nearly remain constant, independently of the loading level. However, once a significant disbond starts to appear at one or both sides, these ratios will change (Fig. 9).

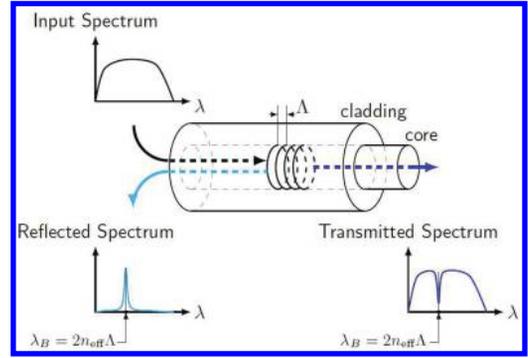
Figure 1. Schematic representation of optical Fibre Bragg Grating (FBG) principle.

A Bragg grating is a periodic change of the refractive index in the core region of an optical fibre. When broadband light is transmitted into the optical fibre, Bragg gratings act as a wavelength

selective filter that reflects a single wavelength called the Bragg wavelength, λ_B (Figure 1). The Bragg wavelength is given by:

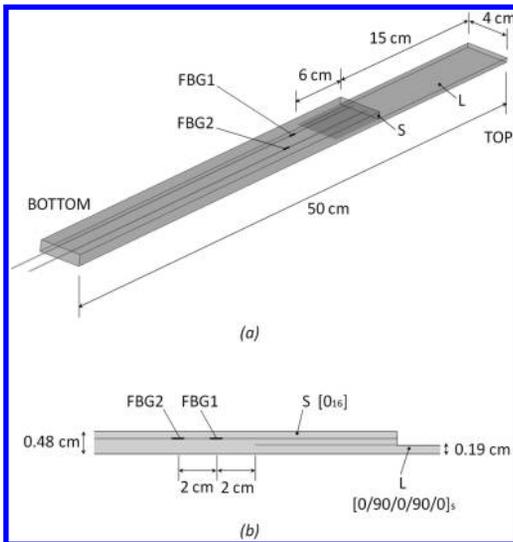
Figure 2. Schematic of the composite beam with two FBG sensors embedded and one delamination: perspective view of the entire beam (a); lateral view of the region close to the delaminated area (b).

The manufactured composite beam was mounted in the setup depicted in Figures 3 and 4a. The first 14 cm of the beam bottom side (see Figure 2a) were clamped using an opportunely designed steel support (Figure 3). The top side of the beam was connected to an electro-mechanical shaker. The connection was made eccentric in order to increase the chances of delamination propagation. Preliminary feasibility studies conducted by the authors on

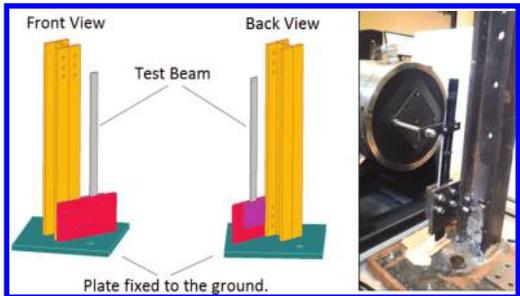
Figure 3. Schematic of the steel support (left); supported beam with electromechanical shaker attached (right). The support consists of a 4 cm thick plate fixed to the floor and welded to a 1.2 cm thick H-shaped beam. The CFR test beam is clamped between two 1 cm thick steel plates which are bolted to the H-shaped support beam.

similar beams, had in fact showed that pure bending loads were not suitable to induce delamination propagation, due to the limitation on the shaker maximum applicable displacement. On the contrary, the use of an eccentric connection allowed the shaker to induce at the delamination interface higher stress concentration resulting from a combination of both bending and torsion.

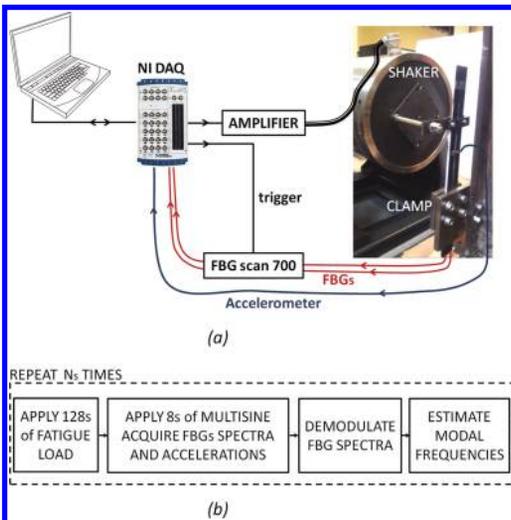
Figure 4. Experimental setup (a) and block diagram of the experimental procedure (b).

The procedure presented in Figure 4b was repeated $N_s = 90$ times, which means that the composite beam underwent a total of 69120 fatigue cycles. Figure 5 shows two views of the beam lateral side during the fatigue loading.

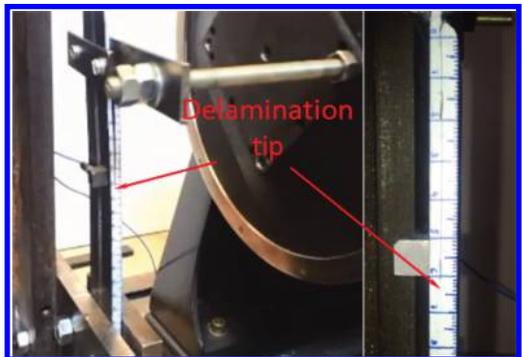
Figure 5. Lateral views of the CFR beam during the fatigue test. Open (left) and closed (right) delamination condition. The delamination tip and extension can be tracked on the graduated scale reproduced on the beam lateral side.

cycles. Figure 7 was obtained by visually inspecting the delamination length on the beam lateral side (see Figure) while Figure 8–10 were obtained by processing in real time both the FBG strains and the accelerations. From the comparative analysis of these 4 figures it is possible to observe that:

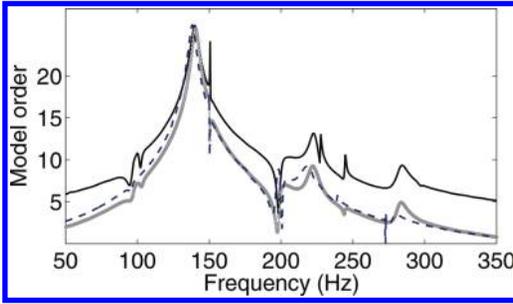
Figure 6. Synthesized beam frequency response amplitudes obtained from FBG measurements after 1 (continuous black), 15360 (dashed black) and 46080 (grey circles) fatigue cycles.

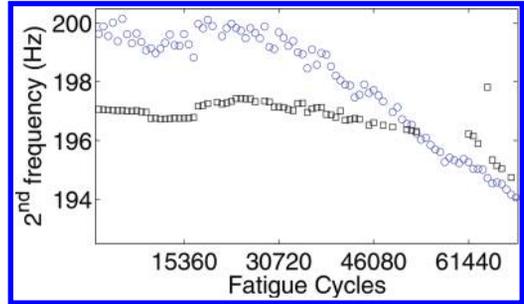
Figure 9. Shift of the 2nd beam modal frequency obtained from FBGs strains (blue circles) and from accelerations (black squares) measurements.

- All three natural frequencies decrease as the delamination propagates. In the case of FBG sensors, the percentage decrease between initial and final condition is 4.07% for f_1 (Figure 8), 2.79% for f_2 (Figure 9) and 5.15% for f_3 (Figure 10).

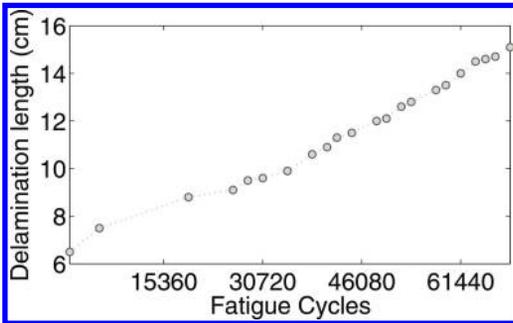
Figure 7. Evolution of the delamination size as function of the fatigue load cycle obtained by visual inspection.

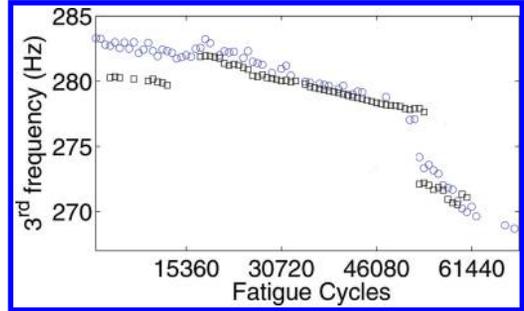
Figure 10. Shift of the 3rd beam modal frequency obtained from FBGs strains (blue circles) and from accelerations (black squares) measurements.

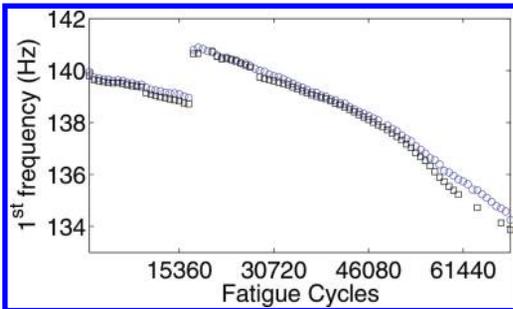
Figure 8. Shift of the 1st beam modal frequency obtained from FBGs strains (blue circles) and from accelerations (black squares) measurements.

- The first modal frequency f_1 presents a discontinuity after 16896 fatigue cycles, corresponding to a delamination length of approximately 8.5 cm. Such behavior was not expected and does not have an evident explanation. A possible explanation, according to the authors, might be associated to changes in the input forces caused by the high coupling between the composite beam and the shaker. Additional investigations are already planned and undergoing.

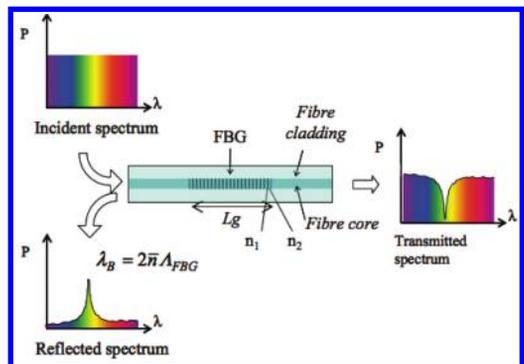
Figure 1. Basic operating principle of fiber Bragg gratings (Voet, 2011).

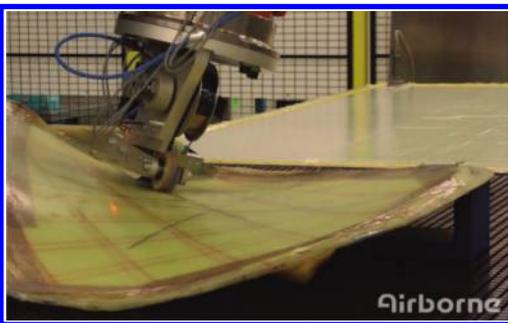
Figure 3. Automatic SMARTFIBER placement robot (SmartFiber).

To overcome the issue regarding the fragile egress point of the optical fiber out of the composite, SMARTFIBER developed a miniaturized and fully embeddable read-out system based on state-of-the-art photonic and electronic technologies. The necessary power and data transmission to a logging device is achieved using wireless technology.

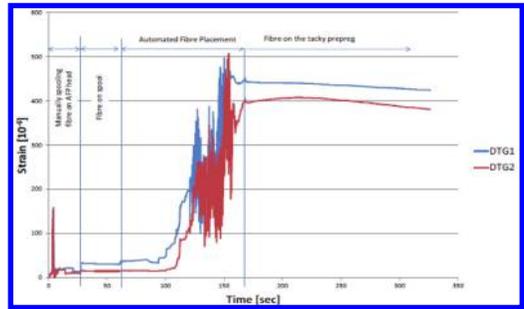
Figure 4. Optical fiber pre-straining during automated lay-down.

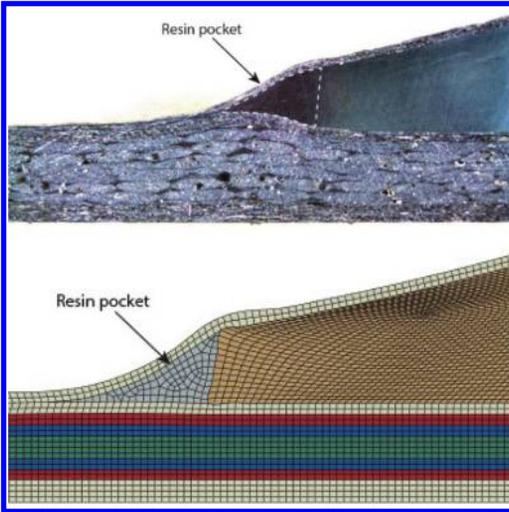
Figure 5. (top) Experimental resin pocket surrounding the SMARTFIBER read-out, (bottom) finite element prediction of resin pocket.

A known issue when embedding structures (such as the SMARTFIBER read-out) is the creation of resin rich zones surrounding the inclusions. These are a consequence of the fibrous nature of the composite, and form weak(er) points in the composite which will influence the strength and stiffness properties of the host (Shivakumar and Emmanwori, 2004). Obviously, the impact of the sensor network on the structural strength should be kept to an absolute minimum.

To study the effects of geometry and resulting resin pockets surrounding the (arbitrary) inclusions on structural performance, a novel finite element method was developed. This method was shown to allow the accurate and efficient simulation of resin pockets while requiring only a minimal amount of experimental tests to determine the material behavior. Figure 5 shows the correspondence between an experimentally measured resin pocket surrounding the SMARTFIBER read-out device, and the resin pocket geometry as predicted using the finite element approach in a quasi-isotropic Glass Fiber Reinforced Polymer (GFRP). Several other experiments were conducted, showing the general applicability and accuracy of the method.

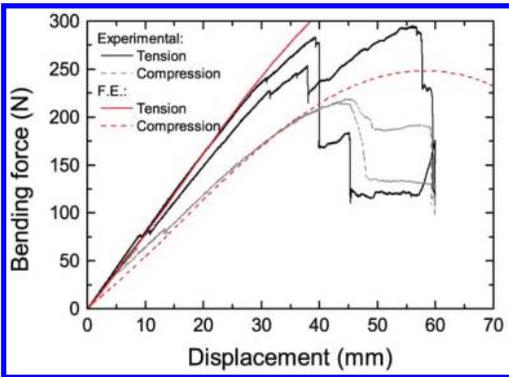
Figure 6. Comparison between experimental (black lines) and numerical (red lines) force-displacement curves in a 3-point bend test.

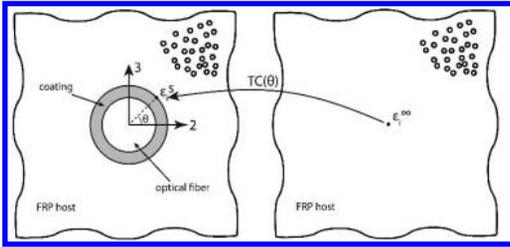
Figure 7. TC-matrix principle mapping far-field strains to coating-composite interfacial strains.

Under the assumptions of small displacements and linear elasticity, the TC-matrix coefficients can be found through the superposition principle by applying all 6 far-field strains independently.

By performing these TC-matrix calculations for several coating thicknesses (expressed dimensionless as the ratio of coating outer diameter to optical fiber diameter b/a), the effect of changing coating thickness for any load case (given by a set of far-field strains) can be determined. This allows the user to extract the optimal coating

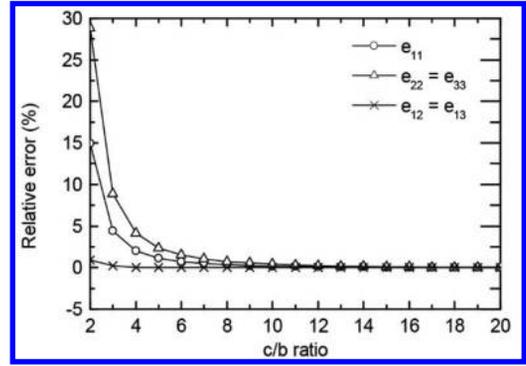
Figure 8. Relative error in TC matrix coefficients in finite samples by assuming an infinite host.

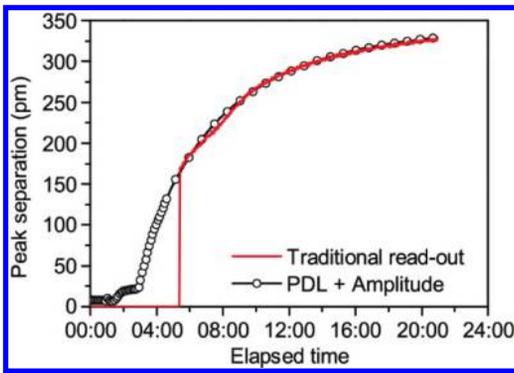
Figure 9. Bragg peak separation using traditional and PDL read-out techniques.

While the two Bragg peaks reflected in a birefringent fiber may have almost identical wavelengths, they do possess a different polarization state (indicated as E_x and E_y). Using a technique known as Polarization Dependent Loss (PDL), it is possible to discriminate between different polarizations of the incoming light, thereby enabling us to measure the two Bragg peaks independently (Caucheteur et al., 2007).

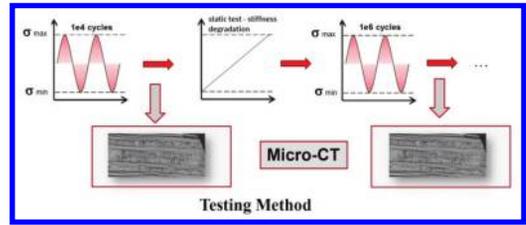
Figure 1. Schematic of the testing method: the fatigue test has been divided in several cycle intervals; between each of them a static test was performed and the sample was scanned for damage assessment.

A preliminary set of static tests in accordance with the ASTM D3039 standard have been performed on three reference samples for each material in order to evaluate the Ultimate Tensile Strength (UTS) and therefore define the load amplitude of the fatigue cycles. The test procedure consisted of a set of cumulative cycle intervals, which were interspersed with static tensile tests; these tests served to evaluate the laminate stiffness and its reduction due to occurring damages. At this stage, the samples were also dismantled from the testing rig, moved to the μCT facility and scanned. Figure 1 summarizes the test procedure in a schematic.

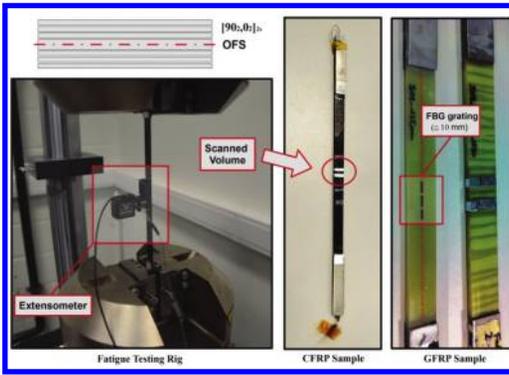
Figure 2. Testing setup: (top-left) schematic of the lay-up for the laminate and fibre optics embedding location, (bottom-left) sample mounted between the grips of the servo-hydraulic testing machine and (right) both carbon and glass fibres specimens prepared for testing.

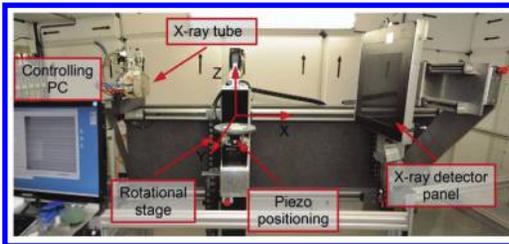
Figure 3. High-energy CT scanner optimized for research (Hector) used to scan at high resolution the composite specimens.

of $4 \times 8 \times 8 \text{ mm}^3$ for the $4 \mu\text{m}$ ones, respectively. The scans were obtained with two different setups, property of the UGCT—Centre for X-ray Tomography of Ghent University. Both of them had an X-ray tube emitting X-rays through the sample, which was fixed vertically on a rotational stage, and a flat panel detector to record digital radiographs. In Figure 3 the HECTOR (High-Energy CT scanner Optimized for Research) scanner is depicted. The X-ray tube is a high-energy XWT 240-SE microfocuss source (from X-RAY WorX®) which was set at a Voltage of 140 kV and 8 W of target power, while maintaining a minimum focal spot size of approx. $4 \mu\text{m}$. A $40 \times 40 \text{ cm}^2$ PerkinElmer 1620 CN3 CS flat panel detector and a total of 9 motorized axes of freedom allows for a high flexibility scanning. Nevertheless, the high-precision stage mounted on the manipulator allows for fine positioning of the sample and therefore a spatial resolution up to $4 \mu\text{m}$ is also achievable.

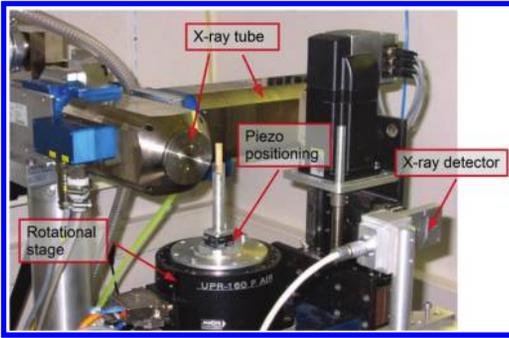
Figure 4. Modular 900 nm medium-energy micro-CT scanner used for the non-destructive evaluation of the composite samples.

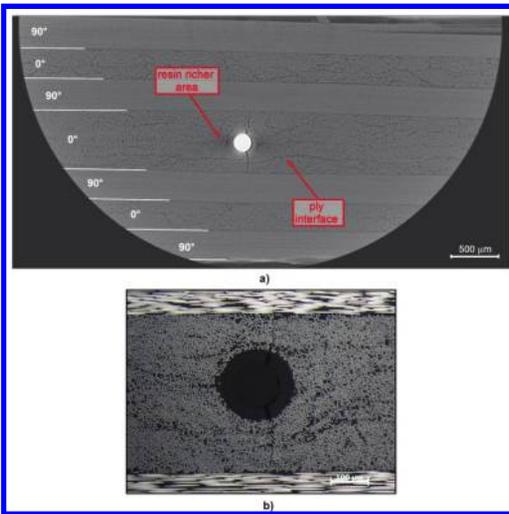
Figure 5. (a) CT cross-section of a carbon fibre sample having a 125 µm optical fibre embedded. (b) The scan is compared with the corresponding picture taken with a microscope after cutting and polishing the sample.

of a stack of 20 adjacent reconstructed slices; this allowed reducing the noise level and enhancing the contrast-to-noise-ratio, with consequent details smoothing. In Figure 5, the post-processed cross-section of a CFRP laminate having a 125 µm embedded optical fibre (195 µm diameter considering its coating) is given. Clearly recognizable in the image are the differently oriented 0° and 90° plies, which are defining the cross-ply lay-up. Each 0° or 90° layer is composed by two prepreg plies; in the centre of the laminate, the fibre was placed in the middle of a four plies layer oriented at 0°. Most relevant to be noted, is the crack which has developed at the sensor/composite interface.

Comparing the fibre close-up with an optical microscopy image taken from a polished cross-section on a similar sample (Fig. 5b), one can notice some analogies. Firstly, the crack presents the exact same geometry in both images. The samples were analysed shortly after manufacturing and were not yet subjected to any mechanical loading. In other words, probably the stress build-up during curing of the prepreg layers has been sufficiently high to induce the damage. This is explainable by the low resistance of the composite plies in the transverse direction (which is governed only by the resin) and by the thermal expansion mismatch between the sensor and the hosting composite. Secondly, even the richer resin content interfaces between two adjacent plies can be distinguished on the fibre neighbourhood. Particularly, it is noticeable how the plies are forced to redistribute around the sensor, resulting in resin richer areas sideways the fibre.

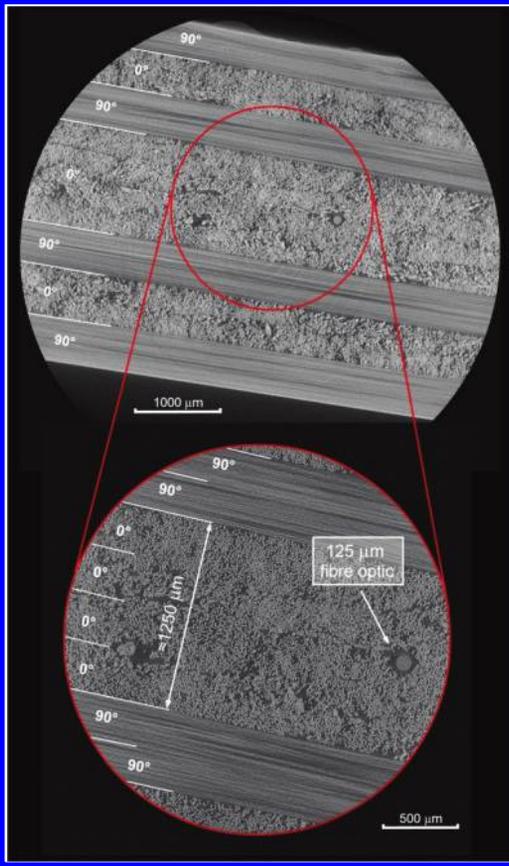
Figure 6. CT cross-section of a glass fibre sample having a 125 µm optical fibre embedded that was scanned at 4 µm voxel size. The enlargement is the result of a finer scan obtained at 2 µm voxel size.

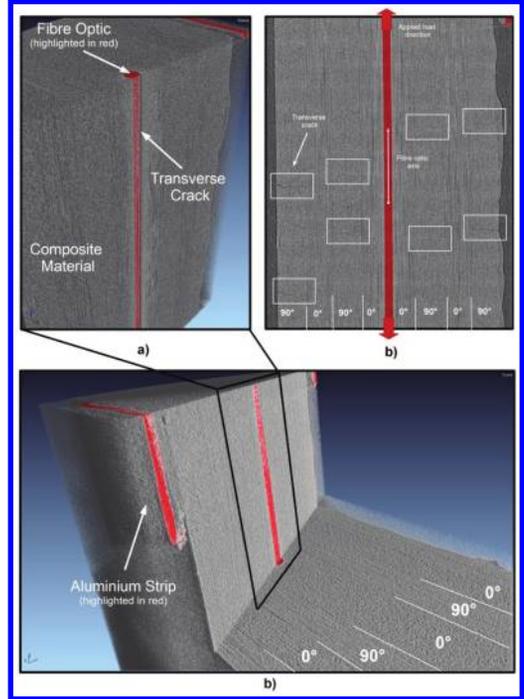
Figure 7. (c) 3D rendering of a CT scan on the fibre optics surroundings for a carbon fibre sample, (a) detail of the crack evolving through the whole fibre coating and (b) cross-section taken along the fibre axis; the matrix cracks are indicated in white boxes.

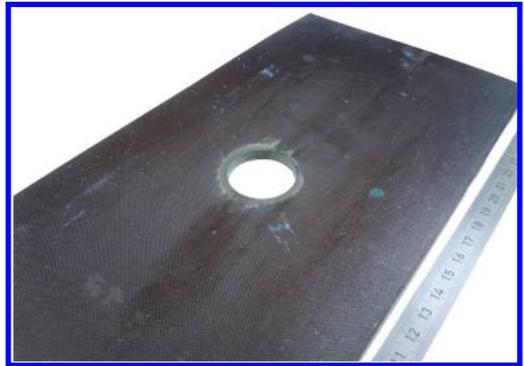
Figure 1. The tested structure.

Despite a composite-optimised process parameters and cutting trajectories, the ultrasonic scanning of these plates indicated the presence of significant delaminations area around cut hole observable in Figure 1.

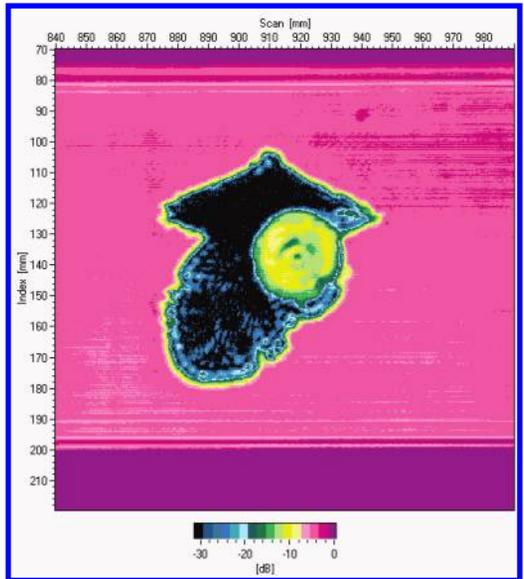
Figure 2. The C-scan of the tested structure.

The Ultrasonic Testing (UT) was performed on the air-coupled ultrasonic transducers system HFUS 2400 AirTech manufactured by the Ingenieurbüro Dr. Hillger. The focusing distance between 250 kHz emitter AirTech 4412 and receiver AirTech 4422 probes was set to 50 mm. The attenuation range was defined from -31 dB to 0 dB with 16 levels in between. The wave running time was set to 250 μ s, which ensures the acceptable quality of the obtained C-scan (Figure 2).

The delamination, resulted from the water-jet cutting, is clearly detectable in C-scan, however this technique allows for damage detection and localization in two dimensions, which results in loss of information of damage location in the normal direction to the surface of the tested structure. Moreover, it is still impossible to determine a type of a damage. The next step of damage localization was performed using CT.

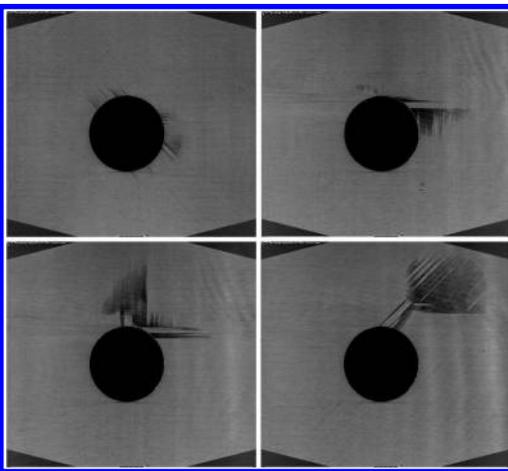
Figure 3. Exemplary virtual 2D slices of a CT scan.

The CT scans were reconstructed to a 3D data array and exported to the tomograph-dedicated software myVGL by Volume Graphics. Examples of virtual 2D slices of the tested structure are shown in Figure 3.

The damaged regions are clearly detectable in the virtual slices presented in Figure 3 but are still of isotropic character. The damage is represented now by three spatial dimensions, which allows performing the classification procedure. Obtained 3D

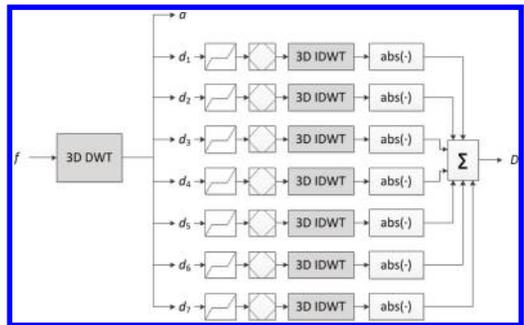
Figure 4. A scheme of wavelet-based processing algorithm.

The exported array was subjected to 3D DWT using the B-spline wavelet of order 4. This wavelet was selected basing on previous analyses (Katunin 2011). As a result, eight sets of coefficients (one set of approximation a and seven sets of directional detail $d_{1,...,7}$ coefficients) were obtained. Since the measured data was highly biased by the measurement noise and artefacts it was necessary to apply the pre-filtering procedure. It was realized by hard thresholding of the data with a threshold level of 25% from the maximal value of every set of detail coefficients. Such a procedure allows filtering out most of low-magnitude noise and the blurring surroundings, resulted by application of decomposition algorithm, of detected defects. After thresholding the labels on the CT images were removed and the boundary effect was reduced using the zero-padding method. After these operations the resulted arrays of detail coefficients (without the array of approximation coefficients) were reconstructed using 3D Inverse DWT (IDWT) algorithm. Each of the sets of detail coefficients was reconstructed separately and then their absolute values were added up, which formed single 3D arrays—the sets of D -coefficients. The scheme of this algorithm is presented in Figure 4.

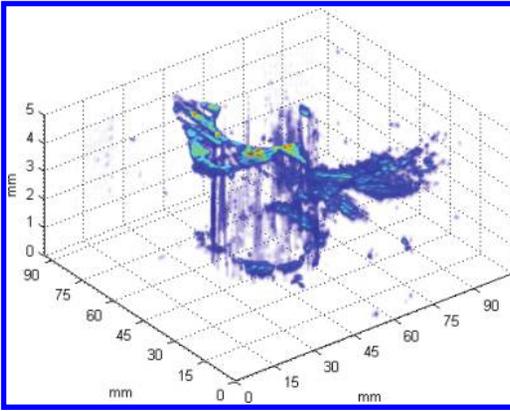
Figure 5. Results of damage extraction using proposed algorithm.

The results of damage extraction is presented in the form of a 3D plot in Figure 5. In order to increase the visibility of particular features on a 3D plot the transparency property, depending on the magnitude of the D -coefficients, was used.

Since the obtained result after processing of the CT scan is the 3D dataset (see Figure 5) the top projection was considered during determination of an area for comparability purpose. Using binarization and some logical operations on the analysed images the boundaries of delamination were determined in both cases (see Figure 9).

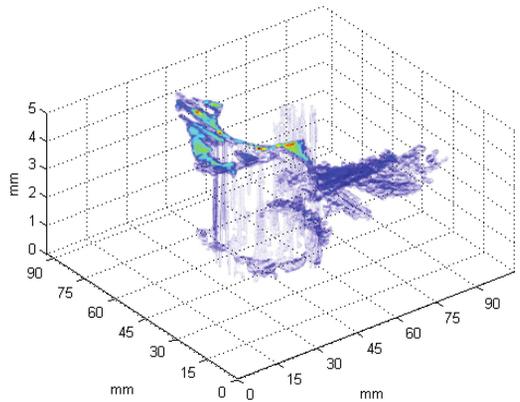
Figure 6. Classified set of delaminated regions.

Using the above-discussed measures three types of defects were effectively classified. The results of classification are presented in Figures 6–8.

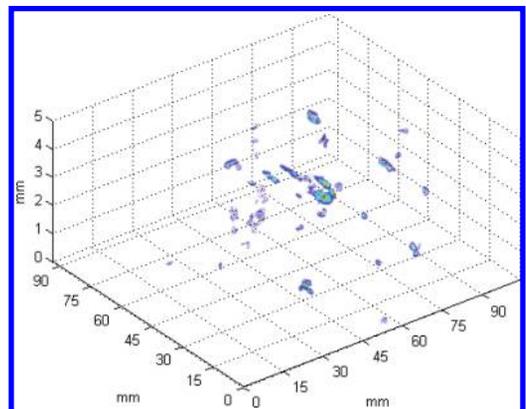
Figure 7. Classified set of air pockets.

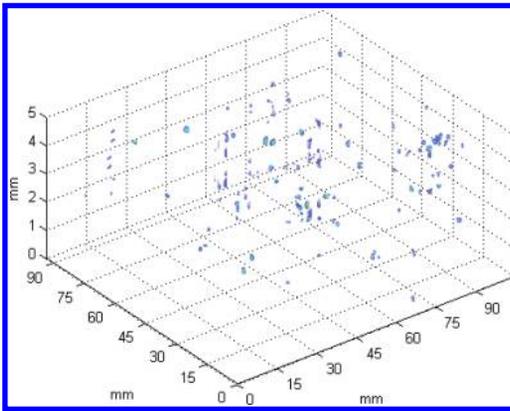
Figure 8. Classified set of noise.

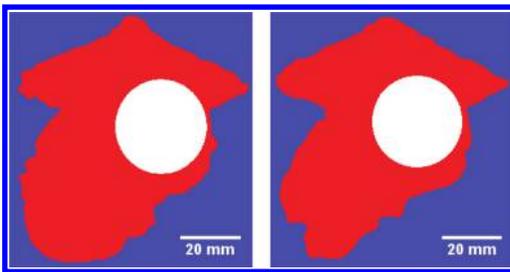
Figure 9. Delaminated region: left—UT, right—CT.

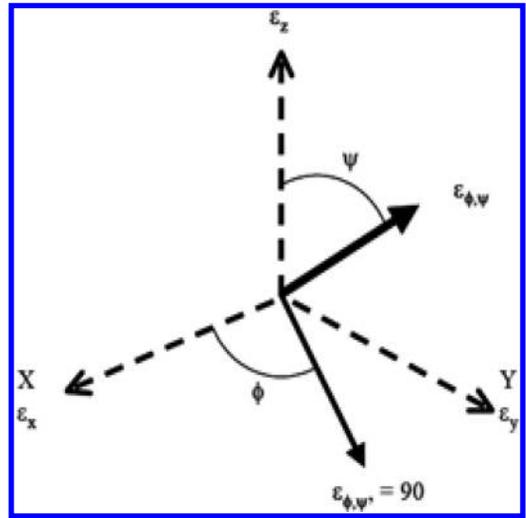
Figure 1. Principle Axis (X, Y and Z) of Strain (Fitzpatrick et al. 2005).

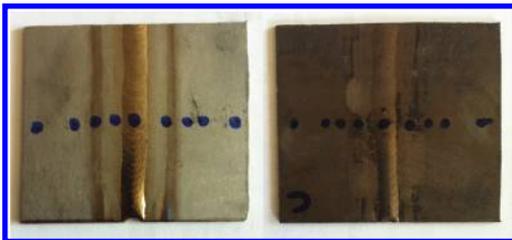
Figure 2. Specimen before and after PWHT.

50 mm × 50 mm with 2 mm thickness in ‘as-rolled’ condition. The specimen was then welded using the following TIG (Tungsten Inert Gas) welding parameters: 40 amps and 10 volts with inert gas shielding of flow rate of 6 lit/min (Fig. 2), this is a ‘bead on plate’ weld with complete penetration over the entire thickness of the plate. These welding parameters represent typical values for weld repairs of aero-engine components.

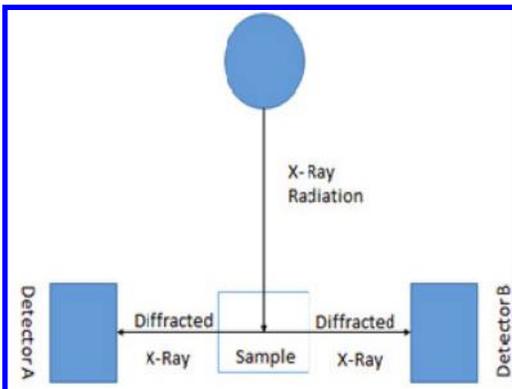
Figure 3. X-stress 3000 residual stress measurement technique (Schematic).

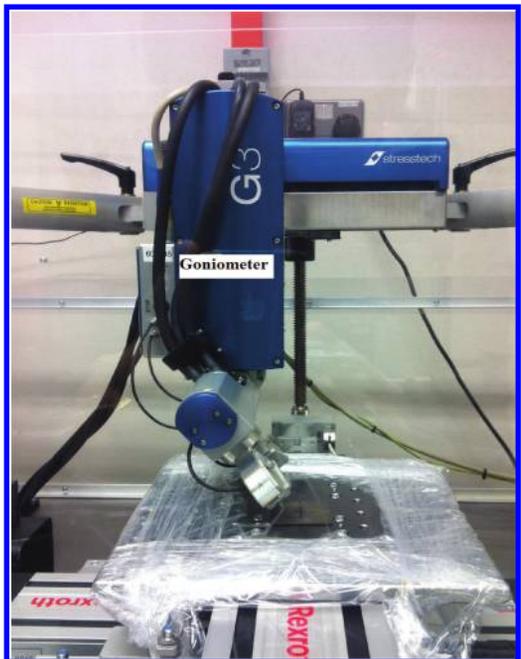
Figure 4. X-ray analyser for stress measurement with Goniometer.

In this work, X-ray diffraction was applied to measure residual stress. Xstress 3000 G3 analyzer (Fig. 4) is calibrated using the “stress-free” samples in order to establish lattice parameter d_0 , and a reference specimen was also used for calibration purpose. As previously discussed, the residual stress was measured at the surface to a depth of about 7 to 10 micron, and the results were obtained from points on the weld-bead, HAZ and base material (Fig. 5).

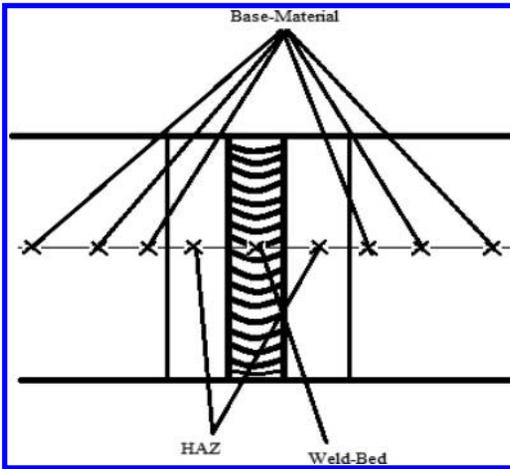
Figure 5. X-ray diffraction measurement zones (Schematic).

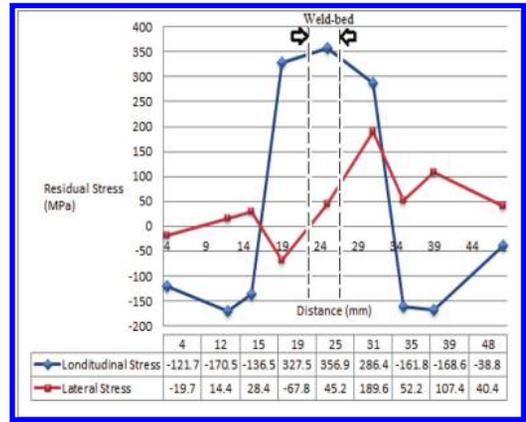
Figure 6. Residual stress before Post-weld heat treatment (PWHT).

ual stress is also measured in the lateral direction and the stress ranges from 190 MPa to -70 MPa (Fig. 6); it can be seen that the stress changes from compressive to tensile in a linear fashion along the weld-bead and HAZ (Kudrayavtsev et al., 2010). Ti-6 Al-4V has high yield strength when compared to commercial pure titanium so it will have less residual stress built up when welded (Song et al., 2014).

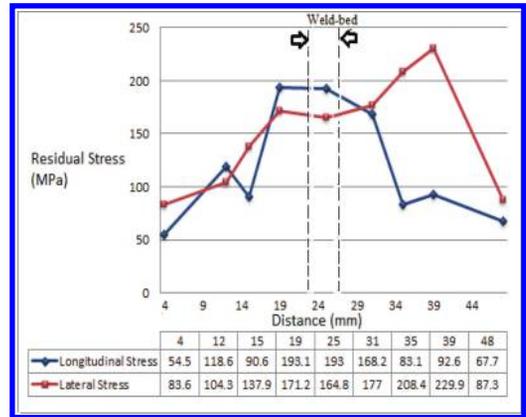
Figure 7. Residual stress after Post-weld heat treatment (PWHT).

The stress in both the directions were found to exist between a range of 50 MPa to 220 MPa (Fig. 7) after PWHT. Tensile residual stresses in the lateral and longitudinal directions may be used for determining the weld-life performance (Pardowska et al., 2009).

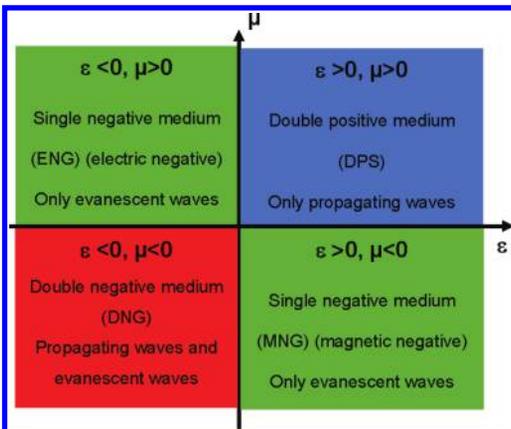
Figure 1. Schematic representation of materials depending on ϵ and μ .

The connection between ϵ and μ for a medium as well as the wave propagation through can be categorized into the following classes (Engheta & Ziolkowski 2006, Zouhudi & Shivola 2008), as presented in Figure 1.

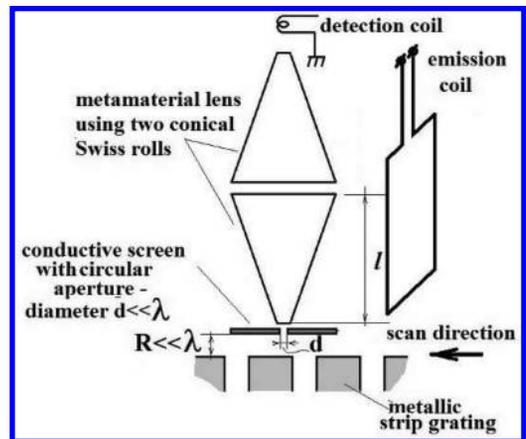
Figure 2. Detection of evanescent and abnormal modes generated in the slits of a metallic strip grating using lens transducer.

When $\epsilon_{\text{eff}} = -1$ and $\mu_{\text{eff}} = -1$, the refractive index of MM slab is $n = -1$ (Veselago 1968) and the surface impedance $Z = 1$, so there is no mismatch and consequently no reflection on the interface slab-air. This metamaterial slab forms perfect lens (Pendry 2000) and is focusing the electromagnetic field and also the evanescent waves (Pendry 2000). Due to experimental difficulties in obtaining a perfect lens, the manipulation of the evanescent modes can be made with a new type of electromagnetic sensors with MM lens that have, at the operation frequency, either $\epsilon_{\text{eff}} = -1$ and electric evanescent modes can be manipulated, either $\mu_{\text{eff}} = -1$, and the lens can focus magnetic evanescent modes (Pendry 1999). The principle of the lens transducer made from two Conical Swiss Rolls (CSR), used for manipulating the evanescent and abnormal modes generated in slits of MSG or carbon fibers of CFRP excited with electromagnetic waves, polarized TEz and respectively TMz is shown in Figure 2.

The proper detection system is made from a lens transducer consisting of two identical CSR having the large basis front to front (Grimberg & Savin 2011). The focal distance of this lens is $f = l$, where l represents the height of CSR (Savin & Steigmann 2014). A conductive screen with a circular aperture having the diameter $d \ll \lambda$ (λ is the wavelength in vacuum) (Fig.2) is placed near the focal object point. A detection coil is placed in the focal image point, converting the localized energy into electromagnetic force (emf). The sample is raster scanned, recording the energy image pixel or electromagnetic signature.

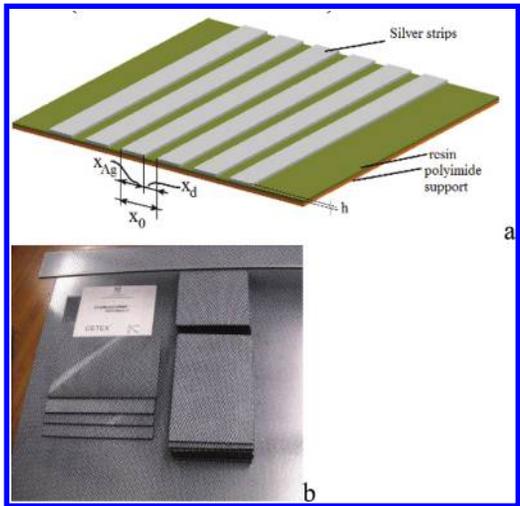
Figure 3. Studied samples: a) MSG; b) FRPC.

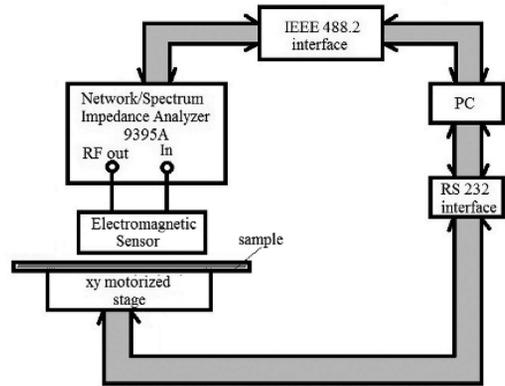
Figure 4. Experimental set-up.

The rectangular frame used for generation of TM_z polarized EM field having one turn with size of 20×60 mm, 1 mm diameter of Cu wire.

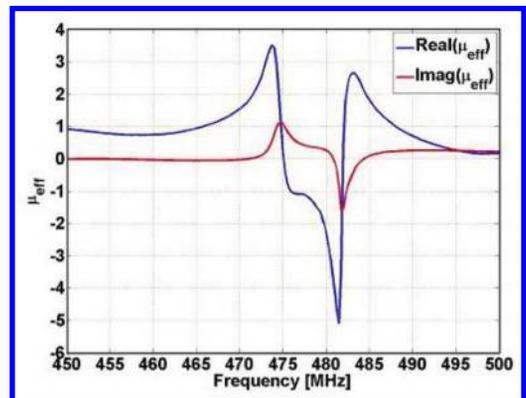
Figure 5. The dependence by frequency of effective magnetic permeability of the lens.

The real component of the effective magnetic permeability reaches the maximum value at 473.8 MHz and the value of -1 at 476 MHz. The distance between screen aperture and the surface to be examined has been maintained at $20 \mu\text{m} \pm 1 \mu\text{m}$.

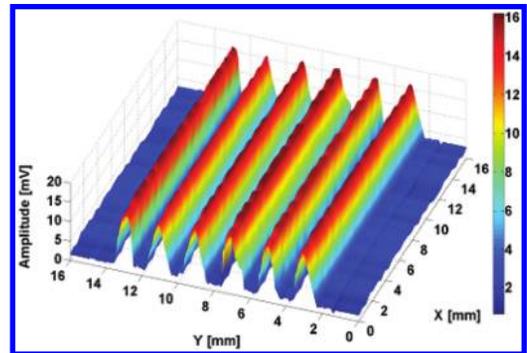
Figure 6. The results at the scanning of $16 \times 16 \text{ mm}^2$ surface.

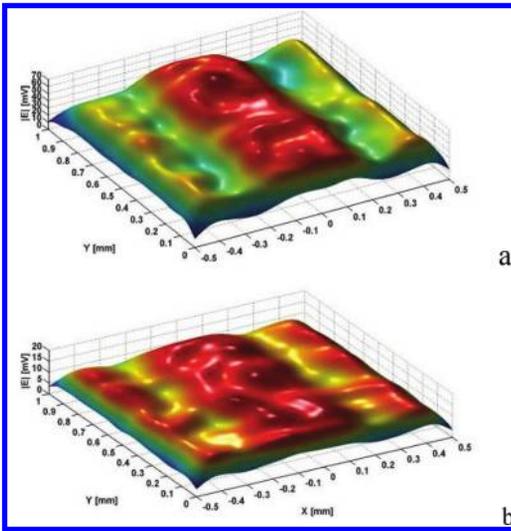
Figure 7. Image of evanescent and abnormal modes generated in slits for TMz polarized excitation at frequency of 476 MHz: (a) slits filled with air; (b) slits filled with isopropyl alcohol.
