Emerging Technologies in Non-Destructive Testing VI

Editors

D.G. Aggelis & D. Van Hemelrijck

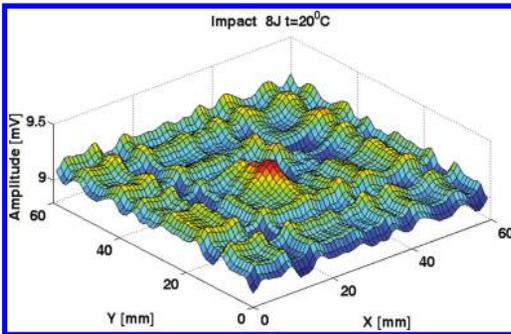
Figure 9. The answer of the sensor with metamaterials lens for 8 J impact.

A region of 60×60 mm from the sample has been scanned in both directions with 1 mm step, using the electromagnetic sensors described above.
